State of Colorado
Streambank Erosion Study

Summary Report
for the
Colorado State Soil Conservation Board
Colorado Association of Soil Conservation Districts

Soil Conservation Service
Denver, Colorado

November 1988

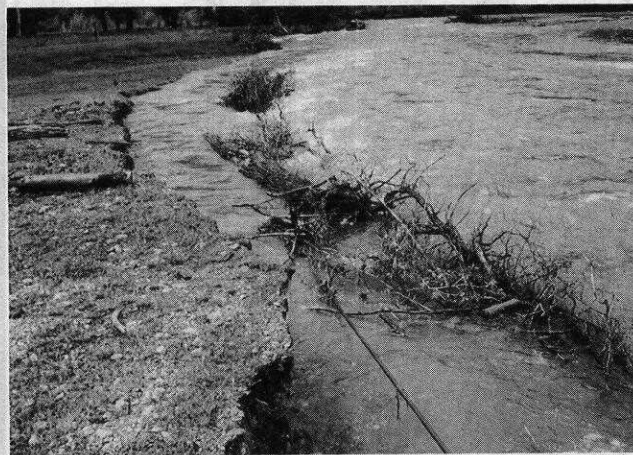
Damage to Anchored Trees on Dolores River
Photography by Jim Thornton, SCS, Denver, Colorado

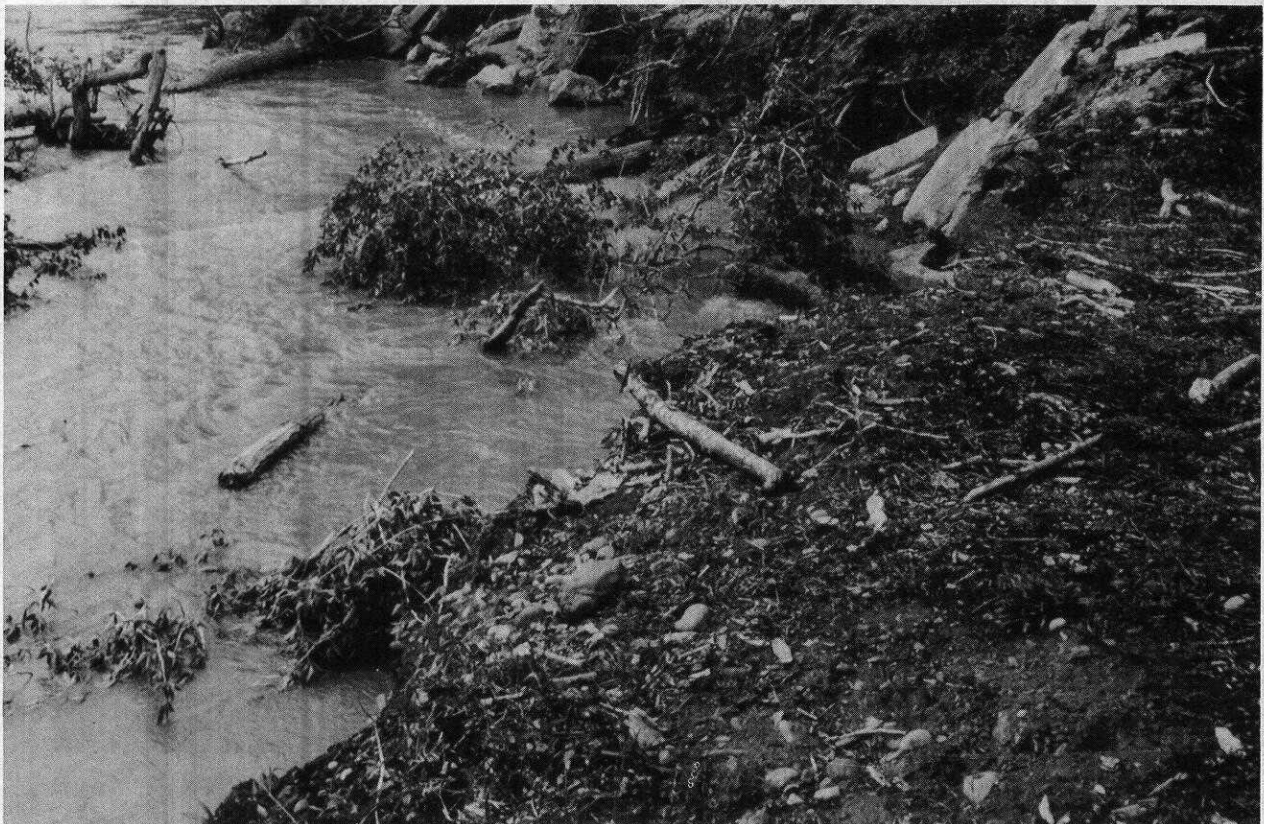
Streambank erosion on the Uncompahgre River
Photography by Jim Thornton, SCS, Denver, Colorado

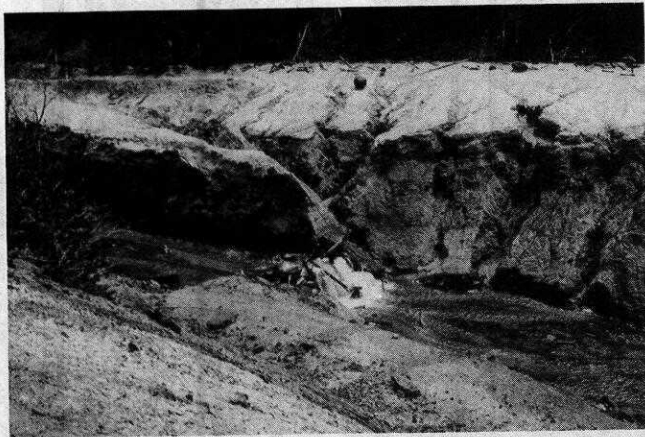
Mine tailings in Kerber Creek
Photography by Jim Thornton,
SCS, Denver, Colorado

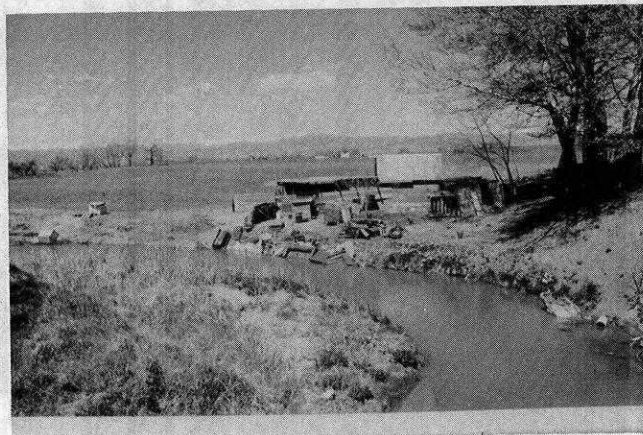
Debris on bank of Little Thompson River
Photography by Jim Thornton, SCS, Denver, Colorado

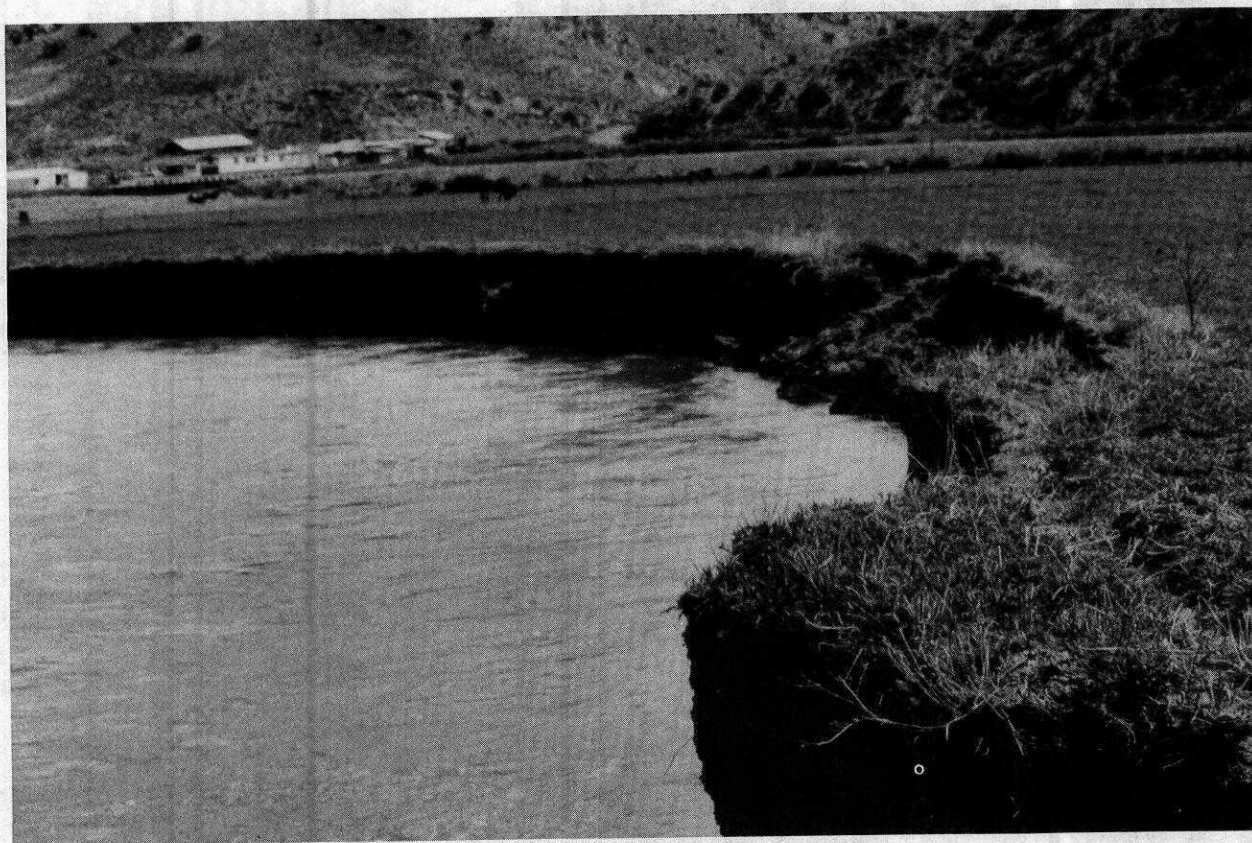
Streambank erosion of the White River into pastureland
Photography by Jim Thornton, SCS, Denver, Colorado

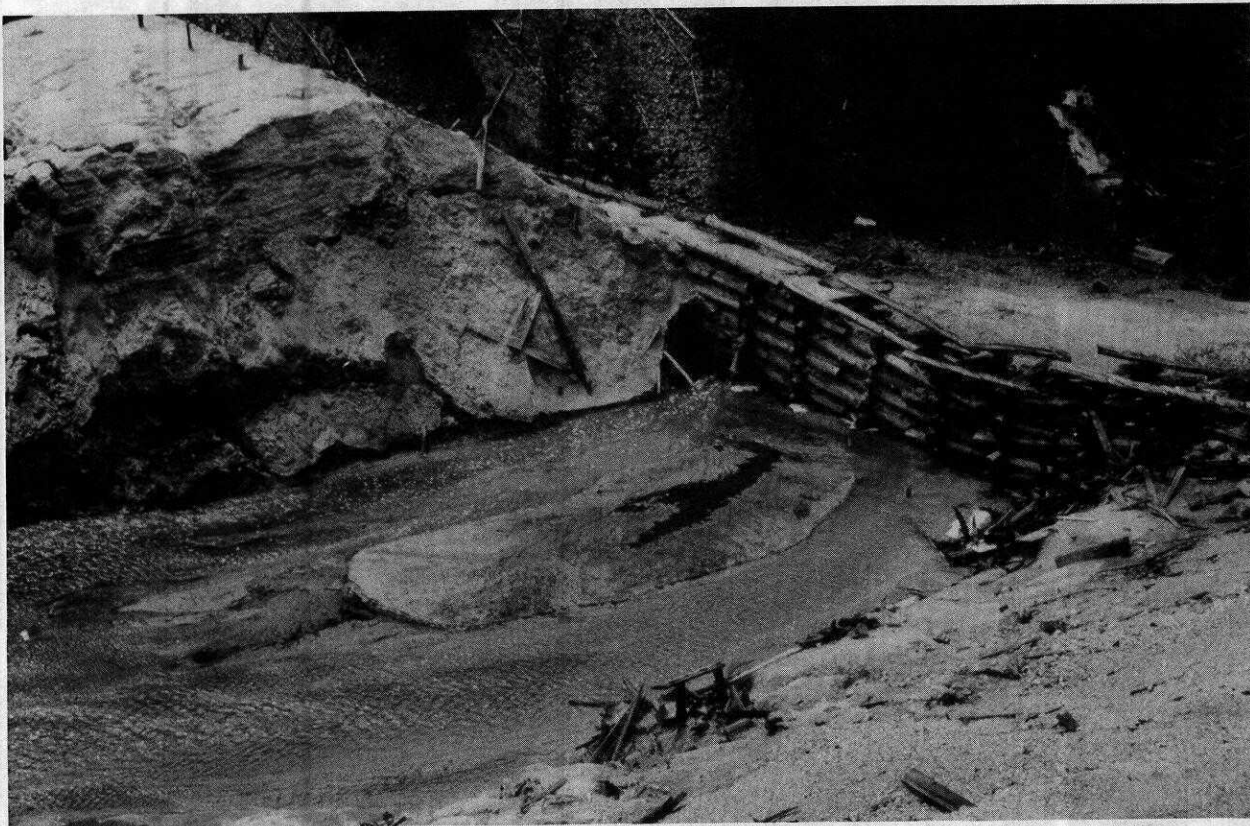
Mine tailings in Kerber Creek
Photography by Jim Thornton, SCS, Denver, Colorado

The proposed measures for improvement include rock riprap, anchored trees, rock jetties, jacks, vegetated buffer strips, vegetative sprig revetment, and riparian zones. Vegetative practices would require the contaminated streambanks to be cleaned and topsoiled so that plants would grow.

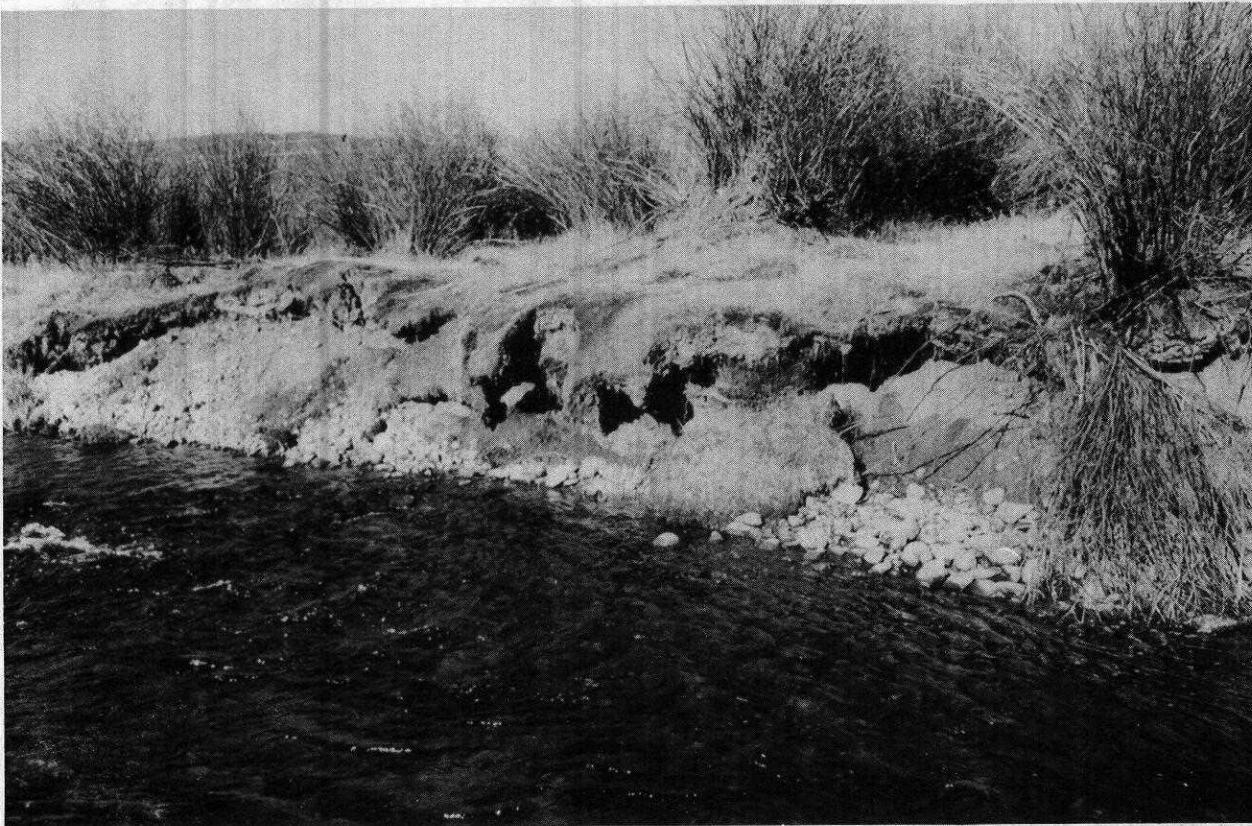
Streambank erosion of mine tailings sediment on Lake Fork
Photography by Jim Thornton, SCS, Denver, Colorado

The proposed measures for improvement included rock riprap, anchored trees, rock jetties, jacks, vegetated buffer strips, vegetative sprig revetment, and riparian zones. Vegetative practices would require the contaminated streambanks to be cleaned and topsoiled so that plants would grow.

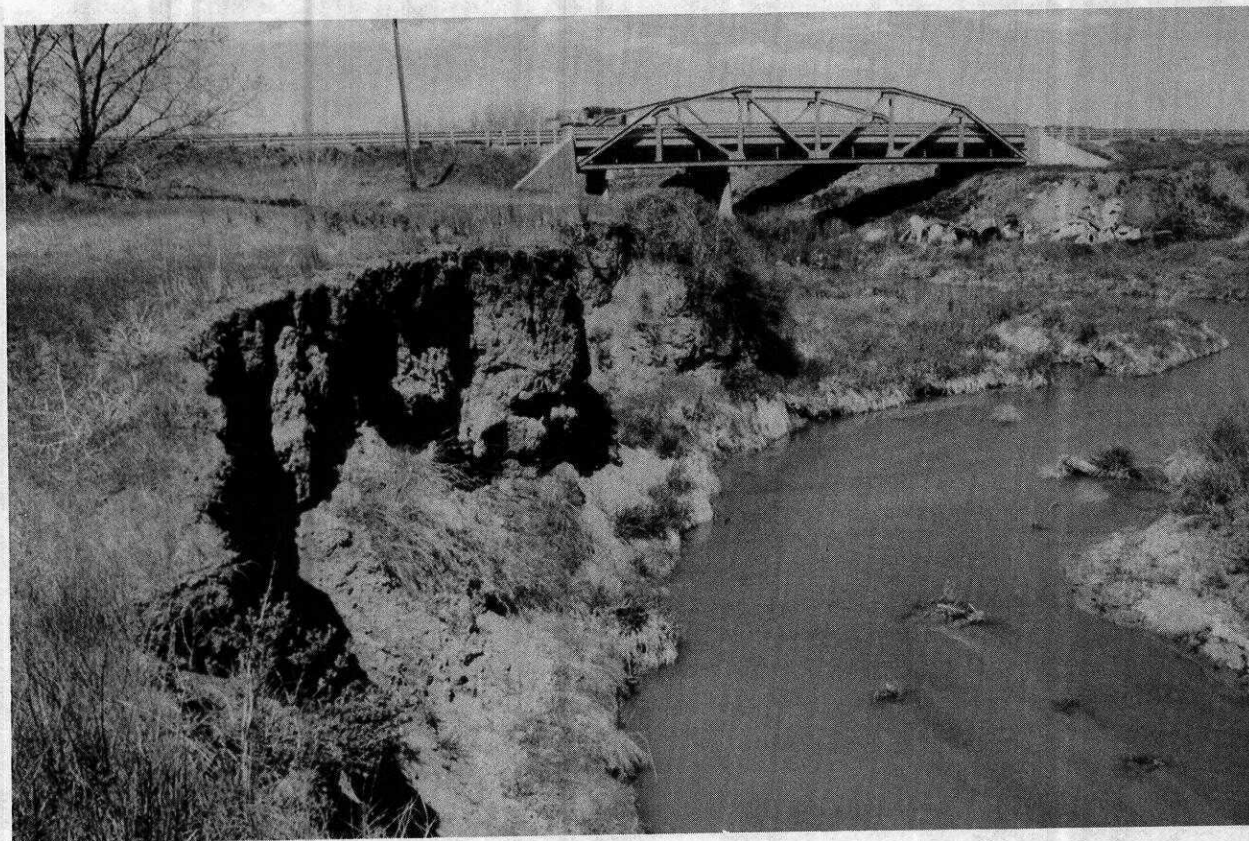
Streambank erosion into cropland on Little Thompson River
Photography by Jim Thornton, SCS, Denver, Colorado

The proposed measures for improvement included rock riprap, anchored trees, rock jetties, jacks, vegetated buffer strips, vegetative sprig revetment, and riparian zones. The water quality can be improved with "Best Management Practices."

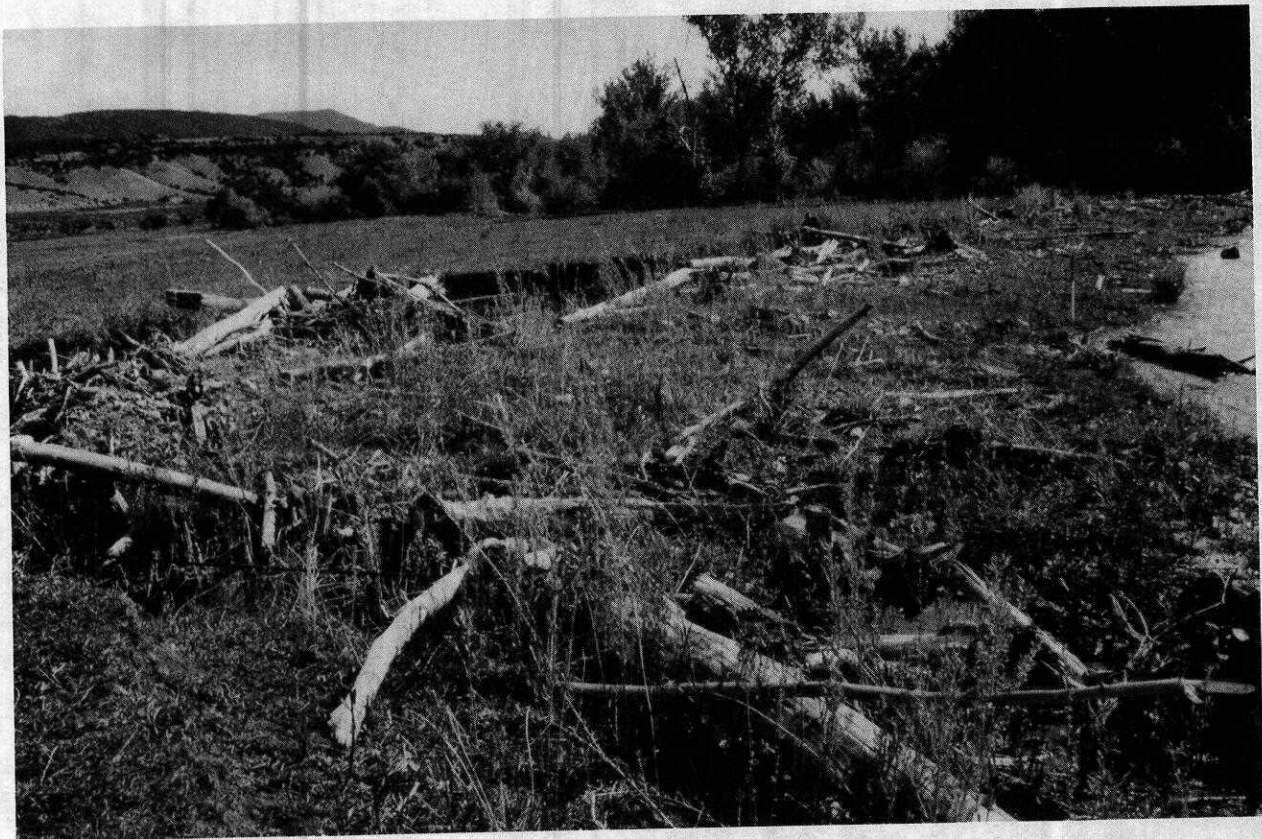
Anchored trees collecting debris on North Fork Gunnison River
Photography by Jim Thornton, SCS, Denver, Colorado

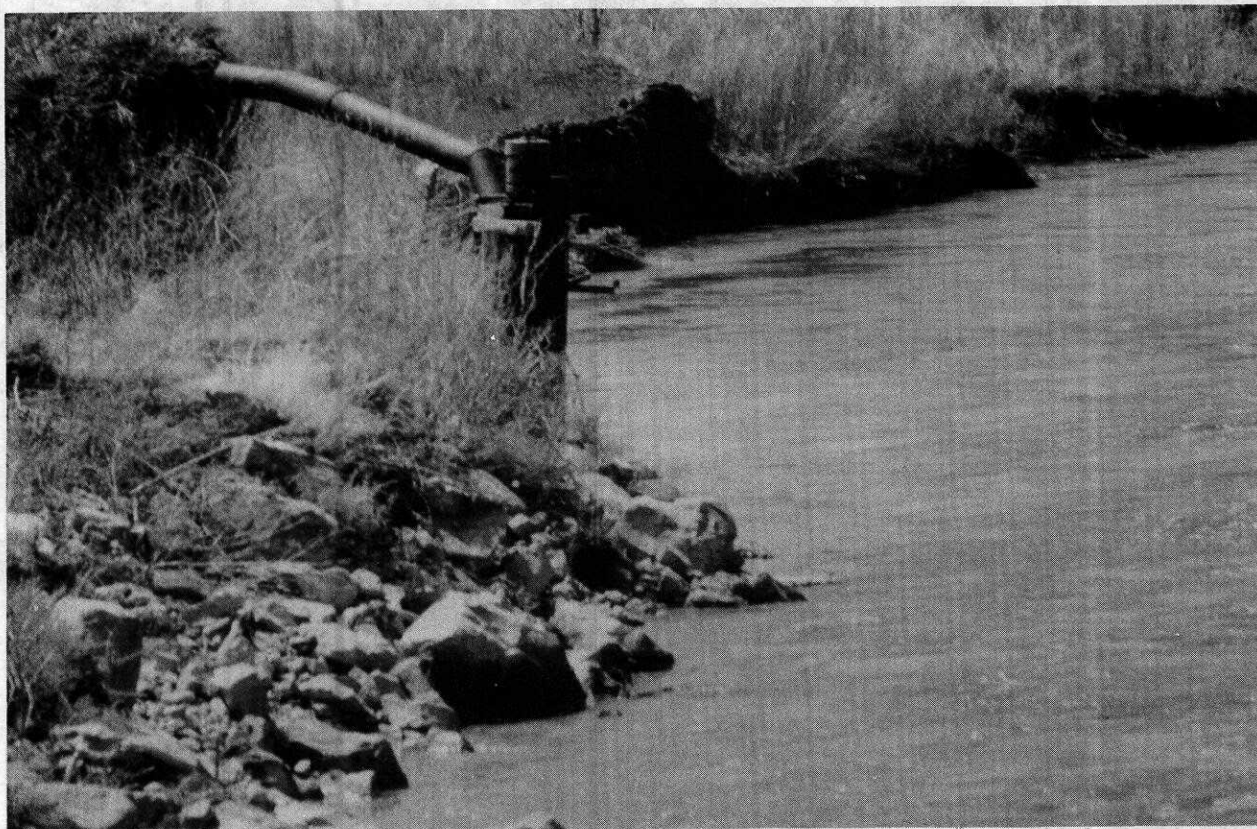
Streambank eorsion damaging irrigation pump on White River
Photography by Jim Thornton, SCS, Denver, Colorado

The proposed measures for improvement included rock riprap, anchored trees, rock jetties, jacks, vegetated buffer strips, vegetative sprig revetment, and riparian zones.
