**Report No. CDOT-2007-7**  
**Final Report**

# **FORENSIC INVESTIGATION OF PAVEMENT FAILURE ON VASQUEZ BOULEVARD**

**May 2007**

**COLORADO DEPARTMENT OF TRANSPORTATION  
RESEARCH BRANCH**

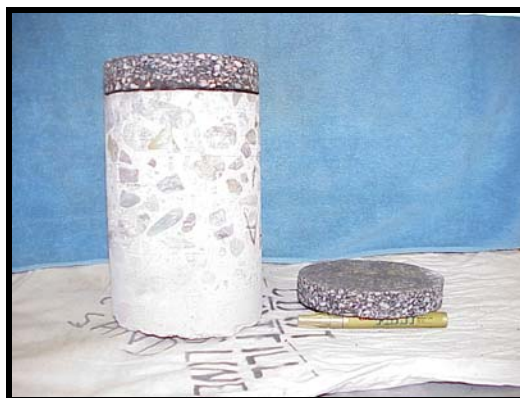
Figure 2: Core sample 4A SMA over PCCP

The two areas that did not show signs of immediate failure were the intersections where HMA was removed and replaced and the area where SMA was placed over existing PCCP. The intersections that received increased structural foundations along with immediate paving after milling have not shown any failure since completion of the project. Areas where full depth patching was performed prior to the SMA rehabilitation to repair the failed SMA appear to be structurally stable and continue to hold up under heavy loads.

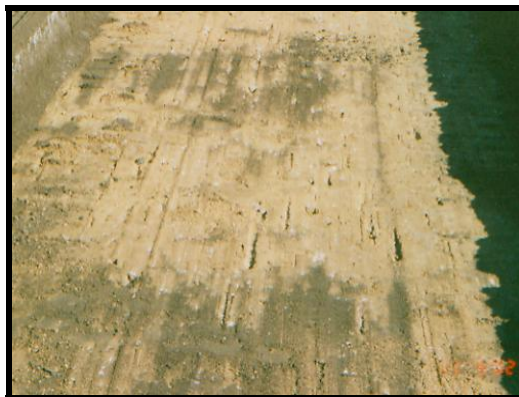
During the remediation of problem areas along Vasquez Boulevard, it was observed that newer SMA asphalt was very malleable to the touch and could be picked apart from old HMA quite easily. The SMA and the top few inches of HMA asphalt were saturated with moisture during removal. Frost had formed between the HMA and SMA layers, indicating that moisture could have seeped through and become trapped within interconnected voids. A cross section of the removed pavement showed that rutting in the top layers of the asphalt had not pushed into the roadbase but had stressed the top few inches of HMA. The roadbase appeared to be in very good condition at the time of the repair. Images of this repair are in Appendix A.

Figure 3: Roadbase exposed during asphalt remediation

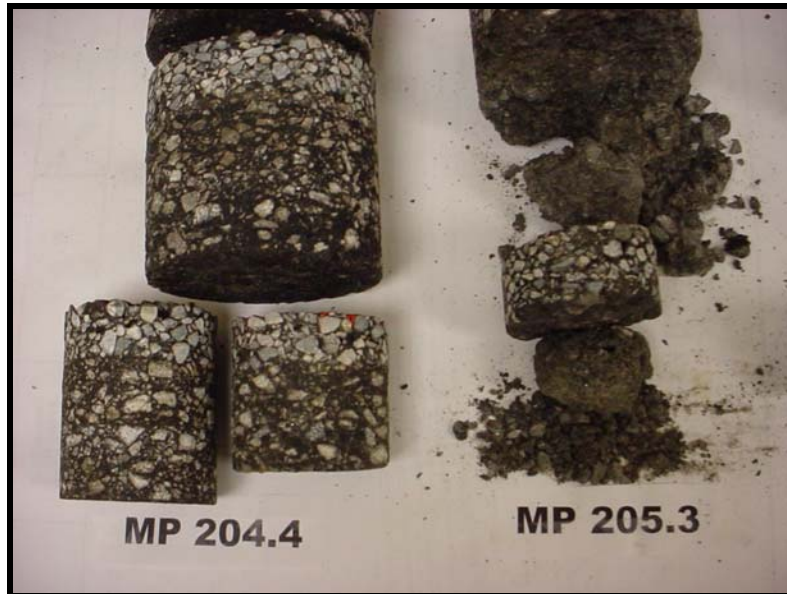
Figure 11: Core samples from I-75 south of Atlanta, Georgia

This picture shows the structural failure of the pre-lime Georgia HMA. The MP 205.3 core has nearly disintegrated.

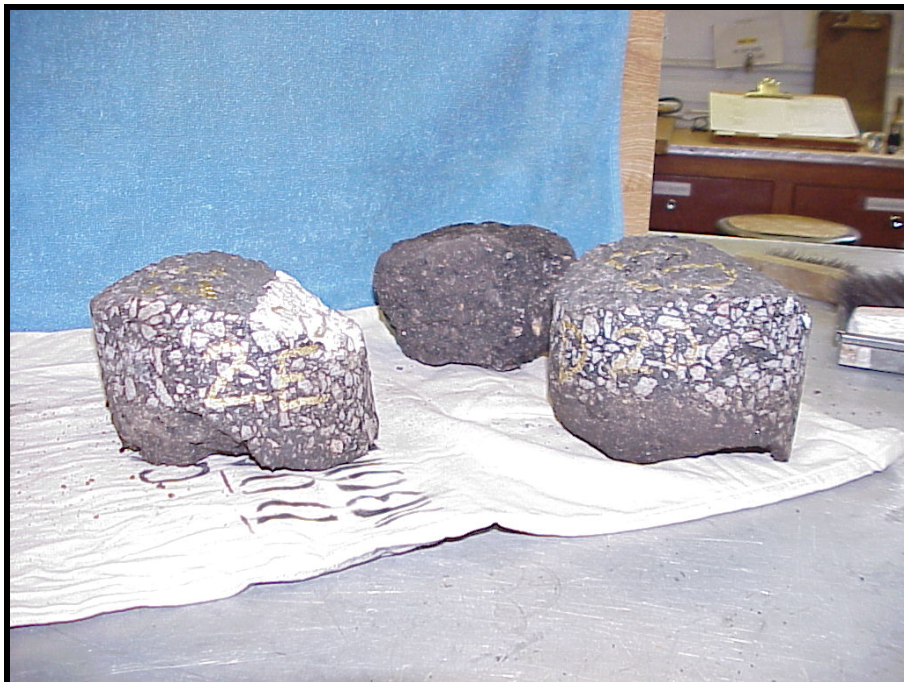
Figure 17: Core samples 2D and 2E from coring site 2

SMA only maintains its thickness to follow the contours of the failed HMA

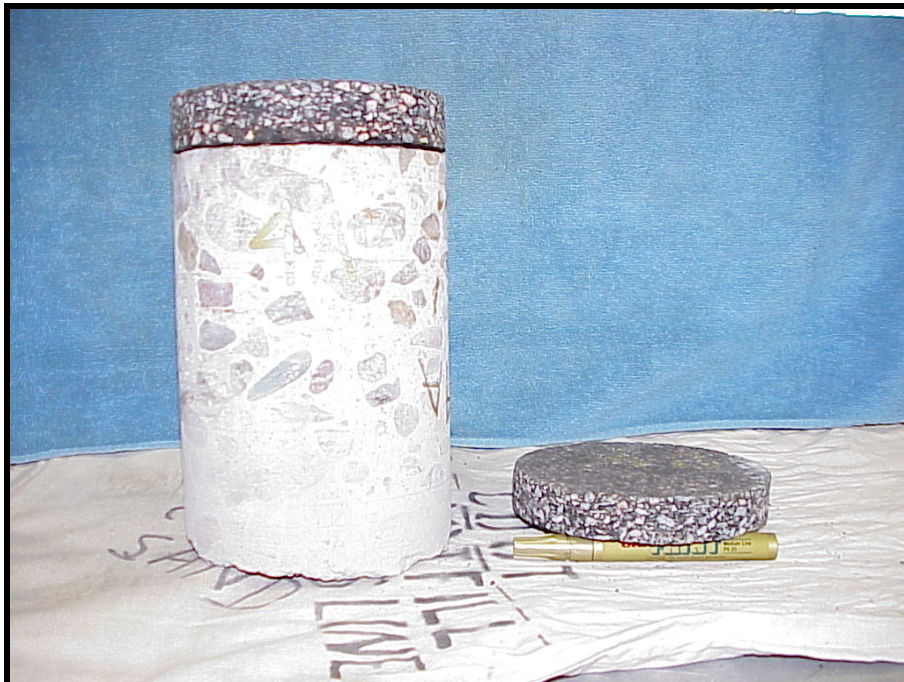
Figure 19: Core sample 4A from coring site 4

No rutting was discovered in the SMA lifts over existing PCCP pavement

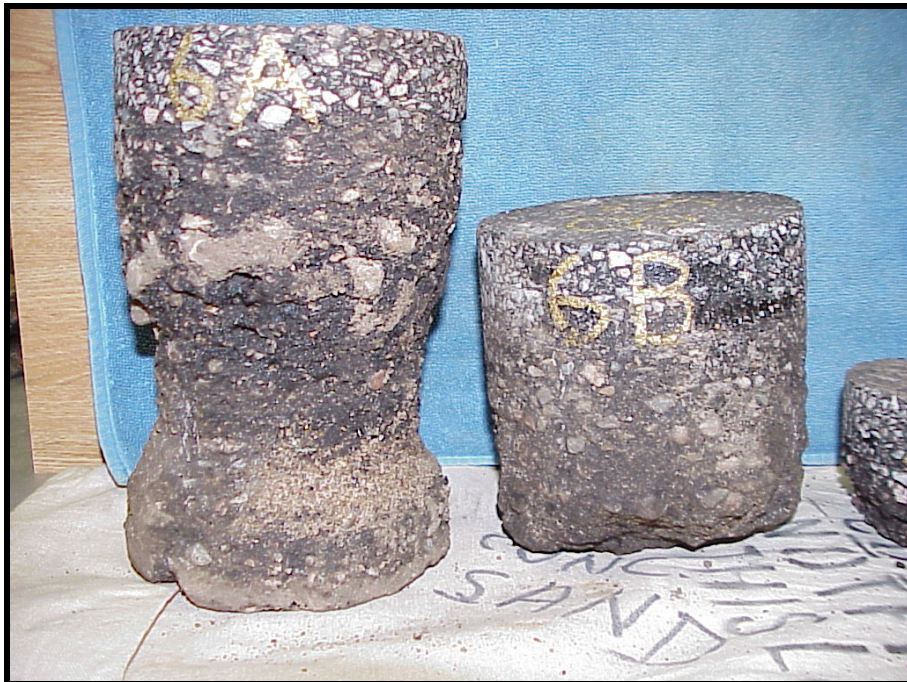
Figure 21: Core samples 6A and 6B from coring site 6

The hourglass failure is indicative of moisture damage in asphalt

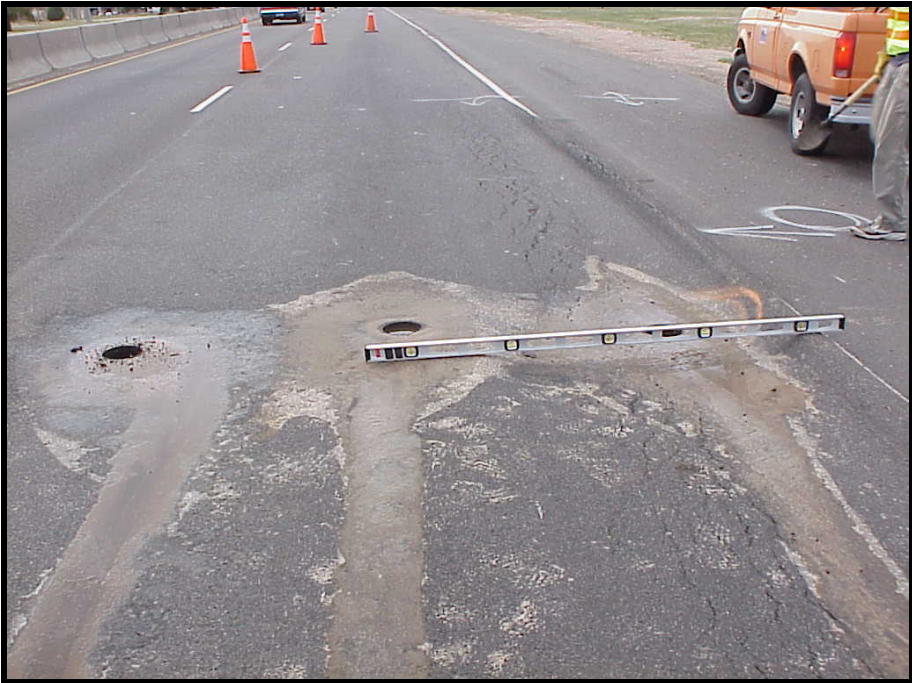
Figure 22: Coring location 6 showing one to two inch ruts in the number 2 lane

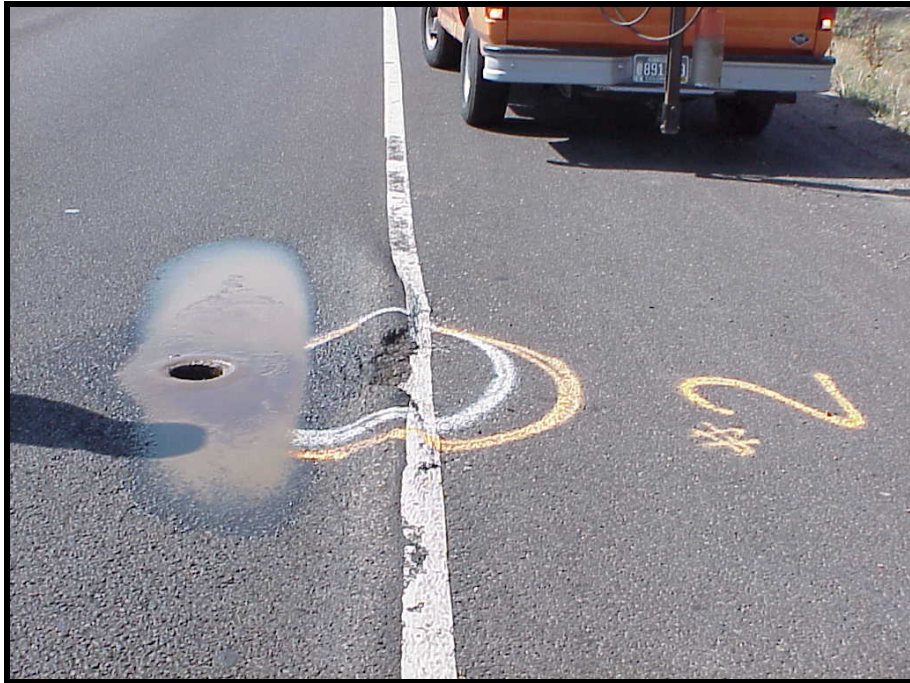
Figure 26: Coring location 2 illustrating the shoving failure of the asphalt

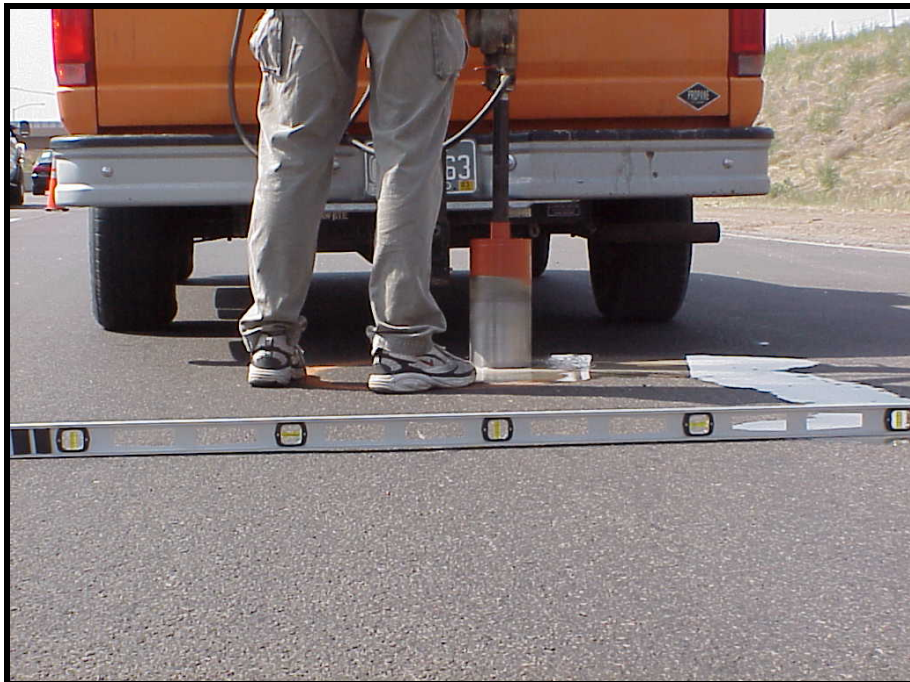
Figure 27: Coring location 4 illustrating quarter inch ruts in the number 2 lane

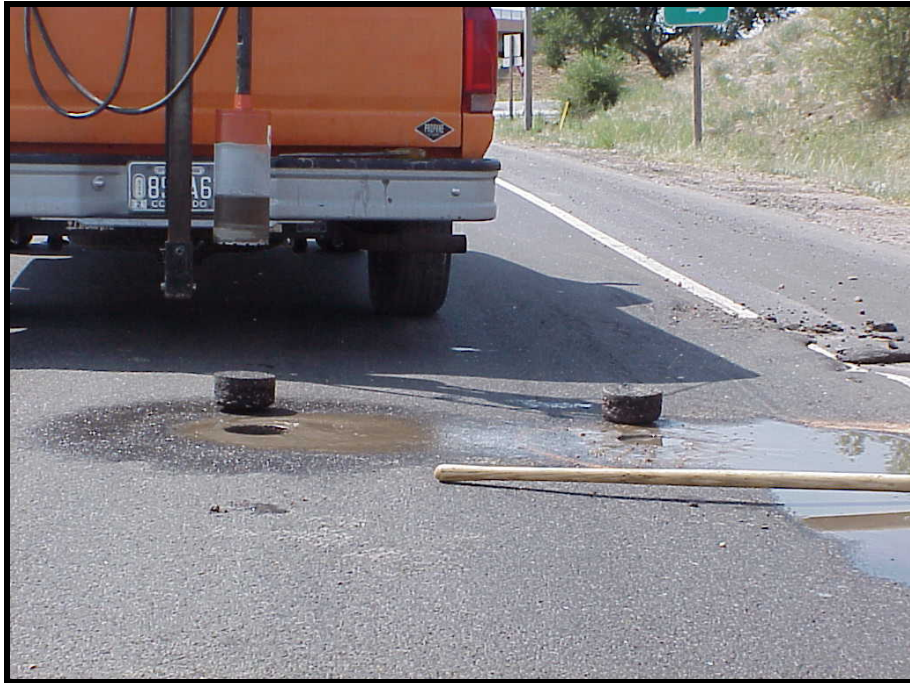
Figure 28: Coring location 5 for investigation

One to two inch ruts in the number 2 lane where truck traffic was concentrated

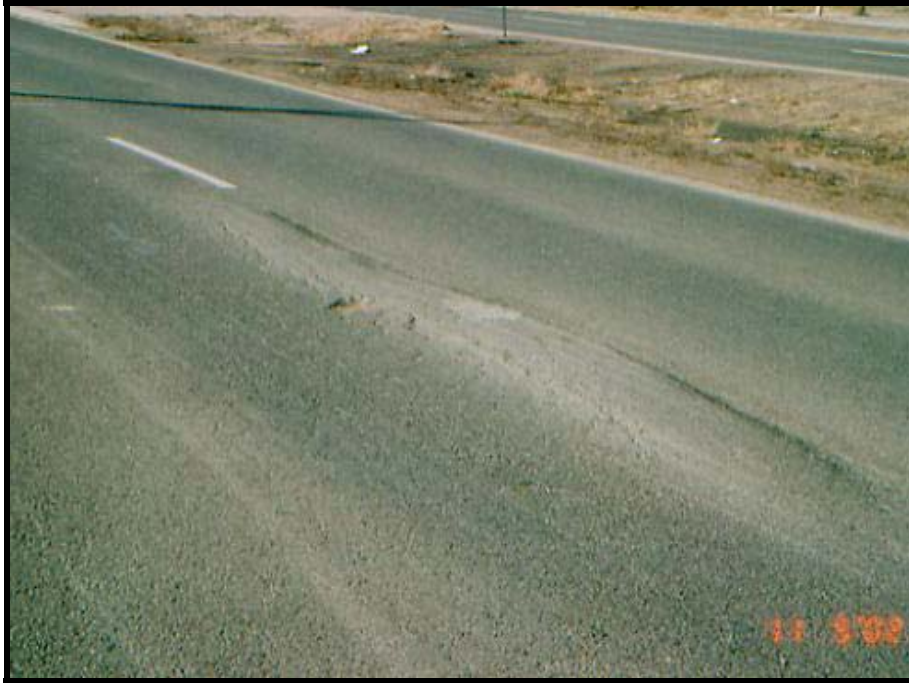
Figure 29: Failed SMA

Rutting and shoving evident during the remediation construction

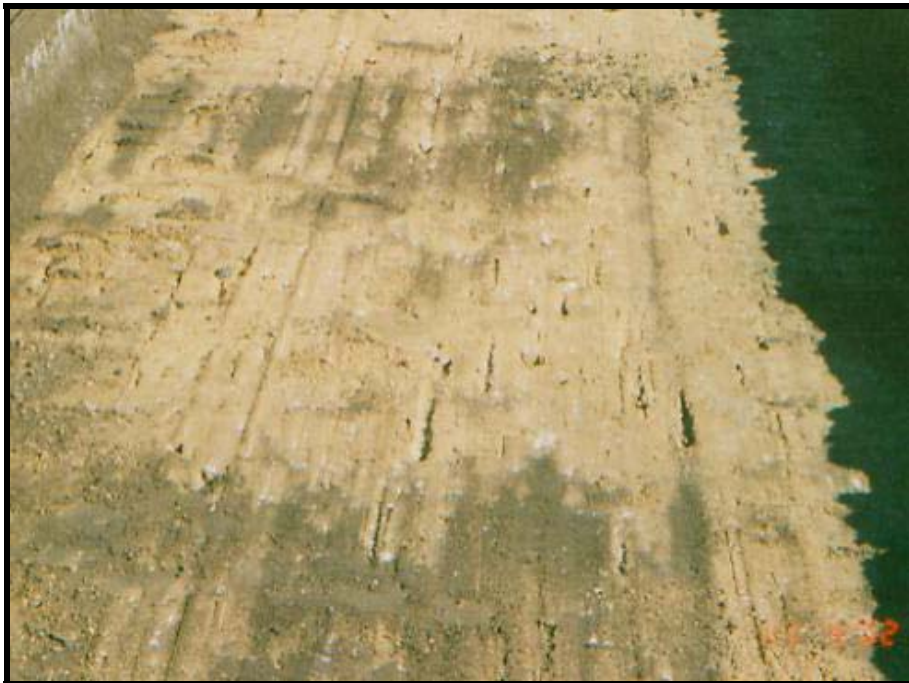
Figure 30: Roadbase exposed during remediation

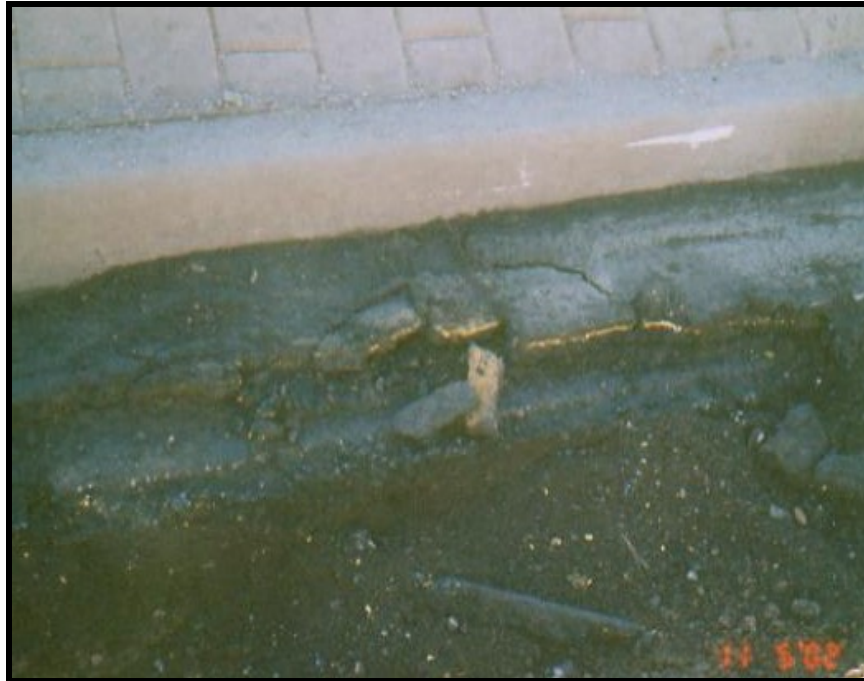
Figure 31: Asphalt removals during rehabilitation construction

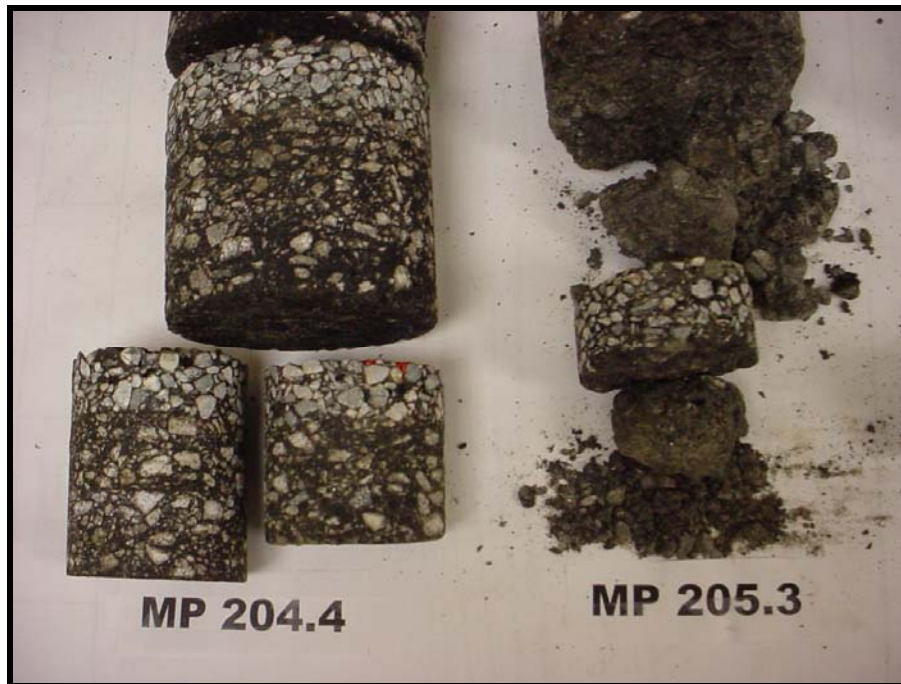
**Figure 32: Core Samples MP 204.4 and MP 205.3**

Sample MP 205.3 Moisture Damage in Hot Mix Asphalt from I-75 in Georgia

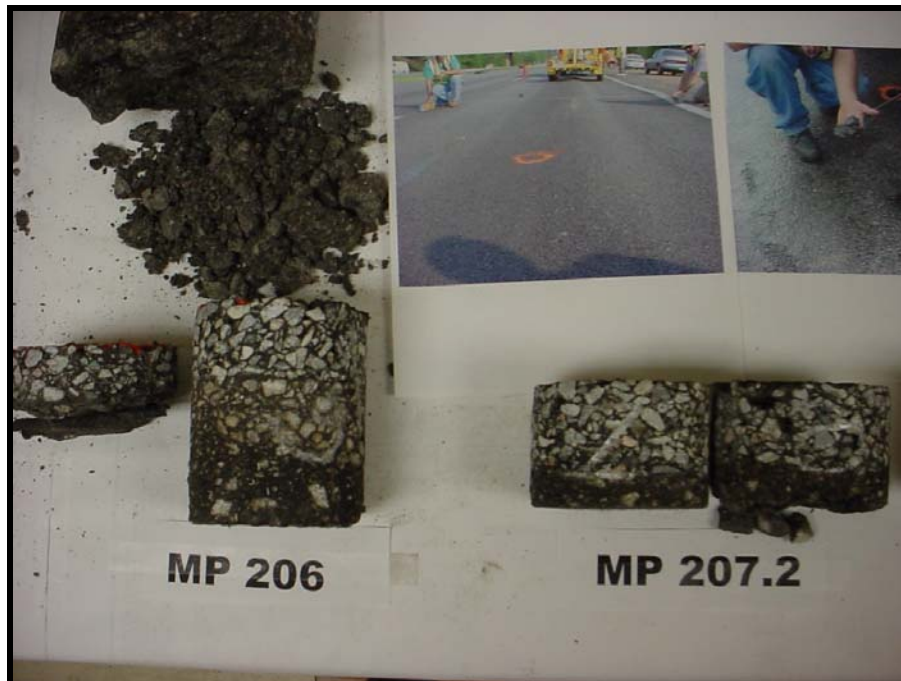
**Figure 33: Core Samples MP 206 and MP 207.2**

Core samples showing moisture damage and pictures of rutting

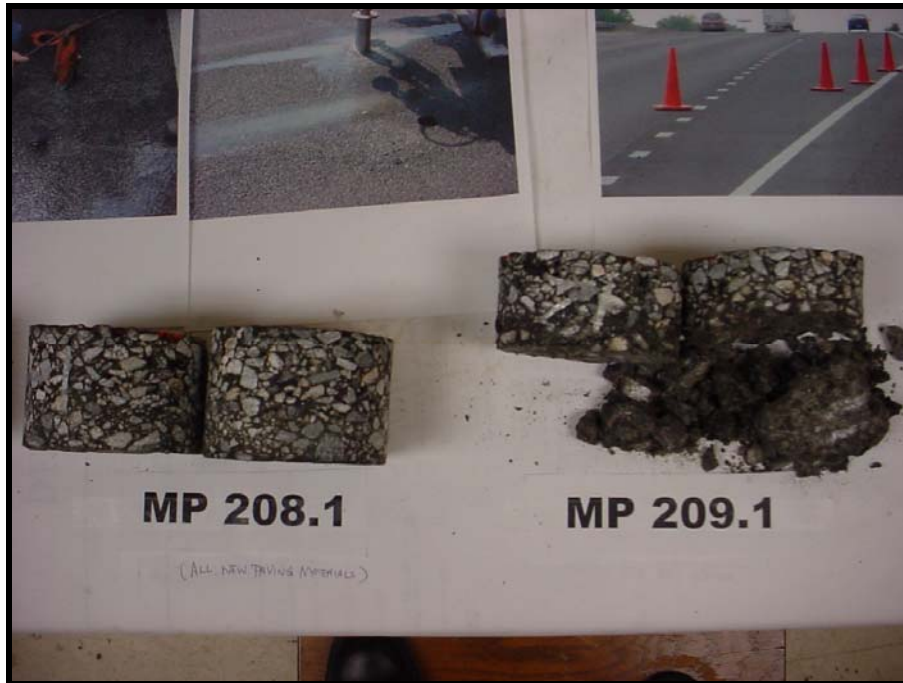
Figure 34: Core Samples MP 208.1 and 209.1

Core samples showing stripping from moisture damage

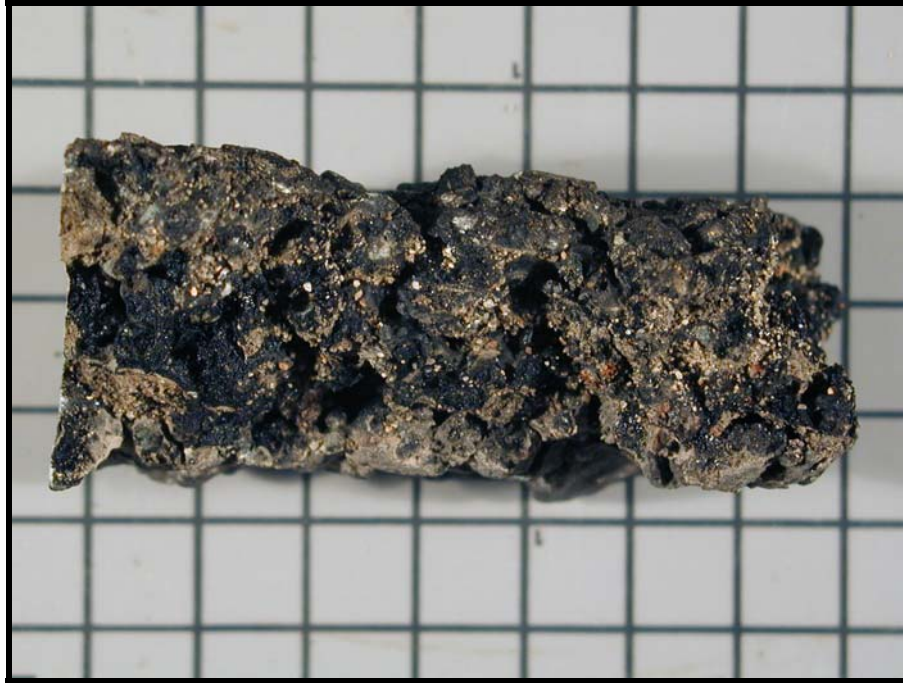
Figure 39: Core sample with evident striping and moisture damage

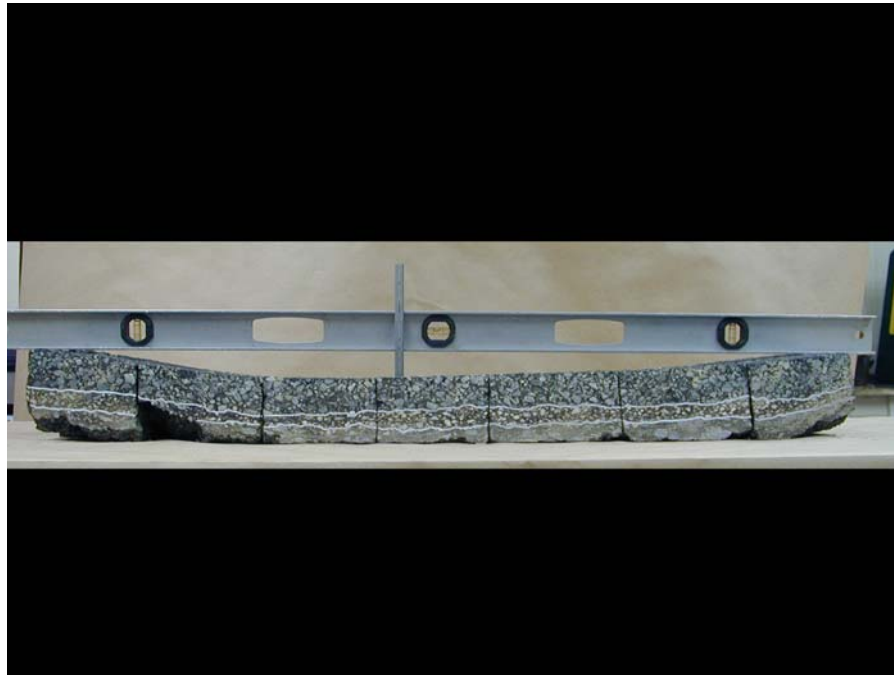
Figure 40: Cross section removed from I-495 showing 2"-3" ruts in SMA
