# OPTIMIZATION OF CONCRETE PAVEMENT MIX DESIGN IN COLORADO

## PHASE I REPORT NO. 2002-8

*An Executive Summary Report  
Developed by The Transtec Group, Inc.  
26 June 2002*

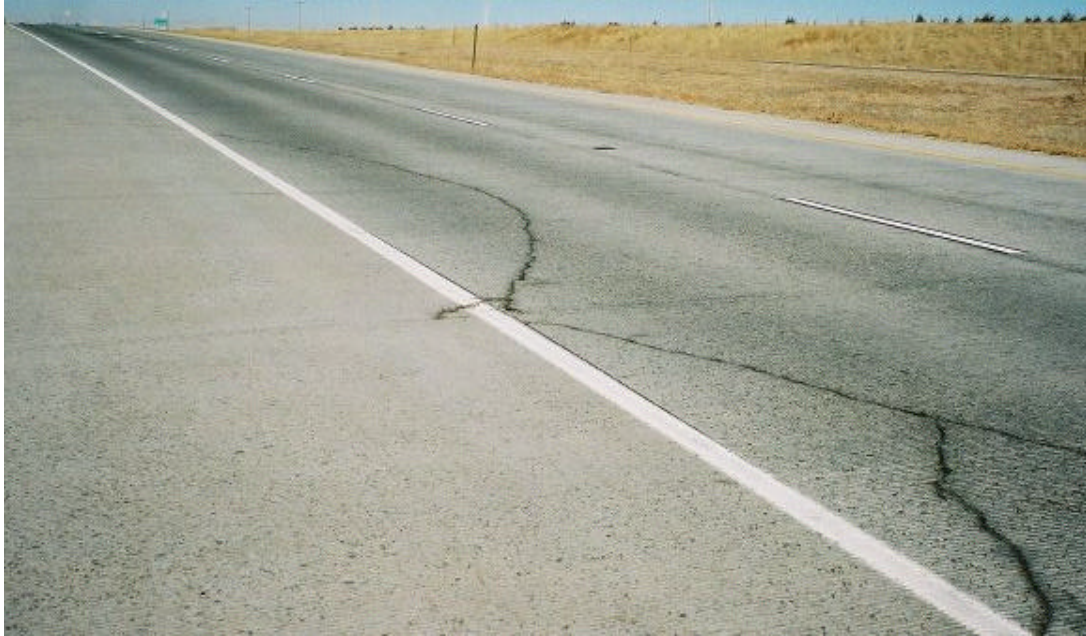
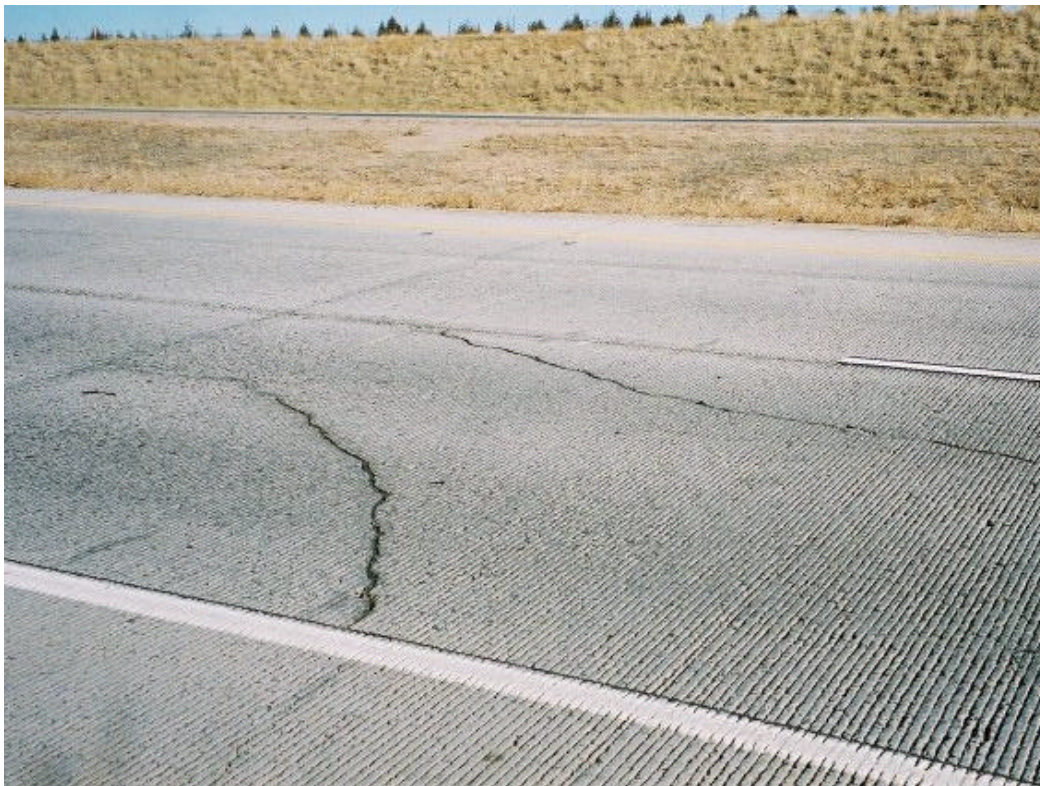
- Some longitudinal cracking observed.
- Cracks have been routed and sealed.
- Cracking could be due to loss of support or from late sawing.

*Figure B-1. Longitudinal Cracking of I-70.*

*Figure B-2. Longitudinal Cracking of I-70.*

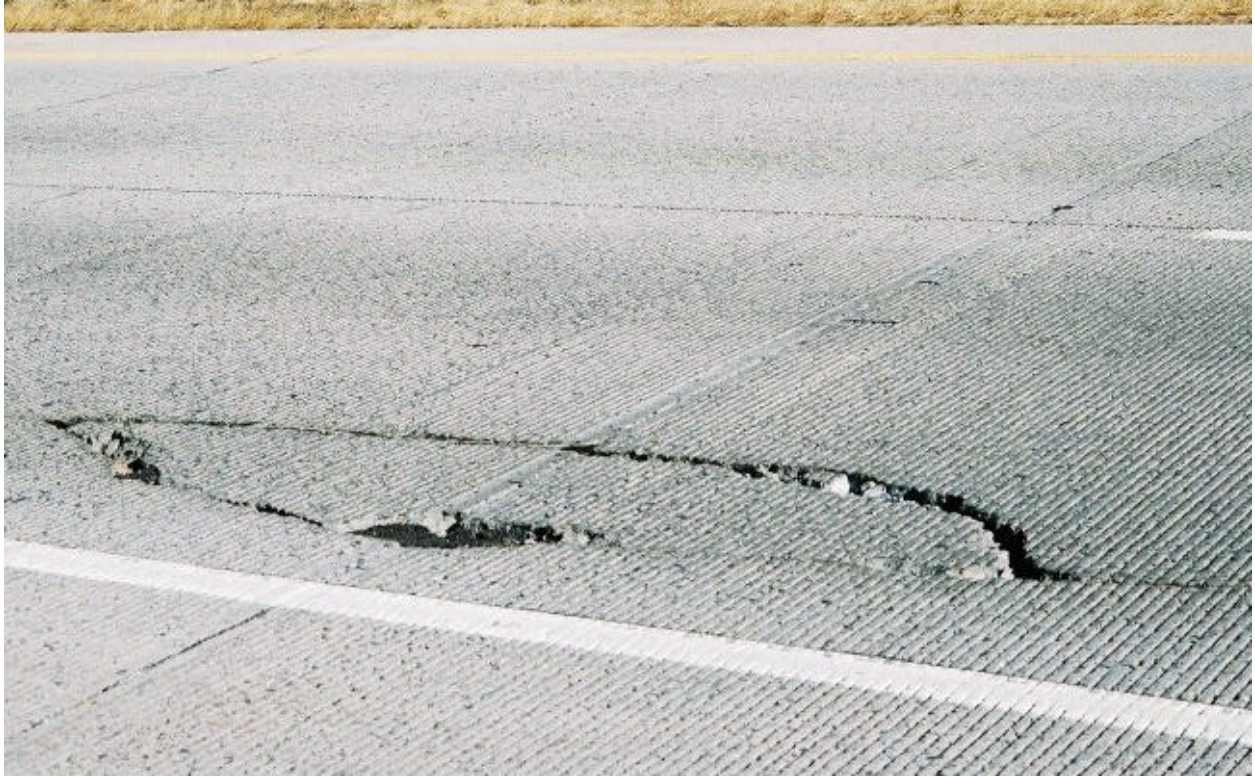
- Evidence of spalling at the cracks.
- Some patching of the spalls noted with an asphalt mix, however additional spalling has progressed after patching.

*Figure B-3. High Severity Spalling of Cracks on I-70.*

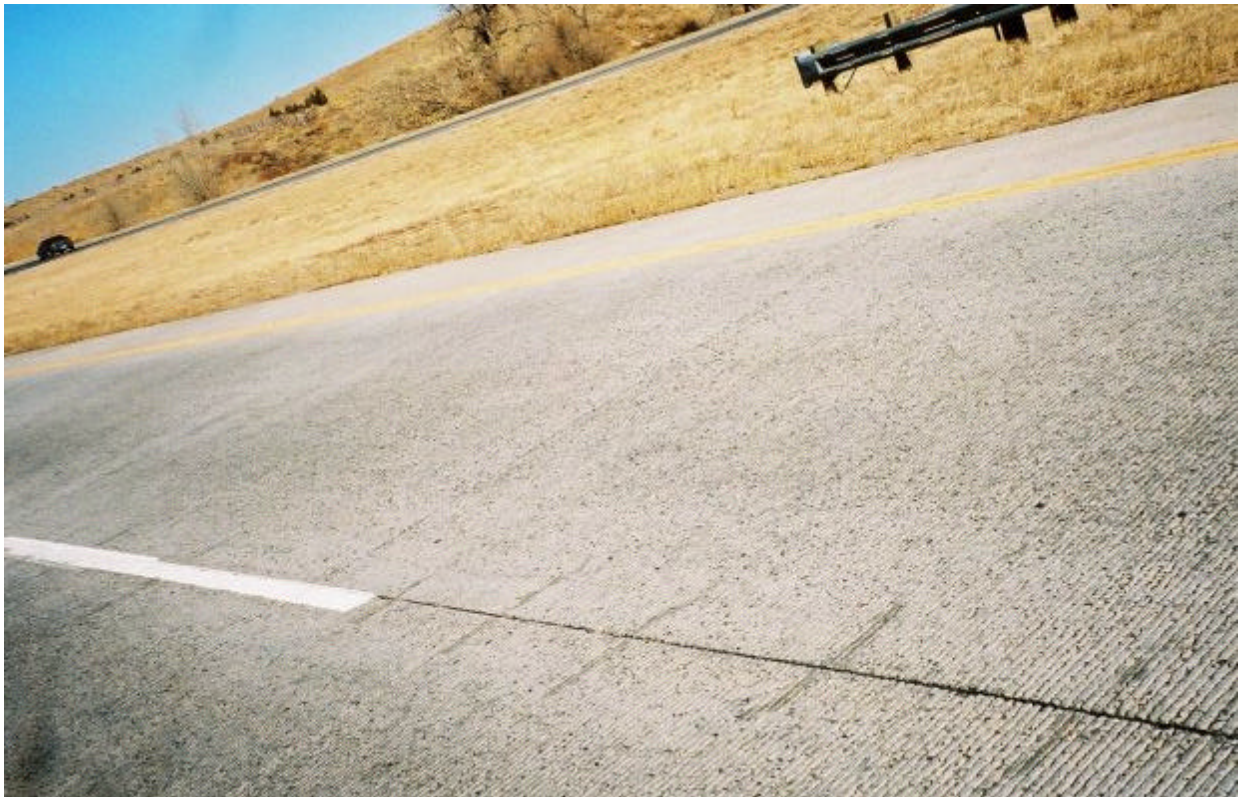
- Significant spalling observed at a longitudinal crack parallel and adjacent to the shoulder.
- Tie-bar “scars” observed. Possibly due to lack of compaction (vibration) from the tie-bar insertion both between the lanes, and at the shoulder.

Other observations included “scarring” of the surface at the tie bar locations observed on both the I-70 and US-34 projects. Improper consolidation of the concrete immediately above the tie bars is suspected. Discoloration of the surface was noted, but no significant disintegration of the concrete was found. On the western I-76 location, some cracks were found to have a white-colored residue. This residue may simply be deicing salt crystals, or it may instead be indicative of a chemical reaction, possibly alkali-silica. However, crack patterns that are typically observed in conjunction with a severe chemical reaction were not noted. A petrographic evaluation of these pavements should reveal additional information.

*Figure B-4. Tie-Bar "Scarring" on I-70.*

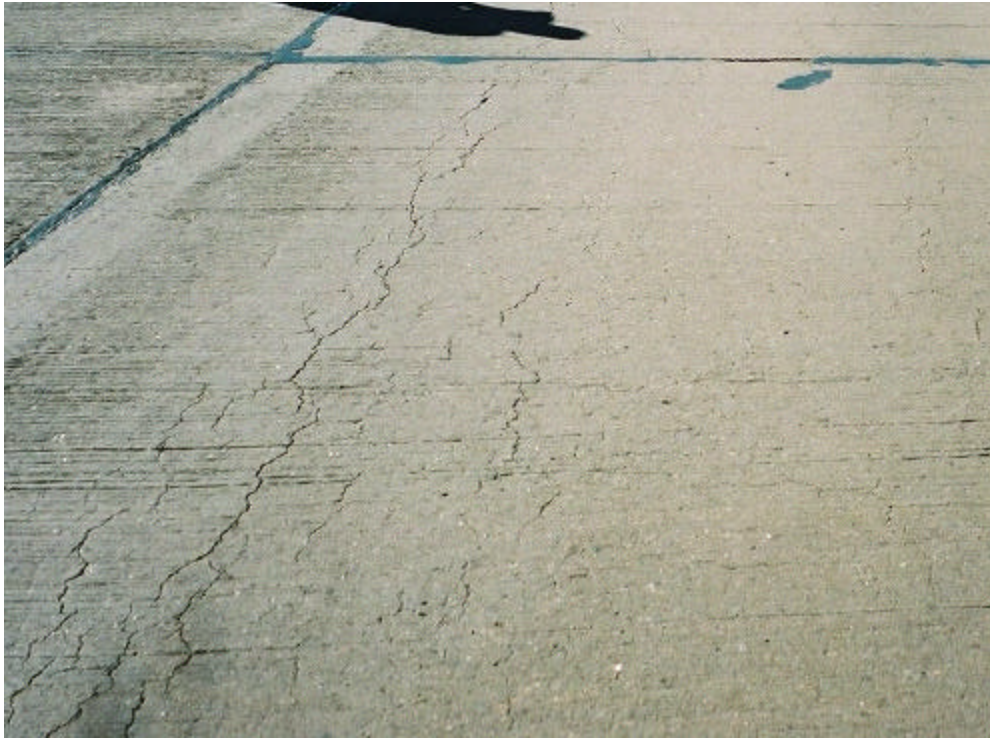
*Figure B-5. Possible Fatigue Cracking on I-76 (Western Site).*

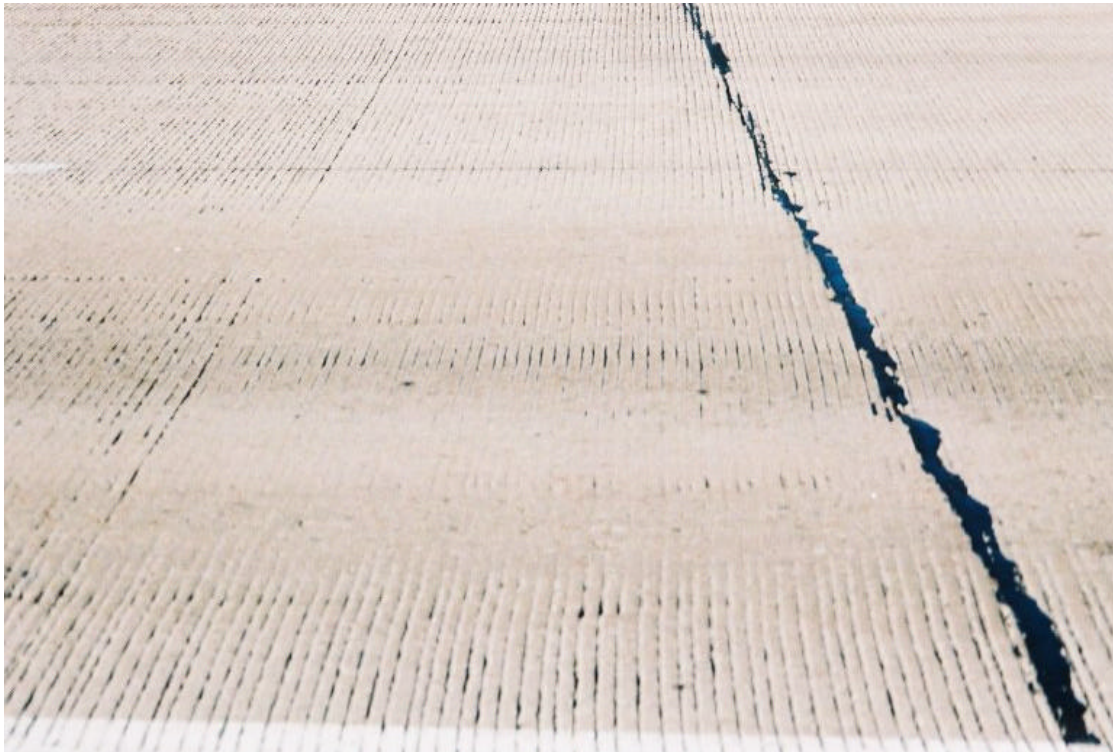
*Figure B-6. Surface Polishing on I-76 (Western Site).*

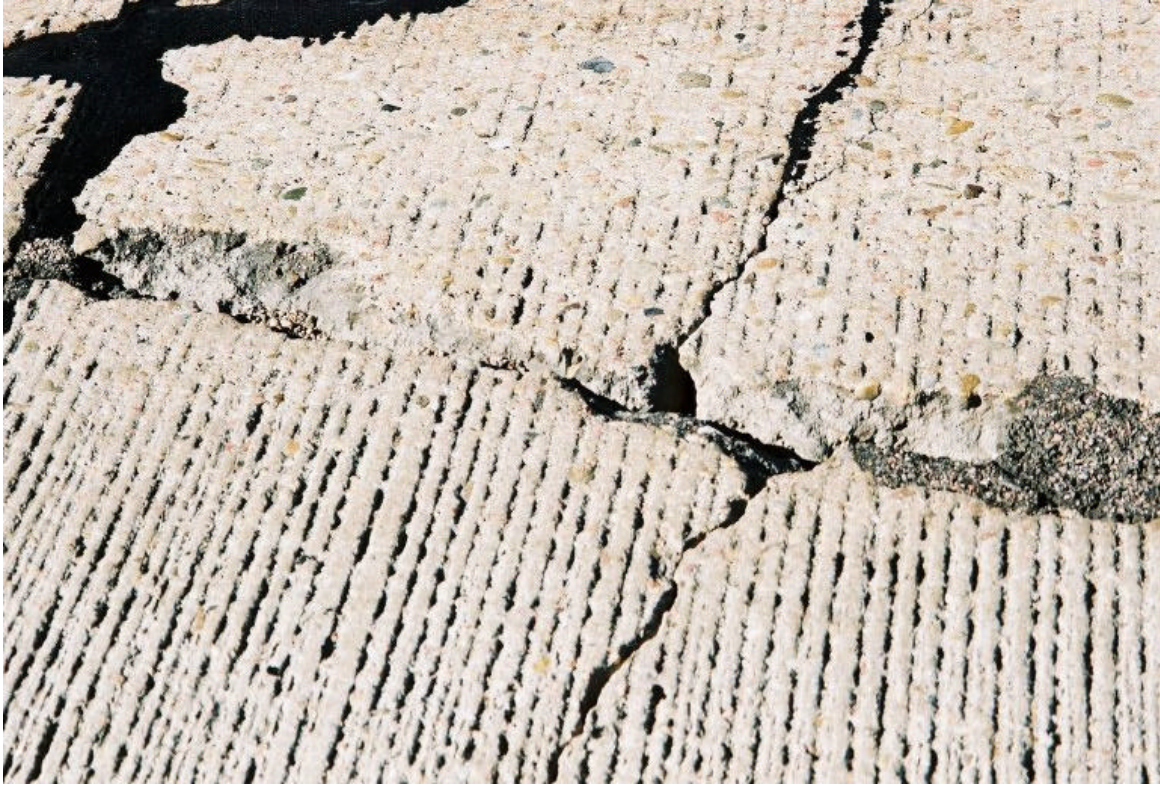
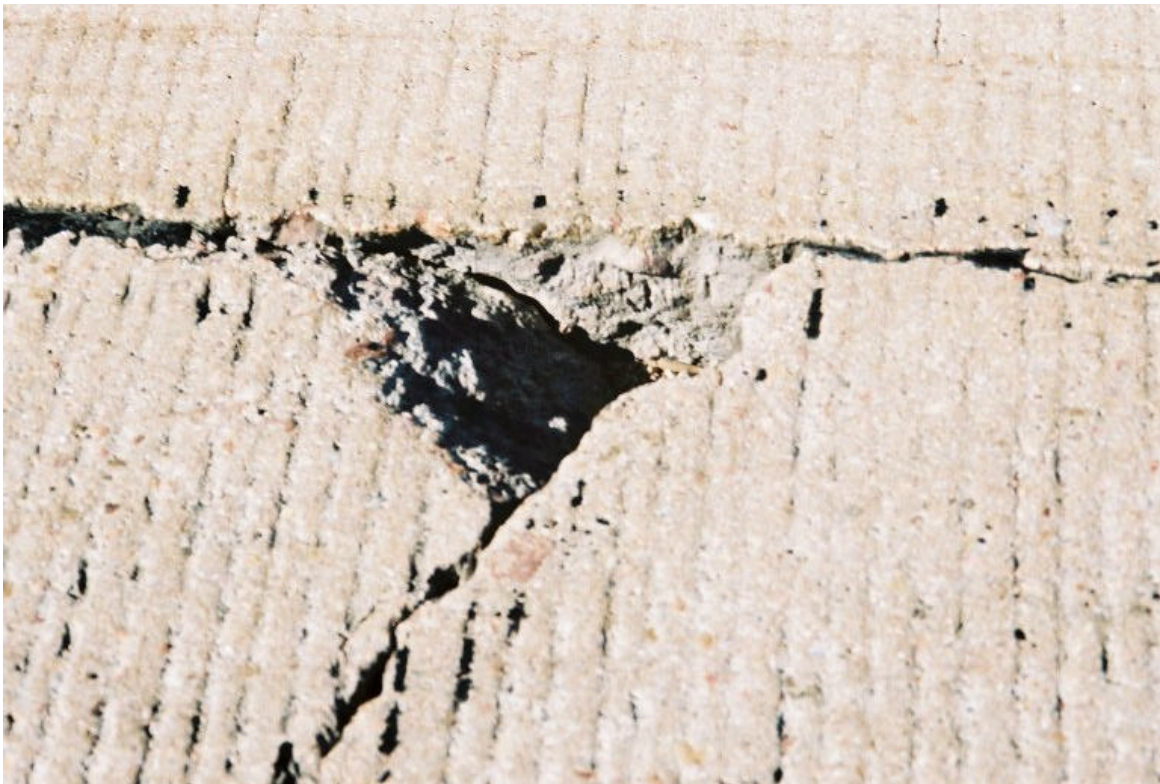
*Figure B-7. Severe Spalling on I-76 (Western Site).*

*Figure B-8. Severe Spalling on I-76 (Western Site).*

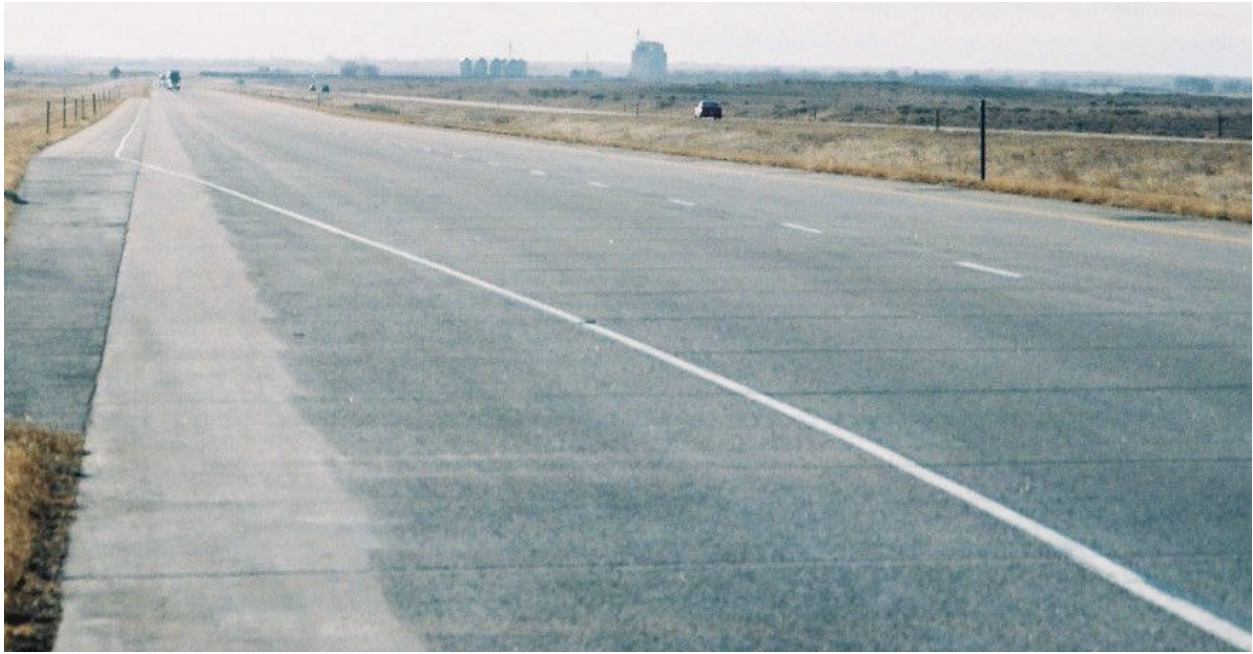
*Figure B-9. Good Pavement Condition on I-76 (Eastern Site).*

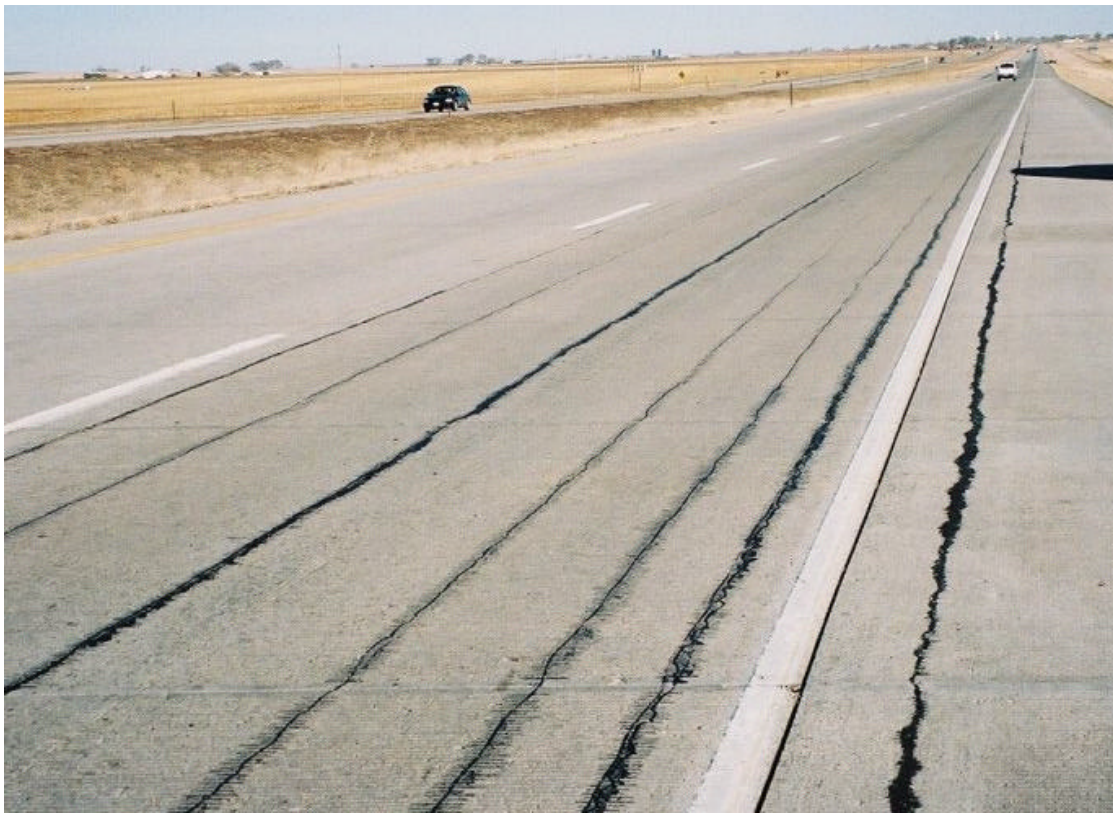
- Longitudinal cracking noted in PMS data is due to grooves in the pavement, not cracks.
- No polishing in wheelpath apparent.
- Ride quality is good.

*Figure B-10. Traffic Scarring of Pavement Falsely Identified as Longitudinal Cracking by PMS on I-76 (Eastern Site).*

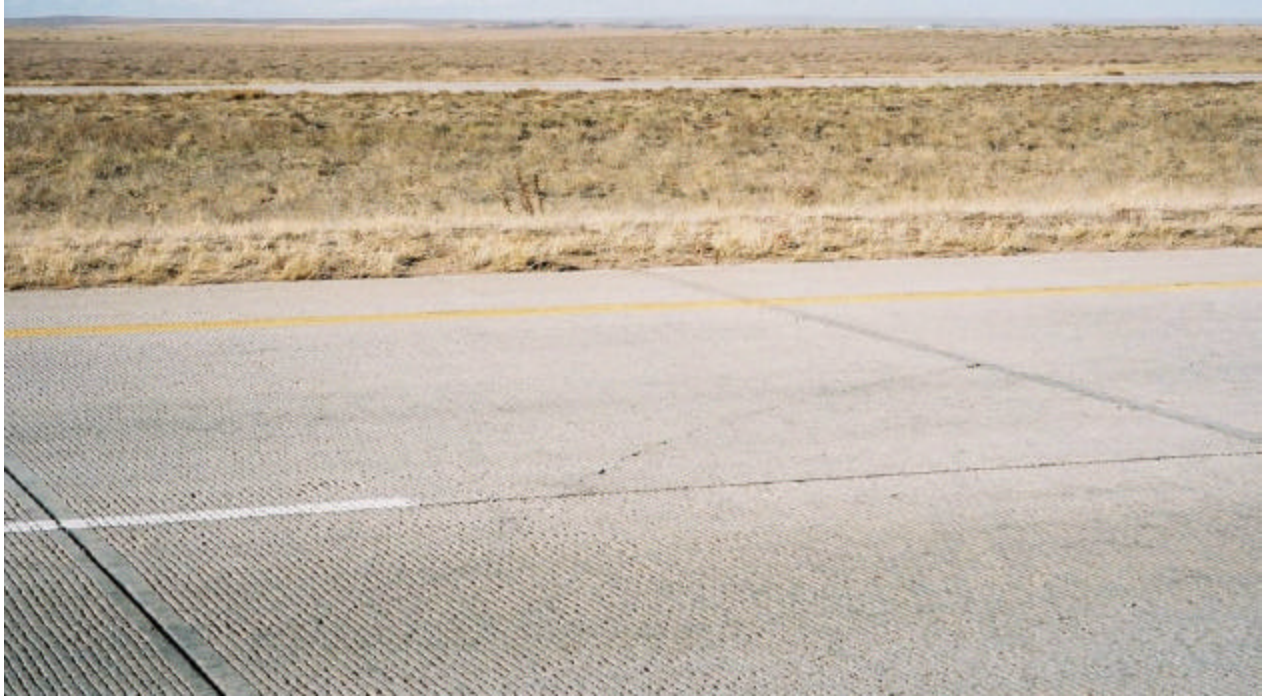
*Figure B-11. Occasional Slab Crack on I-76 (Eastern Site).*

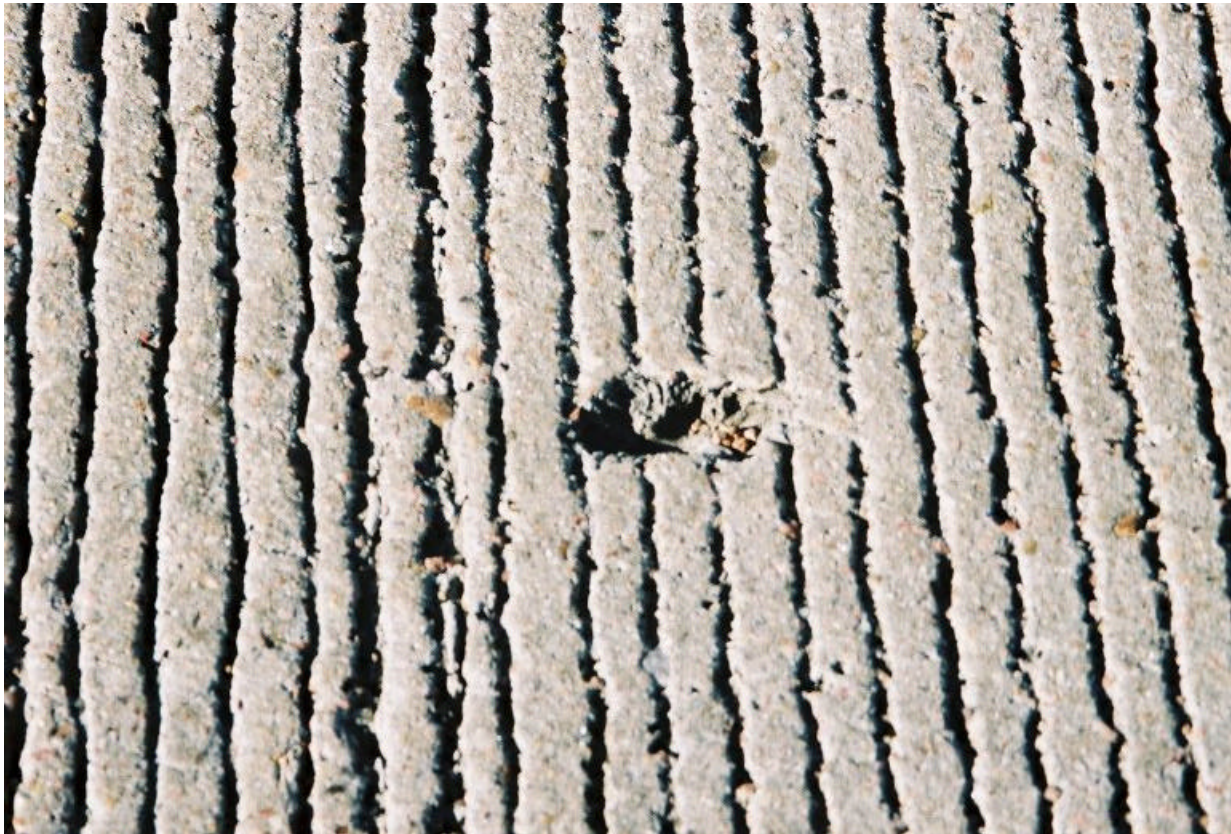
*Figure B-12. Occasional Minor Popout on I-76 (Eastern Site).*

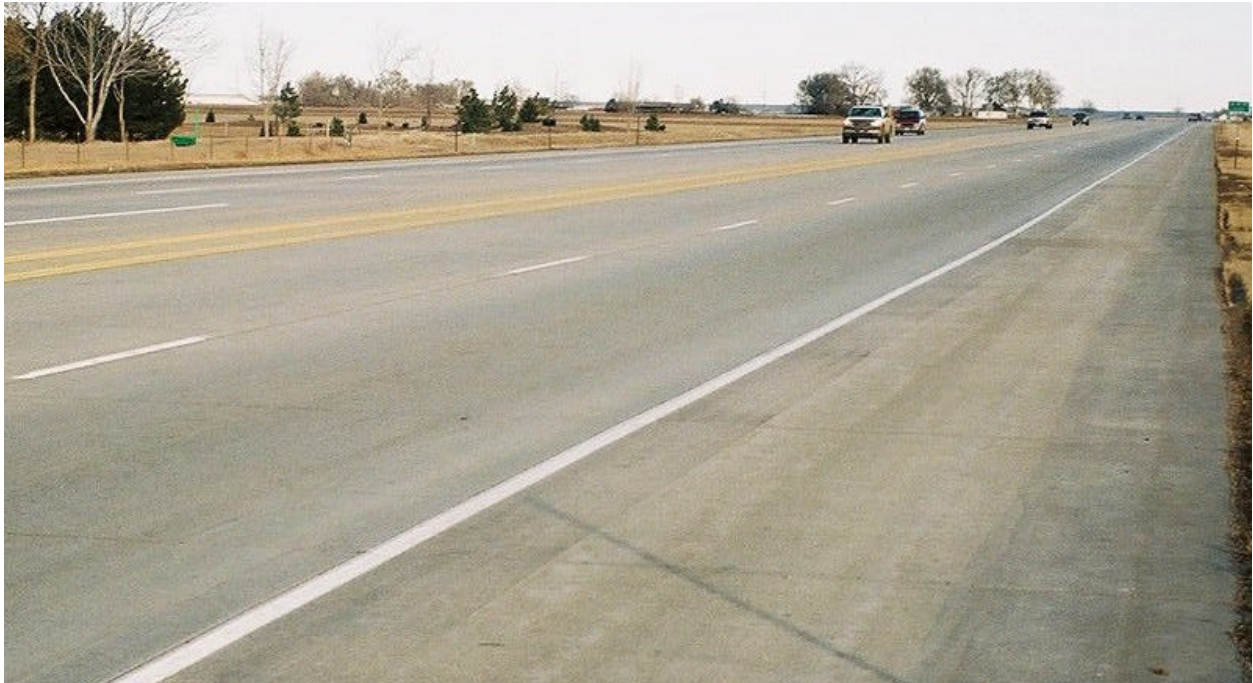
*Figure B-13. Good Pavement Condition on US-34.*

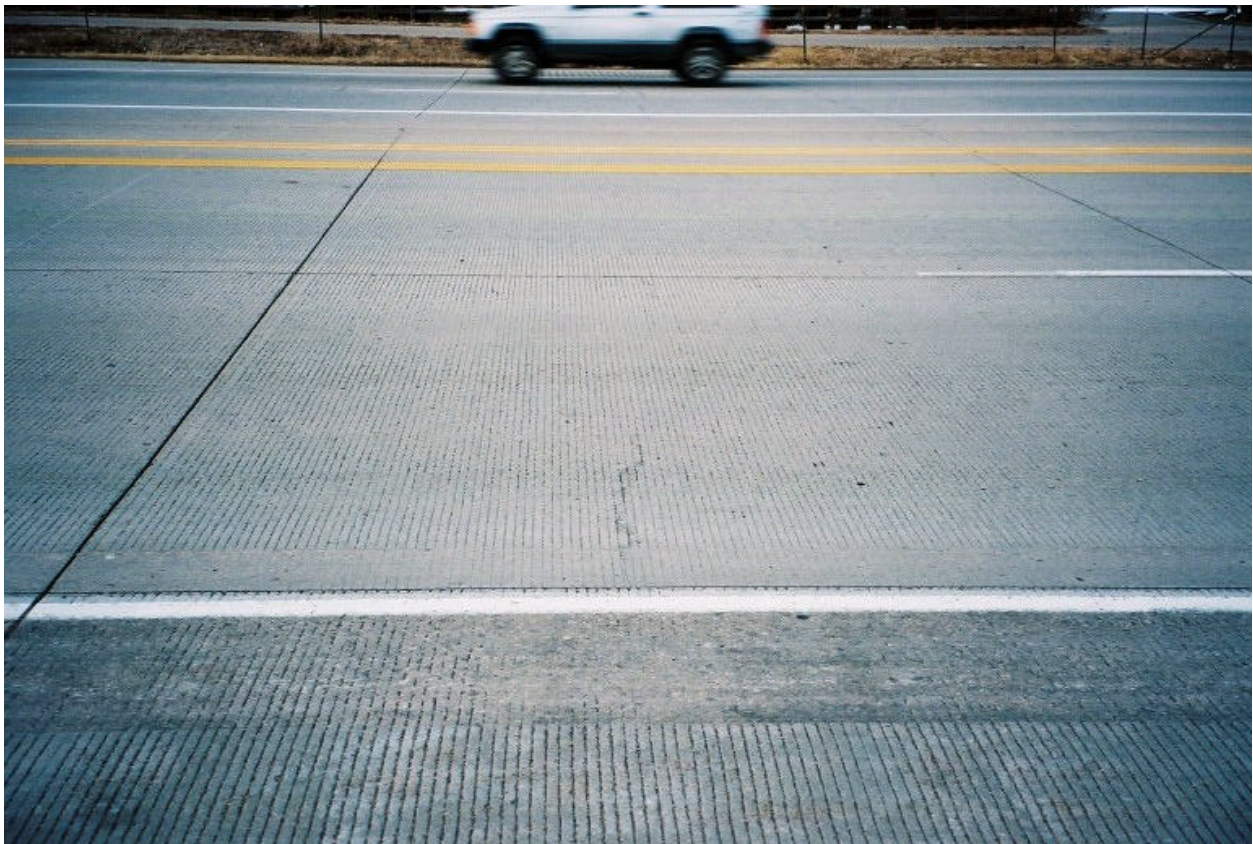
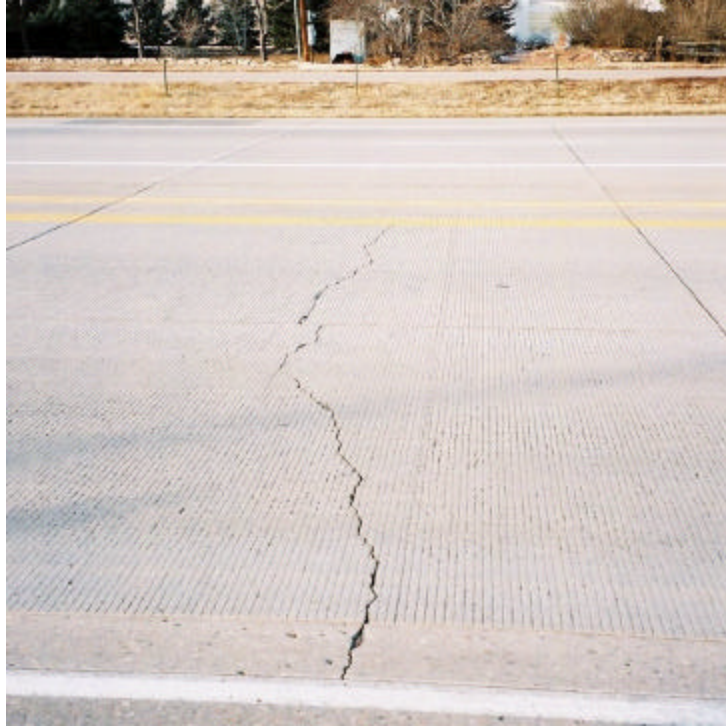
*Figure B-14. Localized Mid-Panel Transverse Cracking on US-34.*

*Figure B-15. Localized Mid-Panel Transverse Cracking on US-34.*

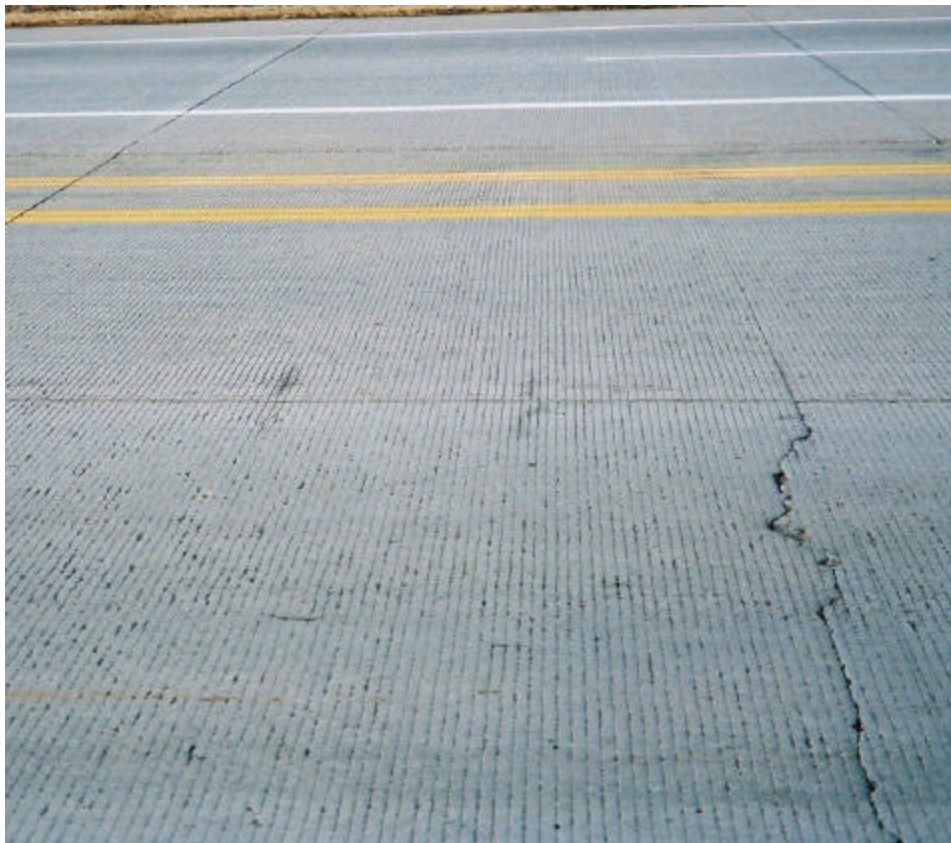
*Figure B-16. Mid-Panel Crack and Tie-Bar "Scarring" on US-34.*

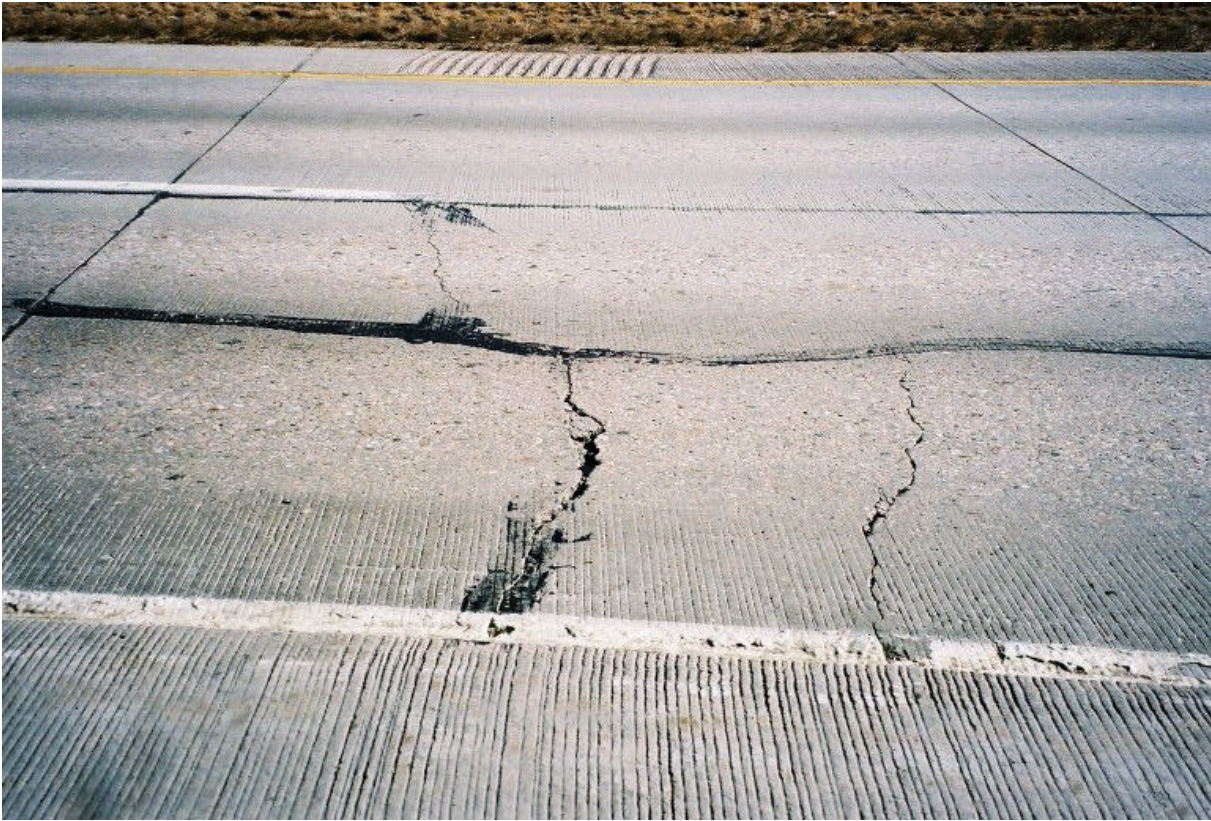
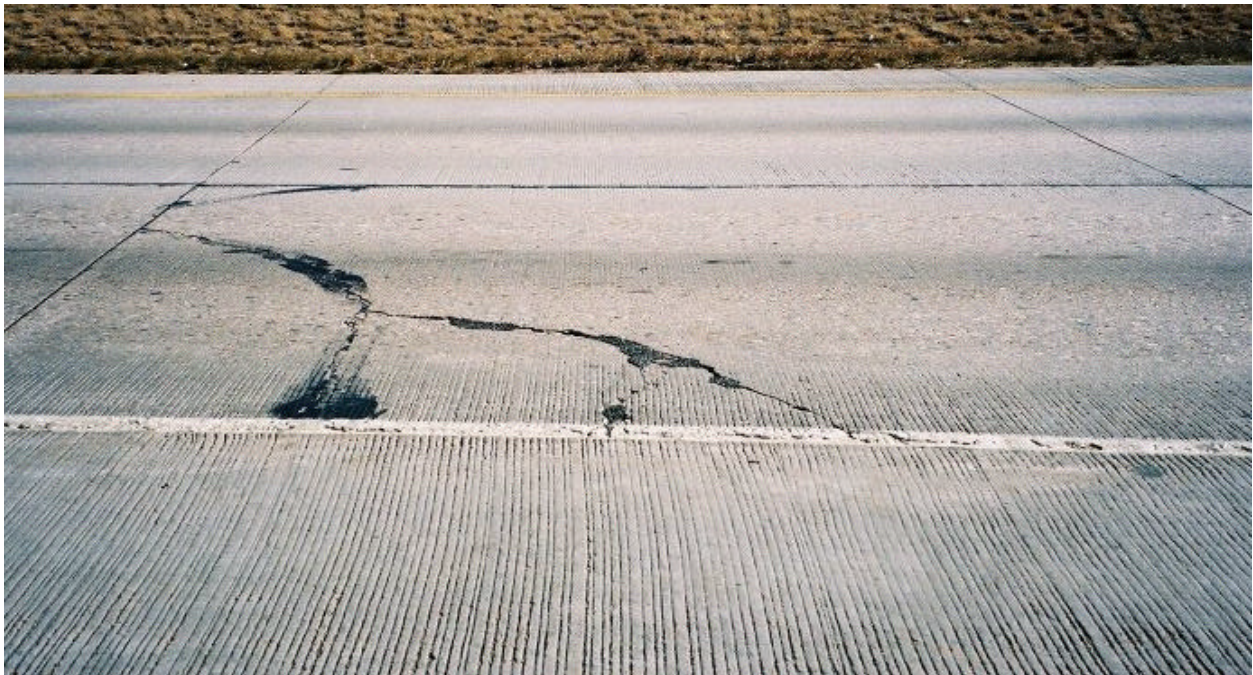
- Distresses observed in the passing lane, not observed to this severity on the southbound direction.
- Similar roughness characteristics.
- Numerous shattered slabs and faulting observed.

*Figure B-17. Shattered Slab on I-25.*

*Figure B-18. Shattered Slab on I-25.*

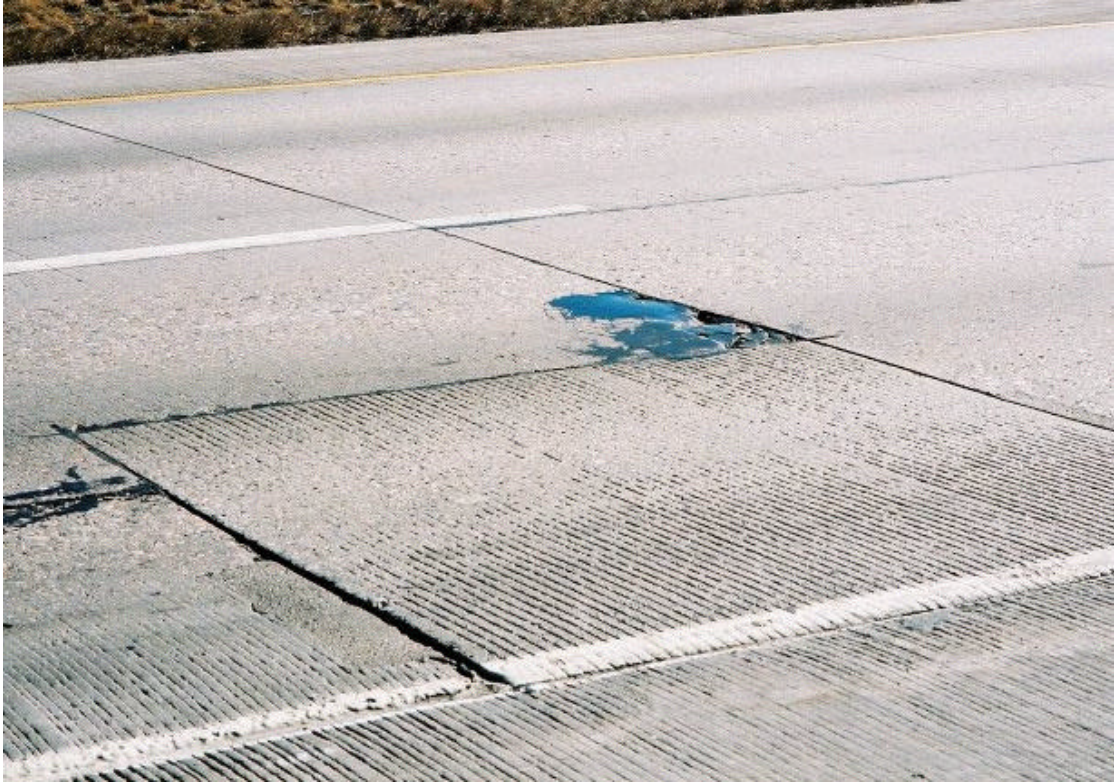
*Figure B-19. Failing PCC Patch on I-25.*

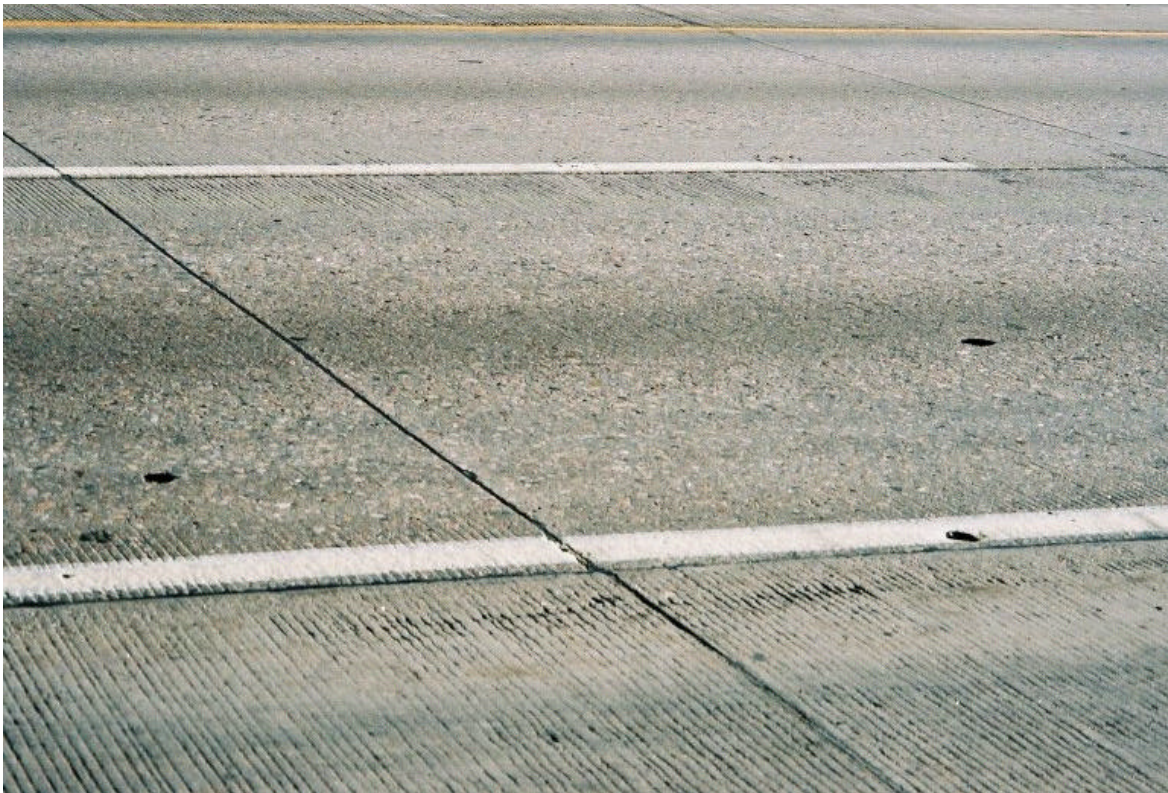
- Surface of pavement heavily polished on both right and left lanes.
- Corner cracks – possibly due to relatively thin slabs (noted from plans).
- Some popouts noted.
- A number of corner cracks noted on the approach end of the slab in the driving lane.
- Numerous faulted cracks, concrete has punched into subbase material.

*Figure B-20. Surface Polishing on I-25.*
