Report No. CDOT-DTD-R-2003-5

**CRACK REDUCTION STRATEGIES ON A
PAVEMENT WARRANTY PROJECT
(INTERSTATE 25 AT FOUNTAIN,
COLORADO)**

**March 2003
Final Report**

**COLORADO DEPARTMENT OF TRANSPORTATION
RESEARCH BRANCH**

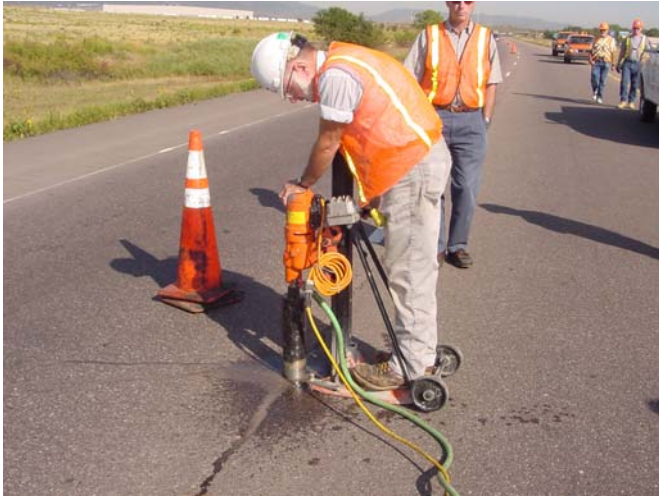
Figure 16 - Coring operation on the affected joint.

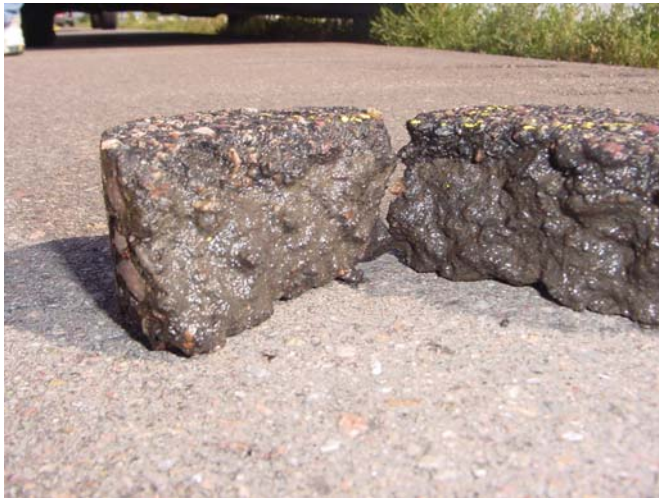
Figure 18 - Lack of AC as result of stripping at the construction joint.

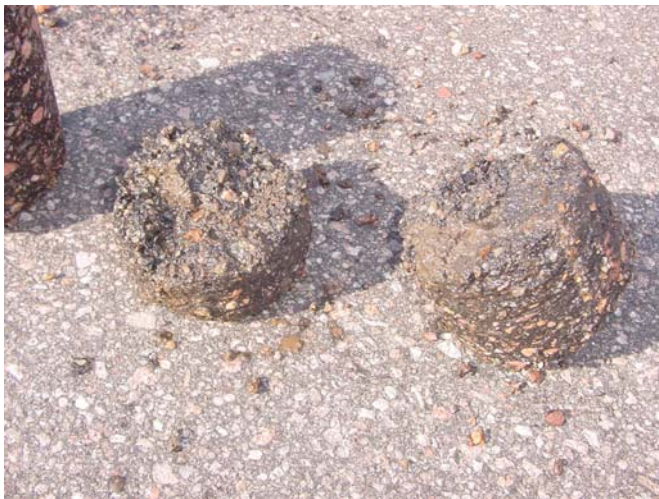
Figure 19 - Fragmented and badly stripped cores .

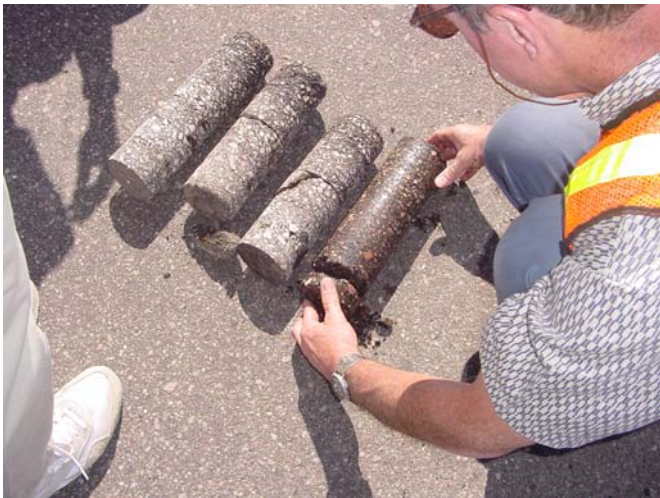
Figure 21 - It is apparent from this picture that the stripping occurs only immediately at the joint. Only the core sample right over the construction joint (right core) has evidence of stripping.

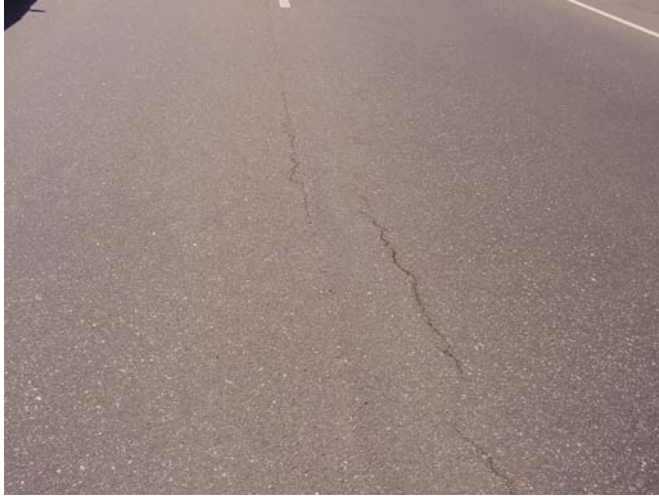
Figure 22 - This photo shows an offset crack from the construction joint, possibly the reflective crack from the original construction joint.

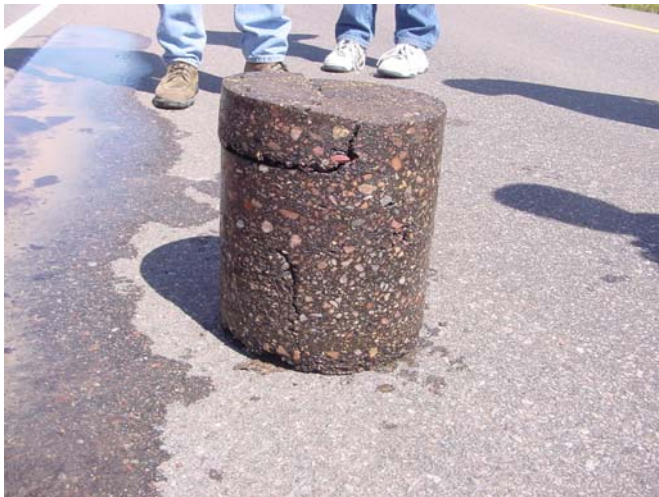
Figure 23 -The resulting core verifies the crack propagation is emanating from the underlying existing pavement layer.

Regardless of the propagation mechanism/cause, the existence of such cracking will eventually weaken the pavement due to moisture, temperature, and traffic loading leading to stripping, as seen in some of the previous photos.
