**Report No. CDOT-DTD-R-2003-1**  
**Final Report**

# **EVALUATION OF PREMATURE PCCP LONGITUDINAL CRACKING IN COLORADO**

**COLORADO DEPARTMENT OF TRANSPORTATION  
RESEARCH BRANCH**

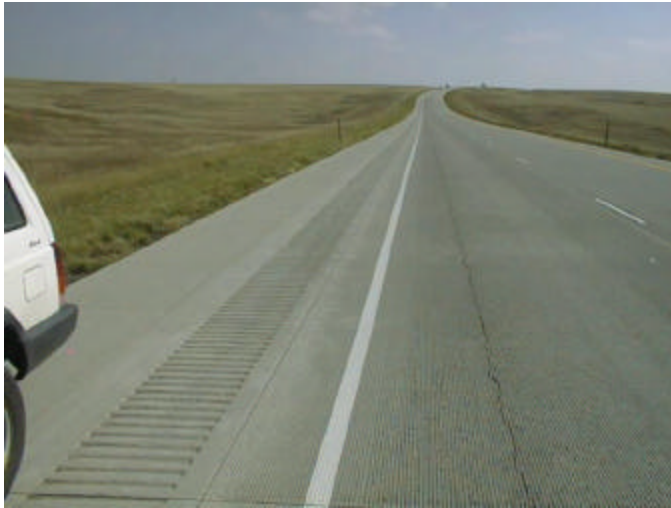
**Figure 1. Premature longitudinal crack on I-70 westbound near Agate.**

month of August 2001, distresses, mainly in the form of longitudinal cracks, were encountered at several locations in the westbound lanes (no distresses were reported in the eastbound lanes). The majority of the cracks were scattered between mileposts 340 and 346. Four cracks, each measuring approximately 200 feet in length, and located about four to five feet to the left of the shoulder paint stripe, appeared to be related to improper vibration practices. These cracks are very straight (**Figure 1**) and at a consistent distance from the edge of the pavement.

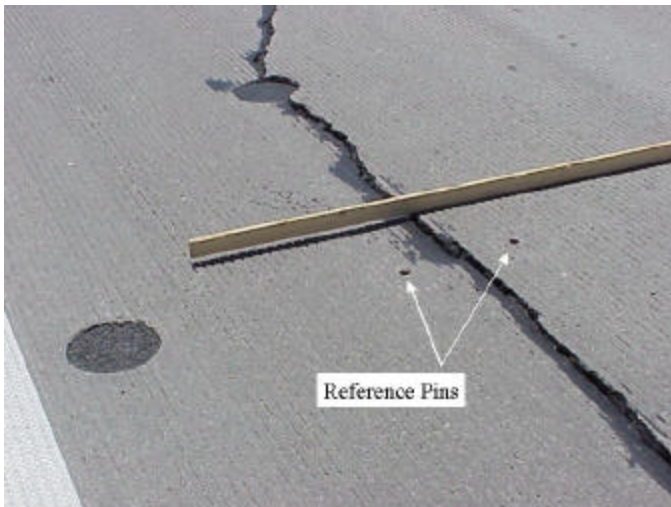
**Figure 2. Differential settlement on I-70 westbound near Agate.**

At some locations near Agate, cracks have developed with substantial differential settlement across the cracks. They tend to wander back and forth between the center of the lane and the right wheel path (**Figure 2**).

These cracks are probably due to under-compaction of the subgrade fill materials or to the high expansive potential of the of highly plastic clayey natural soils in the area (or to the combined effects of

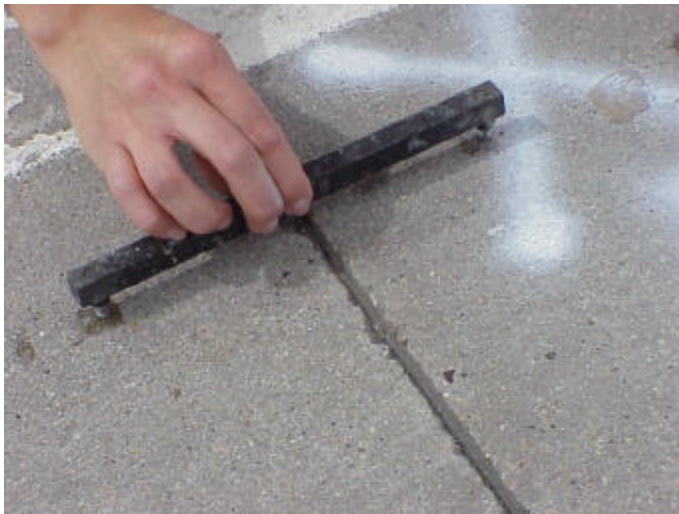
**Figure 3. Reference pins installed across a joint.**

Early in 2001, pairs of steel reference pins (**Figures 2 & 3**) were installed on either side of the longitudinal cracks to provide permanent reference points for monitoring changes in the crack widths and the differential settlement across the crack. Pins were installed at MP's 340.260, 340.453, 340.529, 340.751, 340.891, 341.059, 342.504, and 345.275. The crack widths were measured at 1-2 month intervals. The results are shown in Appendix A.

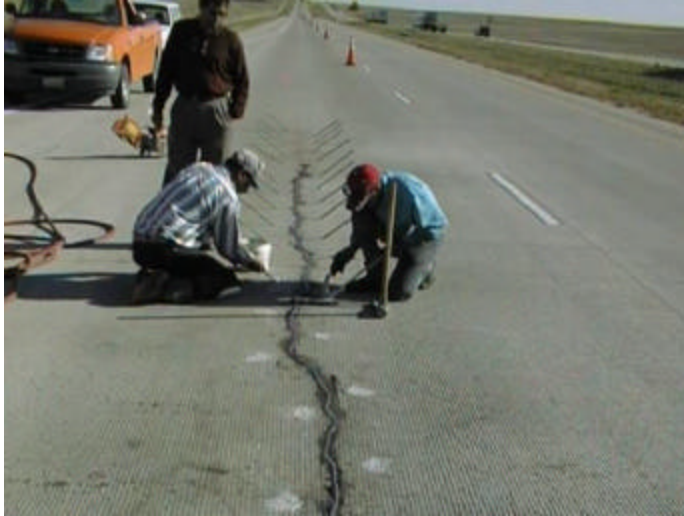
**Figure 4. Installation of stitches on I-70 at Agate.**

drilled through the concrete at about a 45° angle to the surface of the pavement so they crossed the crack near the middle of the concrete depth (**Figure 4**). Twenty-inch-long pieces of 5/8-inch steel rebar were coated with epoxy cement and driven through the concrete into the base. The ends of the bar were driven below the surface of the pavement and the holes sealed with epoxy cement. The performance of the cross stitches is being monitored.

During October of 2002, the Region 1 Limon Residency arranged to cross-stitch the cracks between MP 346 and 340. At 18-inch intervals, on alternate sides of the crack, holes were

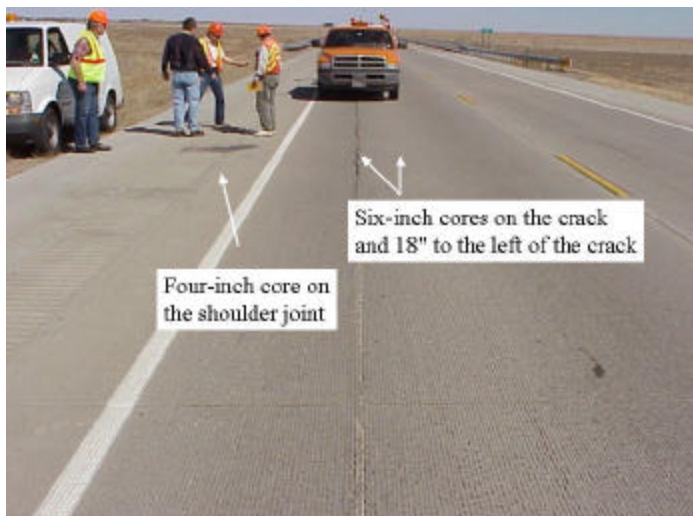
**Figure 5. Core locations on the vibrator trail - US-287 southbound.**

An overactive vibrator apparently created a vibrator trail which caused a weakened plane in the concrete. In some areas, longitudinal cracks developed along the vibrator trail even where the shoulder joint was working, i.e., the saw-cut was at a proper depth and the joint had cracked through.

Split tensile strength tests were performed on 6-inch-diameter cores extracted from the vibrator trail where the tining tracks were deeper, but no longitudinal crack was evident – see the foreground of Figure 5. Split tensile strength tests were also conducted on cores taken next to the vibrator trails

The southbound cracks occurred primarily in the vibrator trail and are a consistent distance from the edge of the pavement (**Figure 5**). In contrast, while most of the longitudinal cracks in the northbound lanes are in the right wheel path, they wander from side to side (**Figure 7**).

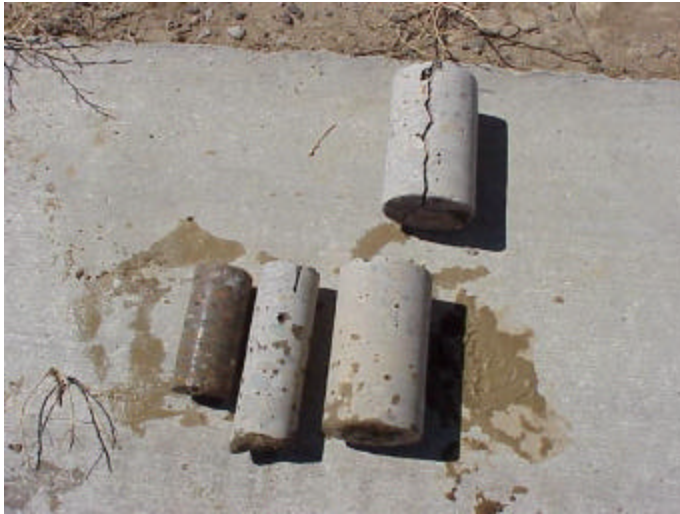
A set of three core samples was taken at each of three different locations southbound through the project. A set consisted of a six-inch core on the longitudinal crack, a six-inch core about 18 inches to the left of the first core, and a four-inch core on the shoulder joint (**Figure 5**). The six-inch cores were sent to Construction Technology Laboratories (CTL) for petrographic analysis; the four-inch cores were used to determine if the shoulder joint had cracked through, as it should (**Figure 6**).

**Figure 6. Cores from US-287 southbound.**

(Figure 6). The main purpose was to determine if the cores taken from the vibrator trials showed lower strength than cores taken next to them. This investigation was inconclusive. The results are shown in Table 1.

Examination of the four-inch cores taken on the shoulder joint revealed that the saw-cuts were not deep enough (less than  $0.4 D$  for 14-foot slabs) to instigate a weakened plane. As a result, longitudinal cracks developed in the travel lanes to release the strength gain of the concrete.

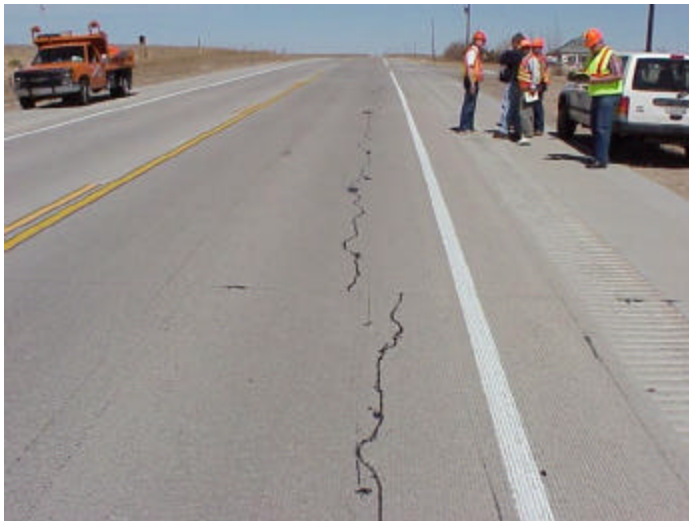
**Figure 7. Wandering cracks in the northbound lane of US-287.**

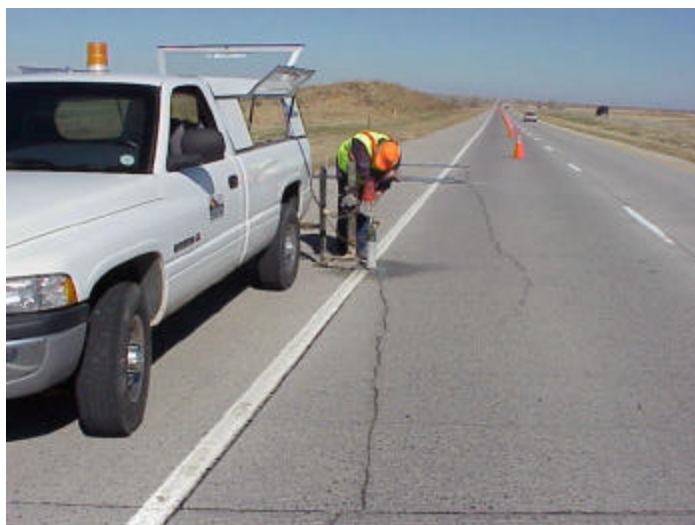
**Figure 8. Longitudinal cracks on 12' wide slabs - I-70 at Deer Trail.**

In April of 2002, CDOT's Research Branch, with the help of Maintenance Patrol 16 from Deer Trail, extracted 4 cores from the longitudinal shoulder joint on I-70 eastbound near Deer Trail between Mileposts 326-327 (**Figure 8**). The slab width in the driving lane, unlike those investigated previously on US-287 (14-foot slabs), was standard 12 feet. The longitudinal cracks at this location consistently began at the shoulder joint and wandered diagonally through the wheel path to about mid-

slab. Cracks were also noted on the shoulder parallel to the joint. I-70 at this location was built in 1987 with lower cement content (565 lb. total cementitious, including 455 lb. of cement and 110 lb. of fly ash) and with skewed transverse joints on 18' spacing.

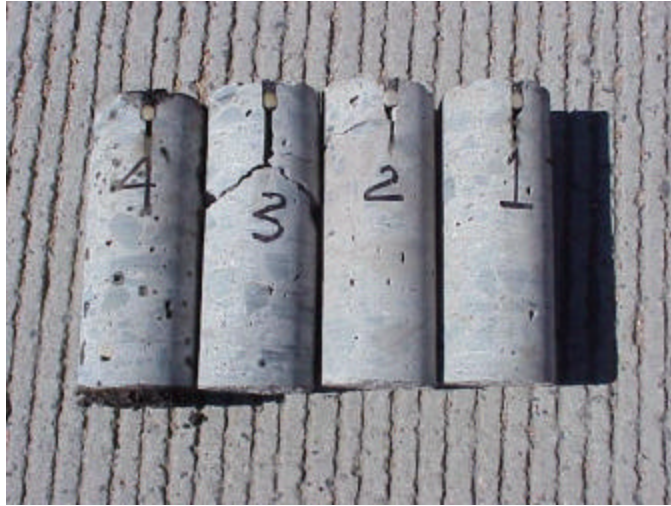
As shown in **Figure 9**, none of the saw-cuts at the shoulder joint were working. The pavement depth was 10.25 inches; the saw-cut measured between 2 and 2.25 inches (35% shallower than  $D/3$ ). This proves, once more, that the longitudinal cracks are due to shallow saw-cut depth at the shoulder joint.

**Figure 9. Cores from the non-working shoulder joint on I-70 at Deer Trail.**

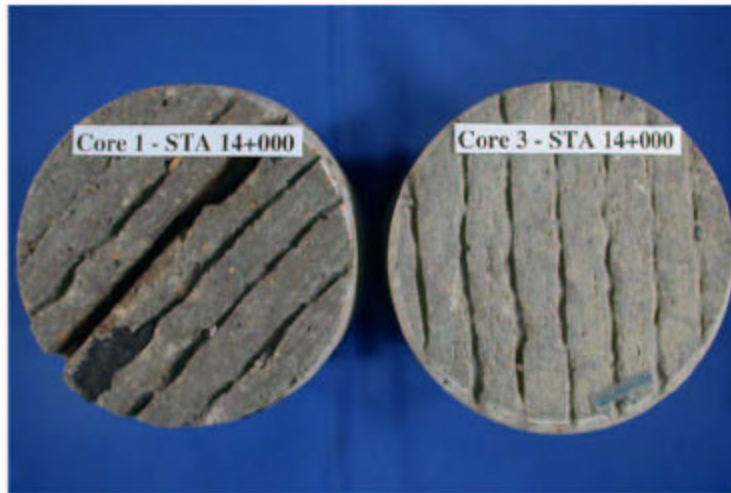
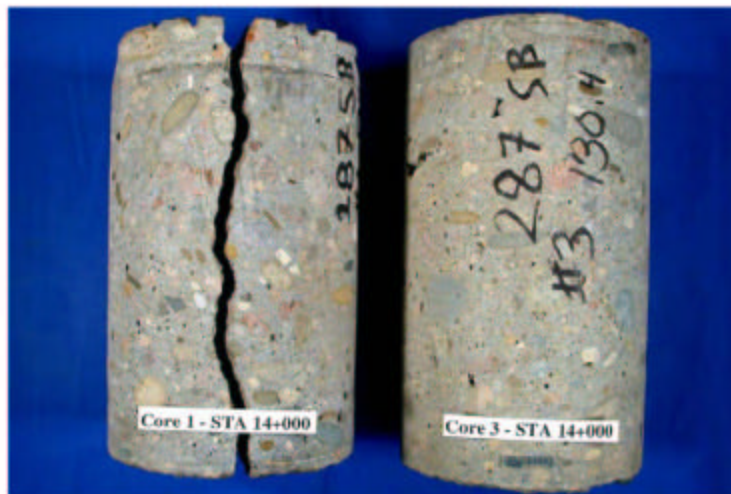
Fig. 1 (a & b) Concrete Cores 1 and 3, as received for analysis. Core 1 is from the cracked portion of the pavement and Core 3 is from the center of the lane.

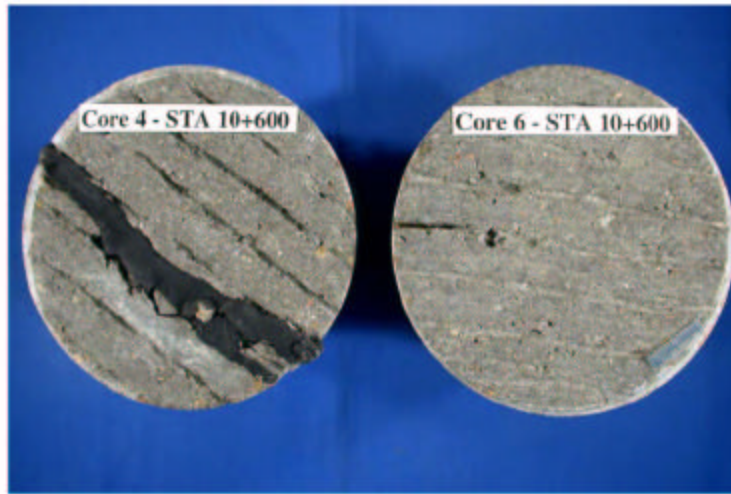
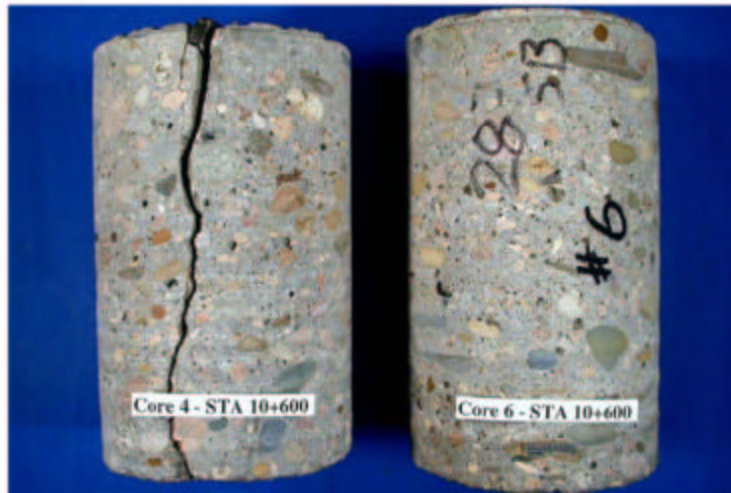
Fig. 2 (a & b) Concrete Cores 4 and 6, as received for analysis. Core 4 is from the cracked portion of the pavement and Core 6 is from the center of the lane.

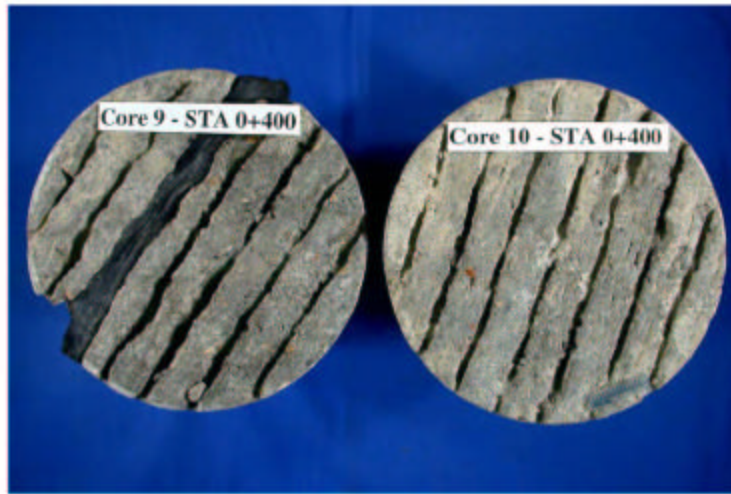
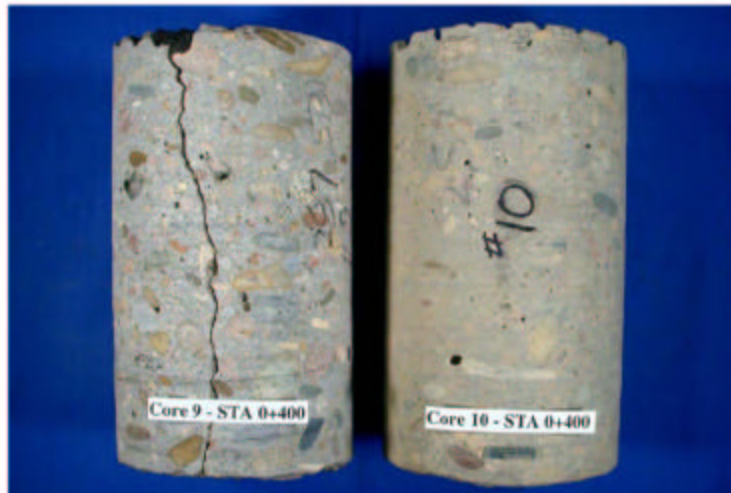
Fig. 3 (a & b) Concrete Cores 9 and 10, as received for analysis. Core 9 is from the cracked portion of the pavement and Core 10 is from the center of the lane.

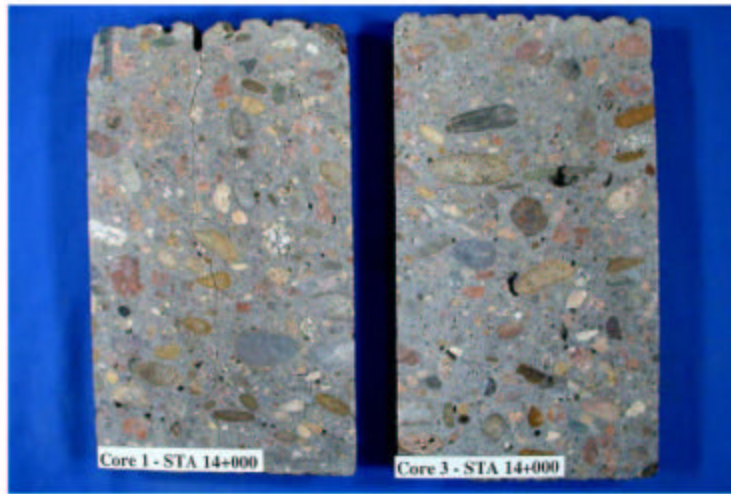
**Fig. 10** Cut cross section of Cores 1 and 3 showing the longitudinal crack in Core 1.

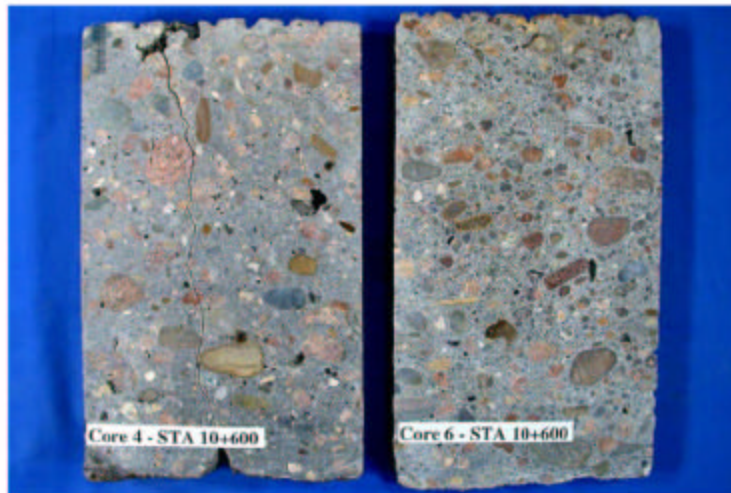
**Fig. 11** Cut cross section of Cores 4 and 6 showing the longitudinal crack in Core 4.

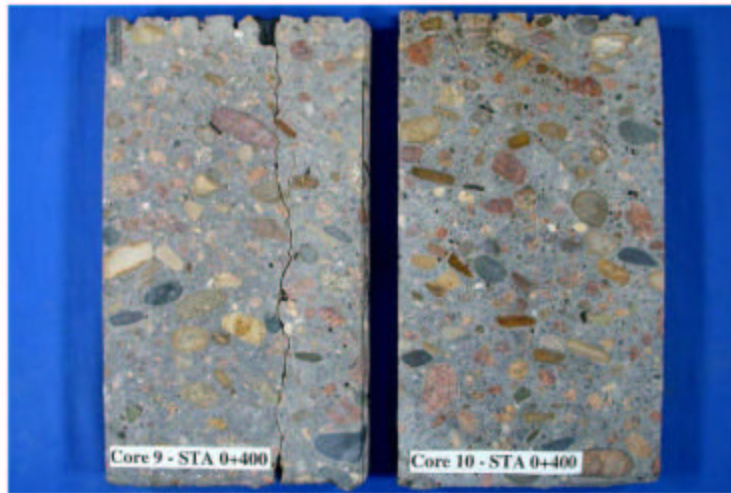
**Fig. 12** Cut cross section of Cores 9 and 10 showing the longitudinal crack in Core 9.
