ADIT INSPECTION REPORTS

TO: Austin Buckingham, CDPHE
FROM: Bruce Marshall and Rich Tocher, P.E., Tetra Tech RMC
RE: 2005 Detailed Inspection of the Reynolds and Chandler Adits, Summitville
Mine Superfund Site, Colorado
Tetra Tech RMC Job No. 19-1149.046.00, WBS 3.3
DATE: September 12, 2005

RE: 2005 Detailed Inspection of the Reynolds Adit and Bulkhead and the Chandler Adit and Bulkhead, Summitville Mine Superfund Site, Colorado; D&A Job No. 0157.041.00

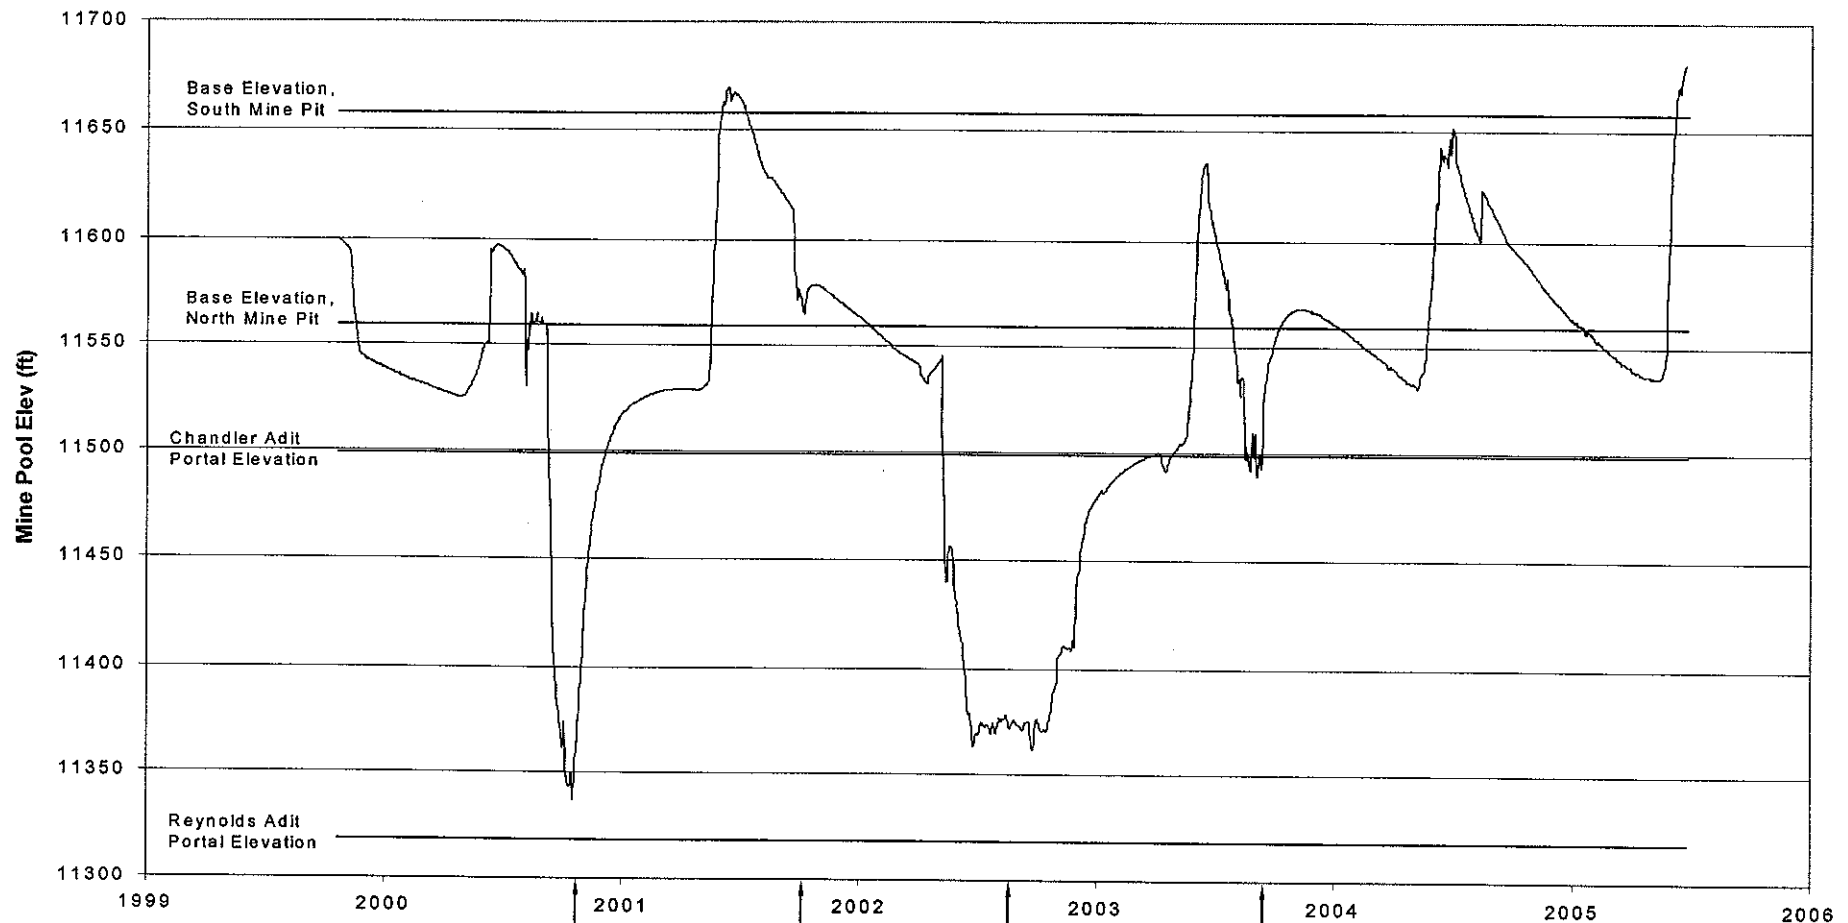
FIGURE:

¹ Mine pool elevation shown on Figure 1 is calculated from pressure transducer readings measured at the Reynolds Adit plug.

SUMMITVILLE MINE SITE OU-5 2005 ADIT INSPECTION REPORT	
HISTORIC ELEVATION OF SUMMITVILLE MINE POOL	
Date: 08/16/05	By: KPA
Source: G:\1149\027\phase_03\RI_Report\Prelim Draft\2000_GW_LV_DB.wb3

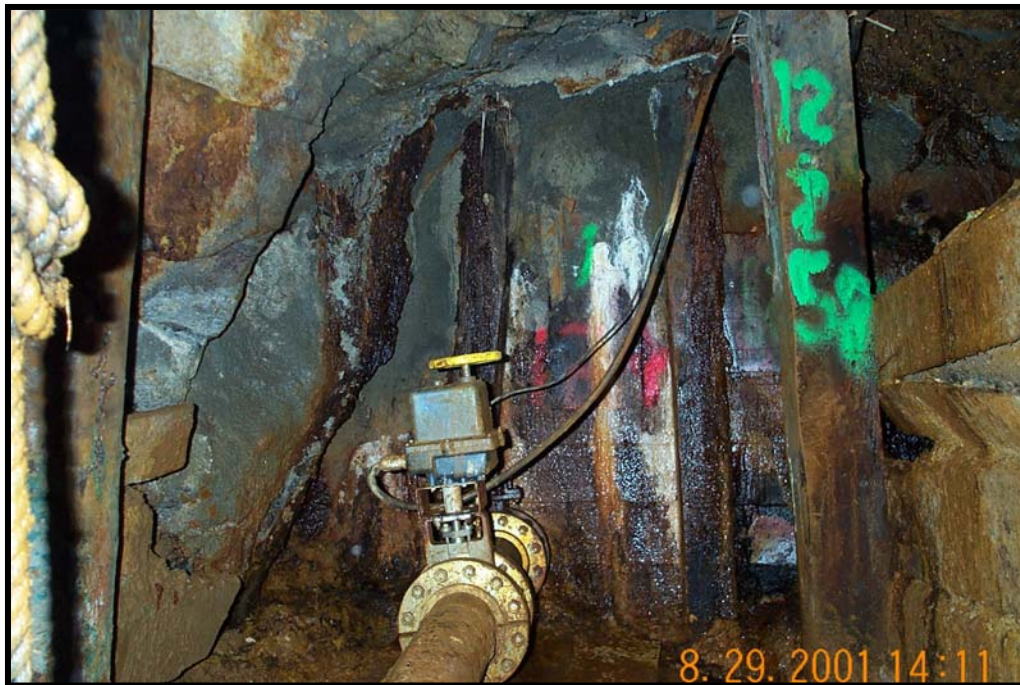
Figure 1 Reynolds Bulkhead 2001

The bulkhead is made of reinforced concrete with a reported shotcrete cover. While it is stained, the face of the bulkhead appears to be in good condition. Three large (one-inch) and several smaller (one-quarter-inch) spots of white material indicate some potential seepage through the concrete. During the inspection, the areas were not leaking and appeared to be healed. They looked similar to the photographs of the 1999, 2001, 2003, and 2004 inspections (see Figures 1 and 2). Iron stained deposits from crown seeps have built-up on the face, pipe, and invert. Small (one-quarter-inch) brown dripping stalactites are found along the crown, especially in the right crown. While there is more dripping from the right crown, the flows are not concentrated.

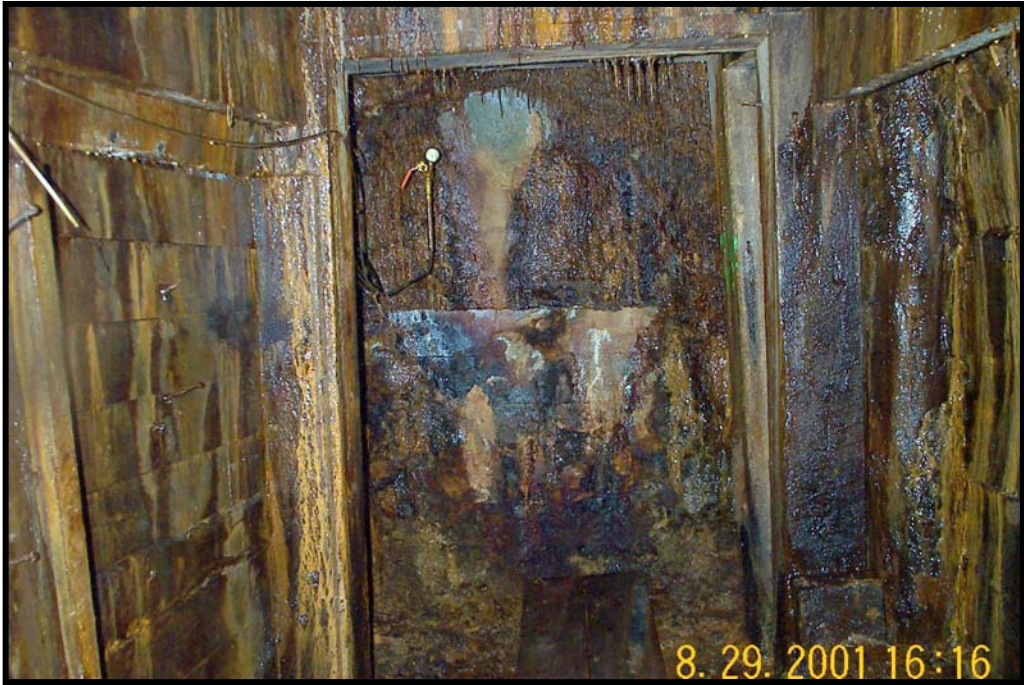
Figure 3 Chandler Bulkhead 2001

The bulkhead is heavily stained and covered in brownish metal deposits. Small stalactites drip from the crown (especially on the right) and the steel internal bulkhead frame. The bulkhead looks very similar to the photographs taken in 1999, 2001, 2003, and 2004 (see Figures 3 and 4). Water was dripping like a light rain from the roof within a few feet of the bulkhead. This looks to be diffuse inflow with no concentrated inflows. Water appears to run down the face of the bulkhead, not through it, and leave the deposits. The concrete is covered by a thick layer of deposits (one to four inches) and appears to be in good shape. The photographs show several spots where the precipitant was knocked off, revealing the concrete underneath.
