***Treatment of Swelling Soils  
West of Agate, Colorado  
Project I 70-4(48)347***

Burrell B. Gerhardt  
Colorado Division of Highways  
Planning and Research Division  
4201 E. Arkansas Avenue  
Denver, Colorado 80222

Final Report  
December 1975

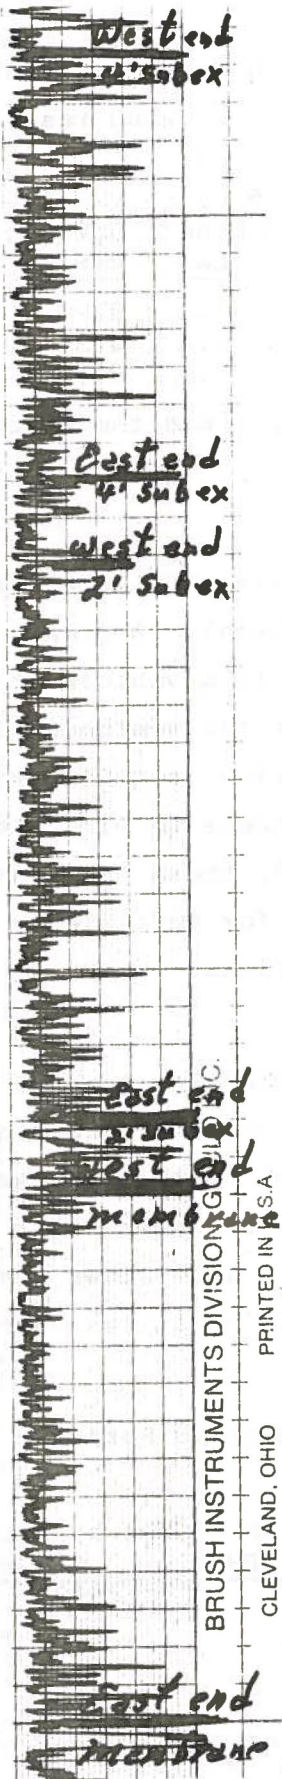
40 mph Graph

The loss in smoothness is due mostly to faulting, since the cracking in the 3 sections is not considered to be severe.

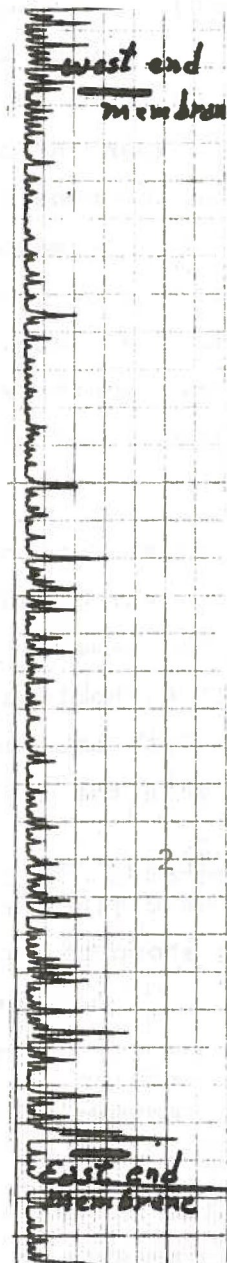
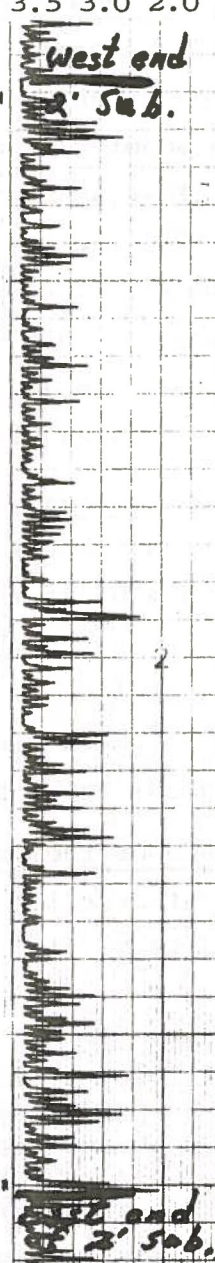
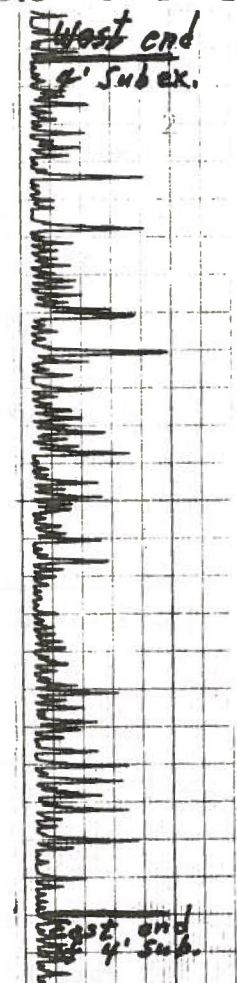
20 mph Graphs

The concrete placed over the membrane test section Sta. 552 to Sta. 572 appears to be quite smooth (PSI approx 3.5). There is little or no difference between the smoothness shown by the accelerometer on the 4' subexcavated section and the 2' subexcavated section.

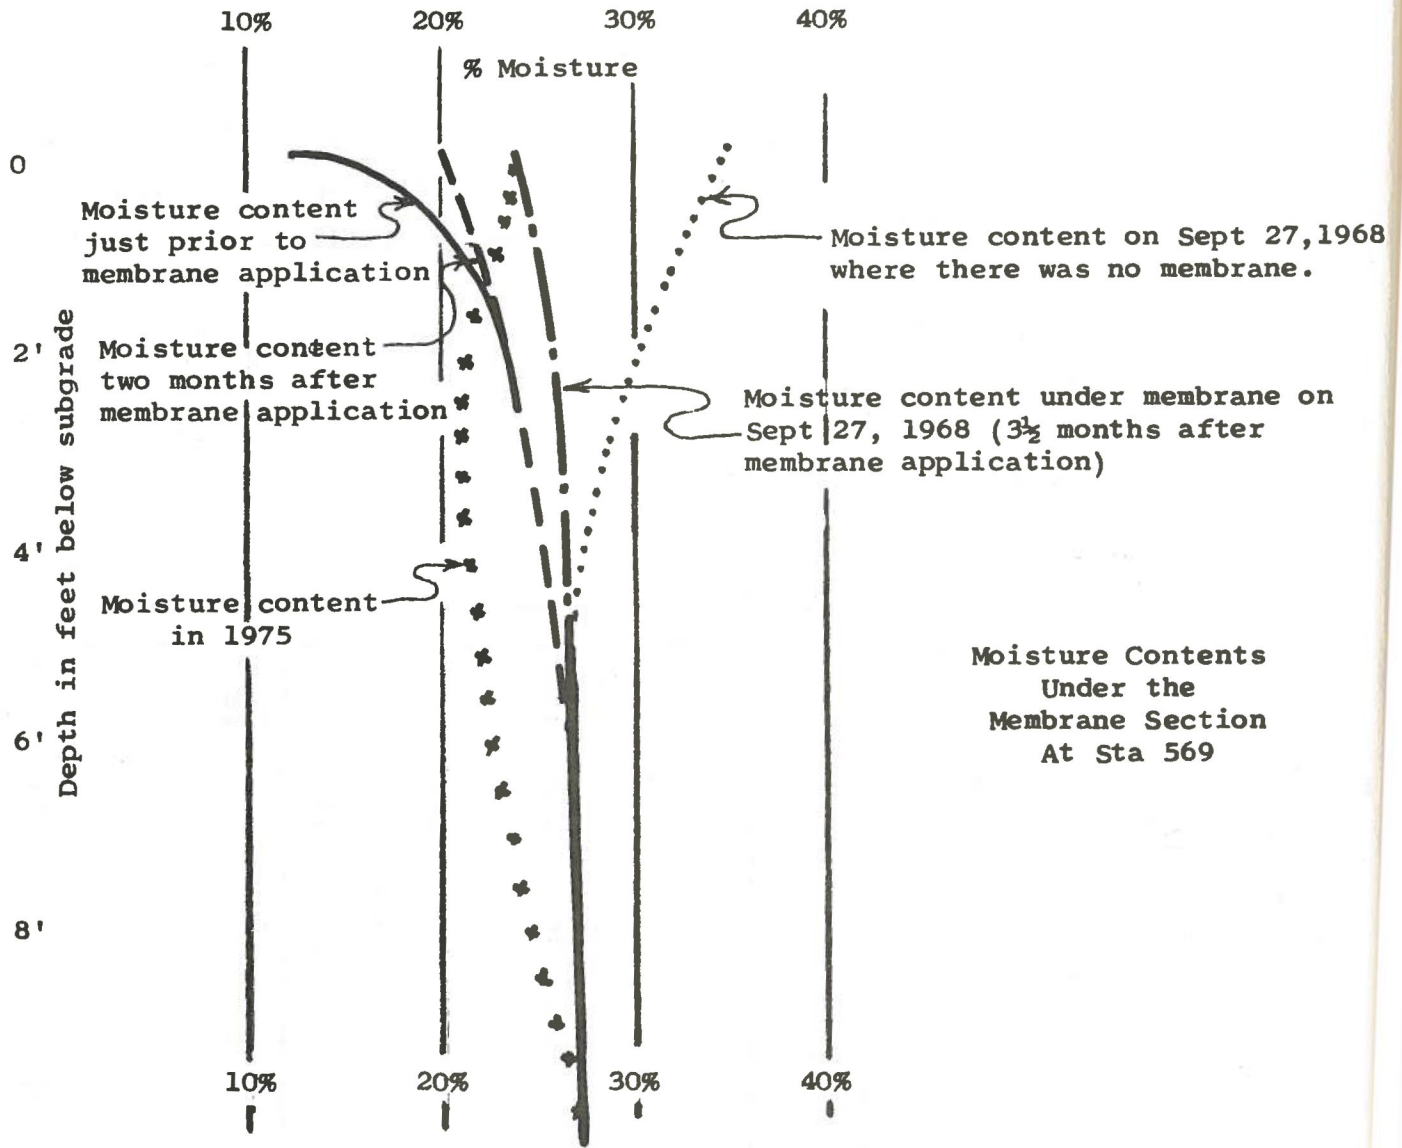
**Moisture Contents  
Under the  
Membrane Section  
At Sta 569**

Subgrade moisture in the membrane section was typically 30% when the membrane was placed in 1968. It was nearer to 26% in 1969, and 23% by 1975.

For a subgrade soil with an optimum moisture of 24-25% it appears that there has been considerable drying since 1968, and this gradual drying out instead of additional saturation is no doubt responsible for at least a part of the tendency of the subgrade to show very little cracking or swell in the last 7 years.

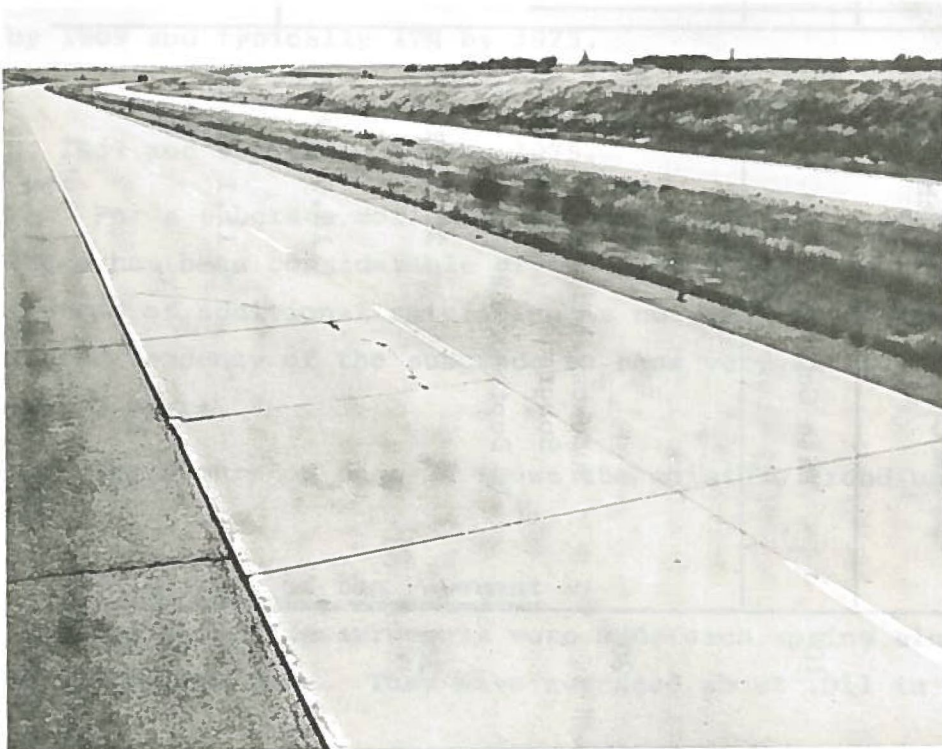
**Photo in 2' (.6 m) Sube  
Section showing the  
cracking at the point  
of maximum surface  
distress and highest  
elevation change.**

**Cracks are thin and  
localized. Faulting  
actually is responsibl  
for more loss of ridin  
comfort than the crack**

.89 There are more cracks and more elevation changes in the 2' (.6 m) sub-  
.89) excavation section than in the other two sections. Probably, it could be  
.90 said that 2 feet (.6 m) of subexcavation is not quite enough treatment for  
.92) an A-7-6(40) subgrade having a plasticity index over 30.  
.91
