SAFETY ASSESSMENT REPORT

State Highway 9 Iron Springs Alignment Environmental Assessment

SH 9C: MP 93.10 - MP 97.20
Region 1
Resurfacing

November 7, 2012

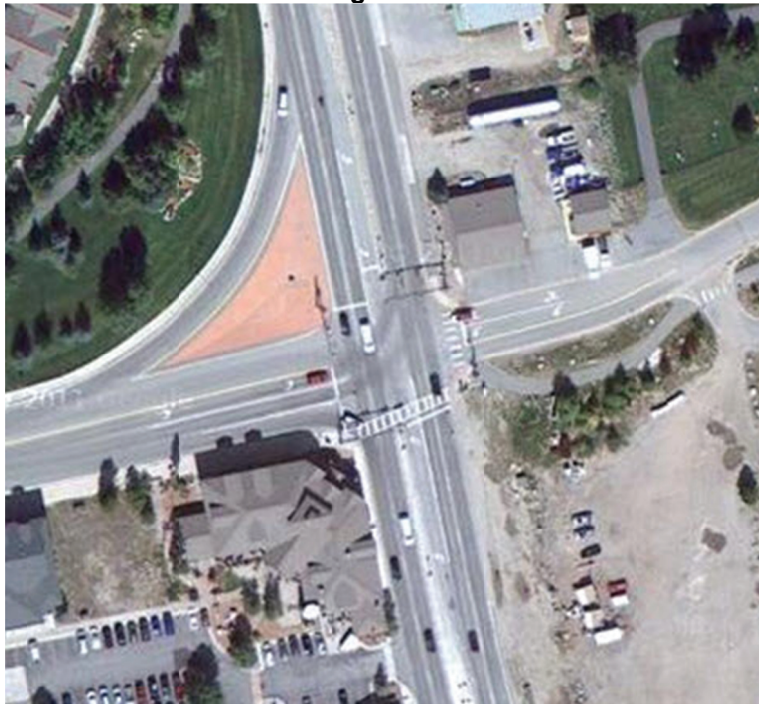
Figure 1a shows an aerial of the intersection of SH 9C with Main St.

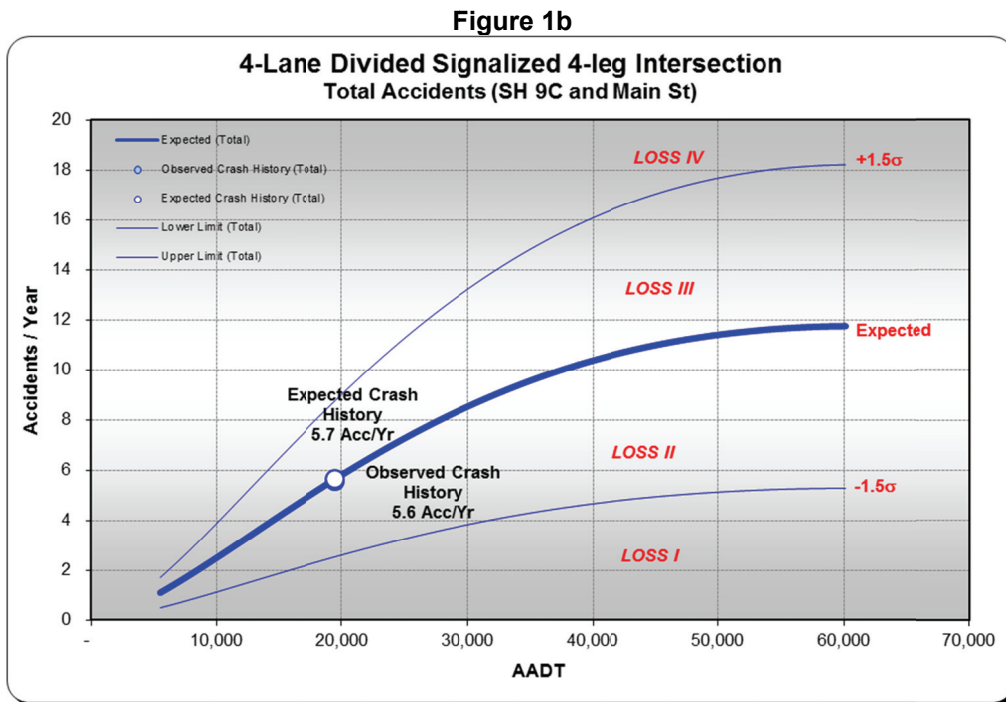
Figure 1b shows the frequency of total accidents over the five year study period performing as expected (LOSS II/III) for a 4-lane divided signalized 4-leg intersection.

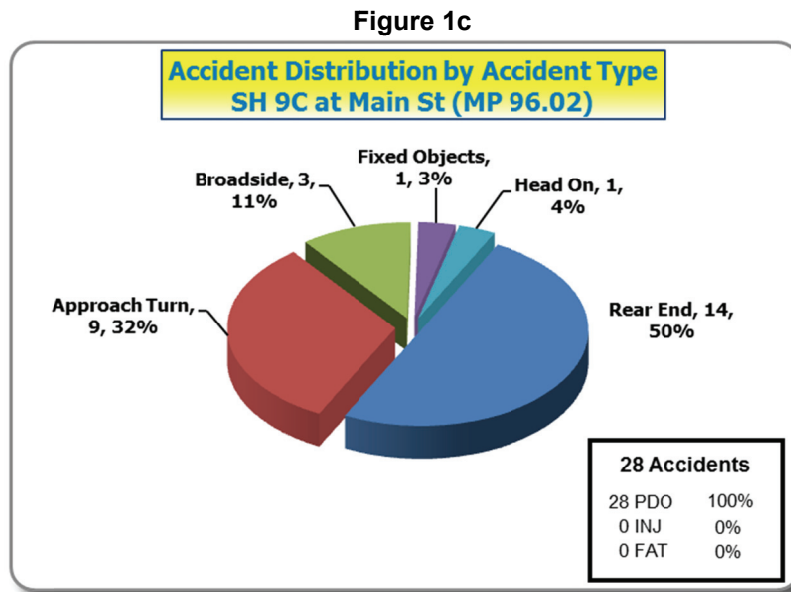
Figure 1c shows the accident type distribution for this intersection. There were 28 accidents over the five year study period related to this intersection.

Approach Turn collisions accounted for 32 percent of the total accidents at this intersection (9 of 28). Direct diagnostics show this percentage to be higher than expected for this type of intersection. All 9 approach turn accidents occurred in the northbound direction. The region should consider upgrading the northbound left turn signal from protective-permissive to a “ Time of Day” fully-protected (flashing yellow) left turn arrow between the hours of 10am and 3pm in order to help with this accident pattern. This signal is detailed in the 2009 MUTCD section 4D.20.

Rear End collisions accounted for 50 percent of the total accidents at this intersection (14 of 28). Direct diagnostics show this percentage to be higher than expected for this type of intersection. They are broken down by the following: 10 eastbound, 3 northbound, and 1 southbound. These accidents are happening throughout the day. This is a weather and congestion related issue. The region should consider installing countdown pedestrian signals to help with this issue. Countdown signals could help increase driver awareness of the signal changes and could help them prepare for the yellow/red light. Also, the region should extend the pavement marking of the right turn lane to be even with the left lane to provide drivers better delineation of the designated lanes and reduce possible confusion.

Approach Turn collisions accounted for 32 percent of the total accidents at this intersection (9 of 28). Direct diagnostics show this percentage to be higher than expected for this type of intersection. All 9 approach turn accidents occurred in the northbound direction. The region should consider upgrading the northbound left turn signal from protective-permissive to a “ Time of Day” fully-protected (flashing yellow) left turn arrow between the hours of 10am and 3pm in order to help with this accident pattern. This signal is detailed in the 2009 MUTCD section 4D.20.

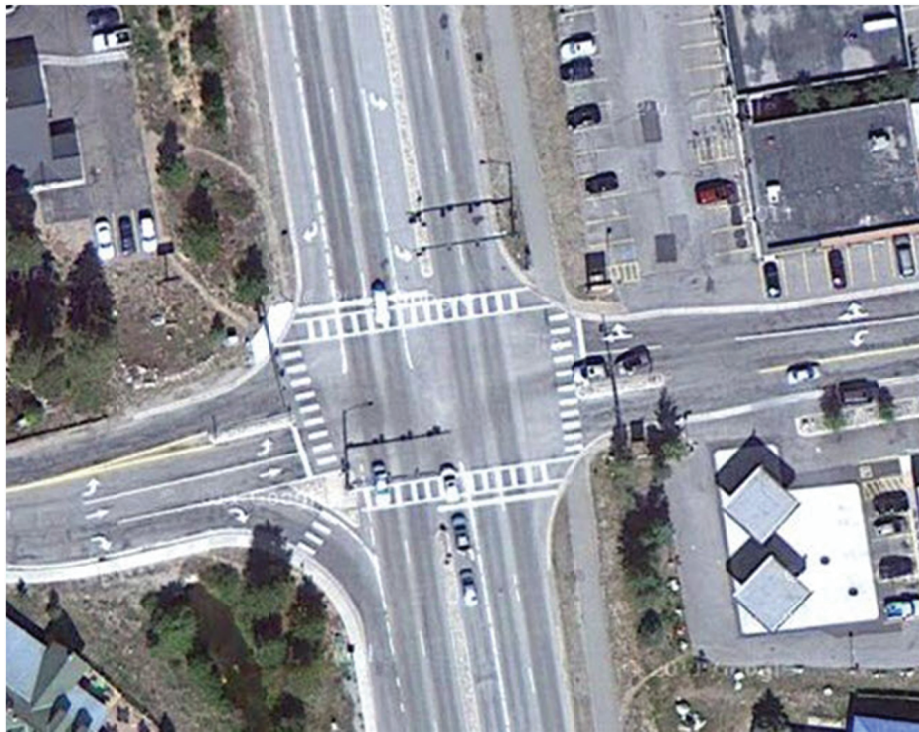
Figure 2a shows an aerial of the intersection of SH 9C with Hawn Dr.

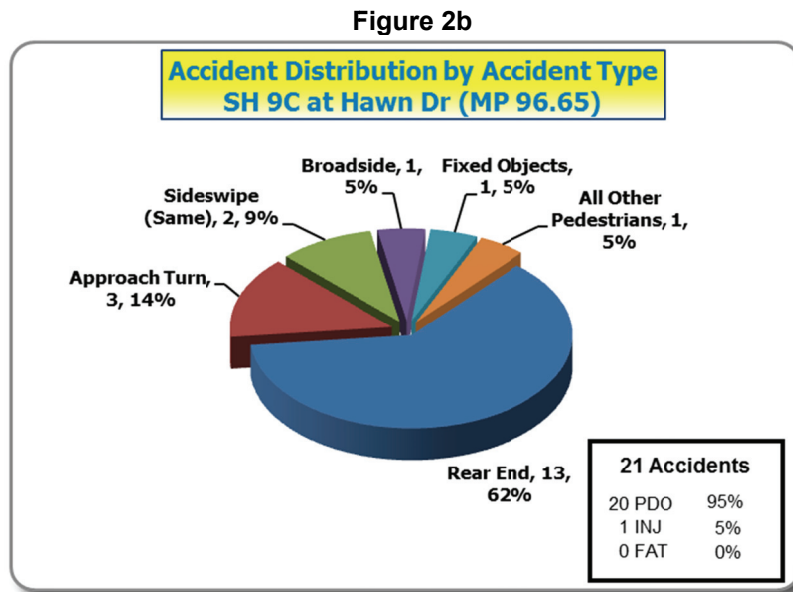
Figure 2b shows the accident type distribution for this intersection. There were 21 accidents over the five year study period related to this intersection.

Rear End collisions accounted for 62 percent of the total accidents at this intersection (13 of 21). Direct diagnostics show this percentage to be higher than expected for this type of intersection, but this is a weather and congestion related issue. They occurred in the following directions: 7 southbound, 3 northbound, and 3 eastbound. These accidents are happening throughout the day and 9 of 13 happened with inclement road conditions. The region can check the signal progression and install countdown pedestrian signals to help with this issue. Countdown signals could help increase driver awareness of the signal changes and could help them prepare for the yellow/red light.

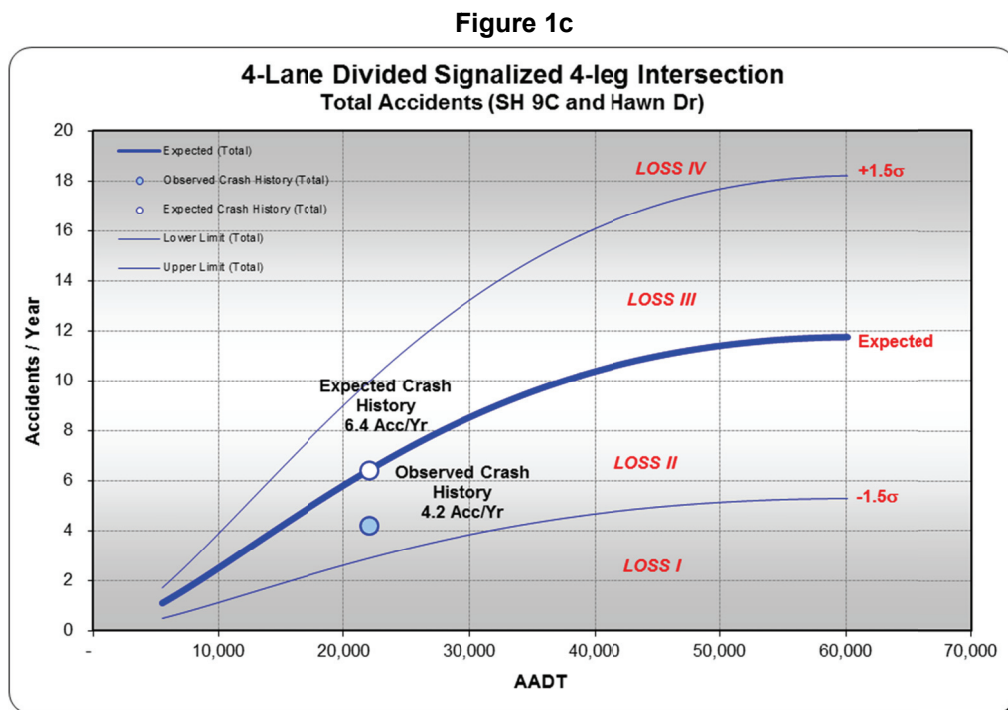
Figure 2c shows the frequency of total accidents over the five year study period was below expected for a 4-lane divided signalized 4-leg intersection which indicates a better than expected performance (LOSS II).

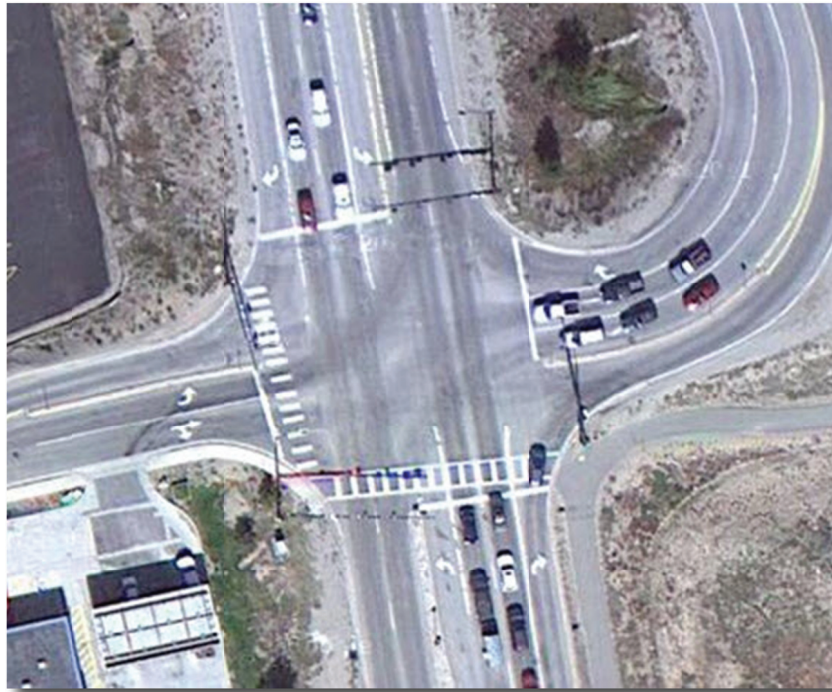
Figure 3a shows an aerial of the intersection of SH 9C with Lusher Court Loop.

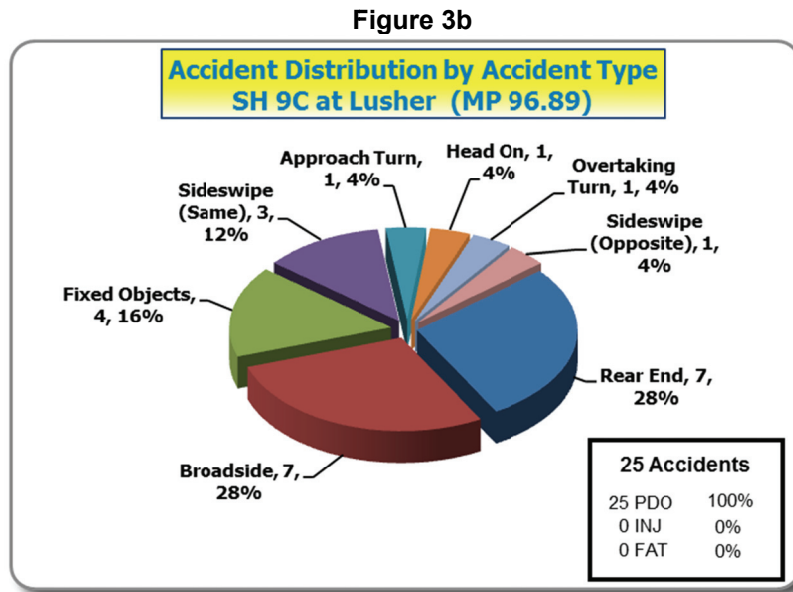
Figure 3b shows the accident type distribution for this intersection. There were 25 accidents over the five year study period related to this intersection.

Broadside collisions accounted for 28 percent of the total accidents at this intersection (7 of 25). Direct diagnostics shows this percentage to be higher than expected for this type of intersection. The yellow and all red intervals appear to be adequate. They occurred in the following directions: 3 northbound, 2 southbound, and 2 eastbound. These accidents are happening throughout the day and 5 of 7 happened with inclement road conditions. The region can check the signal progression and install countdown pedestrian signals to help with this issue. Countdown signals could help increase driver awareness of the signal changes and could help them prepare for the yellow/red light.

Direct diagnostics shows this percentage to be higher than expected for this type of intersection. They are in the following directions: 3 northbound, 2 southbound, and 2 eastbound. These accidents are happening throughout the day and 5 of 7 happened in inclement road conditions. The region can check the yellow and red light intervals and install countdown pedestrian signals to help with this issue. Countdown signals could help increase driver awareness of the signal changes and could help them prepare for the yellow/red light.

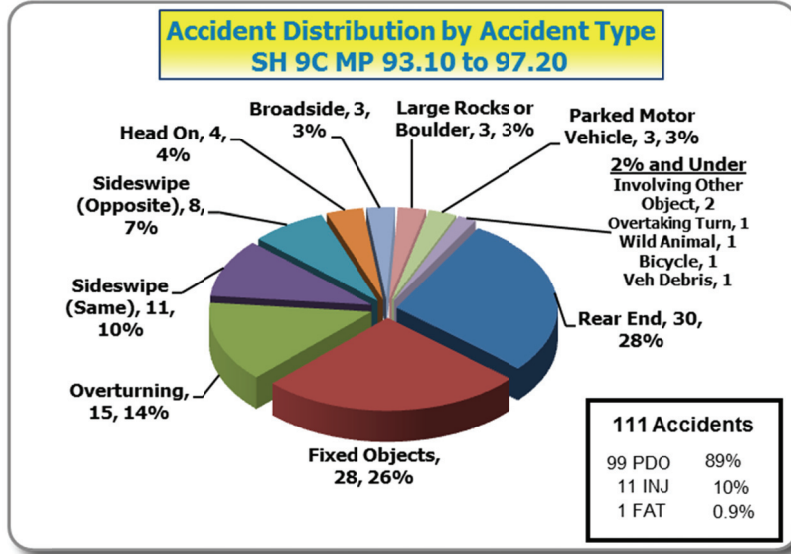
Figure 4a

Accidents that are non-intersection related accounted for 44 percent of the total accidents (111 of 255). **Figure 4a** lists the accident type distribution for non-intersection related accidents. 67 of the 111 accidents (including the fatal accident) occurred with adverse road conditions.

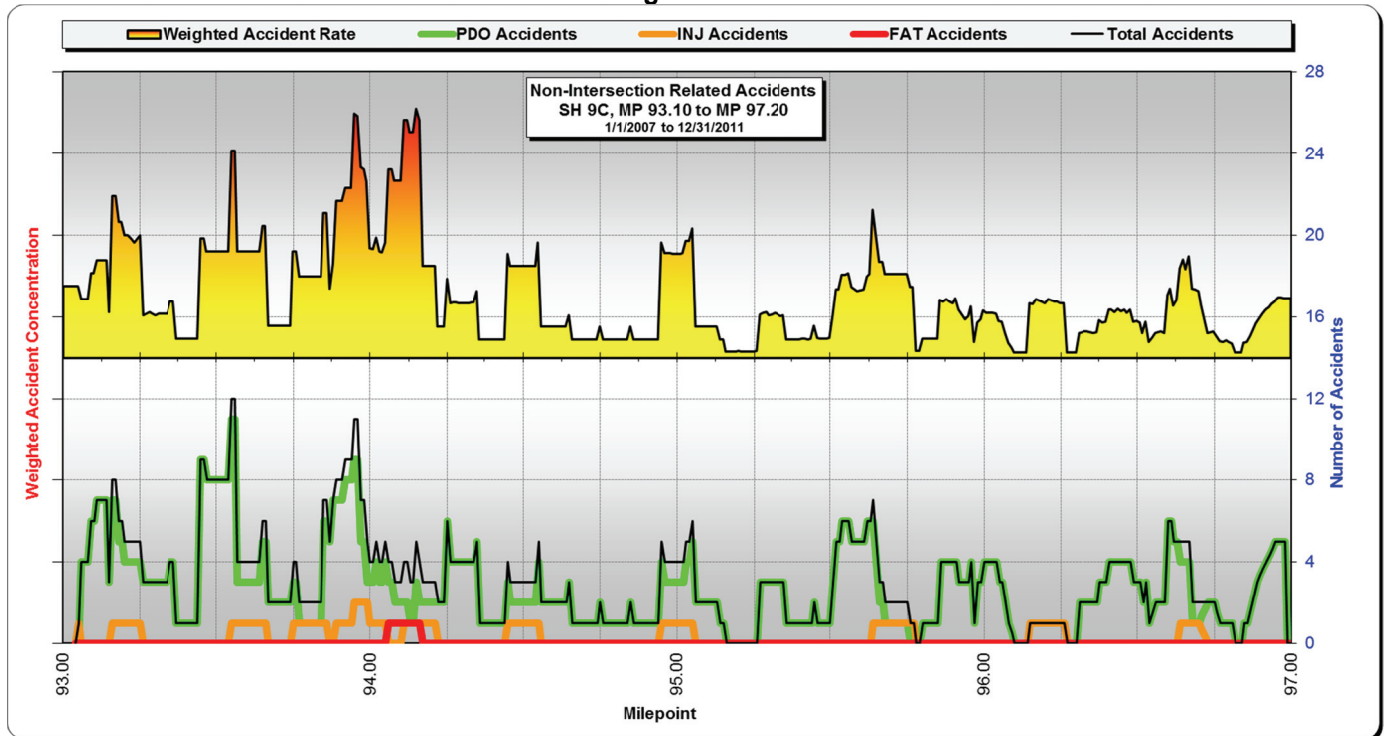
Figure 4b shows a weighted accident diagram concentration of non-intersection related accidents. There was one notable concentration within the project limits from MP 93.10 to 95.00. 67 total accidents including 8 injuries and 1 fatality occurred within this 2 mile section. 43 of these 67 accidents occurred with adverse road conditions. 12 of the 15 overturning accidents occurred between MP 93.90 and 94.80. The Region should consider extending the existing guardrail through this section to help reduce the off-road related accidents.

There was one notable concentration of accidents within the project limits from MP 93.10 to 95.00. 67 total accidents including 8 injuries and 1 fatality occurred within this 2 mile section. 43 of these 67 accidents occurred with adverse road conditions. 12 of the 15 overturning accidents occurred between MP 93.90 and 94.80. The Region should consider extending the existing guardrail through this section to help reduce the off-road related accidents.
