Re: Lonetree Reservoir Dam (CO 01734)  
W. Div. 1 W. Dist. 4

## SUMMARY OF ASSESSMENT AND RECOMMENDATIONS

### LONETREE DAM AND DIKE

INSPECTION ON 20 OCTOBER 1978

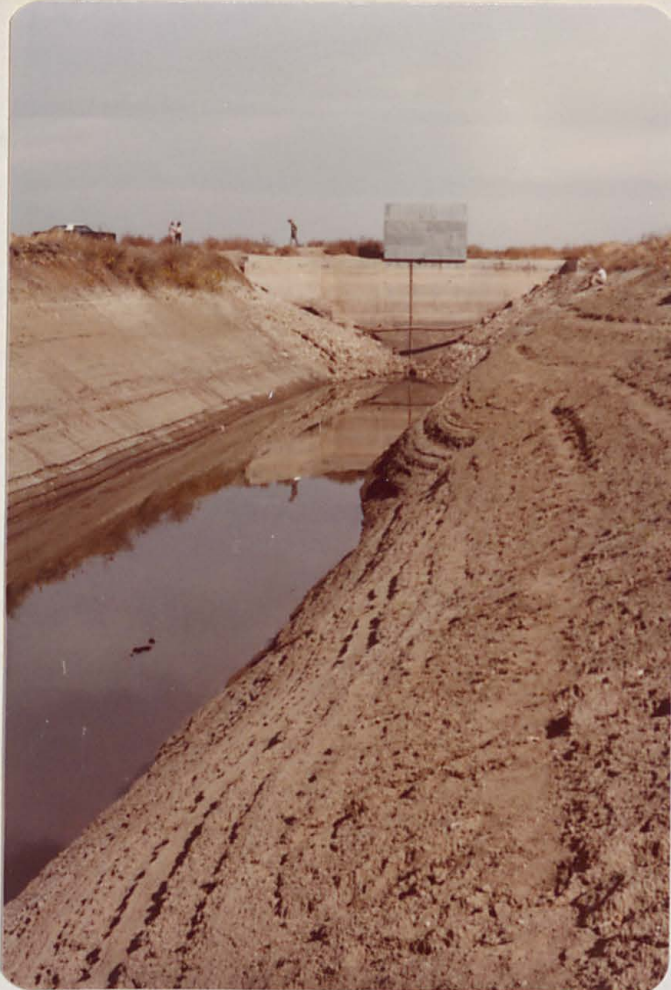
Concrete structure was placed against old masonry dam which is backed up with earth embankment as shown on Plate 2, Appendix C

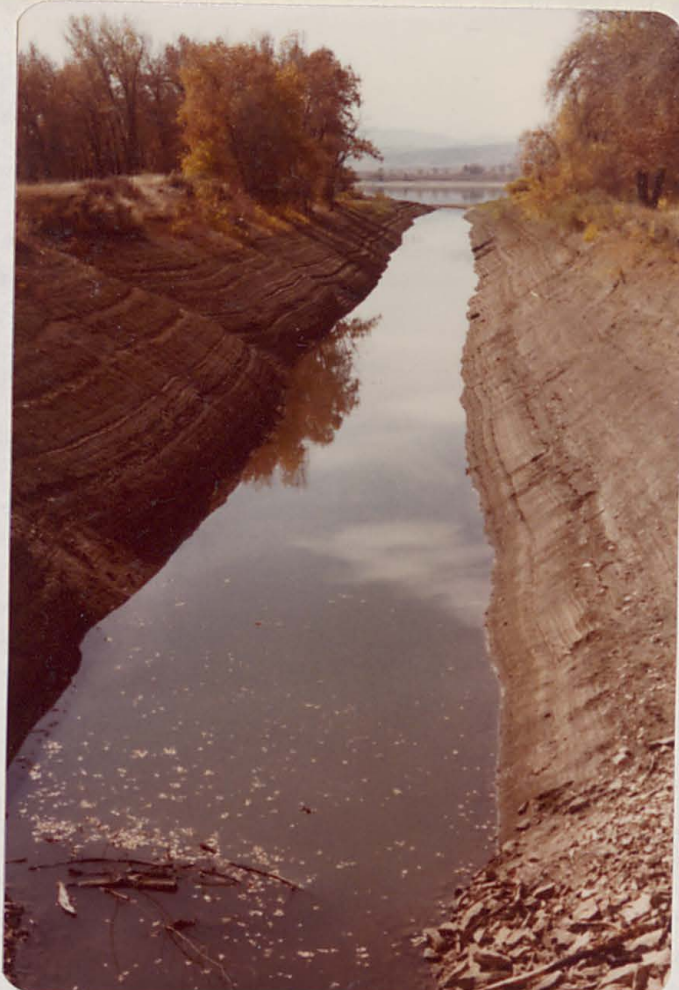
Looking upstream from top of dam. Intake structure is under water near branches in foreground.

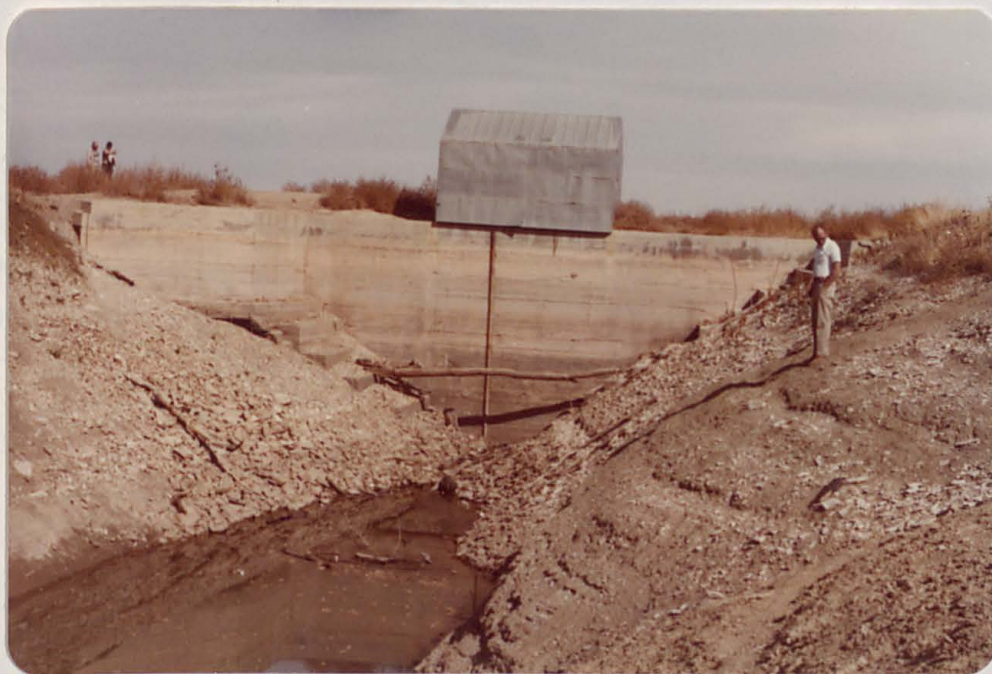
Photo No. 1 Upstream face of Lonetree Dam and Reservoir extension V channel, 10/20/78

Concrete surface appeared to be in good condition. No serious structural cracks were observed. Metal house protects gate hoists. Vertical pipe extending down from house contains staff gage for measuring elevation of reservoir.

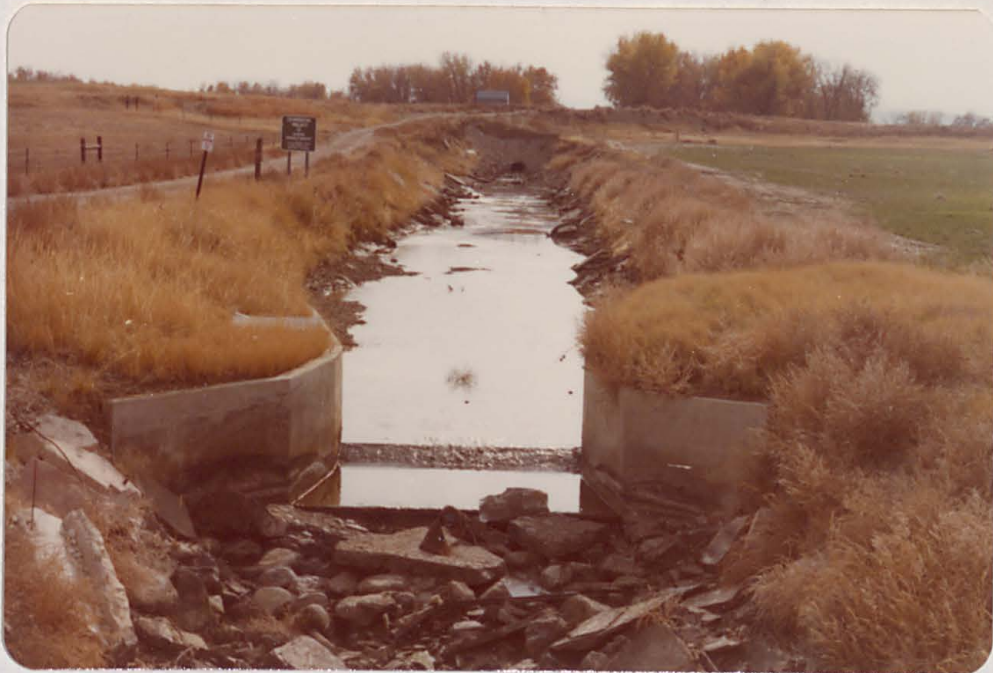
Downstream face of Lonetree Dam below metal gate house resting on top of dam in background. Parshall flume in foreground measures discharge from outlet into Lake Ditch Canal.

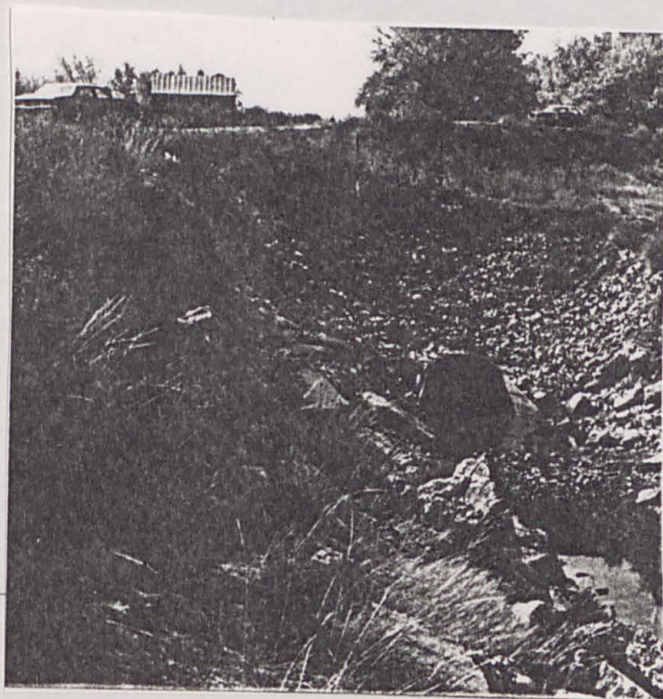
New seven-foot-long aluminum transition attached to a 60-foot-long, five-foot-diameter 14-gauge corrugated aluminum pipe extension to old 140-foot-long masonry arch tunnel

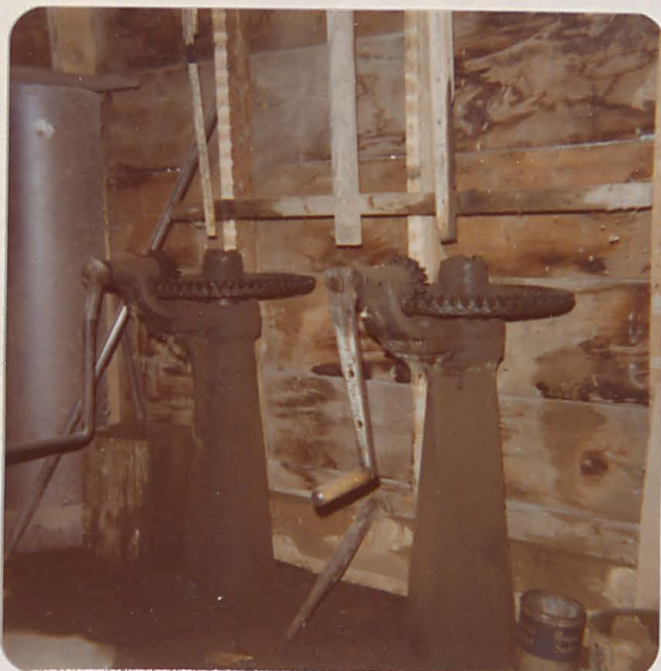
Gate hoists operate two 24" x 36"  
Armco slide gates

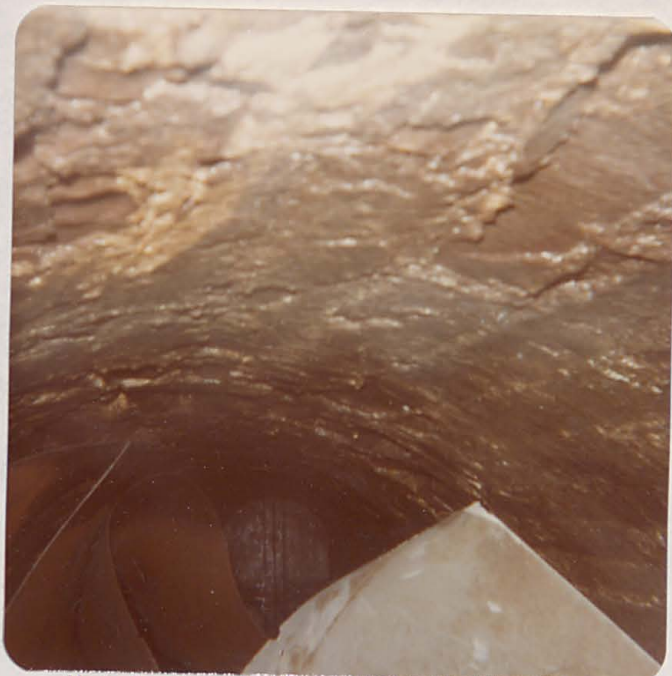
Metal fins below slide gates for  
improving flow characteristics

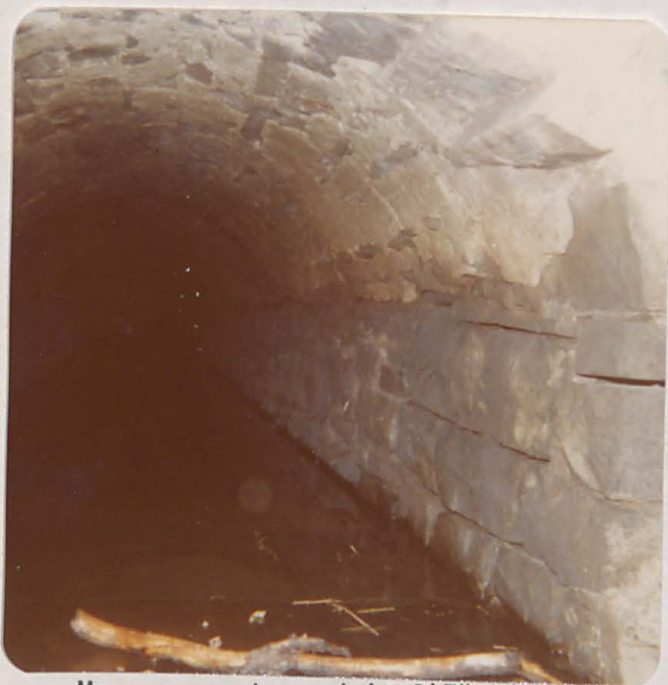
Some seepage was noted coming through the masonry walls under the Home Supply Canal, although the canal was dry at the time of the inspection.

Masonry arch conduit 3'7" high,  
5' wide, 140' long

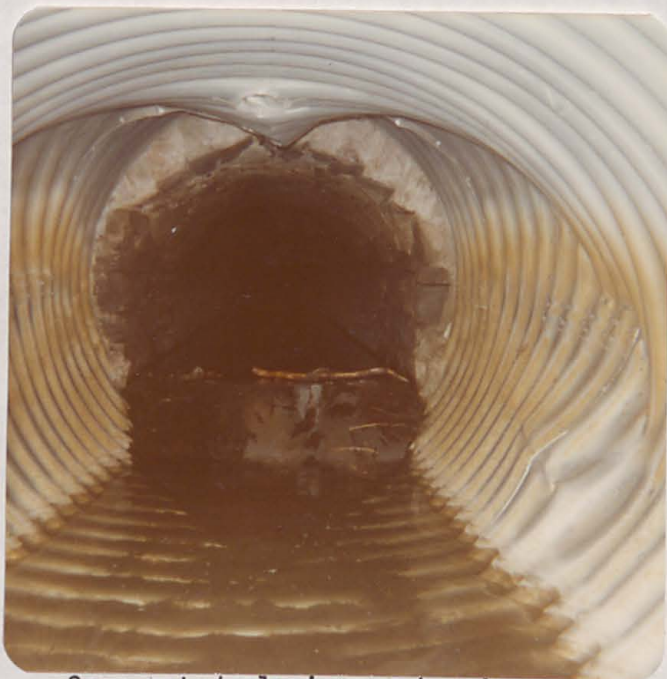
Corrugated aluminum extension  
5' diameter, 60' long, added to  
masonry conduit in 1978

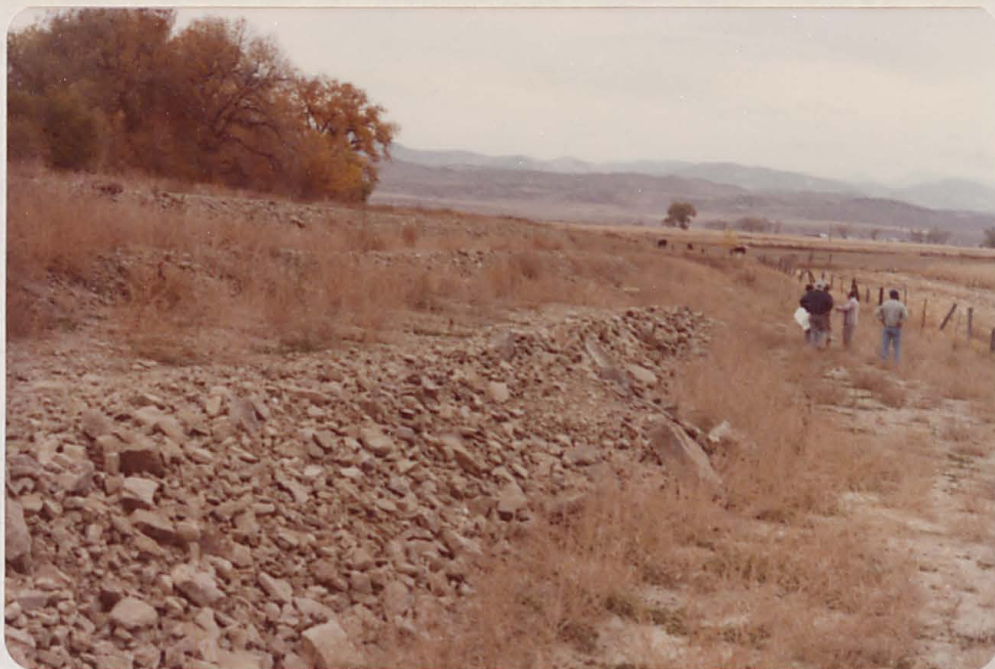
Maximum section--11 feet between crest and downstream toe of dam

Tile drains under embankment have stabilized this old marshy area

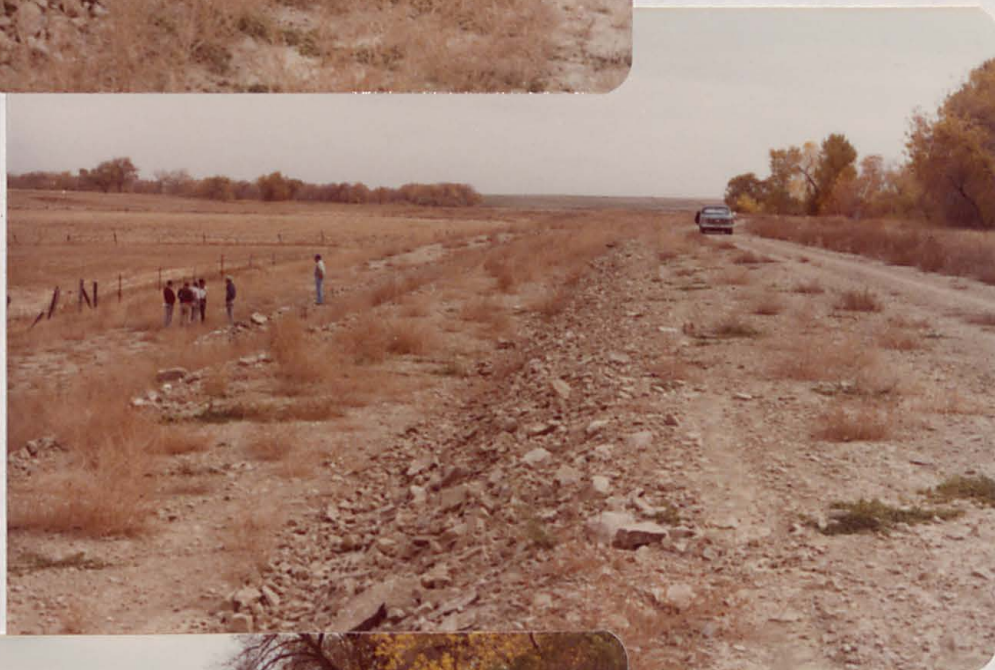
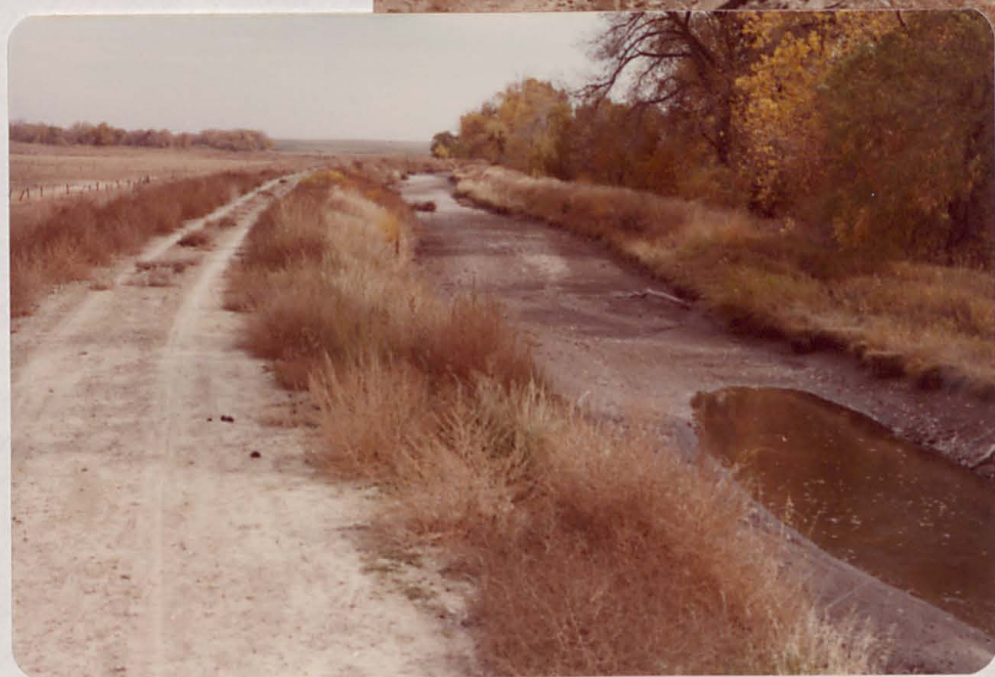
Photo No. 4 Lonetree dike and Home Supply Canal, 10/20/78

Typical section of dike which includes the Home Supply Canal and its banks and side slopes. Base of trees on right side of photo are below high water line of Lonetree reservoir.

- a. Replace or modify the present spillway weir to provide an erosion-resistant structure.
- b. Consider placing the Home Supply Canal in a siphon under the spillway to protect it from damage during a spill and to minimize the possibility of canal water contributing to failure of the dike in this area.

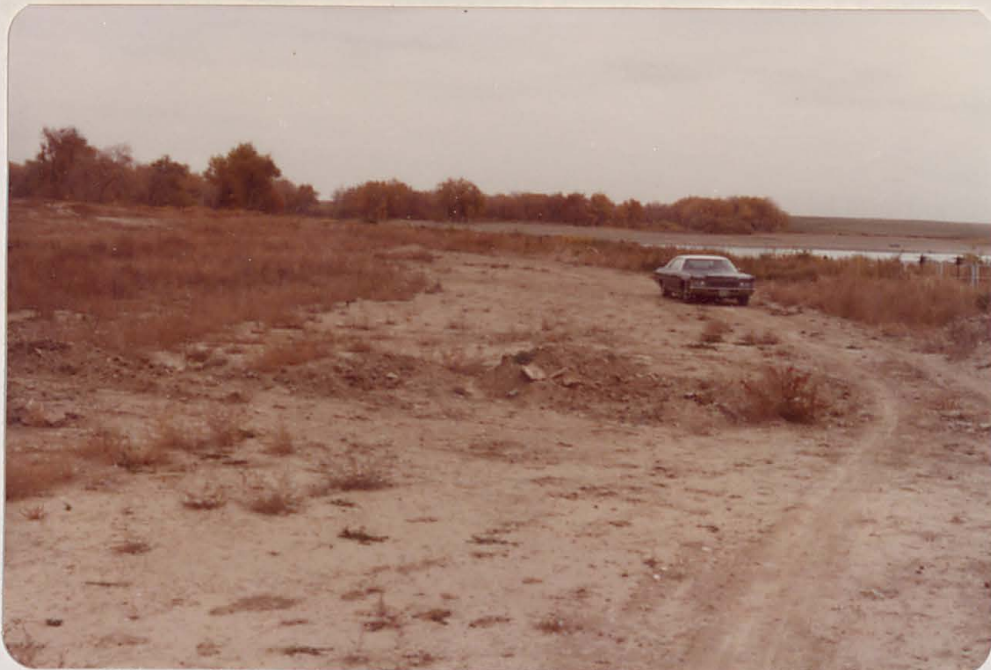
Spillway is about 1150 feet in length. Sandstone crest is about 950 feet wide. Elevation is 25.0 gage, 3.5 feet below crest of dike.

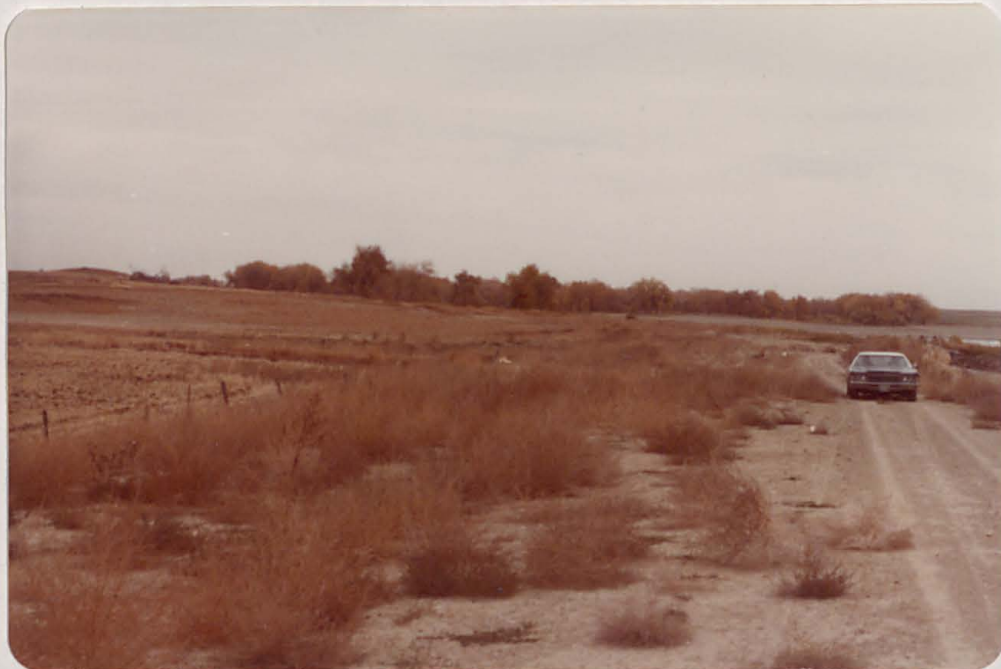
Photo No. 5 Uncontrolled spillway, largely cut from shallow sandstone bedrock, Lonetree Dam, 10/20/78

More distant view of spillway cut. Note swale to left of spillway. This is beginning of Ryan Gulch which would carry spill to Big Thompson River.

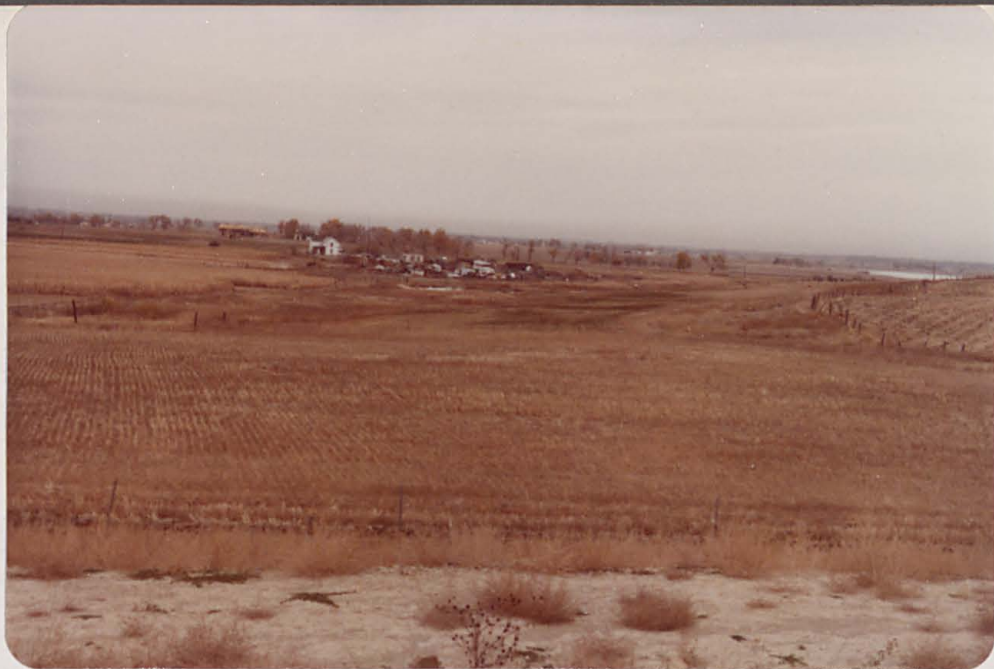
View from left side of spillway crest. Note house in flood plain and Ryan Gulch Lake in background.

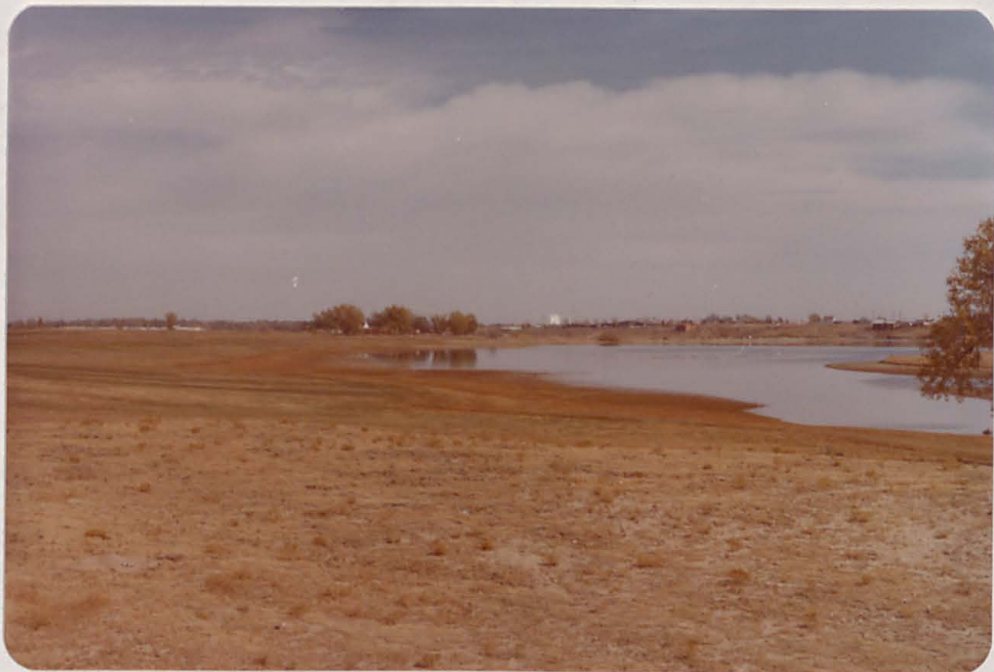
Ryan Gulch Lake would receive spill from Lonetree. Buildings in background are on outskirts of Loveland, Colorado.

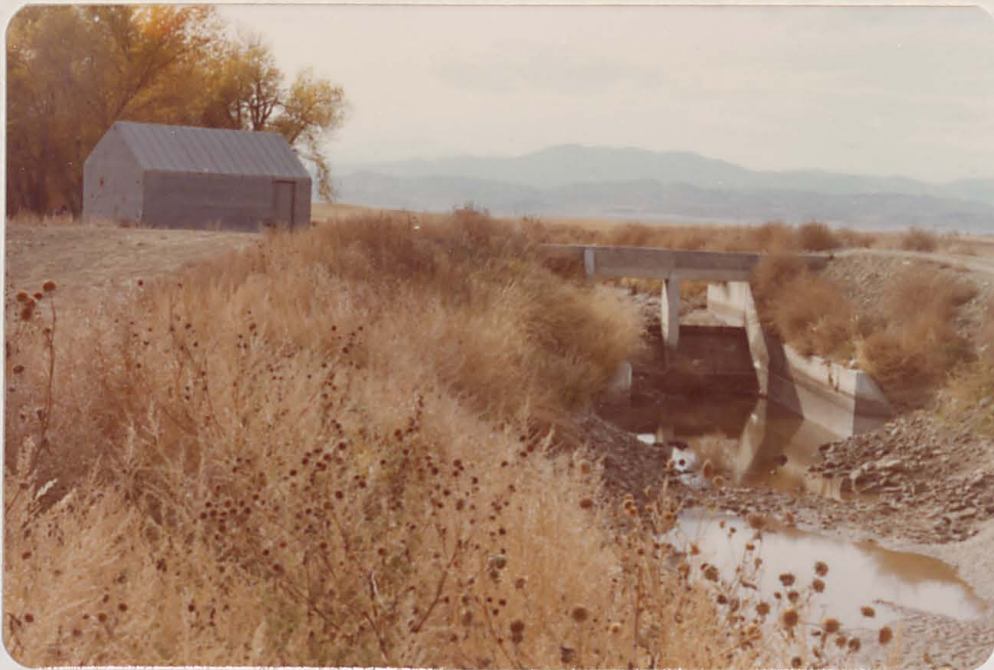
Metal gate house sits on Lonetree Dam. Outlet from dam to Lake Ditch Canal runs under Home Supply Canal. Crest of dam runs from barrier wall on top of check structure to contour 28.5 on right abutment.

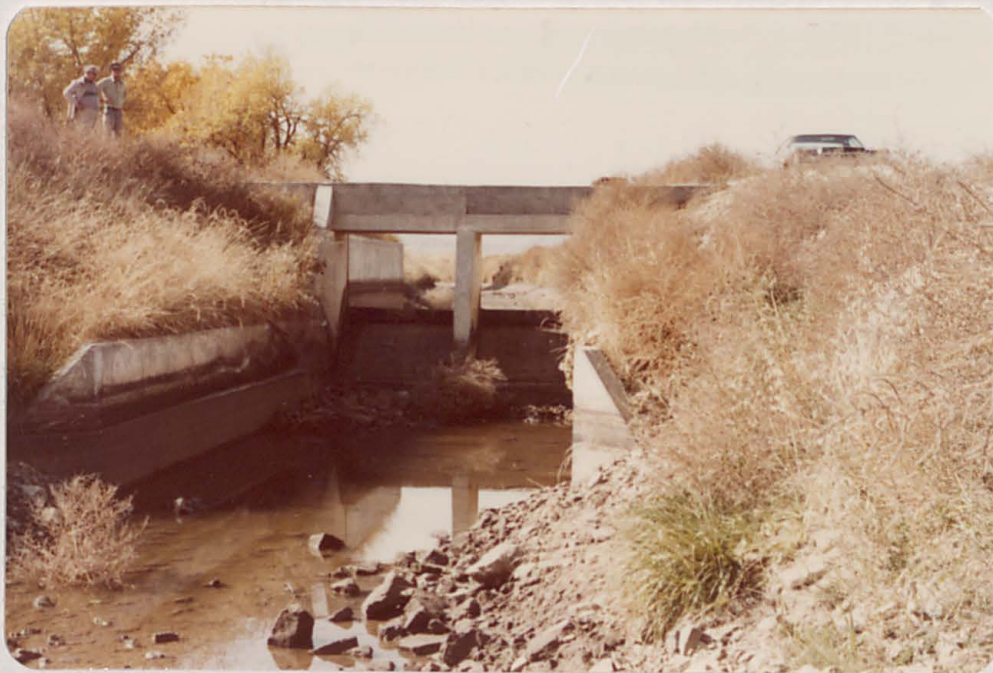
Photo No. 7 Check structure in Home Supply Canal  
(River Ditch) at Station 0+50, 10/20/78

Concrete barrier wall was added to check structure to retain water spilling from Lonetree Reservoir into the Home Supply Canal. The barrier is 3.5 feet above spillway crest.

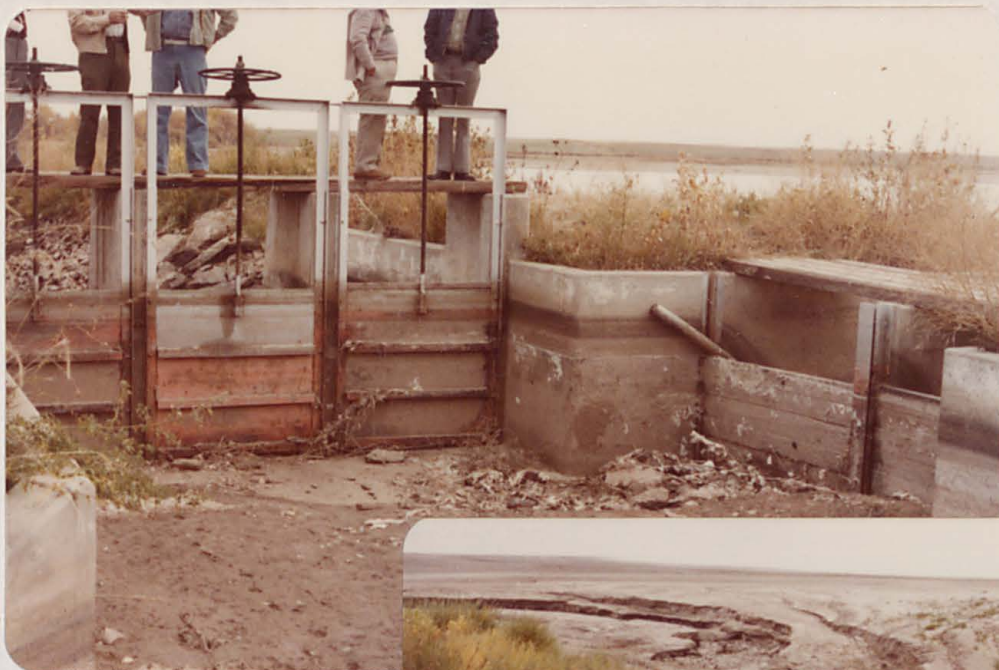
Lower diversion structure at Station 31+50 is in spillway reach as shown on Plate 5, Appendix D

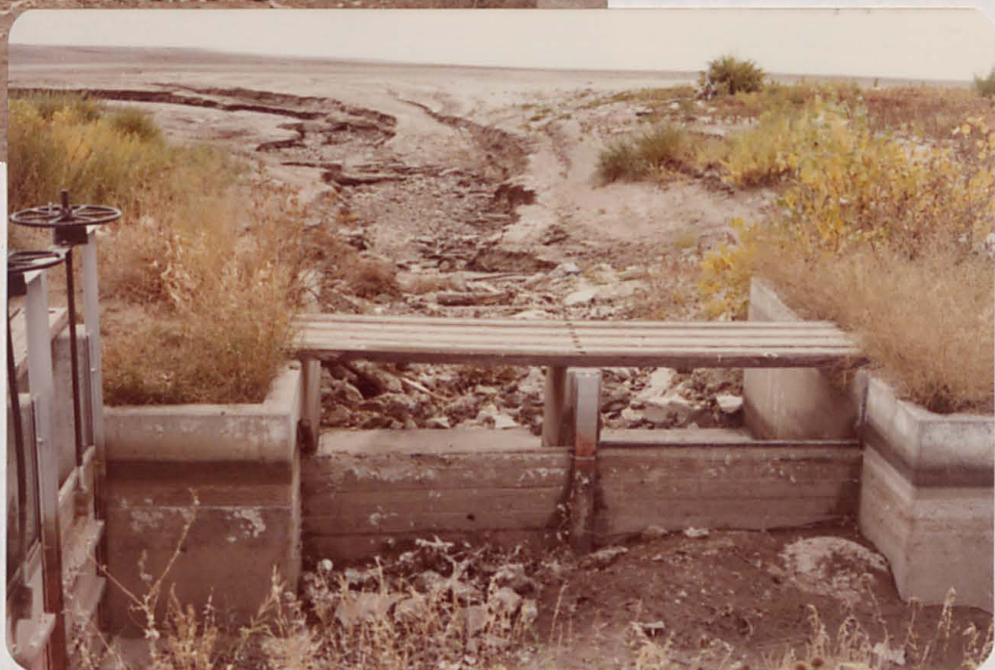
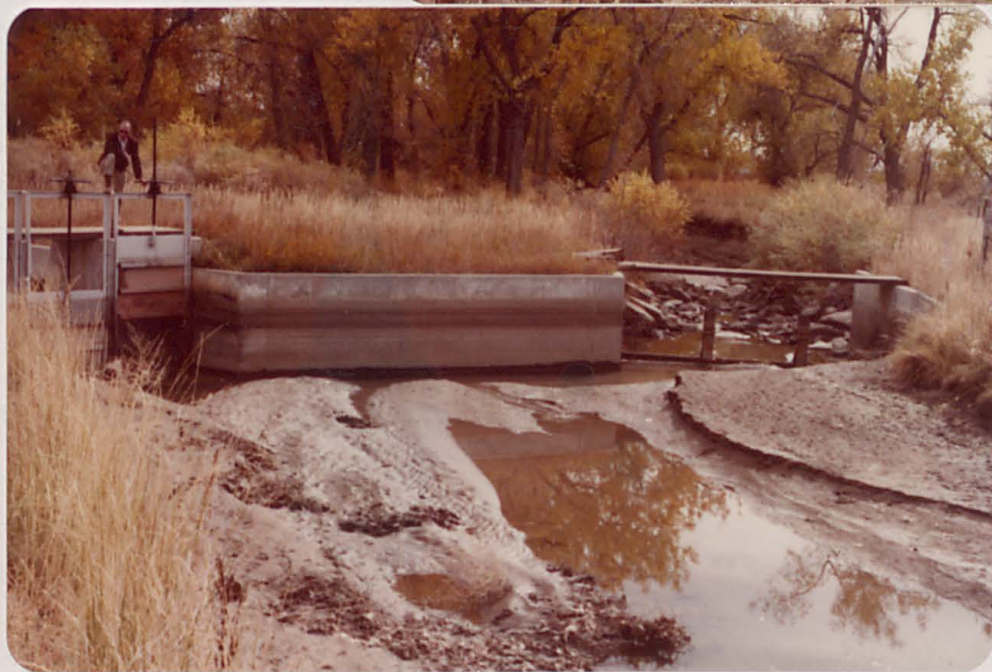
Looking from supply canal to reservoir. Note gentle slope between canal reservoir and water surface.

Upper diversion structure at Station 51+50. This diversion will handle 200 cfs. The supply canal can carry 350 cfs. When it does both diversion structures are used to fill the reservoir.

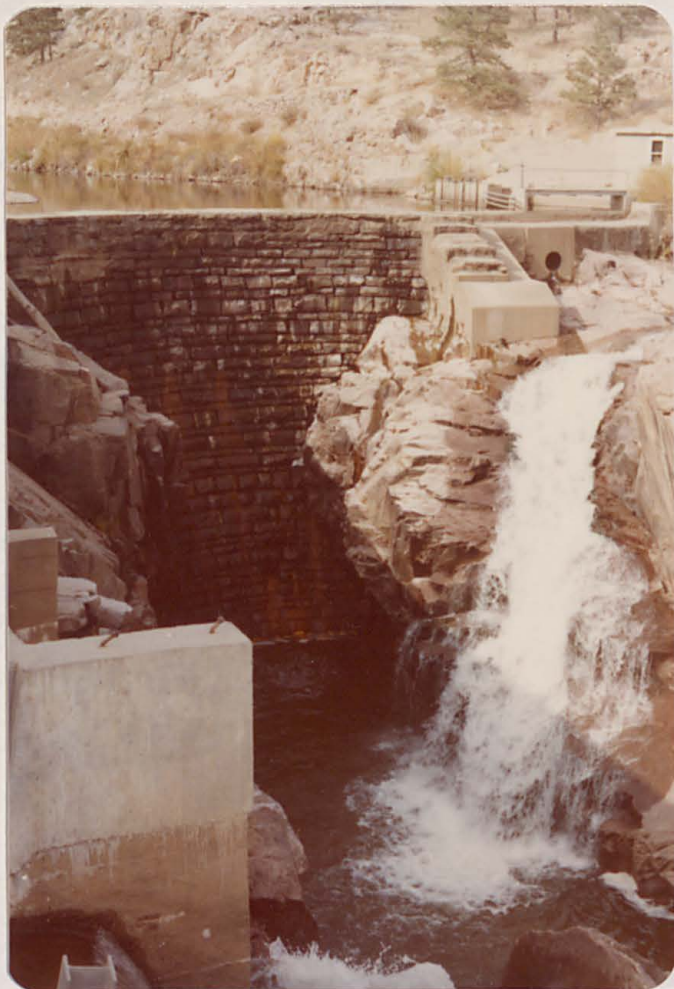
Masonry arch diversion dam  
supplies water to Home Supply  
Canal from right side of river.  
Structure withstood the 1965  
flood.

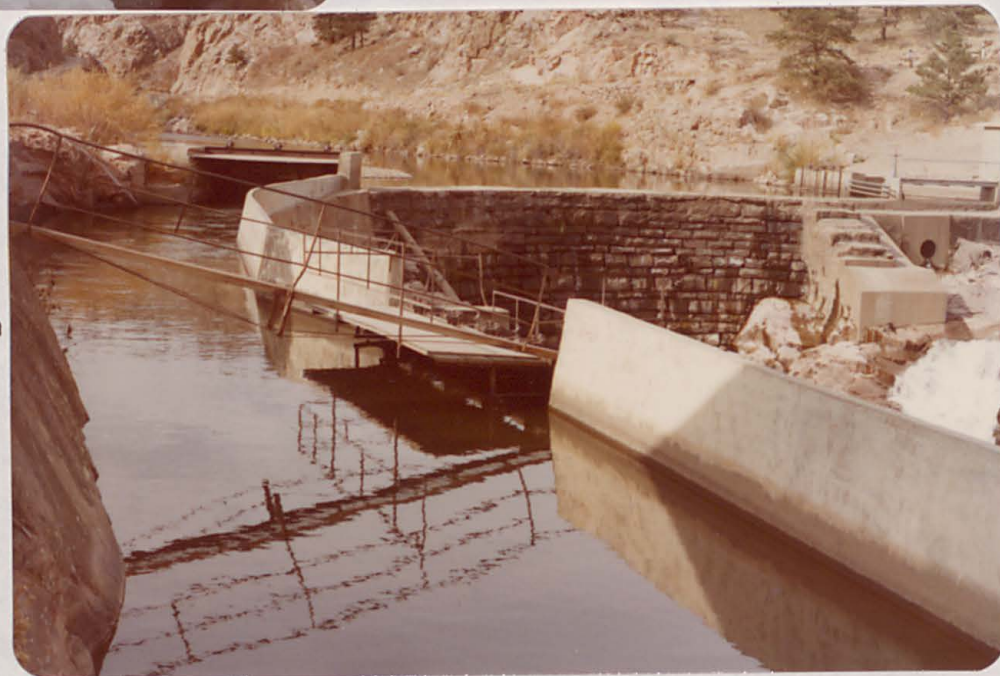
Photo No. 9    Diversion dam on Big Thompson River and  
diversion for Home Supply Canal, 10/20/78

Intake for Home  
Supply Canal.  
Note wasteway  
back to river in  
foreground.

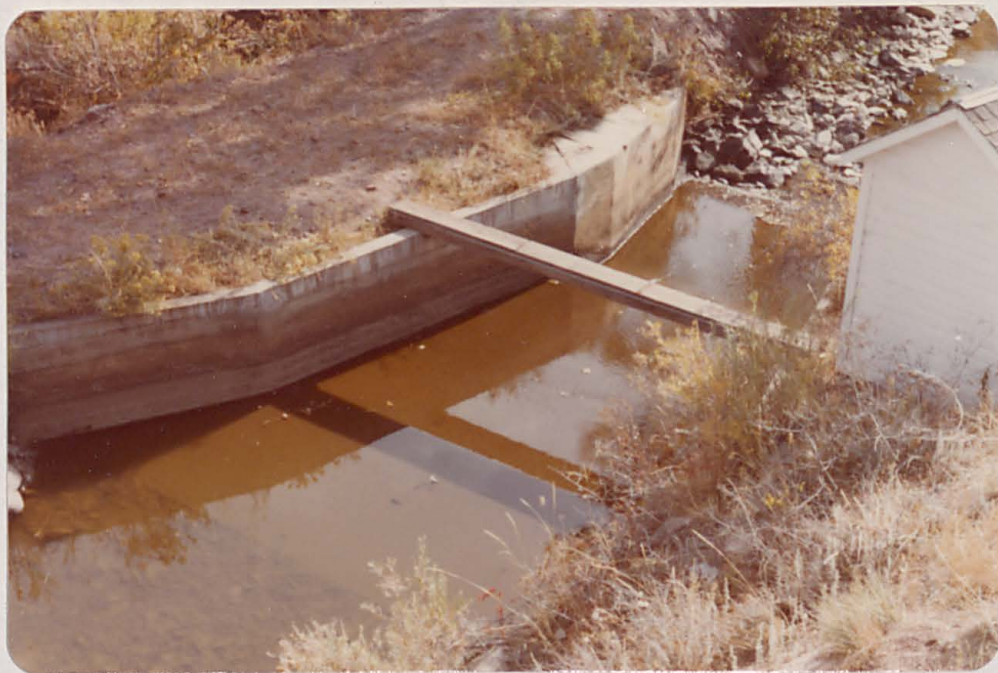
Parshall flume just below intake structure measures flow going to Lonetree Reservoir

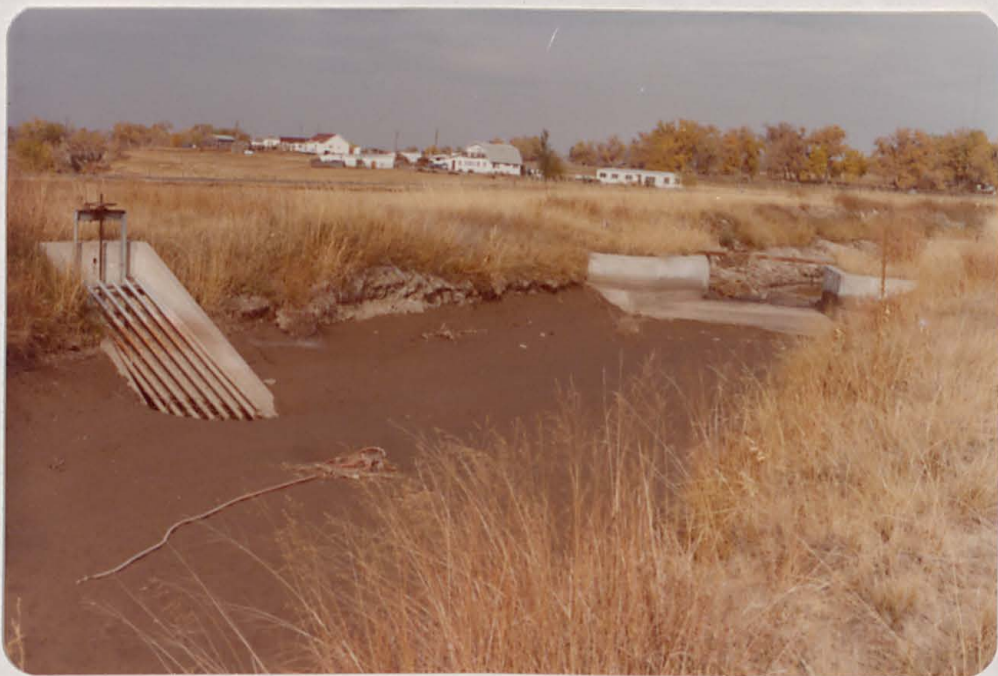
Photo No. 10 Measuring for Home Supply Canal feeding Lonetree Reservoir, 10/20/78

Parshall flume just downstream from Lonetree Dam measures flow in Home Supply Canal going past Lonetree Reservoir. Wasteway in front of flume can divert water to Lake Ditch Canal.
