## **Appendix D. Traffic Safety Report**

**US 85 PEL  
SAFETY ASSESSMENT**

Colorado Department of Transportation  
Region 4  
10601 West 10<sup>th</sup> Street  
Greeley, CO 80634  
970/350-2148 or 970/350-2163

March 2016

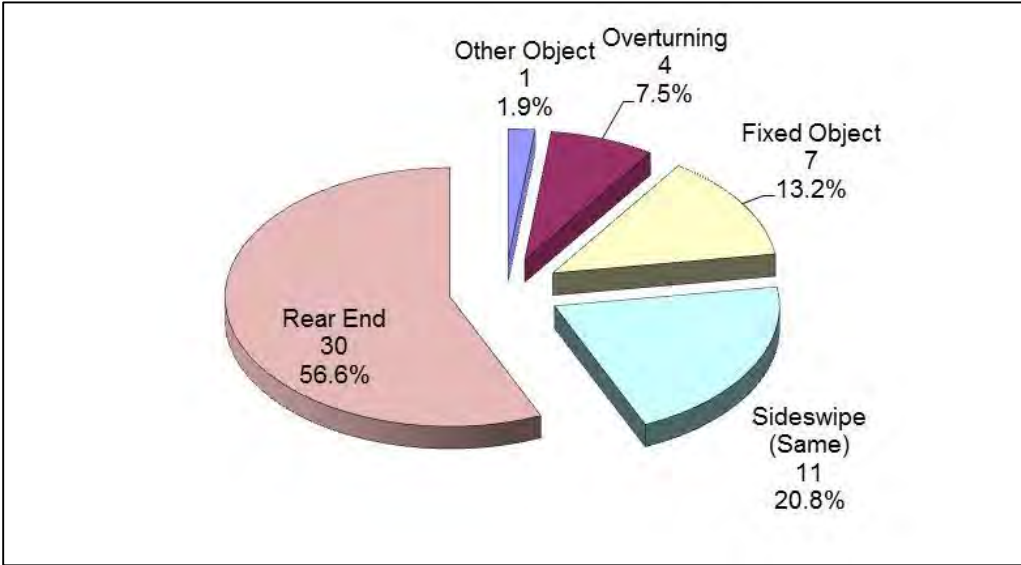
**Figure 4  
Non-Intersection Crash Types  
(Segment 1A: MP 226.80 – MP 227.47)**

The frequency of rear end type crashes was higher than expected for this type of roadway. A review of the rear end crash history indicated that there were 19 crashes northbound, nine crashes southbound, and two crashes eastbound. Road conditions for rear end type crashes showed that 29 of the 30 were dry road conditions. This crash pattern seen above is related to the high volumes, congestion, and higher speed at the signalized intersection (SH 44) north of the US 85C/I-76A interchange. It is recommended to consider repositioning the northbound flashing warning sign of the upcoming signalized intersection further south on US 85C. Repositioning location could be considered before going under the I-76A bridge that obstructs the view of the upcoming intersection. Additionally, consideration for a southbound flashing warning sign of the upcoming signalized intersection north of the intersection is recommended.

The frequency of sideswipe (same direction) type crashes was higher than expected for this type of roadway. A review of the sideswipe (same direction) type crashes indicated there were three crashes northbound and eight crashes southbound. Ten of the 11 crashes occurred in dry roadway conditions. The sideswipe (same direction) type crashes occurred throughout Segment 1A. A review of the crash history indicates that there is no current pattern to the sideswipe (same direction) type crashes. There are no suggestions for improvement at this time.

Although there is no significant pattern of off-road left or head-on crashes, it is recommended that a cable rail median barrier be considered due to the high volumes and narrow median.

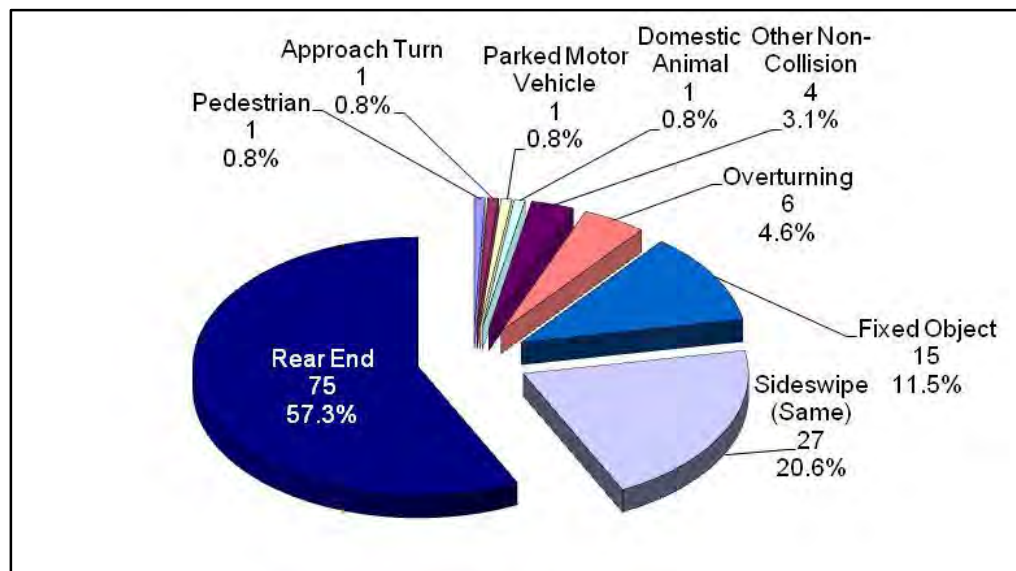
**Figure 5**  
**Non-Intersection Crash Types**  
**(Segment 1B: MP 227.48 – MP 230.86)**

The frequency of rear end type crashes was higher than expected for this type of roadway. A review of the rear end crash history indicated that there were 33 crashes northbound, 41 crashes southbound, and one crash westbound. Road conditions for rear end type crashes showed that 70 of the 75 were dry road conditions. This crash pattern is related to the high volumes, congestion, and higher speeds near the signalized intersections within the study area. Signalized intersections with US 85C within this segment are: 112<sup>th</sup> Avenue, 120<sup>th</sup> Avenue, and 124<sup>th</sup> Avenue with 120<sup>th</sup> Avenue having slightly fewer crashes than the other two intersections. Recommendations for these intersections can be found in the intersection portion of the report.

The frequency of sideswipe (same direction) type crashes was higher than expected for this type of roadway. A review of the sideswipe (same direction) type crashes indicated there were 14 crashes northbound and 13 crashes southbound. Twenty-six of the 27 crashes occurred in dry roadway conditions. The sideswipe (same direction) type crashes were throughout Segment 1B. A review of the crash history indicates that there is no current pattern to the sideswipe (same direction) type crashes. There are no suggestions for improvement at this time.

Although there is no significant pattern of off-road left or head-on crashes, it is recommended that a cable rail median barrier be considered due to the high volumes and narrow median.

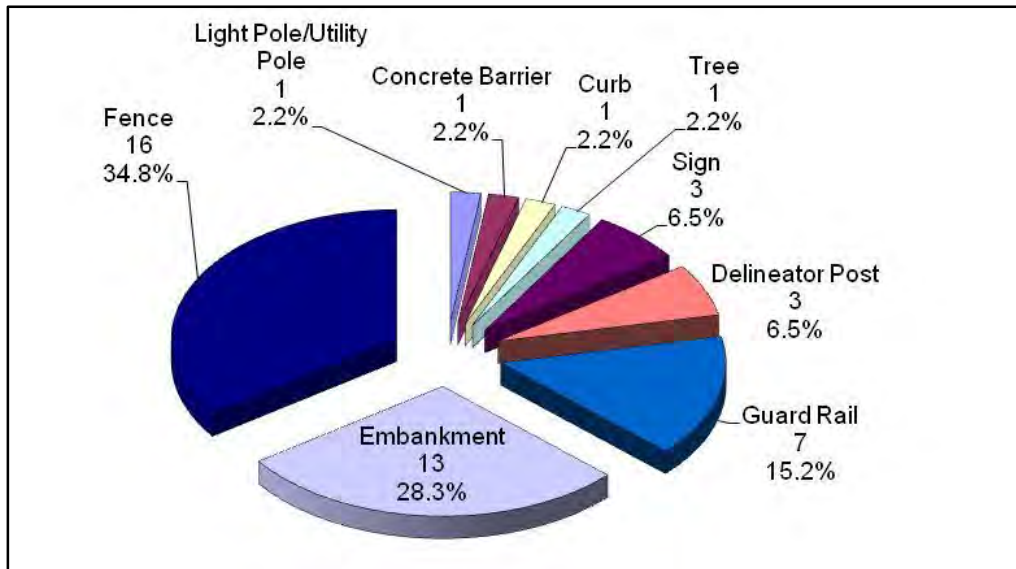
**Figure 7**  
**Fixed Object Crash Types**  
**(Segment 1C: MP 230.87 – MP 235.19)**

The frequency of fixed object type crashes was higher than expected for this type of roadway. A review of the fixed object type crashes indicated that 22 crashes occurred northbound and 24 crashes occurred southbound. Only 21 of the 46 crashes occurred with dry roadway conditions. The fixed object type crashes occurred throughout Segment 1C. It can be seen in **Figure 7** of the fixed object type crashes, fence type crashes (34.6%) were the predominant crash type followed by embankment type crashes (28.3%). In addition to considering a cable rail barrier in the median, it is recommended that the clear zone for all roadside obstacles be reviewed in the field.

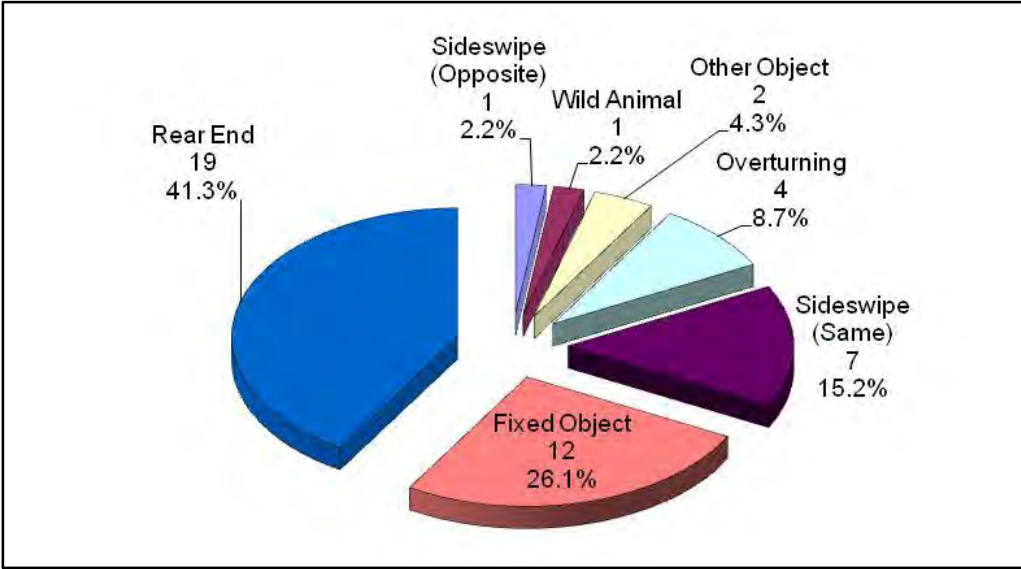
**Figure 8  
Non-Intersection Crash Types  
(Segment 1D: MP 235.20 – MP 236.62)**

The frequency of rear end type crashes was higher than expected for this type of roadway. A review of the rear end crash history indicated that there were 13 crashes northbound and six crashes southbound. Road conditions for rear end type crashes showed that 17 of the 19 were dry road conditions. Fifteen of the 19 crashes occurred during daylight lighting conditions. A review of the locations of the crashes indicated a pattern related to signalized intersections but not any in particular. However, recommendations for intersections can be found in the intersection portion of this report.

The frequency of fixed object type crashes was higher than expected for this type of roadway. A review of the fixed object type crashes indicated that seven of the 12 fixed object crashes were fence related crashes. Of the fence type crashes, three occurred northbound and four crashes occurred southbound. Only two of the seven crashes occurred with dry roadway conditions. Two occurred at MP 236.00 near the intersection of 168<sup>th</sup> Avenue and three at MP 236.33 north of 168<sup>th</sup> Avenue. No pattern was found for the fixed object type crashes, but it is recommended to review the existing snow/ice removal procedures to ensure current procedures are sufficient.

Although there is no significant pattern of off-road left or head-on crashes, it is recommended that a cable rail median barrier be considered south of CR 2 due to the high volumes and narrow median.

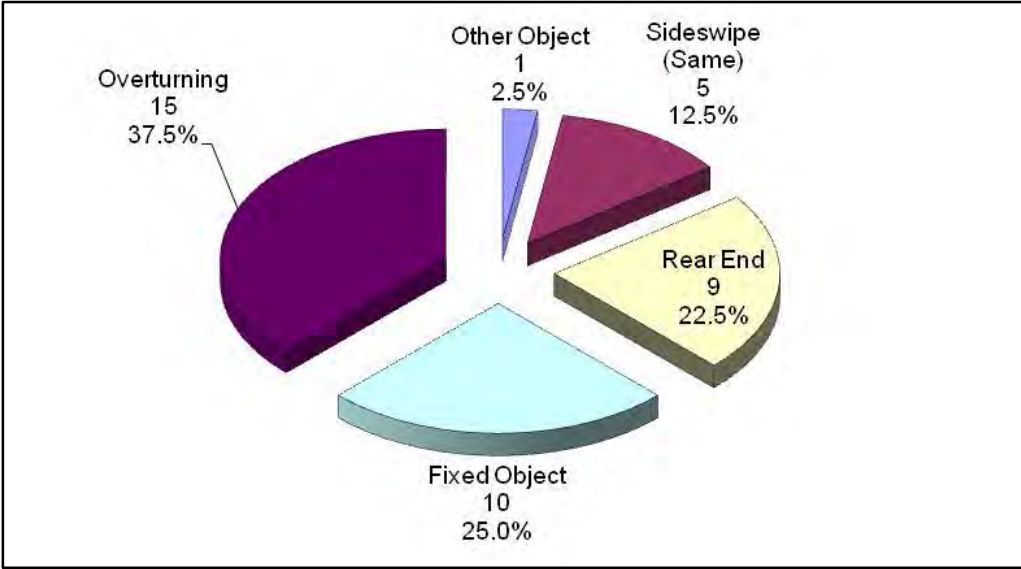
**Figure 9  
Non-Intersection Crash Types  
(Segment 1E: MP 236.63 – MP 238.32)**

There was one fatal crash that occurred in Segment 1E at MP 237.41 on August 15, 2009 north of the intersection of CR 4. The crash occurred in dry, daylight conditions. Vehicle #1 was traveling southbound on US 85C in the left through lane and stopped to attempt a U-turn in a median crossover (no signs were posted in the median). Vehicle #2 was also in the southbound left through lane and rear-ended Vehicle #1. Alcohol was suspected in both drivers of the vehicles. Vehicle #2 driver was the fatality. No crash pattern found.

The frequency of overturning type crashes was higher than expected for this type of roadway. A review of the overturning type crashes indicated there were eight crashes northbound and seven crashes southbound. Twelve of the 15 occurred on dry roadway conditions. The overturning type crashes were throughout Segment 1E. None of the overturning type crashes were documented to be traveling over the posted speed limit of 65 mph. Eight of the 15 occurred in daylight lighting conditions. Nine of the crashes resulting in the vehicle leaving the left side of the road; four went off the right side. A review of the crash history indicates that these crashes occurred throughout the sub-segment. It should be noted that a cable rail median barrier has been constructed recently. This could reduce the number of vehicles that depart into the median and overturn. There are no further suggestions for improvement at this time.

The frequency of rear end type crashes was higher than expected for this type of roadway. A review of the rear end crash history indicated that there were three crashes northbound and six crashes southbound. Road conditions for rear end type crashes showed that all nine crashes were dry road conditions. Eight of the nine crashes occurred during daylight lighting conditions. A review of the crash history indicates that there is no current pattern and there are no suggestions for improvement at this time.
