Miscellaneous Publication 8

Engineering Geologic Factors of the Marble Area, Gunnison County, Colorado

By
William P. Rogers,
Engineering Geologist
and
John W. Rold,
Director and State Geologist

Colorado Geological Survey
Department of Natural Resources
Denver, Colorado
1972

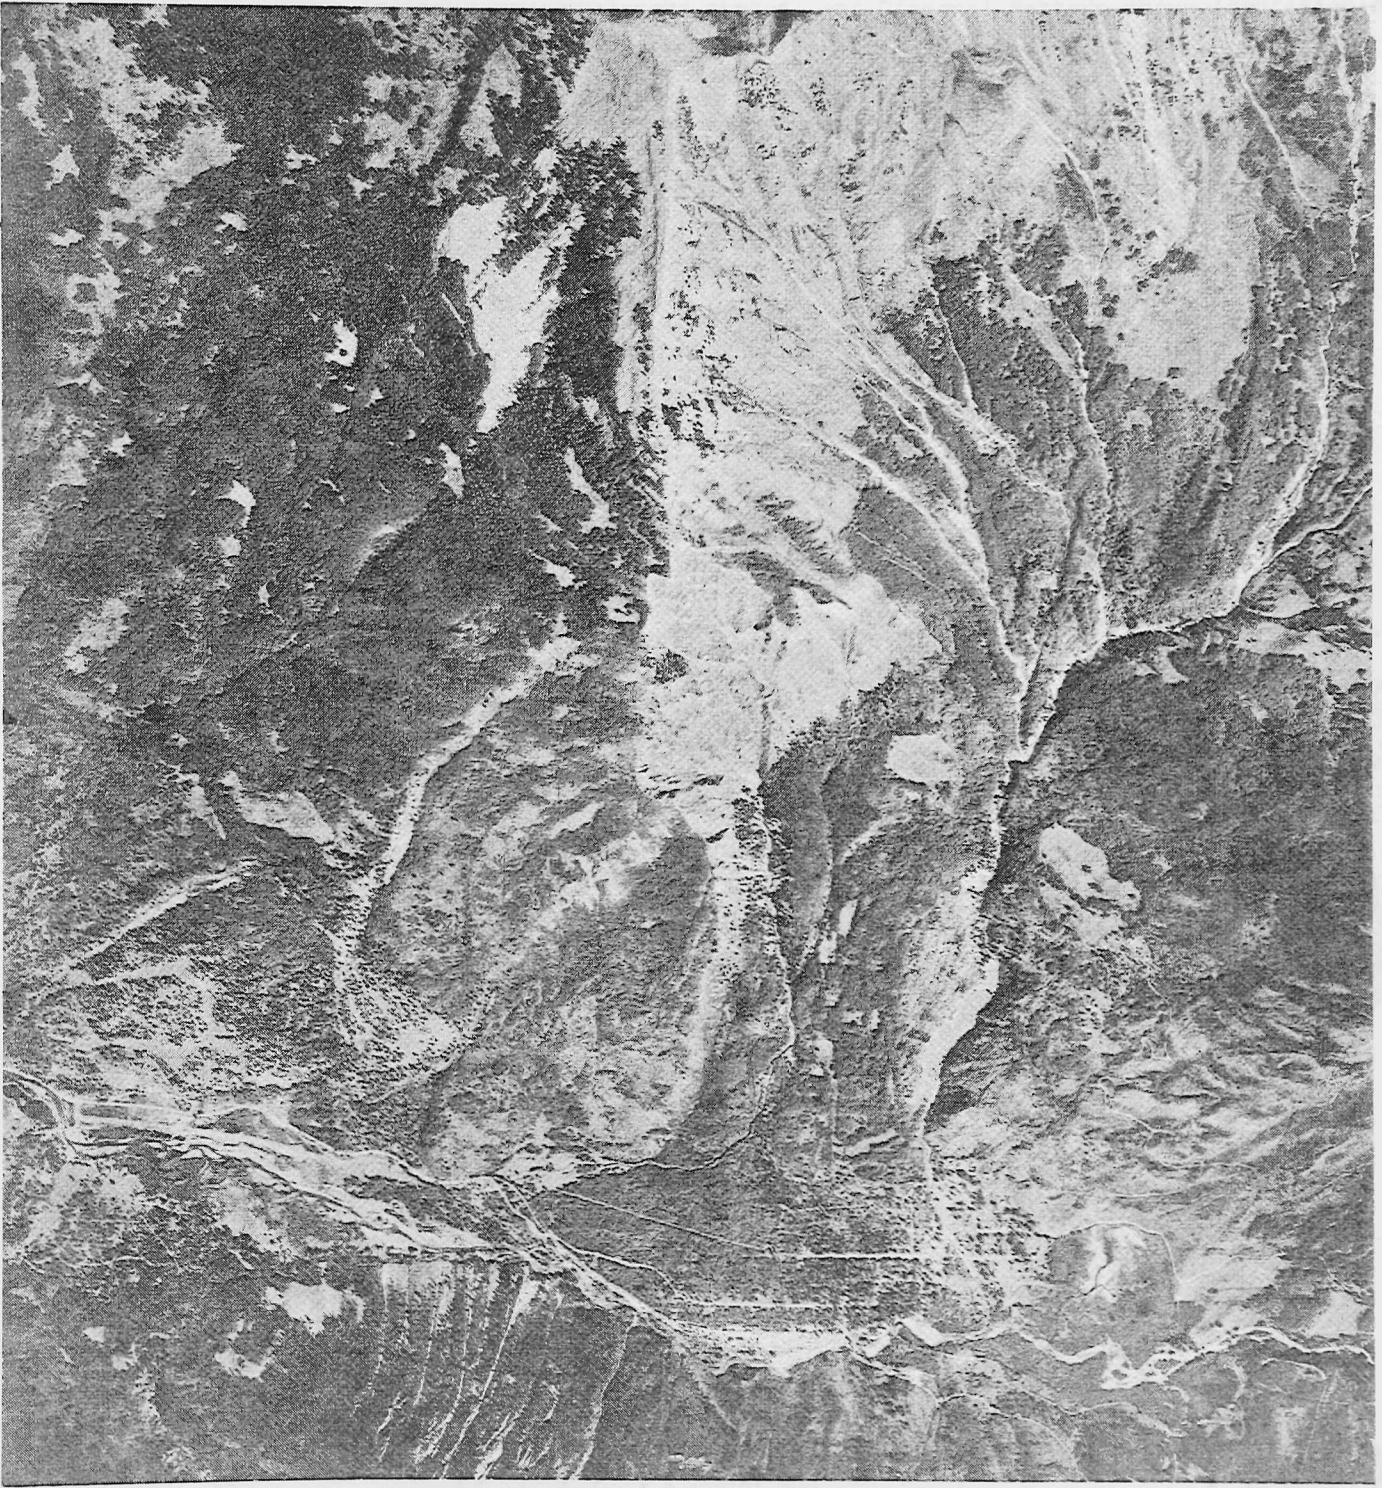
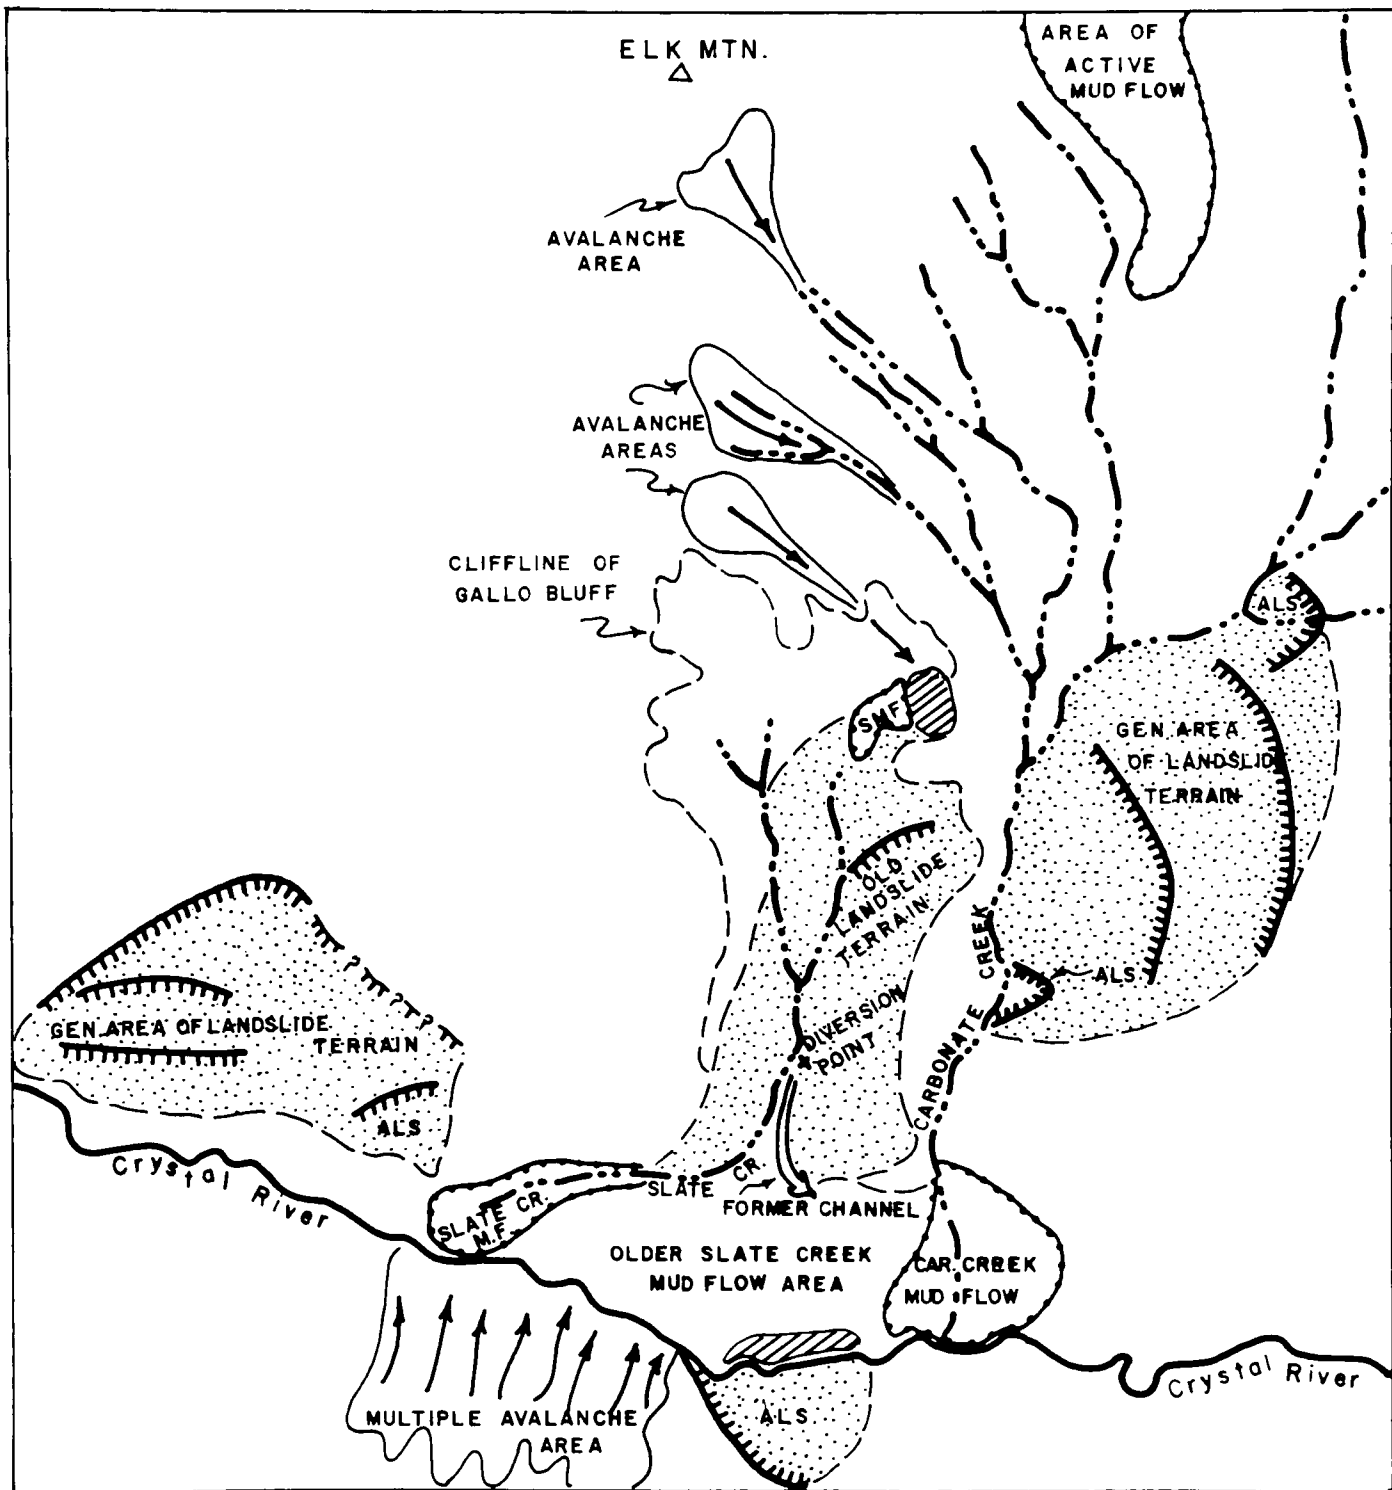
FIGURE 1. PHOTOLOGIC INTERPRETATION OF MAJOR FEATURES

Heavy Arrows indicate snow avalanche chutes, and Diagonal Pattern shows identifiable landing areas.

SMF indicates area of small mudflows at base of Gallo Bluff.

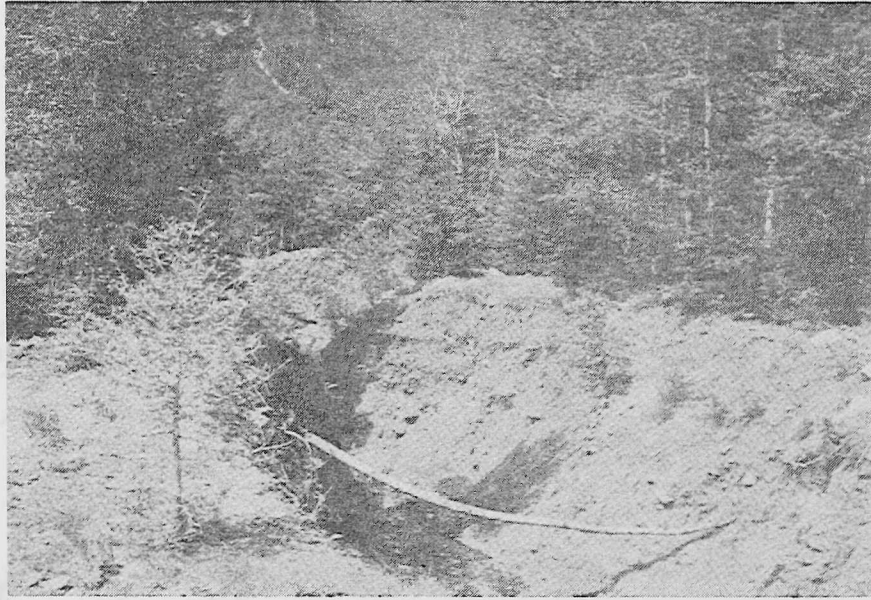
Figure 2. Entrenched portion of Slate Creek channel, showing steepness of banks and mudflow material in channel sides.

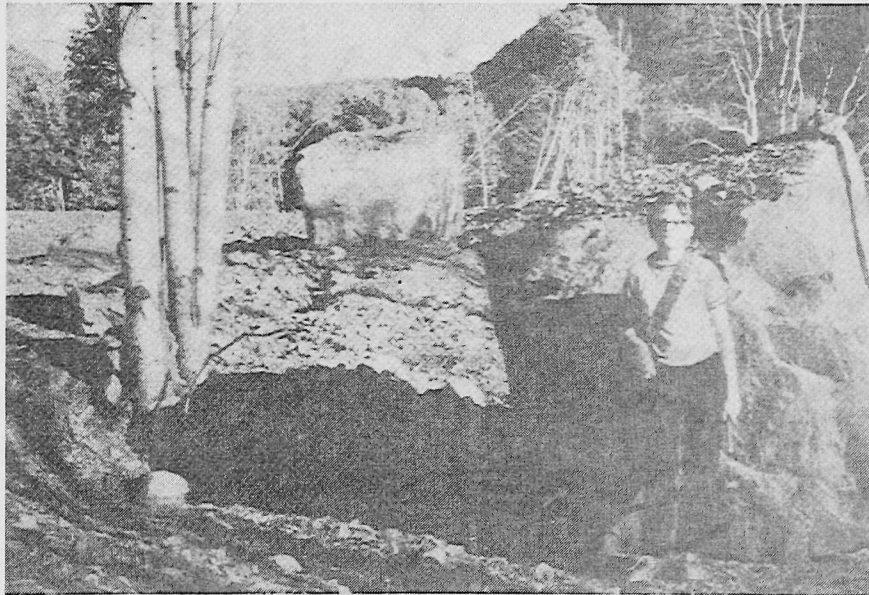
Figure 3. Large blocks of Mesa Verde Sandstone in recent mudflow debris of Slate Creek, twelve year old boy in foreground. Recency of deposit indicated by fine debris on top of blocks.

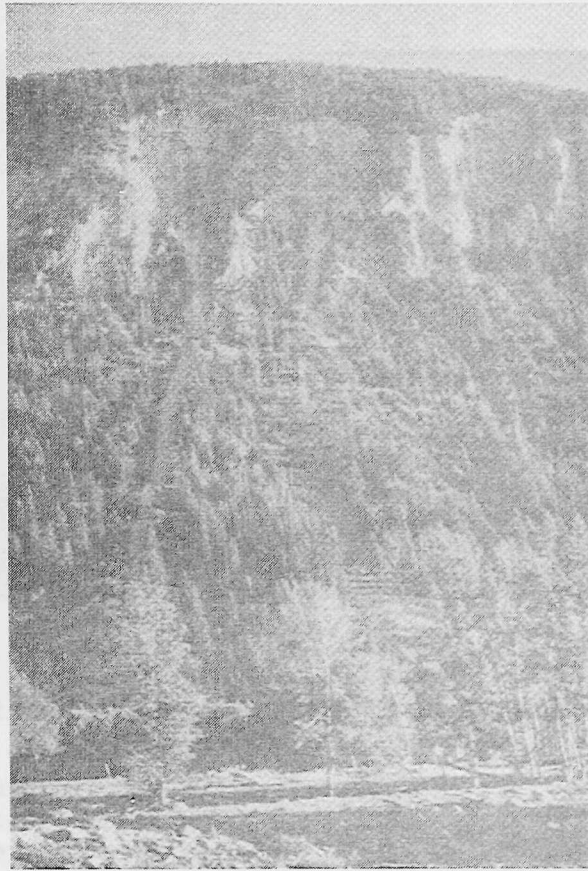
Figure 4. Lower part of Slate Creek mudflow area in foreground, avalanche and rockfall area south of the Crystal River in background.

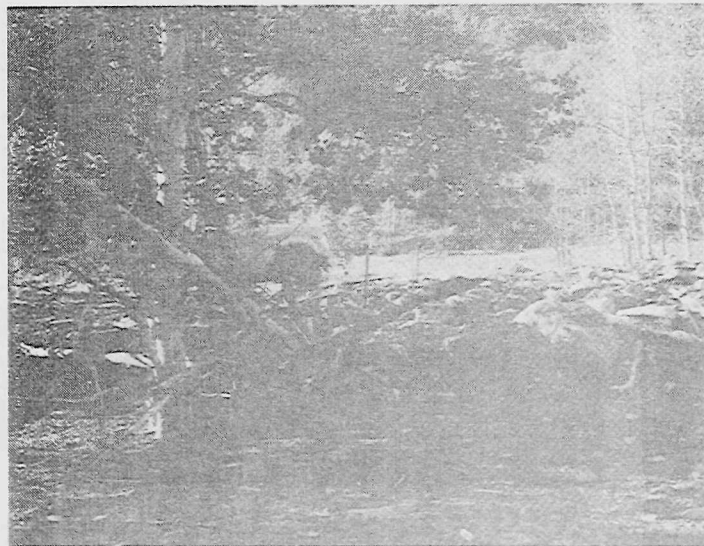
Figure 5. Edge of very recent mudflow debris sheet in Slate Creek area.

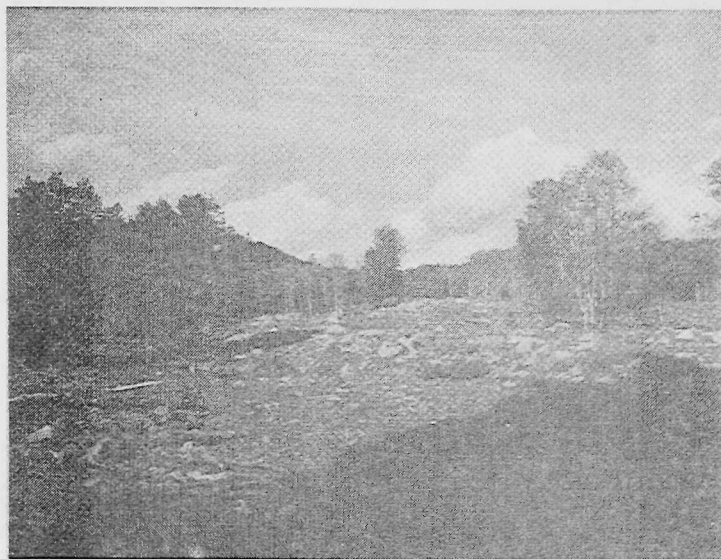
Figure 6. Looking up (northeast) along recent mudflow plain of Slate Creek.

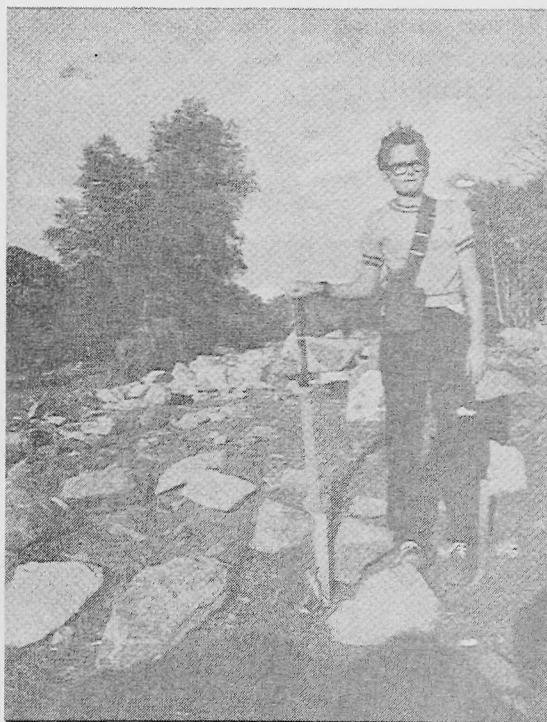
Figure 7. Rock-strewn surface of upper part of Slate Creek mud-flow plain in subdivided area. Stake indicates a lot corner.

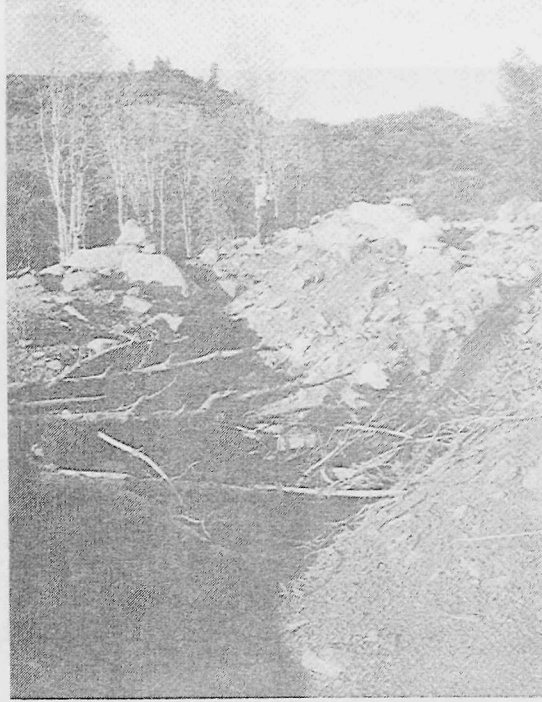
Figure 8. Abandoned channel and mudflow debris in subdivided land of recent Slate Creek mudflows. Boy is standing by the same lot corner shown in figure 7.

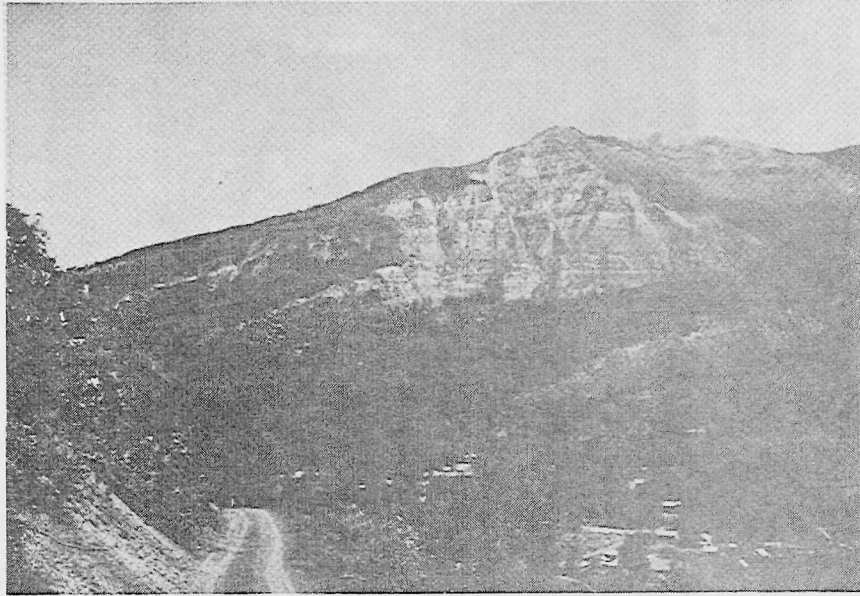
Figure 10. Large unvegetated scar in background is Gallo Bluff. Bare scarp in right center is Mancos Shale on the west bank of Carbonate Creek. Town of Marble in right foreground.

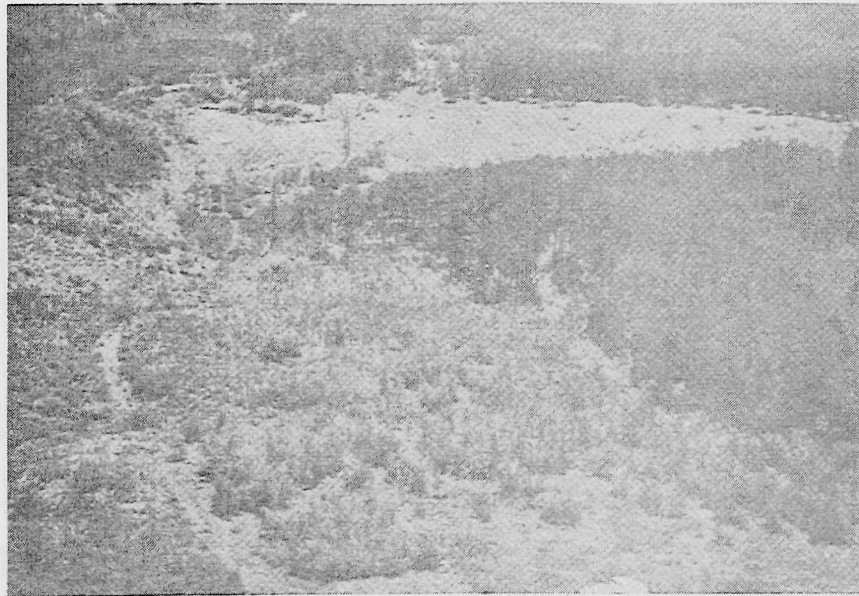
Figure 11. Area below north end of Gallo Bluff. Stunted and pushed timber on left side is result of airborne snow avalanches from Elk Mtn. Small mudflows have moved through larger timber on the right to the edge of the clearing in background.

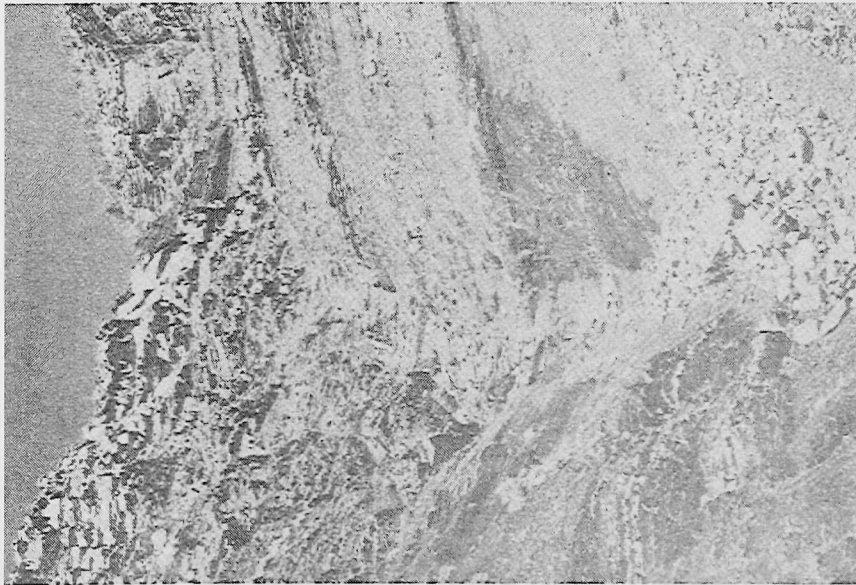
sist of stacks of loose, joint-bounded blocks which are precariously unstable when undercut by erosion (figures 12, 14, 15, 16). This situation gives rise to the constant minor rockfalls which can be precipitated by a gust of wind or another falling rock. Evidence of larger scale instability in the cliffs can be seen in the weathered and open joints which, in many cases, form fissures several tens of feet back of the cliff face (figures 13, 17). These are especially prominent in projecting points in the cliff which form between adjacent gullies. Such gullies or re-entrants in the cliffline tend to follow minor faults which are oriented at approximate right angles to the cliffline. The precipitous gullies on Gallo Bluff, and also those in the Carbonate Creek watershed that lie between the north end of the bluff and Elk Mountain, are locally choked with coarse rock rubble at a precarious angle of repose. The currency and active nature of cliff retreat is shown by still-green trees that can be seen along with rubble in the steep gullies (figure 12).

Figure 12. Typical gully on face of Gallo Bluff. In background, loose overhanging sandstone blocks can be seen. Dark color just below center is from water seepage. In lower center, note loose rock rubble and recently fallen tree.

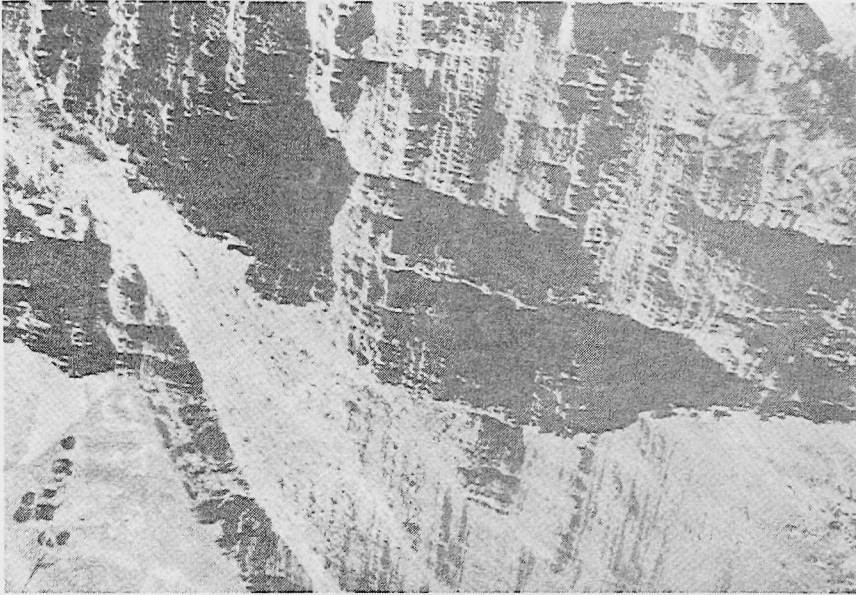
The above described processes produces a general "Grand Canyon" type of topography with waste slopes of shaley debris alternating with nearly vertical ledges of broken sandy shale or sandstone (figure 13). The average slope of the highest part of the cliff is approximately 36 degrees, or 75%. At this location, the bluff has 1,400 ft. of vertical rise in 1,900 ft. horizontal distance.

Figure 13. Typical appearance of middle part of Gallo Bluff. More resistant sandy beds stand near-vertical with numerous open and weathered joints back of cliff face.

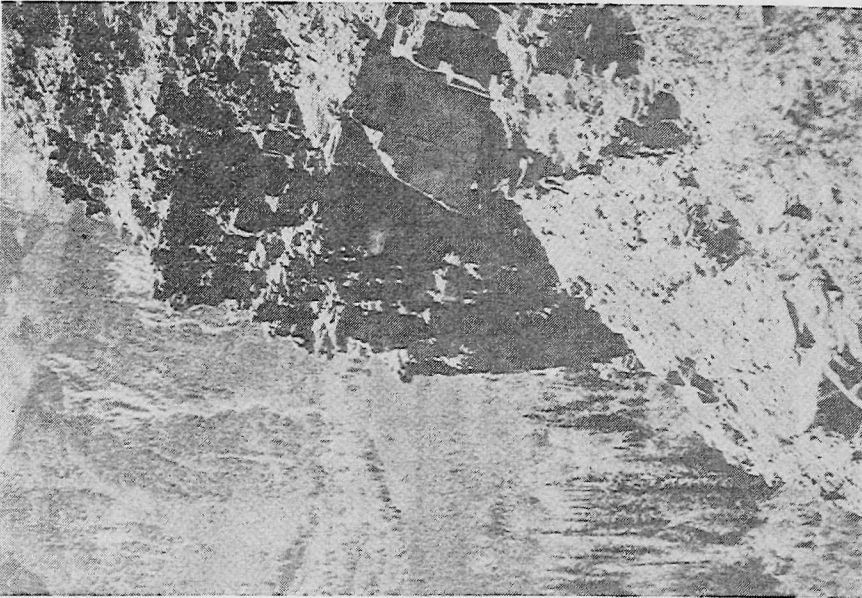
Figure 14. Interbedded shale and sandstone in middle part of Gallo Bluff. Avalanche scars south of Crystal River in background.

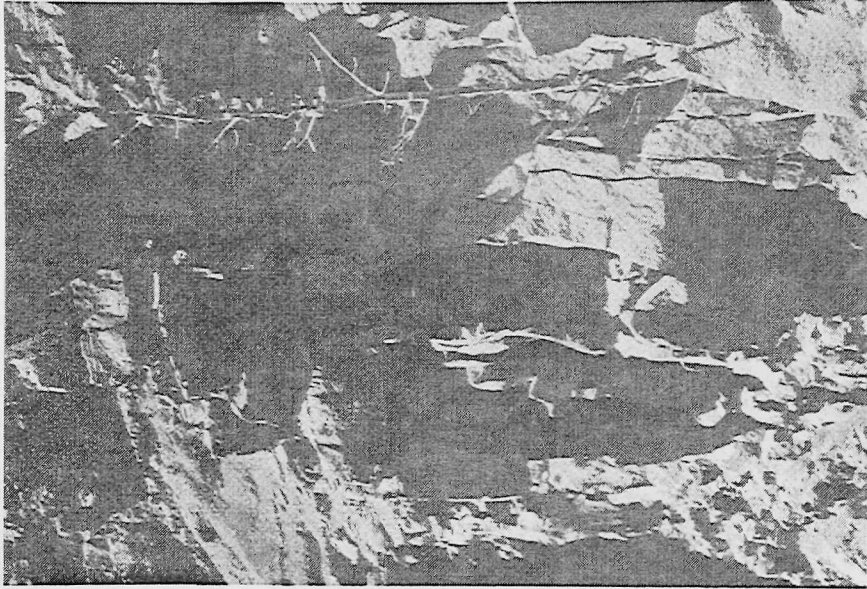
Figure 15. Fractured and loose blocks of Mesa Verde Sandstone in upper part of cliff of Gallo Bluff.

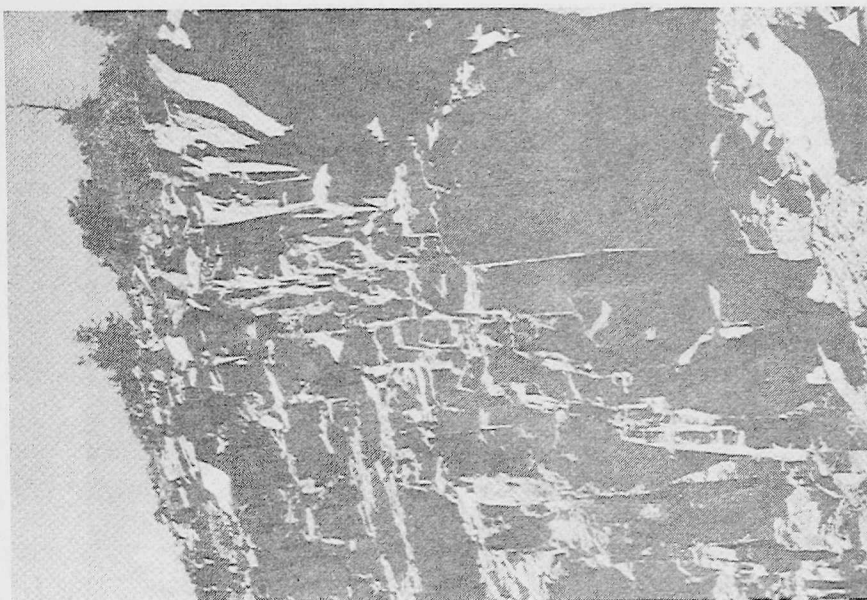
Figure 17. Strongly jointed Mesa Verde Sandstone on ridge just above Gallo Bluff.

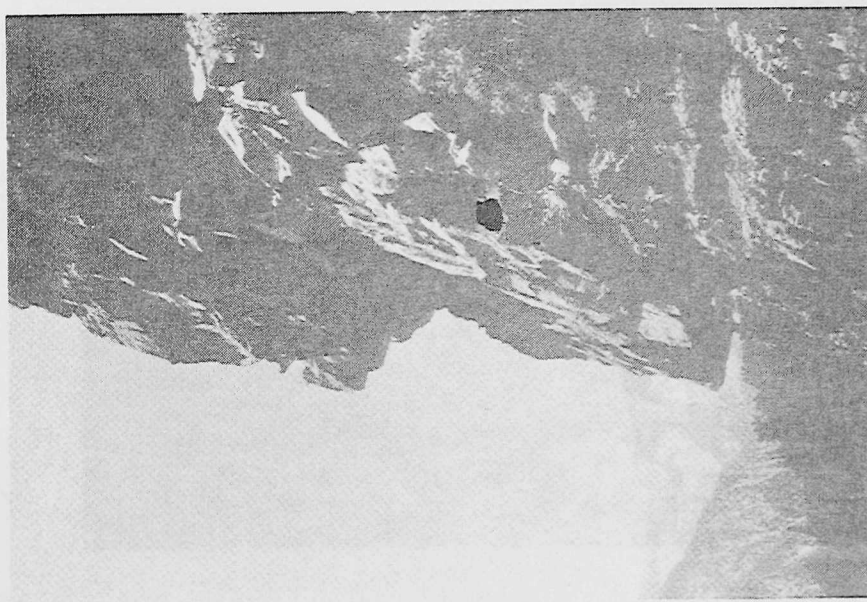
Figure 16. Overhanging ledges of broken and fractured Mesa Verde Sandstone in upper part of Gallo Bluff.

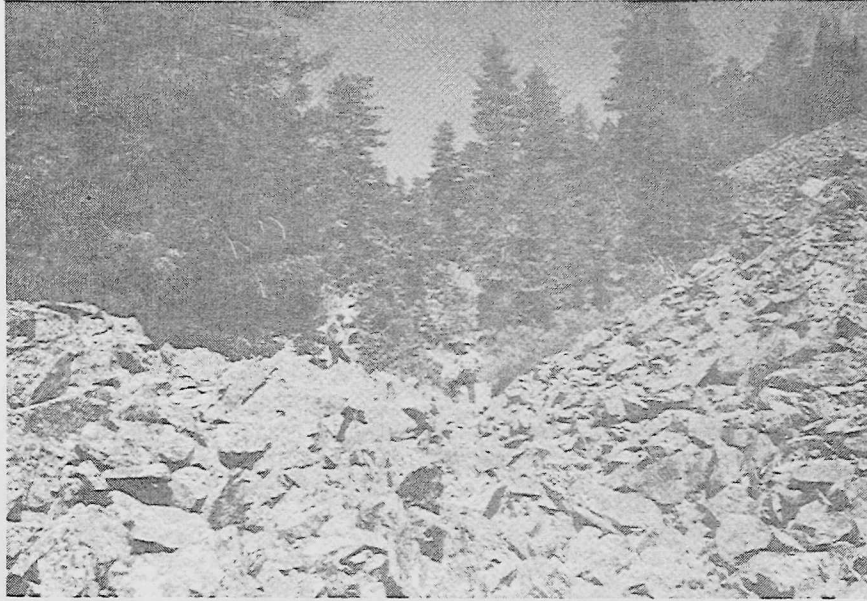
Figure 18. Corrugated surface of coarse talus produced by landslide movements within the talus (area 5 of text).

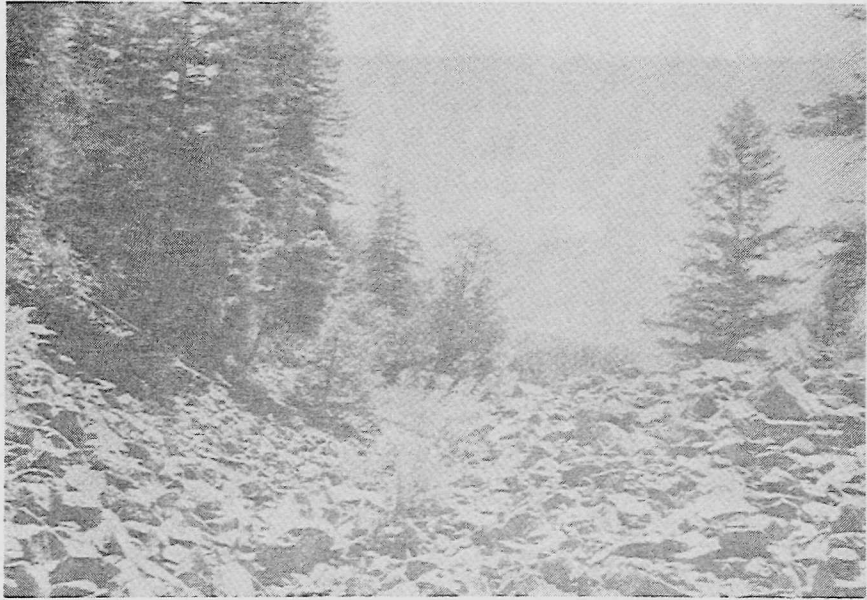
Figure 19. Same general area as above but showing tilting of trees indicating recent movements.
