Colorado Water Conservation Board  
Floodplain Management Section

CHRONOLOGY OF FLOODS IN COLORADO

Copy to  
Staff Design  
DRAINAGE STRUCTURE FLOOD SUMMARY

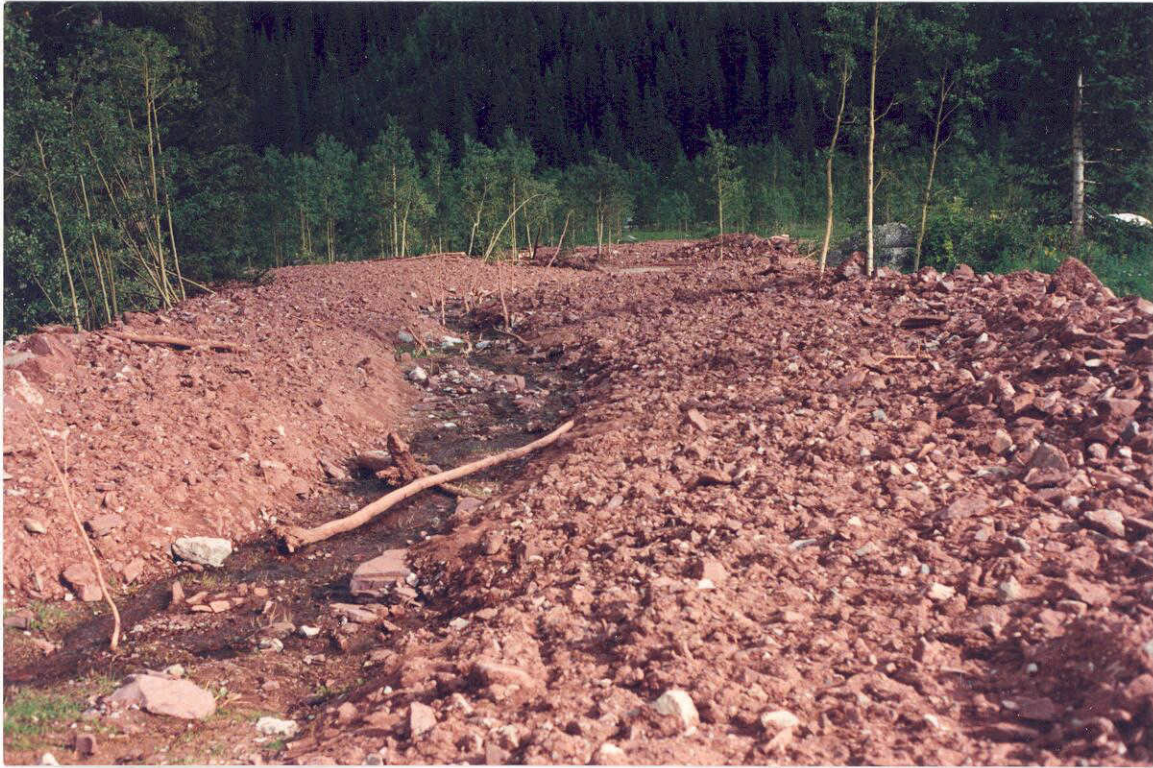
William Stanton

A mudflow in an unnamed tributary to Maroon Creek  
at Maroon Lake Campground occurred on July 29, 1989.

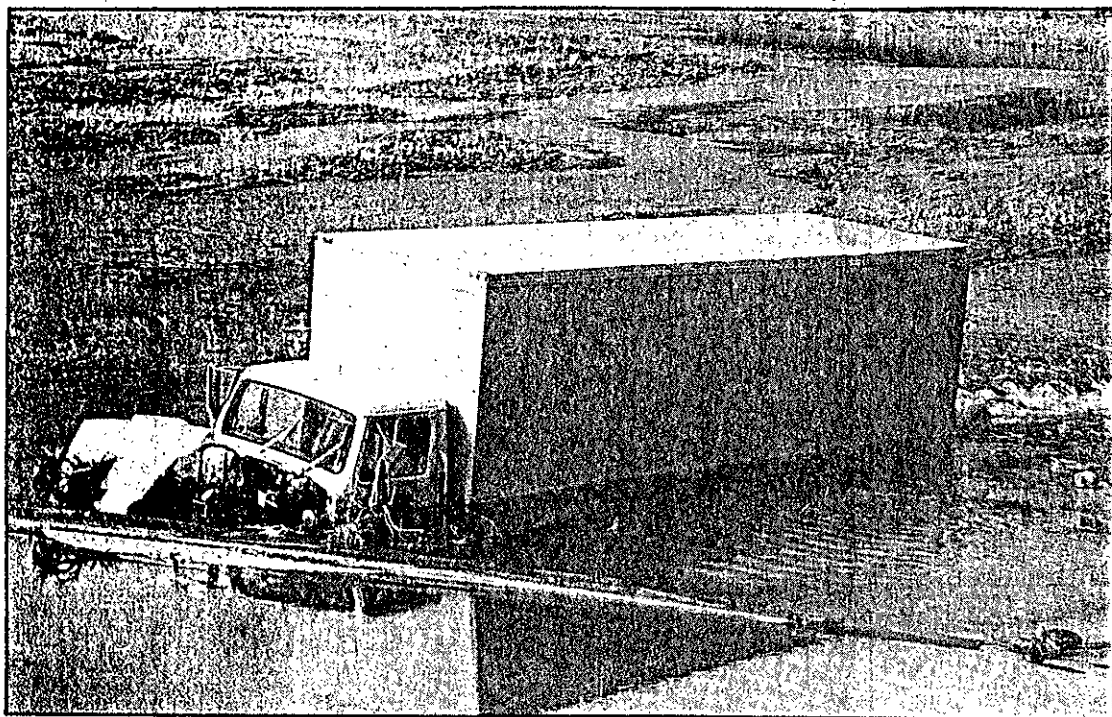
Kerry Mulholland

On July 31, 1989, a 4 foot high wall of water from Dry Creek east of Gunnison hit this truck and swept it off U.S. Highway 50 into Tomichi Creek.

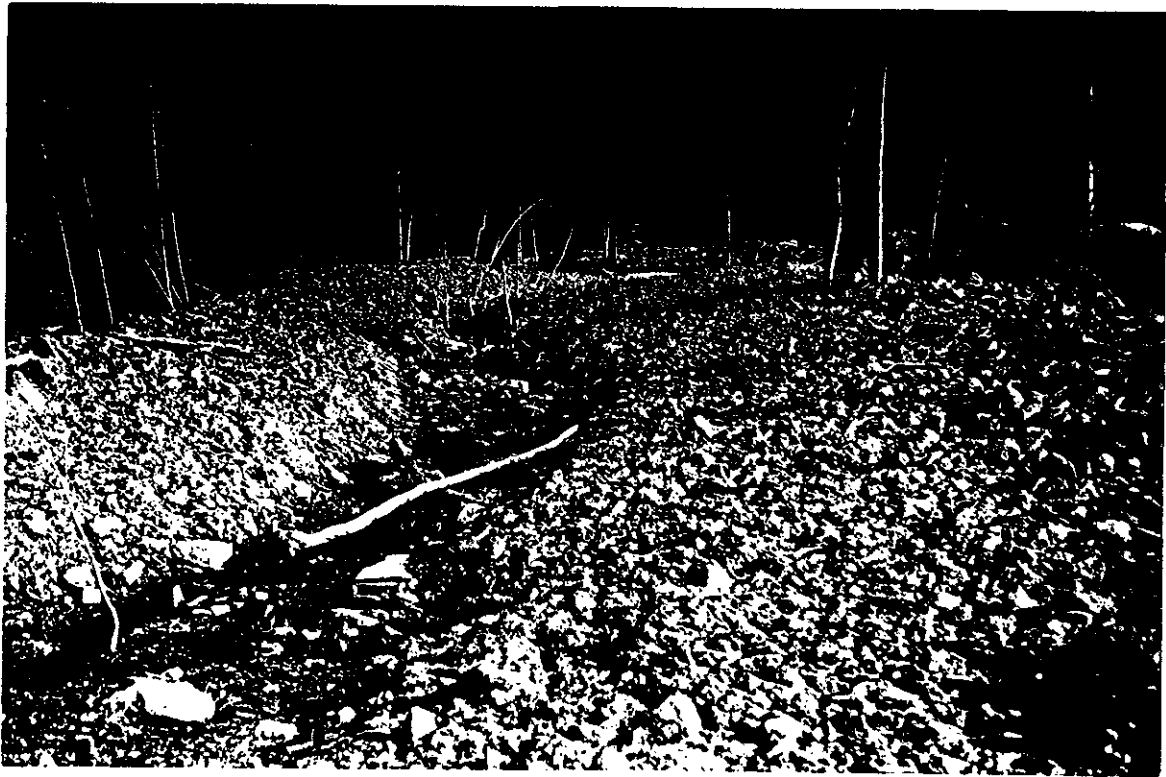
William Stanton

A mudflow in an unnamed tributary to Maroon Creek  
at Maroon Lake Campground occurred on July 29, 1989.

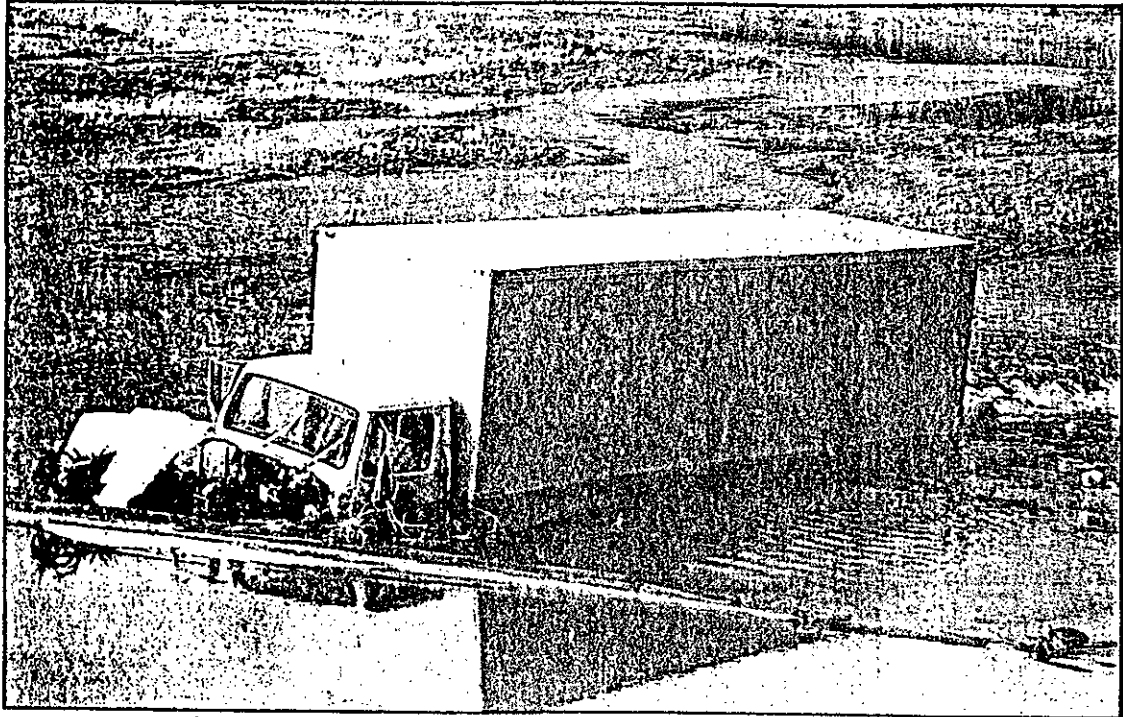
Kerry Mulholland

On July 31, 1989, a 4 foot high wall of water from Dry Creek east of Gunnison hit this truck and swept it off U.S. Highway 50 into Tomichi Creek.
