**Report No. CDOT-2012-2
Final Report**

THE RELIABILITY AND EFFECTIVENESS OF AN ELECTROMAGNETIC ANIMAL DETECTION AND DRIVER WARNING SYSTEM

**COLORADO DEPARTMENT OF TRANSPORTATION
APPLIED RESEARCH AND INNOVATION BRANCH**

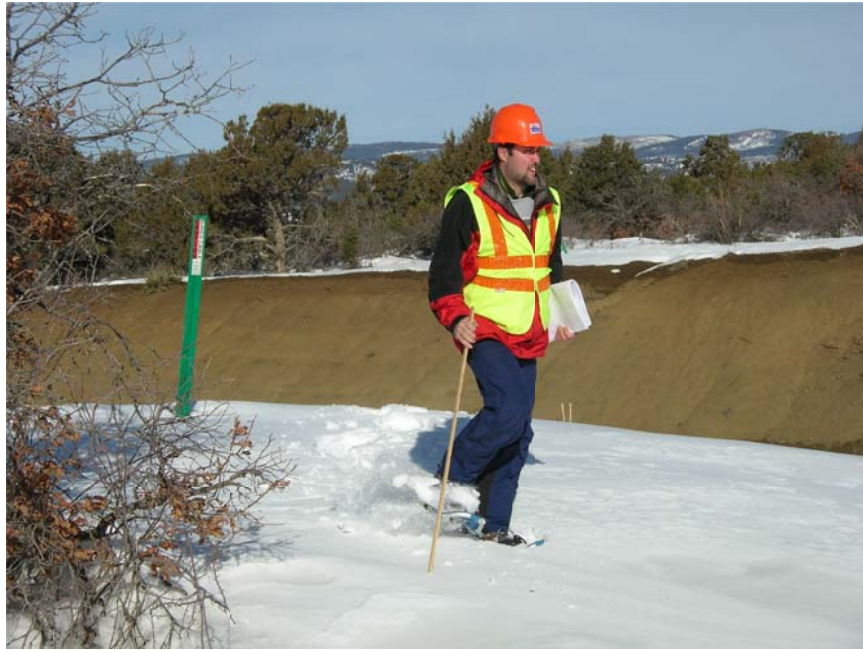
Figure 3.1: Example of a researcher crossing the buried EM cable. The green post in the background represents the location of the buried EM cable (cable extends left to right in photo). Tracks left in the snow by the researcher indicate the nature of the crossing activity by the researcher: perpendicular to the buried EM cable.

While the researcher crossed the buried cable at regular intervals (Figure 3.1), the system continuously logged the signal strength for the different detection zones. A detection occurred when the signal strength exceeded a specific threshold. This threshold value is adjustable to accommodate different species (e.g. smaller species require a lower threshold) and environmental conditions (e.g. greater snow depths require lower thresholds).

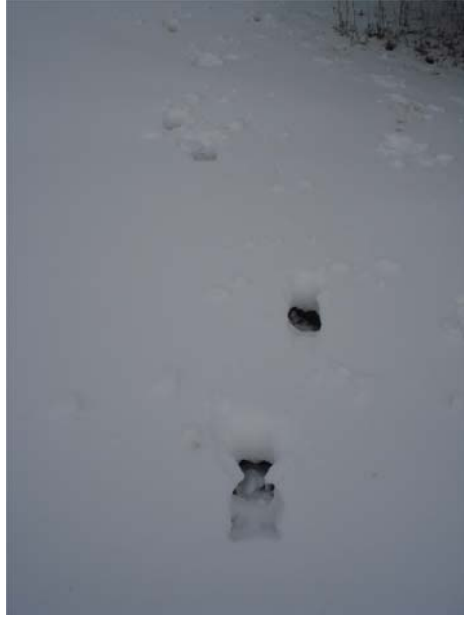
Figure 3.3: Example of a track left by a mule deer. Tracks were identified to species and subsequently “erased” by raking snow over the tracks in preparation for the next day of sampling.

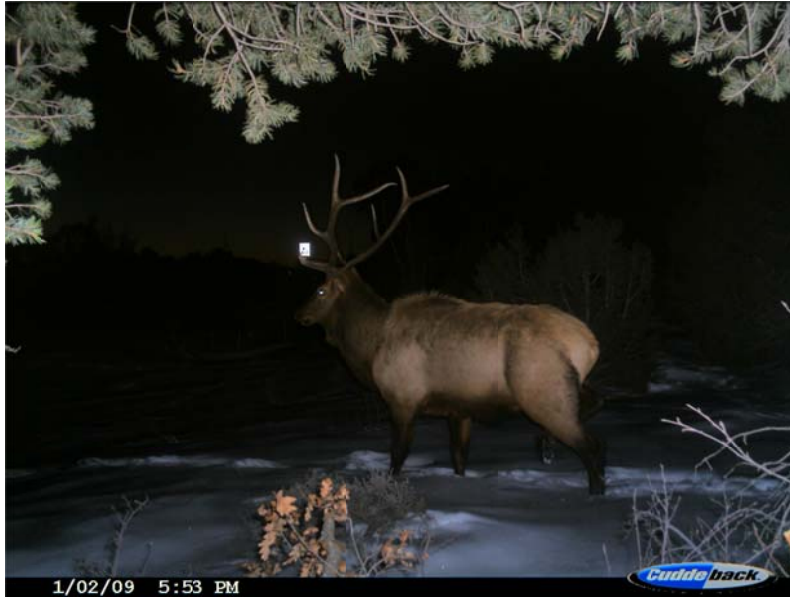
Figure 3.4: Example of photo taken at camera station. Cameras were positioned so as to capture any animals crossing the buried EM cable.

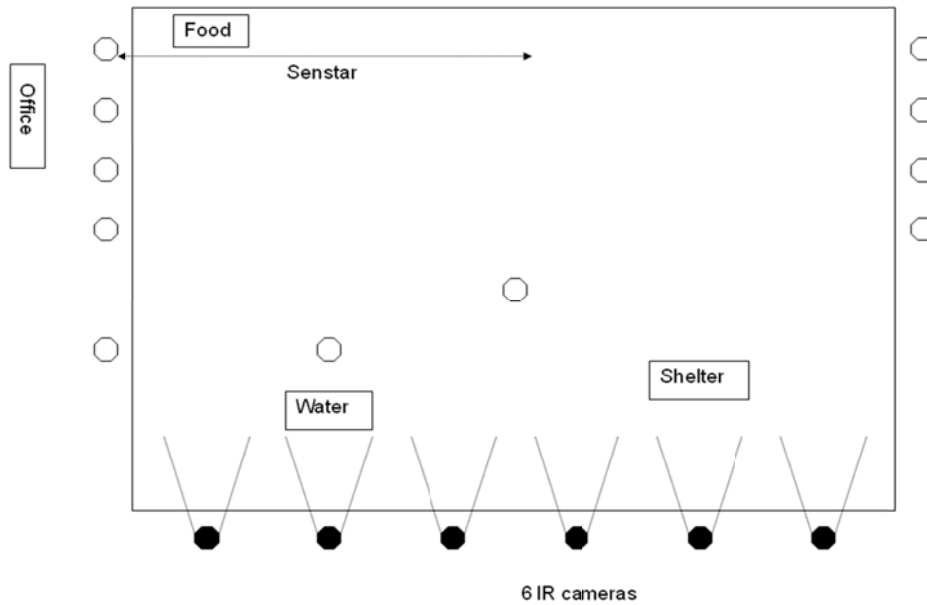
Figure 4.2: Test-bed design including an animal enclosure, the Perimitrax® animal detection system manufactured by Senstar Corporation tested for this project (open circles represent poles on which sensors can be attached), the six infrared (IR) cameras aimed at the enclosure from the side (solid circles), and the office with data recording equipment.

The RADS test-bed is part of the TRANSCEND cold region rural transportation research facility and is located along a former runway at the Lewistown Airport in central Montana. The test-bed location experiences a wide range of temperatures, and precipitation ranges include mist, heavy rain, and snow; the topography is flat, and the rocky soil does not sustain much vegetation that may obstruct the signals transmitted or received by the sensors of some types of animal detection systems. The test-bed consists of an animal enclosure, space for multiple animal detection systems, and six infrared cameras with continuous recording capabilities (Figures 4.1 through 4.4). The distance covered by the system tested for this project was about 50 m (164 ft) (from the left to about the middle of the enclosure). The animal enclosure includes shelter, water, and an area alongside the fence that was designated for feeding. These three resources are located in different parts of the enclosure to maximize animal movement through the detection areas.

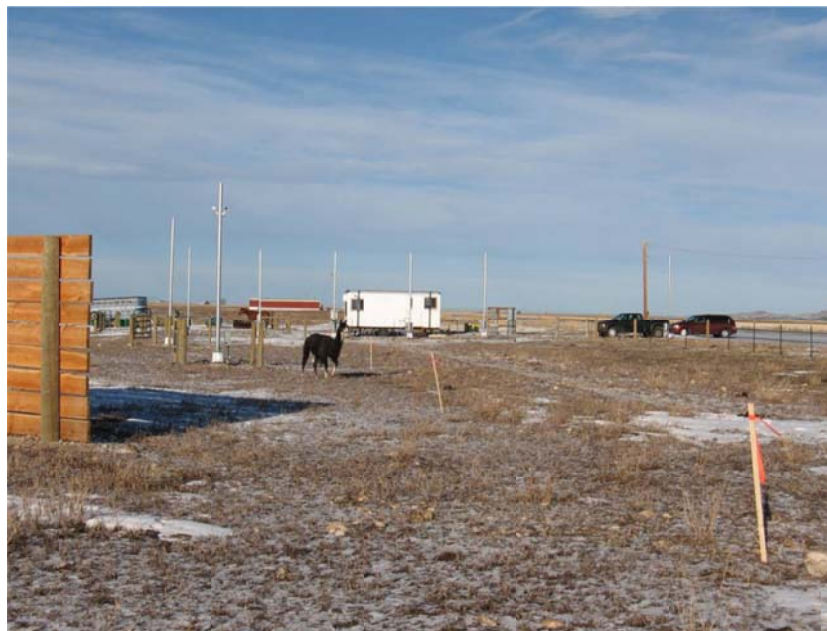
Figure 4.3: The test bed with the remote office, poles on which sensors can be attached, the shelter, and a llama (Photo: Marcel Huijser, WTI/MSU).

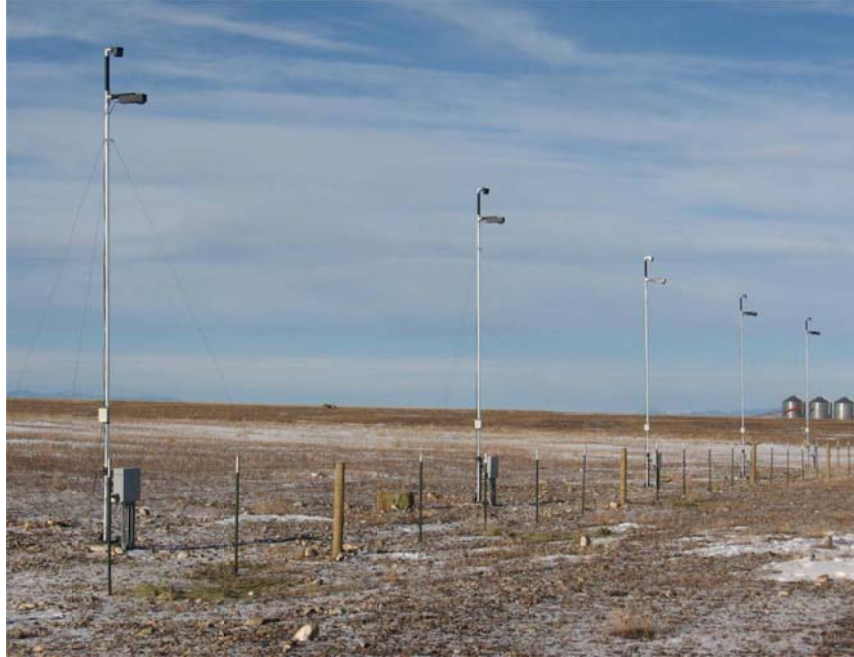
Figure 4.4: The infrared cameras that monitor animal movements in the enclosure (Photo: Marcel Huijser, WTI/MSU).

Six infrared cameras (Fuhrman Diversified, Inc.) were installed perpendicular to the detection system (Figure 4.4). These cameras and a video recording system record all animal movements within the enclosure continuously, day and night. The Senstar Perimitrax® system saved its individual detection data with a date and time stamp. These data were compared to the images from the infrared cameras, which also had a date and time stamp, allowing the researchers to investigate the reliability of the system. Orange cones marked the location of the cable on the images (Figure 4.10).

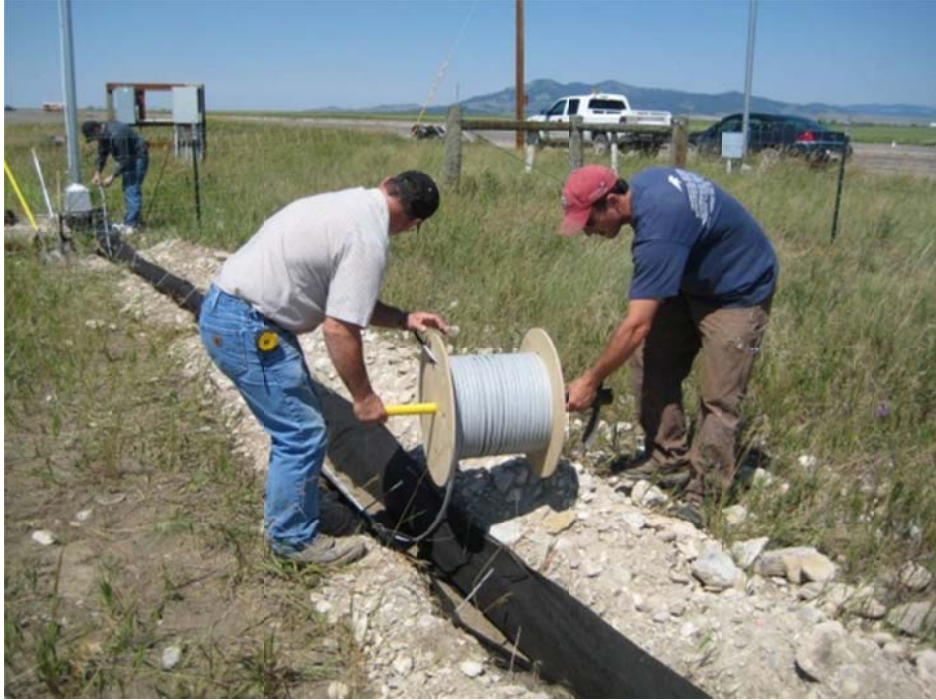
Figure 4.5: The installation of the Senstar Perimitrax® cable. The cable is embedded with sand and wrapped in geotextile (Photo: Marcel Huijser, WTI/MSU).

The system tested for this project is a buried cable (Perimitrax®) that detects large mammals when they move across the cable (Figures 4.5 through 4.9). The system is manufactured by Senstar Corporation, Carp, Ontario, Canada, and it is the exact same technology as originally installed along US Hwy 160 near Durango, CO, USA. The buried cable was placed in a trench and wrapped in sand and geotextile nine inches below the surface. System installation took place on 11 and 12 August 2009. The system generates an invisible electromagnetic field and when a large animal crosses the cable it causes a disturbance in this electromagnetic field. The electrical conductivity, size and speed of the animal all affect the magnitude of the disturbance. However, the threshold that needs to be met to declare an “alarm” or “detection” is adjustable and can be set depending on the size of the animal one wishes to detect. Detection messages are transmitted to a computer in the research trailer at the test-bed where they are saved in files for later analysis.

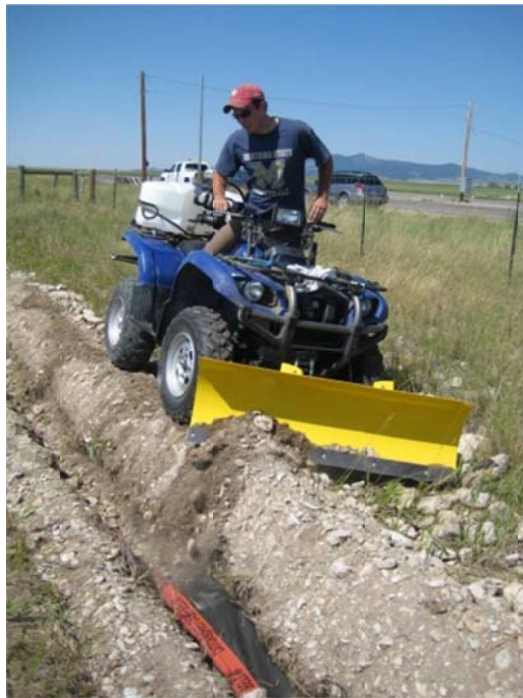
Figure 4.6: The installation of the Senstar Perimitrax® cable. Filling up the trench (Photo: Marcel Huijser, WTI/MSU).

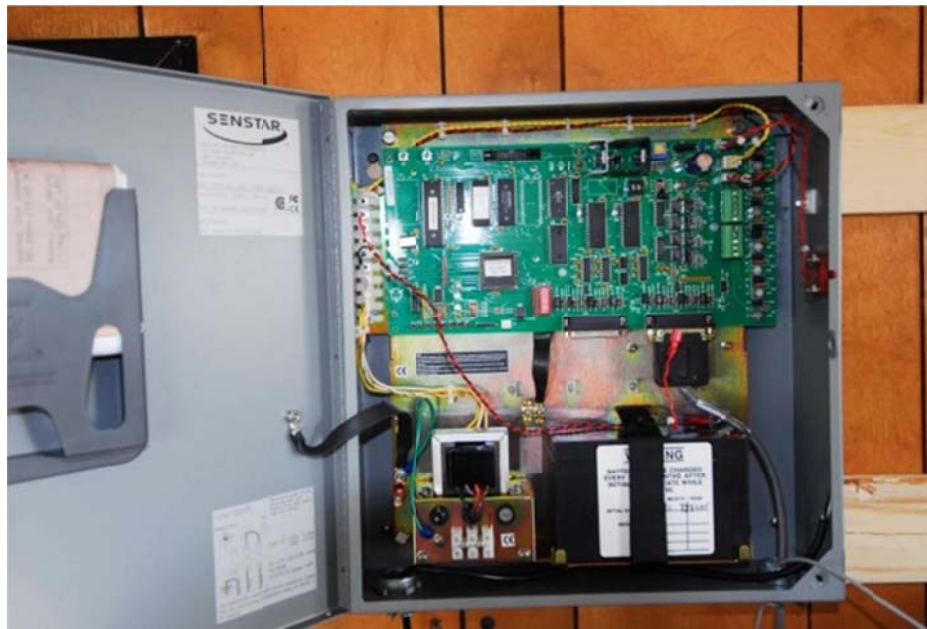
Figure 4.8: The Senstar Perimitrax® Network Controller inside the research trailer (Photo: Marcel Huijser, WTI/MSU).

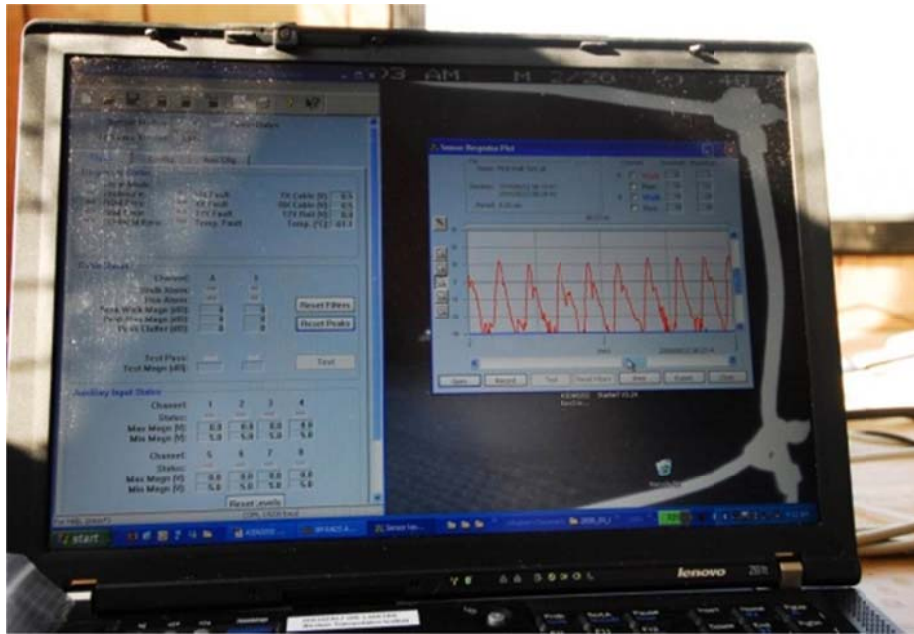
Figure 4.9: The Senstar Perimitrax® interface on a PC in the research trailer during a “walk” test by a human (Photo: Marcel Huijser, WTI/MSU).

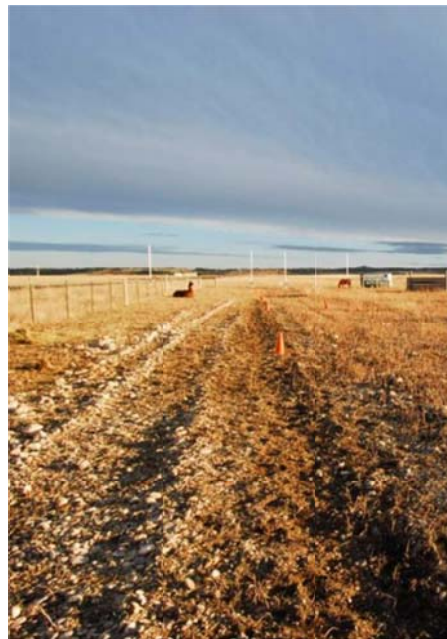
Figure 4.10: The orange cones mark the location of the Senstar Perimitrax® buried cable. These cones are visible on the IR video images (Photo: Marcel Huijser, WTI/MSU).

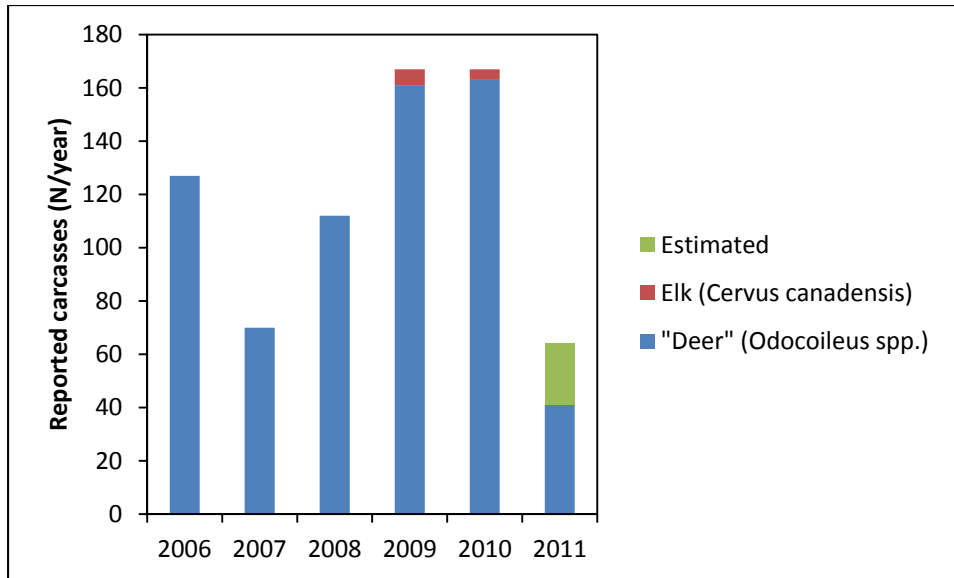
Figure 8.1: The number of reported large mammal per year between 2006 and 2011 for the road section along Hwy 160. Note that the 2011 data included an estimate for the carcasses for the months October through December.

The number of reported large mammal carcasses was highly variable for the different years (between 64 and 167) (Figure 8.1). The treatment road sections (animal detection systems and vegetation clearing in the right-of-way) only related to relatively short road sections of about 1 mile (1,609 m) while the data relate to the entire road section of 19.2 mile (30.9 km). Therefore the relatively low (estimated) number of large mammal carcasses in 2011 is not likely related to the treatments but rather a reflection of changes in the population size of the large ungulates, or reduced search and reporting effort by road maintenance crews.

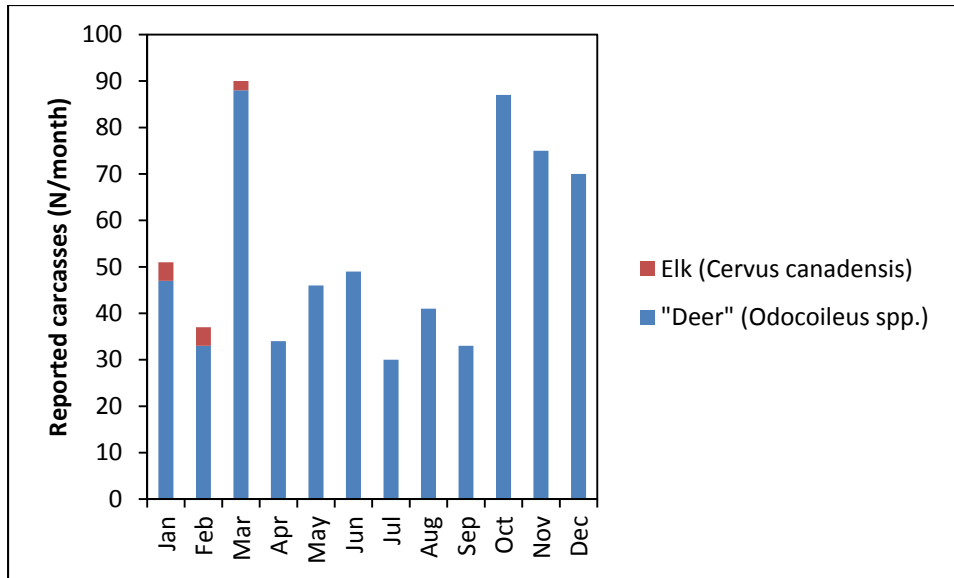
Figure 8.2: The number of reported large mammal per month between 2006 and 2010 for the road section along Hwy 160.

The average number of reported large mammal carcasses was also highly variable for the different months (between 30 and 90) (Figure 8.2). Peaks (March and October-December) may relate to spring and fall migration of primarily mule deer.
