Revisit and Condition Assessment of Targeted Riparian Areas on the Rout National Forest

May 25, 2012

Colorado Natural Heritage Program
Colorado State University
Fort Collins, CO 80523

Revisit and Condition Assessment of
Targeted Riparian Areas on the
Routt National Forest

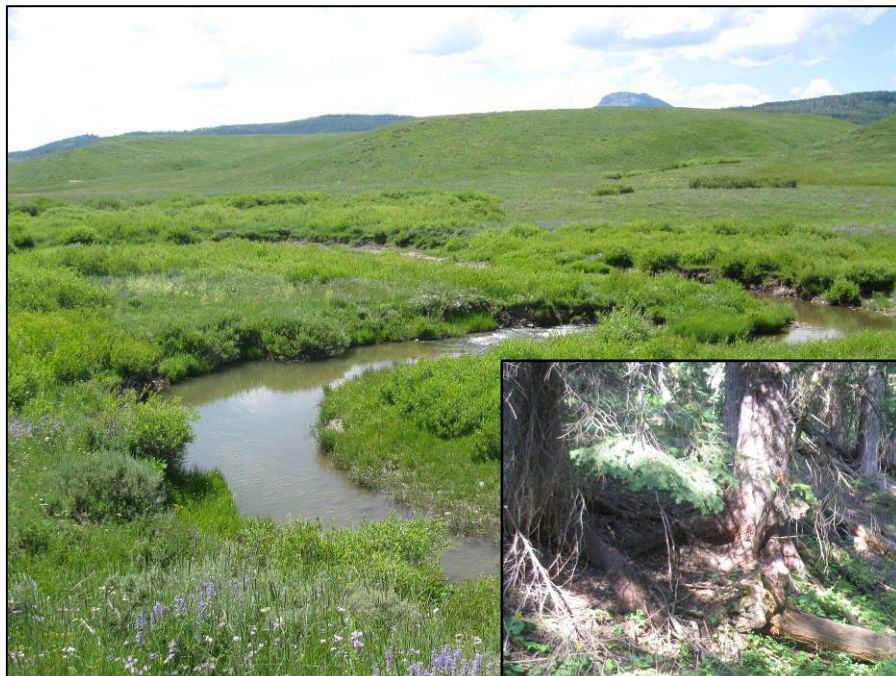
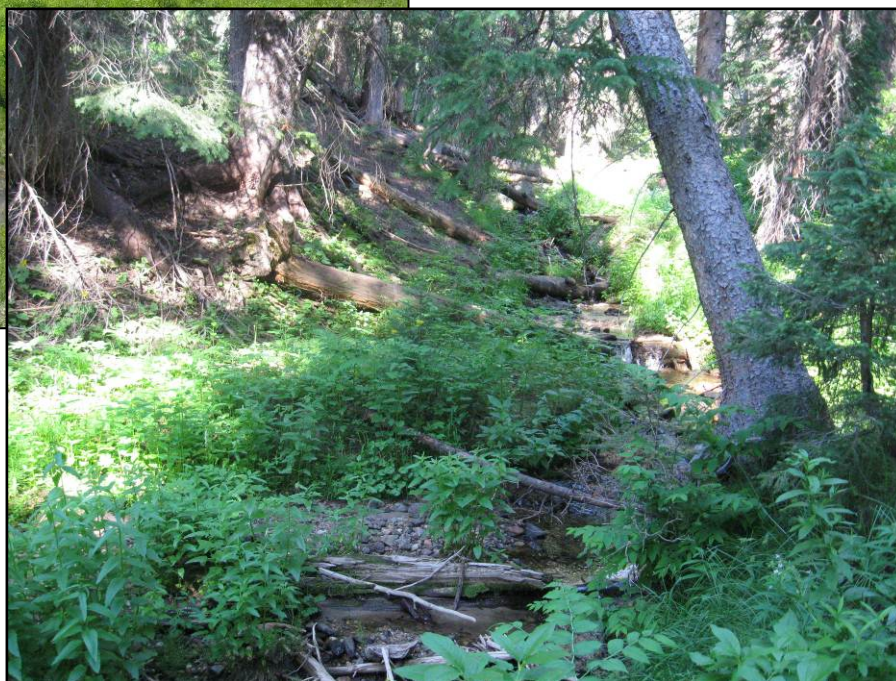
Cover photographs: Top left – Wetland riparian shrubland, Bottom left – Non-wetland riparian woodland.

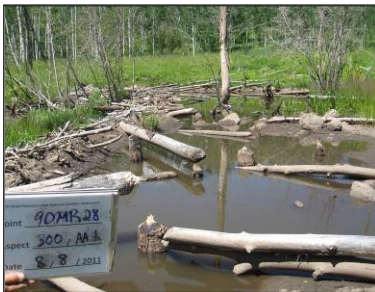
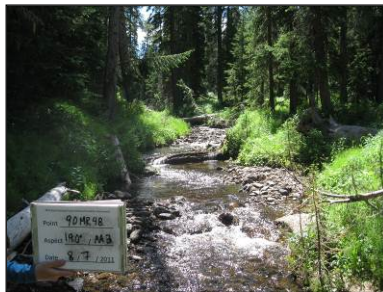
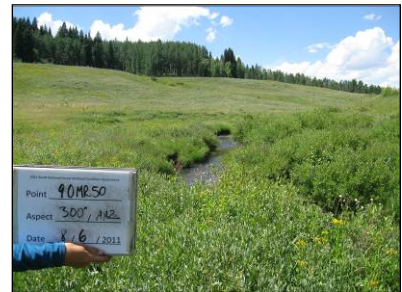
Figure 2. Example AA photos.

- UTM coordinates at four locations around the AA
- Elevation, slope, and aspect
- Place name, county, and land ownership
- Ecological System classification (Comer et al. 2003)
- HGM classification (Brinson 1993)
- Cowardin classification (Cowardin et al. 1979)
- Vegetation zones within the AA
- Description of onsite and adjacent ecological processes and land use
- Description of general site characteristics and a site drawing
- At least four photos were taken at each site along the edge of the AA looking in towards the site (Figure 2).
- Additional photos were taken as need to document the wetland and surrounding landscape.

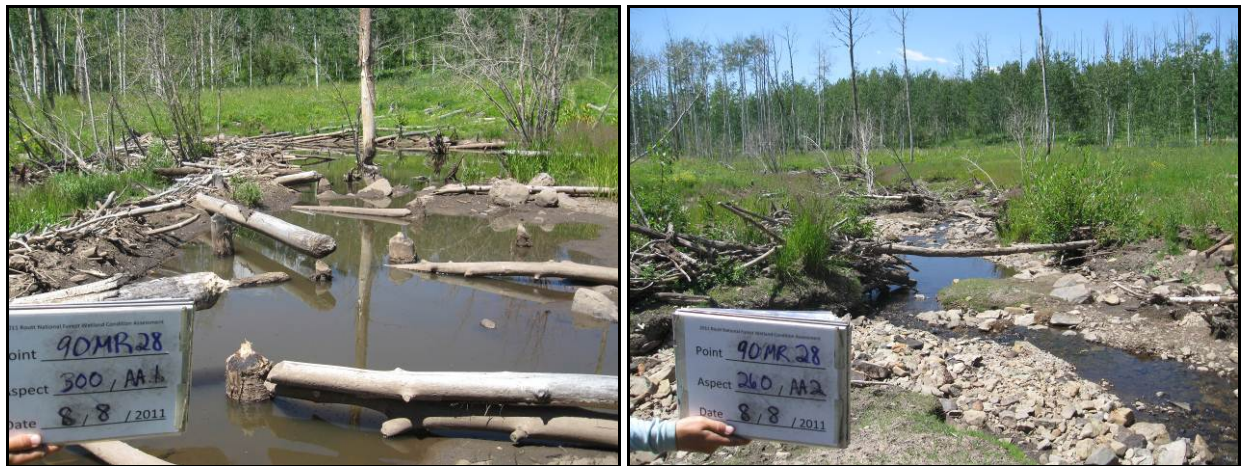
Photos of plot 90MR28 from 2011 survey.

Survey detail: Identified area to survey using GPS waypoint, which was in upland. Navigated to stream that was similar to annotated topographic map. Surveyed linear riparian area along Cottonwood Creek with two systems – 1) *Alnus incana*-lined channel and 2) multiple beaver dams recently blown out and not yet completely colonized by much herbaceous plant cover. New shallow channel cut through old pond beds. Prolific rotting smell (likely dead animal) along entire AA could be beaver mortality.

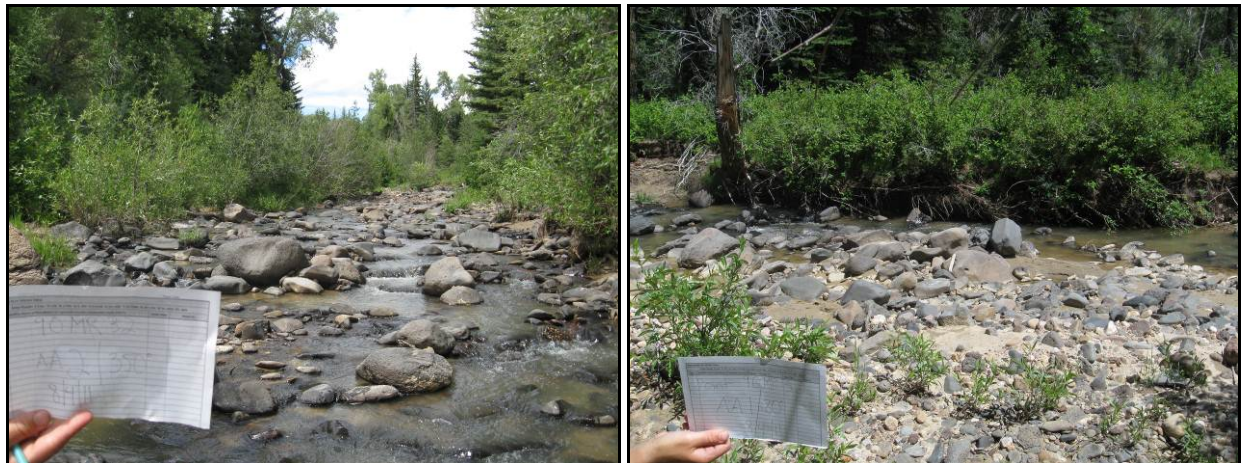
Photos of plot 90MR32 from 2011 survey.

Survey detail: Identified area to survey using GPS waypoint, which was above stream. Navigated to point along Elkhead Creek using topographic map. Area surveyed in 2011 appears similar to hand drawing obs. (subplot) #1 from 1990 along stream, but grades into obs. #2. *Alnus incana* – *Swida (Cornus) sericea* shrubland with *Carex*/grass understory along cobble boulder channel.

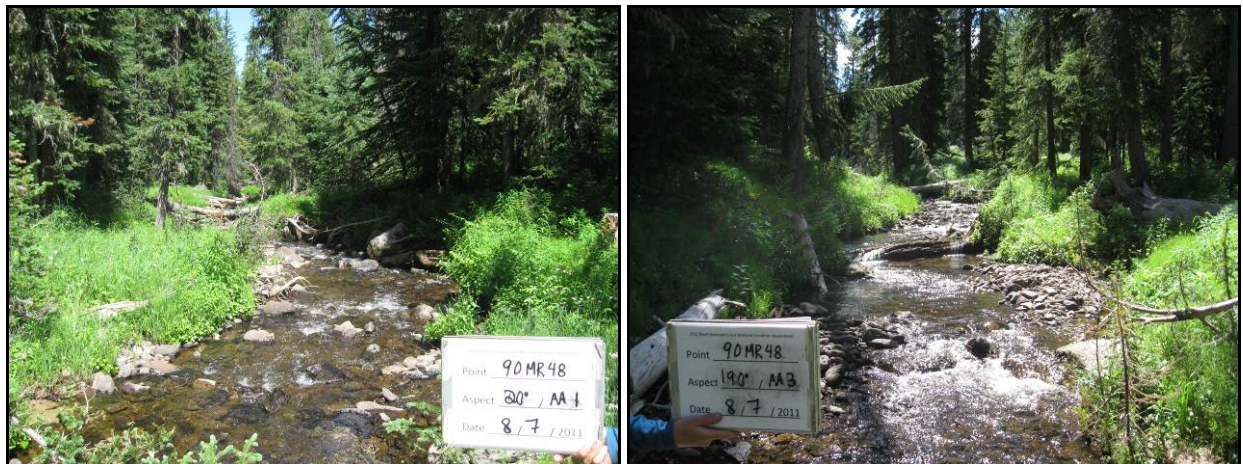
Photos of plot 90MR48 from 2011 survey.

Survey detail: Identified area to survey using annotated topographic map. Surveyed forested (*Picea*, *Abies*) riparian area on both sides of narrow stream and along seep inputs bordering stream (seep species list addendum in database labeled 90MR49). Area surveyed in 2011 appears similar to hand drawing obs. (subplot) #1 from 1990, but seeps overlap with #2.

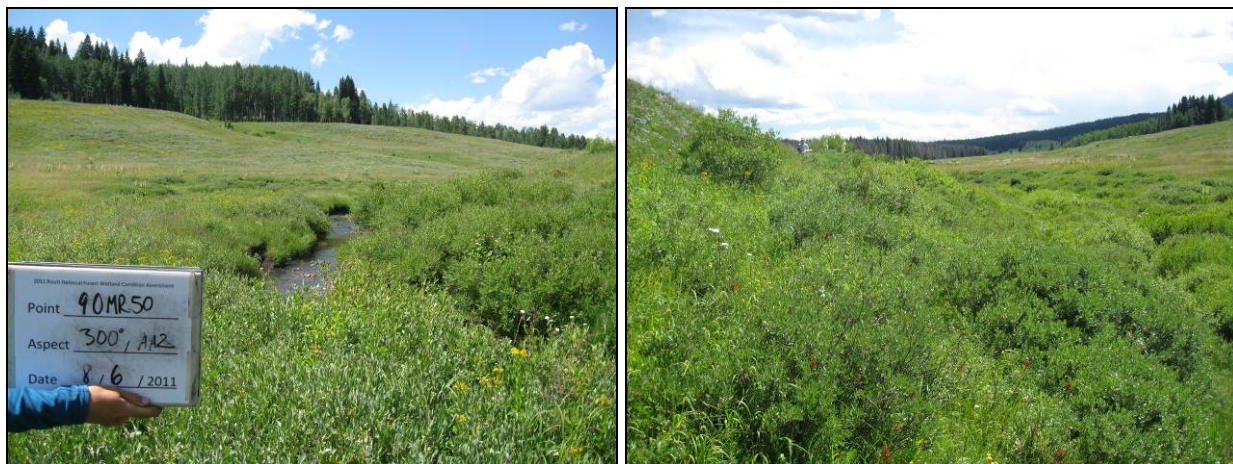
Photos of plot 90MR50 from 2011 survey.

Survey detail: Exact location of initial 1990 survey unclear, more than one area shown on topographic map (used "Plot 50" location instead of GMK 1 or 2). No mention of abundant hillside seeps. Placed plot in Grizzly Creek Park, before *Salix* riparian corridor narrowed (similar to one of points drawn on topographic map). AA in *Salix wolfii/boothii* narrow shrubland, with most of vegetation dependent on seeps from upslope. East slope has more pronounced seeps and areas with >60 cm organic soil (peat). In other areas, soil mixed mineral-organic, pools above channel level. Occasional thin sand lenses in peat from flooding.

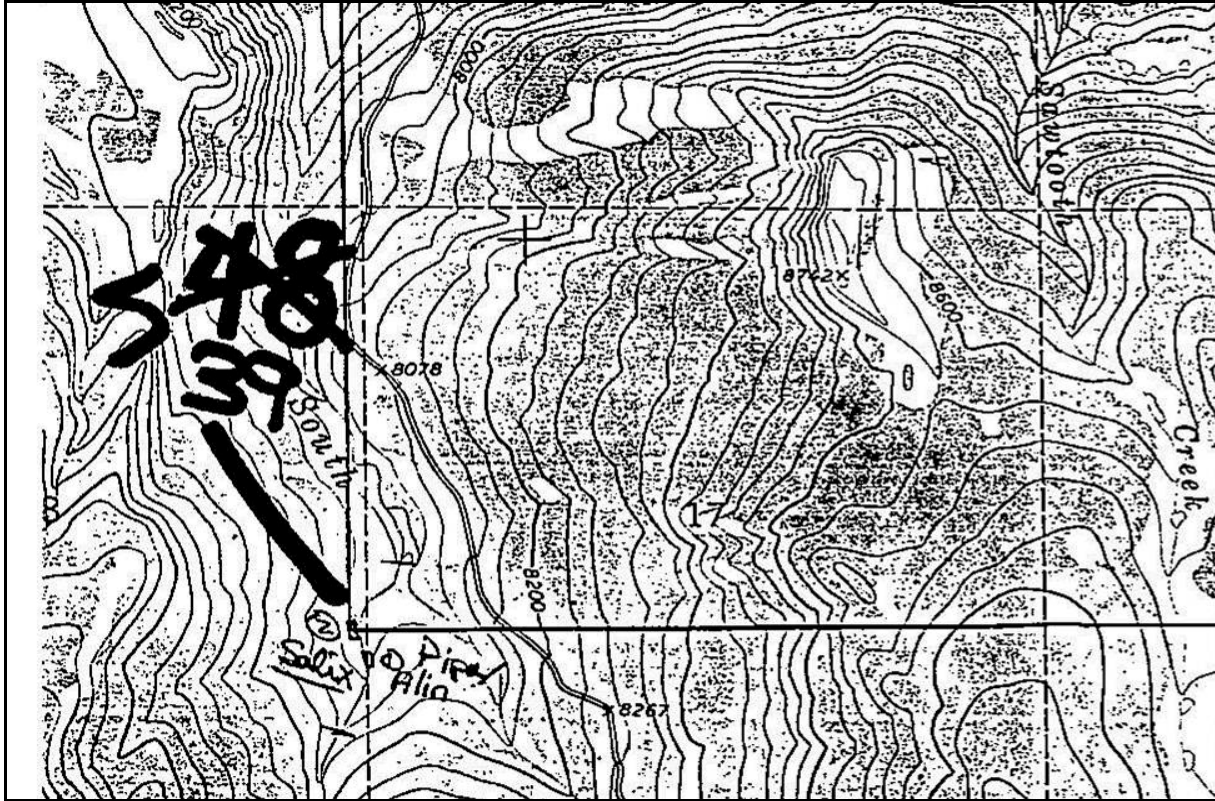
Location of 90MR52 plot from 1990 shown on Buck Point Quadrangle as Plot #S39. Annotated map is scanned from old data sheet.

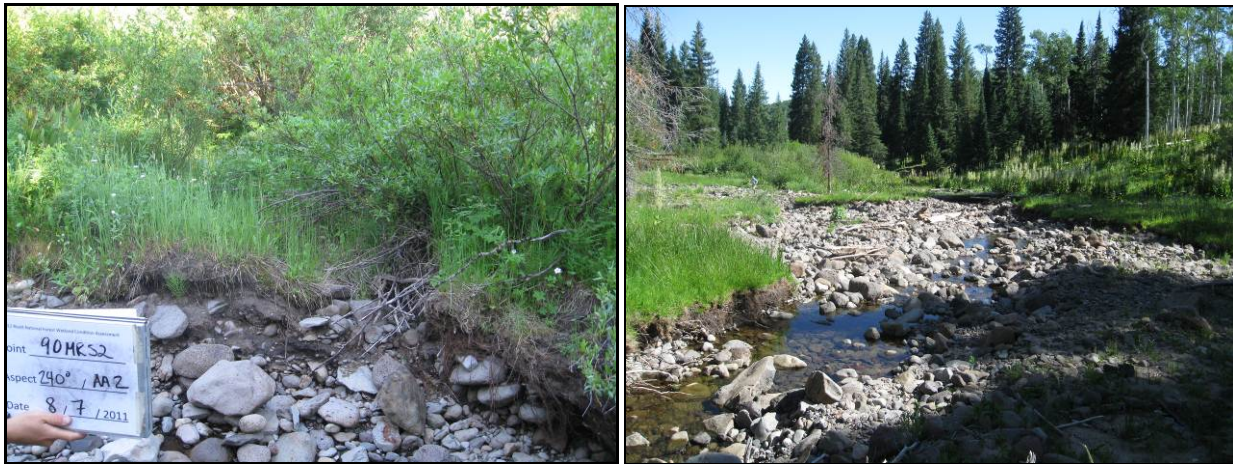
Photos of plot 90MR52 from 2011 survey.

Survey detail: Identified area to survey using GPS waypoint, which was in aspen. Navigated down to stream that was similar to annotated topographic map. Area surveyed in 2011 appears similar to hand drawing obs. (subplot) #2 from 1990. Recently insized channel that experienced massive flood and upstream beaver dam blowout (flushed out all coarse woody debris), new sedimentation supports diverse annuals. Mixed *Salix* and *Alnus* riparian shrubland with large cobbles recently scoured by flood.

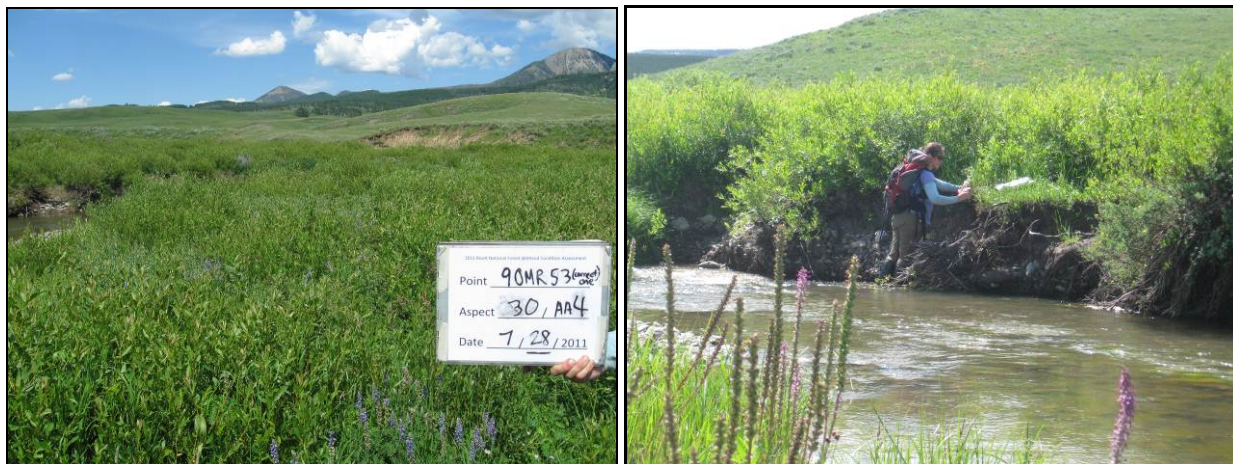
Photos of plot 90MR53 from 2011 survey.

Survey detail: Identified area to survey using GPS waypoint, which was upland adjacent to road, navigated directly to where stream was closest to road and used that point as AA edge. AA is *Salix boothii* riparian shrubland. Location surveyed appears similar to plot in 1990.

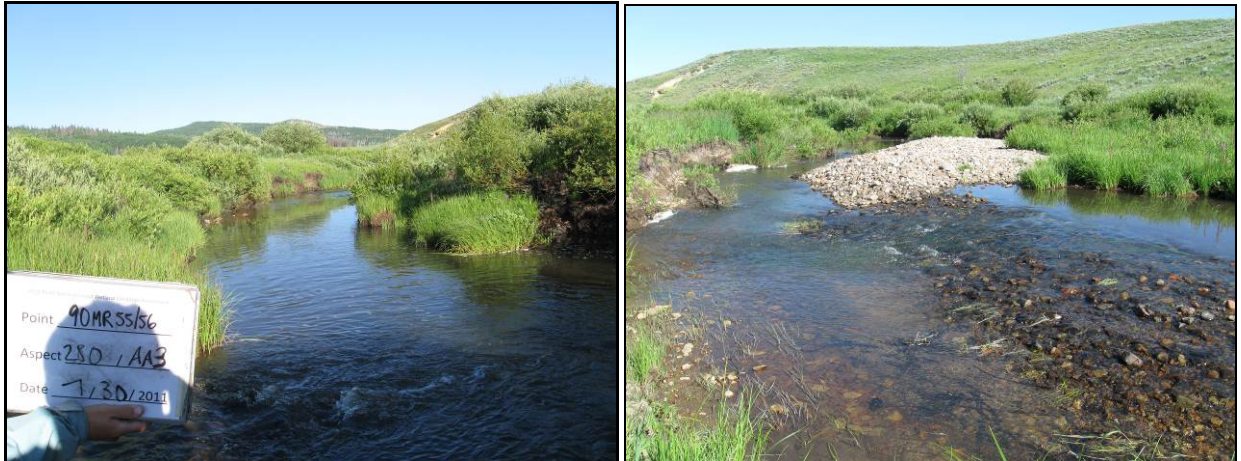
Photos of plot 90MR55 from 2011 survey.

Survey detail: Identified area to survey using annotated topographic map and hand drawings on old field form. AA encompasses both obs. (subplot) #'s 1 and 2 from 1994. Surveyed riparian willow shrub wetland on both sides of Slater Creek.

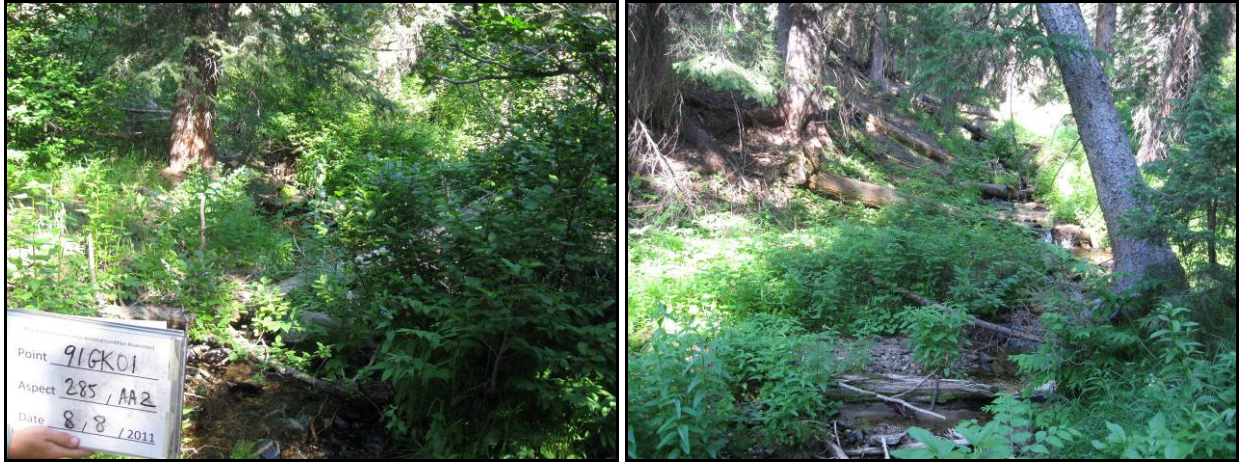
Photos of plot 91GK01 from 2011 survey.

Survey detail: Identified area to survey using GPS waypoint, which was in forest. Navigated down to stream at closest point to original GPS point uphill. AA is *Picea engelmannii/Abies* forested steep narrow channel riparian area, interspersed with *Alnus* and *Sambucus* shrubs. There was no annotated topographic map from 1991 data sheets for this point.

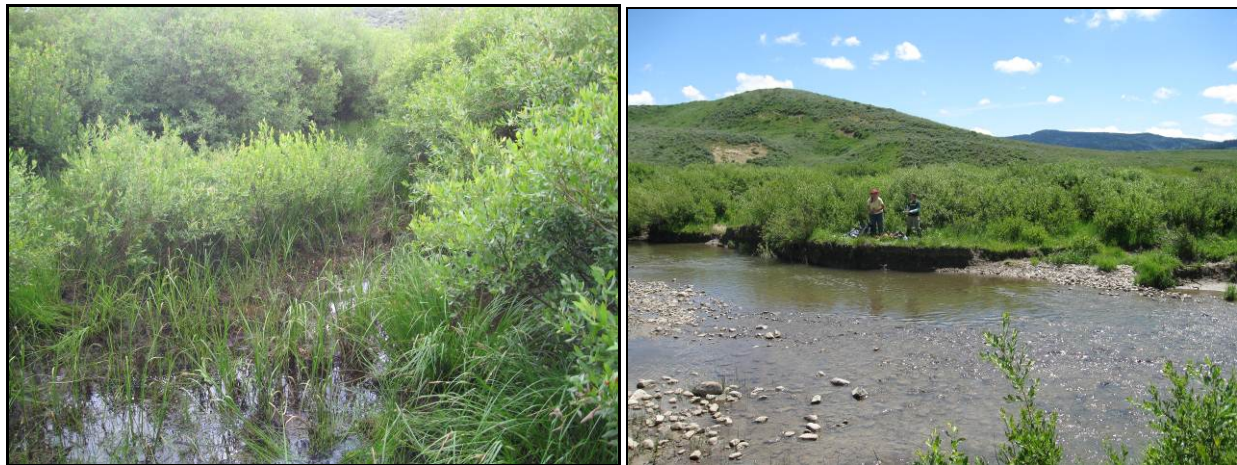
Photos of plot 91GK08 from 2011 survey.

Survey detail: Note that in AA photos (from data package) placard is incorrectly labeled 90MR53, with date 7/27/11. Marti Aiken met us for this site survey. Identified area to survey using annotated topographic map, labeling 91GK01. Area surveyed in 2011 best matches hand drawing obs. (subplot) #1 from 1991. Surveyed riparian willow shrub wetland on both sides of Elkhead Creek at intersection with Stuckey Creek. *Salix boothii* is dominant willow with mesic forb understory, AA surveyed borders wet meadow.

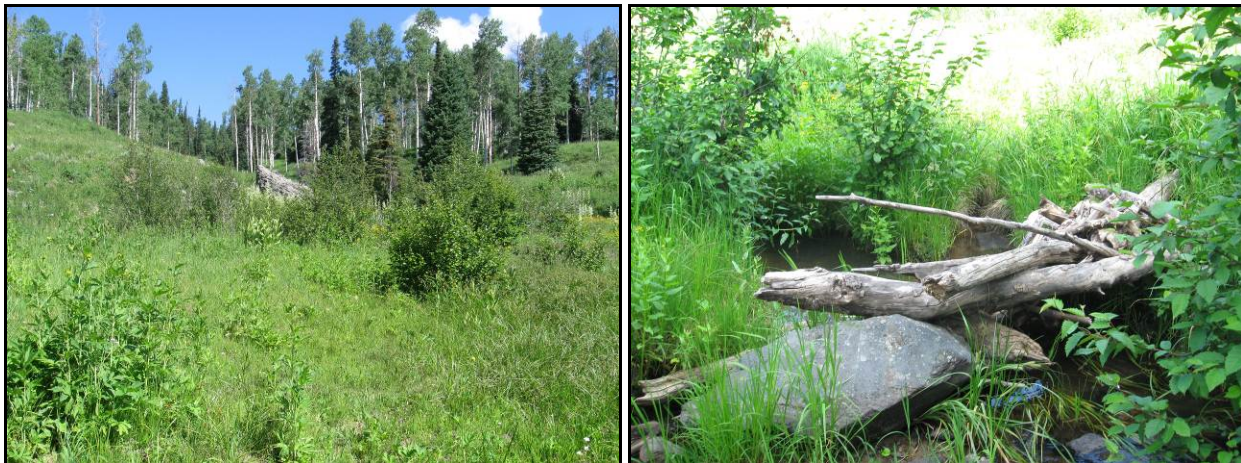
Photos of plot 94A540 from 2011 survey.

Survey detail: Identified area to survey using GPS waypoint, which was 80m above stream. Navigated directly down to Stuckey Creek. AA includes narrow *Alnus incana* shrub wetland with *Calamagrostis/Carex*/mesic forb herbaceous areas, interspersed with seeps. Area surveyed in 2011 appears similar to hand drawing obs. (subplot) #'s 2 and 3 from 1994.

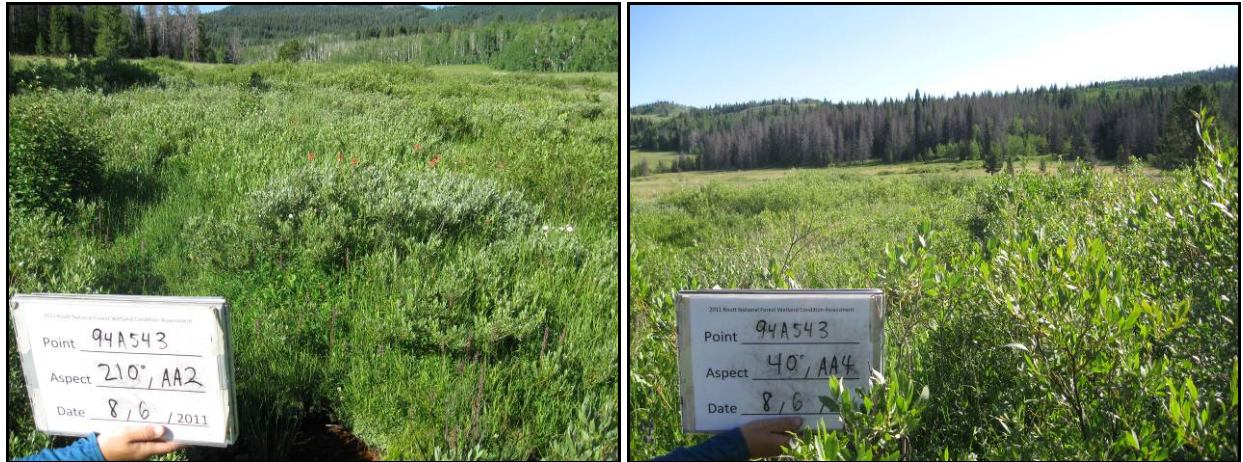
Photos of plot 94A543 from 2011 survey.

Survey detail: Identified area to survey using GPS waypoint. Navigated down to Grizzly Creek from waypoint. AA is *Salix boothii* and *wolfii* shrubland with many side channels. There were no original data forms or annotated topographic maps from 1994 for this point.

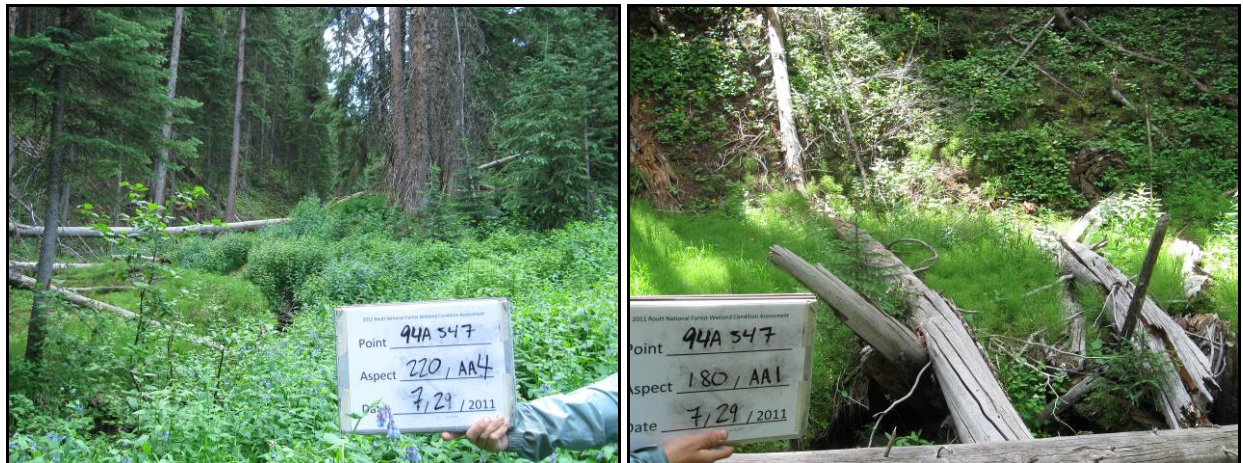
Photos of plot 94A547 from 2011 survey.

Survey detail: Identified area to survey using GPS waypoint, which was 100m above stream. Navigated directly down to Stuckey Creek. Low confidence in direct matchup between initial survey location and resurvey because not clear which resurvey point matches initial survey point best. Area surveyed in 2011 appears similar to hand drawing obs. (subplot) #'s 2 and 3 from 1994. This point is few hundred meters upstream from resurvey point 94A548. Narrow forested riparian area, with *Equisetum* as dominant understory with some bank seeps.

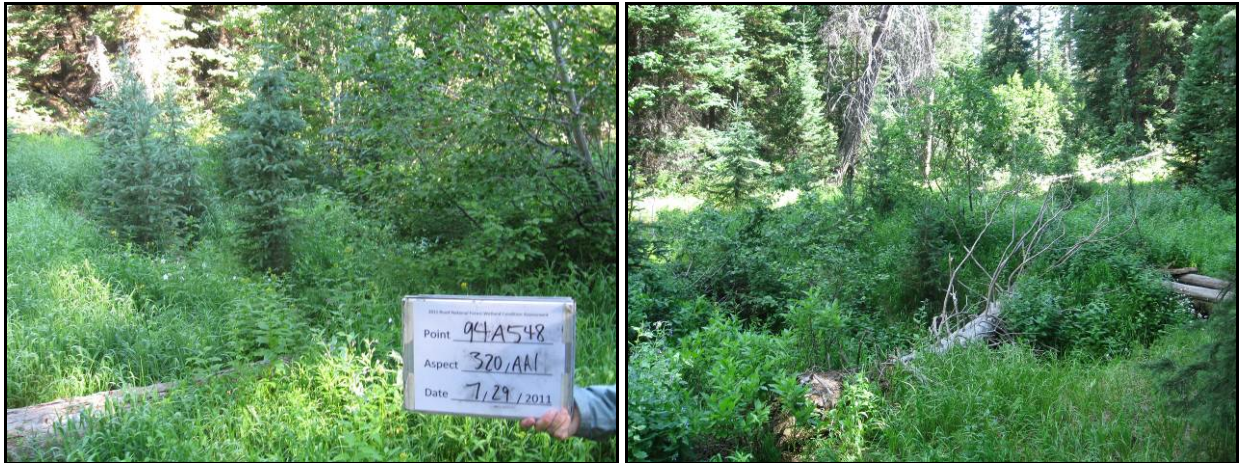
Photos of plot 94A548 from 2011 survey.

Survey detail: Identified area to survey using GPS waypoint, which was 100m above stream. Navigated directly down to drainage. Low confidence in direct matchup between initial survey location and resurvey because not clear which resurvey point matches initial survey point best. Area surveyed in 2011 appears similar to hand drawing obs. (subplot) #'s 2 and 3 from 1994. This point is few hundred meters downstream from resurvey point 94A547. Narrow forested riparian area, with *Picea/Alnus/Calamagrostis* spp dominant, interspersed with open slope seeps.

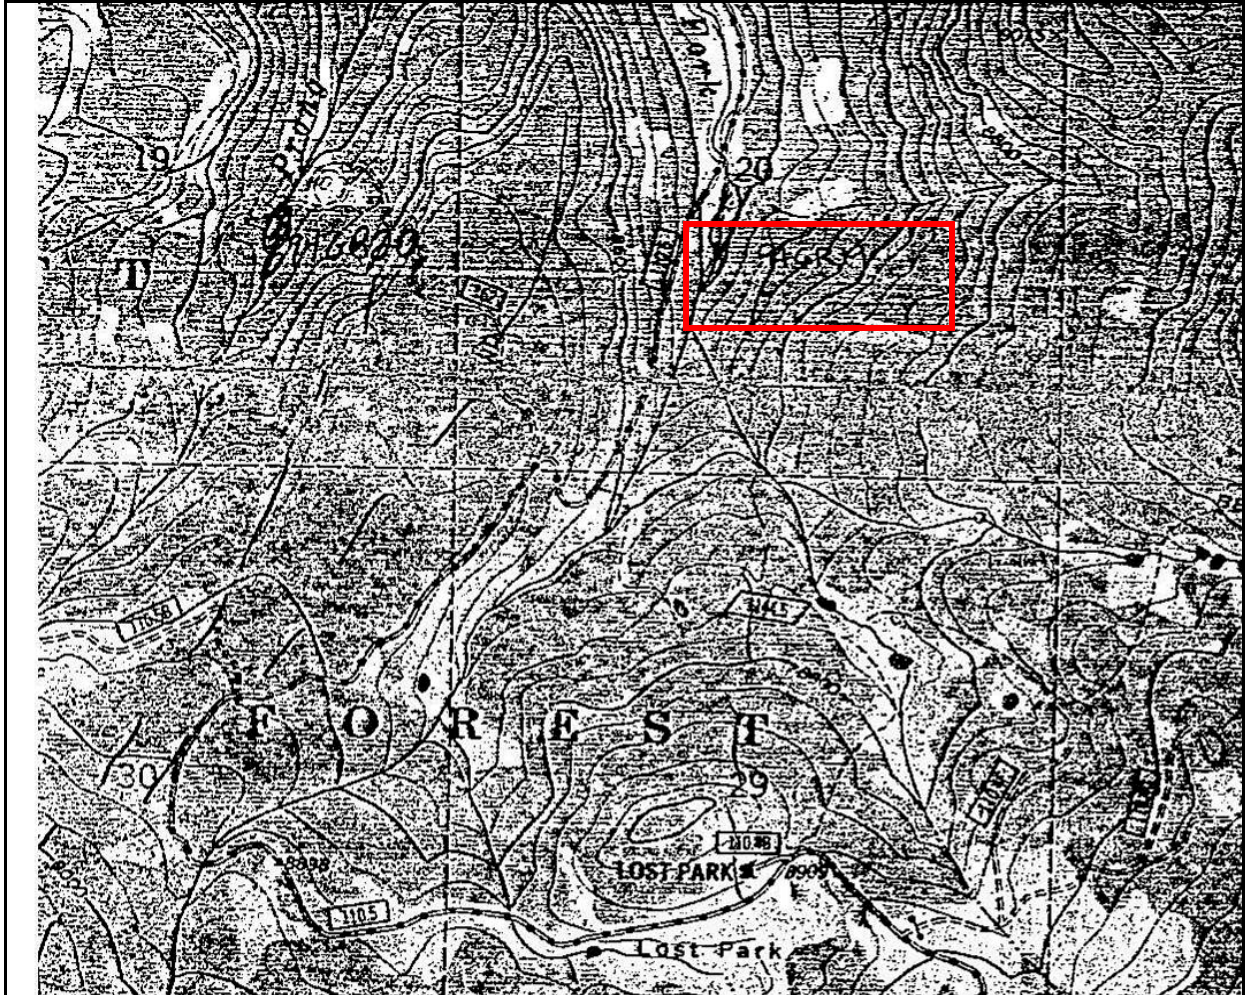
Location of 94R549 plot from 1994 shown on Buck Point Quadrangle as Plot #94GR19. Point is outlined in red box. Annotated map is scanned from old data sheet.

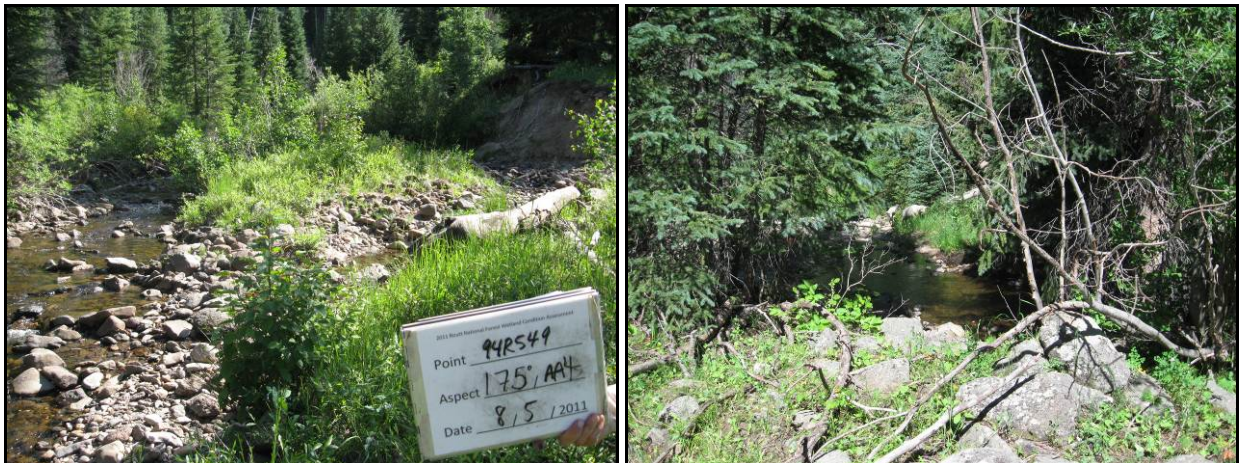
Photos of plot 94R549 from 2011 survey.

Survey detail: Identified area to survey using GPS waypoint and navigated to closest point on floodplain, which seemed similar to annotated topographic map. AA is mixed *Salix* riparian shrubland with overstory of canopy trees. Diverse site with much microtopography, moist soil area and *Salix* maintained with side channels.

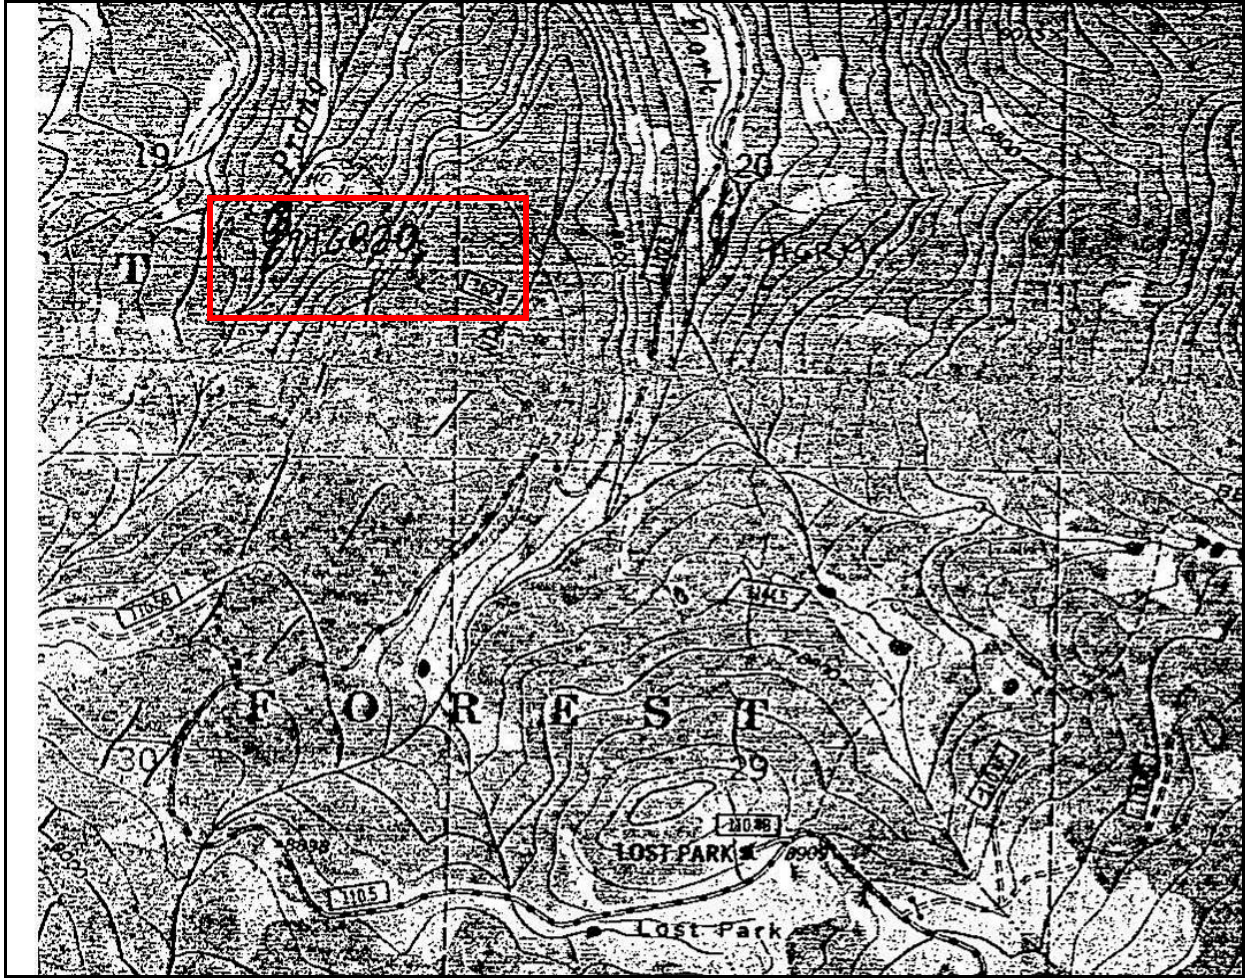
Location of 94R550 plot from 1994 shown on Buck Point Quadrangle as Plot #94GR20. Point is outlined with red box. Annotated map is scanned from old data sheet.

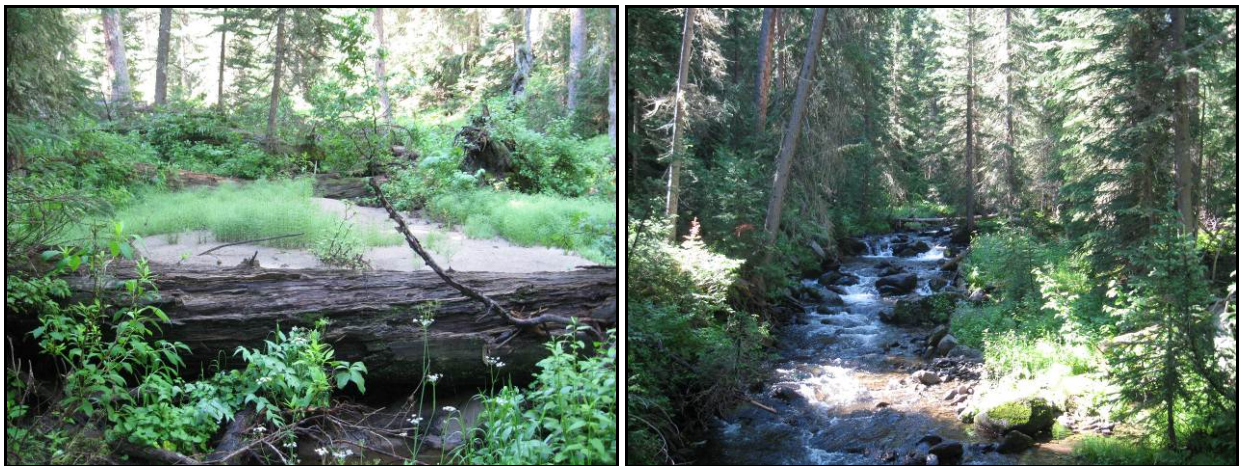
Photos of plot 94R550 from 2011 survey.

Survey detail: Identified area to survey using description on field form (point bar upstream from Trail 1144 and W Fork Prong Creek intersection). AA is riparian forest of *Abies* and *Picea* along braided stream, small seep areas on W side of AA. Very dynamic system, new large-sized gravel deposits from heavy flow spring.

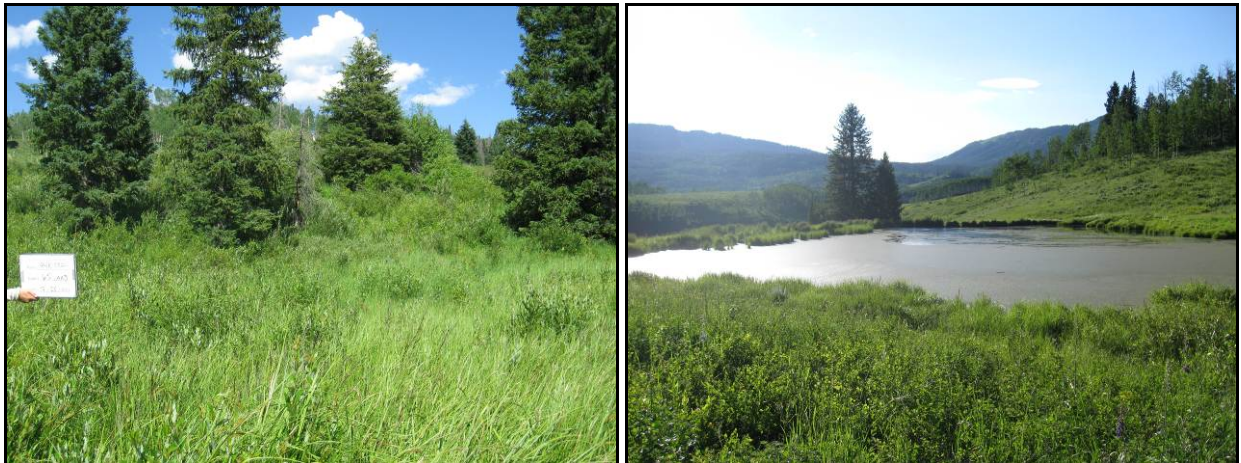
Photos of plot 94R552 from 2011 survey.

Survey detail: Identified area to survey using hand drawn maps. Wetland area surveyed in 1994 was too large for EIA survey methods. EIA methods also treat Torso Creek riparian area differently than beaver wetland complex – surveyed beaver complex of willow and mixed graminoid/herb wetland. Dominant willow = *Salix boothii*. Surveyed area does not include larger stream (Torso Creek). Area surveyed in 2011 best matches hand drawing obs. (subplot) #3 from 1994. Small channels connect beaver ponds (intact this year), slope is saturated and receives groundwater input, but small channels connecting beaver ponds likely overbank in spring.

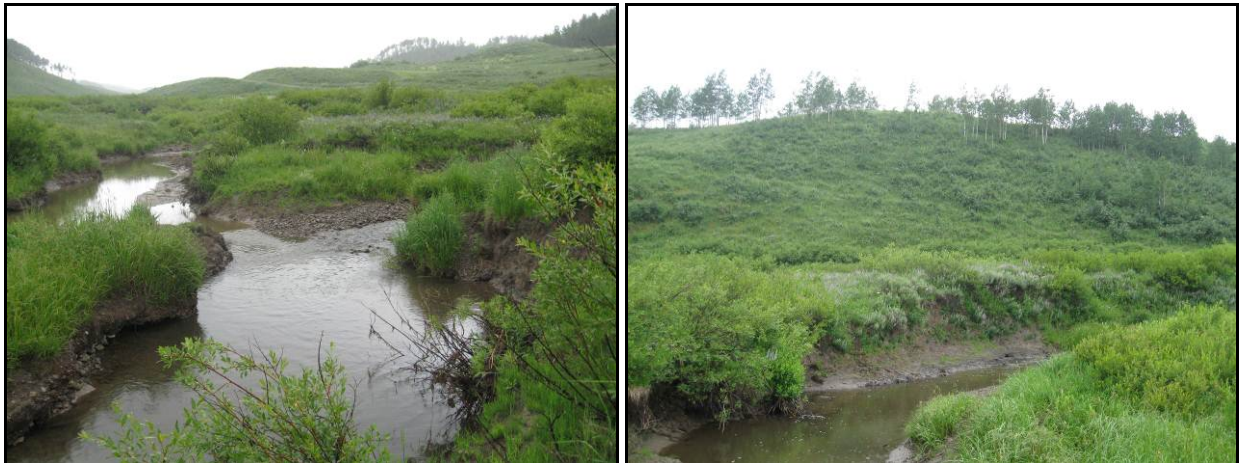
Photos of plot 94A554 from 2011 survey.

Survey detail: Identified area to survey using description on field form (50 m downstream of the confluence of Torso Creek and Elk Creek). Area surveyed in 2011 best matches hand drawing obs. (subplot) #3 from 1994. Surveyed riparian willow shrubland on both sides of Elkhead Creek. A *Salix boothii* shrub wetland interspersed with *Carex* vegetated swales and upland *Lupinus/Trifolium* understory. Channel is incised ~2m.
