South Platte River Chatfield Downstream Channel Improvement Vegetation Management Plan

Prepared for:
**Colorado Water Conservation Board
Watershed Protection & Flood Mitigation Section**

Prepared by:
Lifeline Ecological, Inc.

**Agency Review Draft: February 21, 2008
Final Report: April 30, 2008**

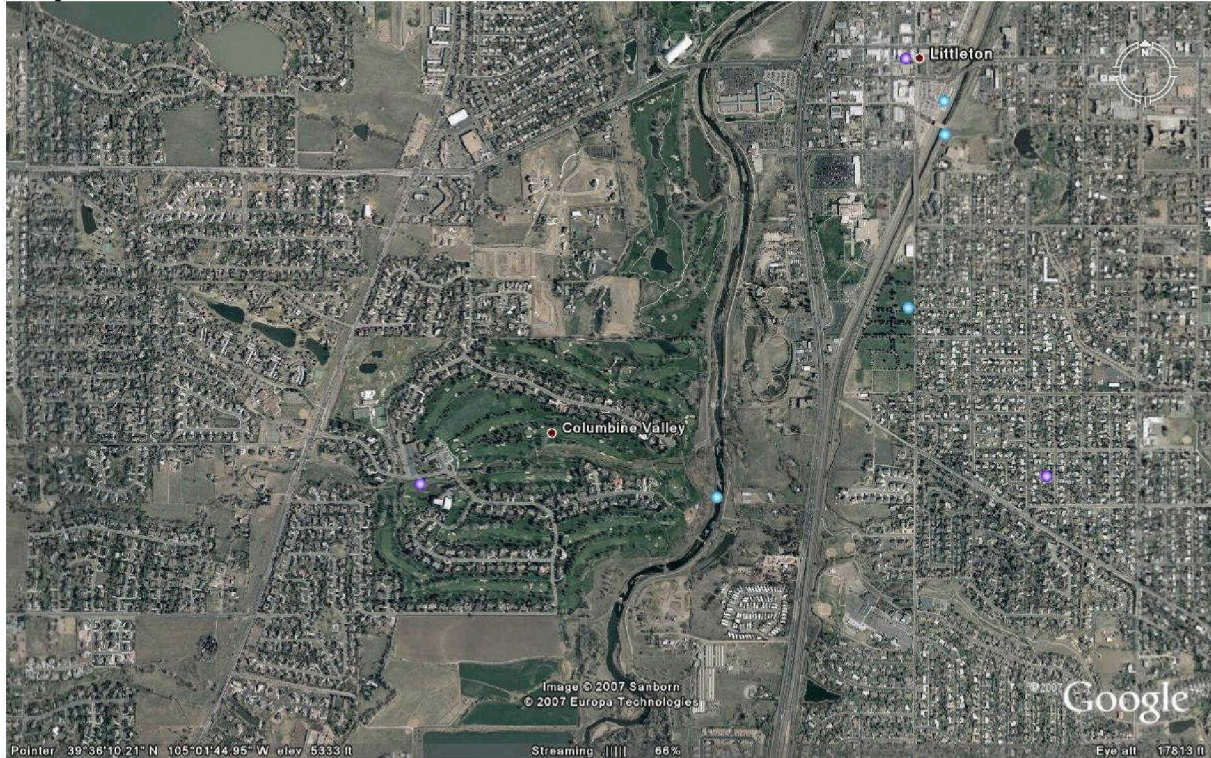
Map 2: Reach A) South Platte Park to Bowles Avenue

Reach A) South Platte Park to Bowles Avenue

Engineered Structures – Reach A includes the location where the flood control channel starts and includes a series of drop structures, ramps, culverts, and bridges. **Vegetation** – The riparian habitat in this reach is dominated by cottonwood gallery forests on the upper floodplain and narrow willow riparian habitat in the channel and along the banks of the river. Sandbars are dispersed throughout the reach and are dominated by willow. The understory along the banks contains cattails, sedge, rush, with a diverse layer of grasses and forbs. Upland-riparian cottonwood galleries have shrub understories. However, several contain smooth brome, which may have historically been seeded. Off-channel low areas, which may be historic oxbows, occur along the reach and have dense wetland vegetation. This reach is diverse in vegetative communities. **Wildlife** – Essential breeding habitat for dozens of species of resident and migratory birds can be found in this reach. Mature cottonwood trees provide nesting, hunting, perching, and loafing habitat for raptors. Bald eagles frequently fly over the area in the winter. A pair attempted to nest in a tree on an adjacent property south of the reach. This reach has extremely important habitat for mammals, reptiles, and amphibians. Riparian woodland and shrubland ecosystems provide optimum shelter and food for wildlife and function as movement corridors. Off-channel wetland and aquatic habitats are important nursery habitats for fish. Riparian habitat is

generally considered the single most important wildlife habitat in Colorado. This reach is highly valuable to wildlife species. Potential listed species that may find suitable habitat in this site include the northern leopard frog (*Rana pipiens*), common garter snake (*Thamnophis sirtalis*), peregrine falcon (*Falco peregrinus anatum*), ferruginous hawk (*Buteo regalis*), western yellow-billed cuckoo (*Coccyzus americanus*), and Iowa darter (*Etheostoma exile*). Hydrology – Channel is sinuous to some degree in this reach but straightens through the Hudson’s Garden and Columbine Country Club areas. Drainages in the reach include Lee Gulch, Dutch Creek, and Little’s Creek. Several ponds occur adjacent to the river including Lee Gulch Pond, Denver Seminary Pond, Hudson’s Garden Pond, Columbine Country Club, Centennial Golf Course and Watson Lake. Soils – River alluvium consists of sand, gravel, and cobble with some large boulders. Sandbars are stabilized with roots from willow thicket in most in channel areas. Sandbars are small to medium sized and can be found dispersed through out the reach Bank soils are higher in organic material and include sandy clay silt.

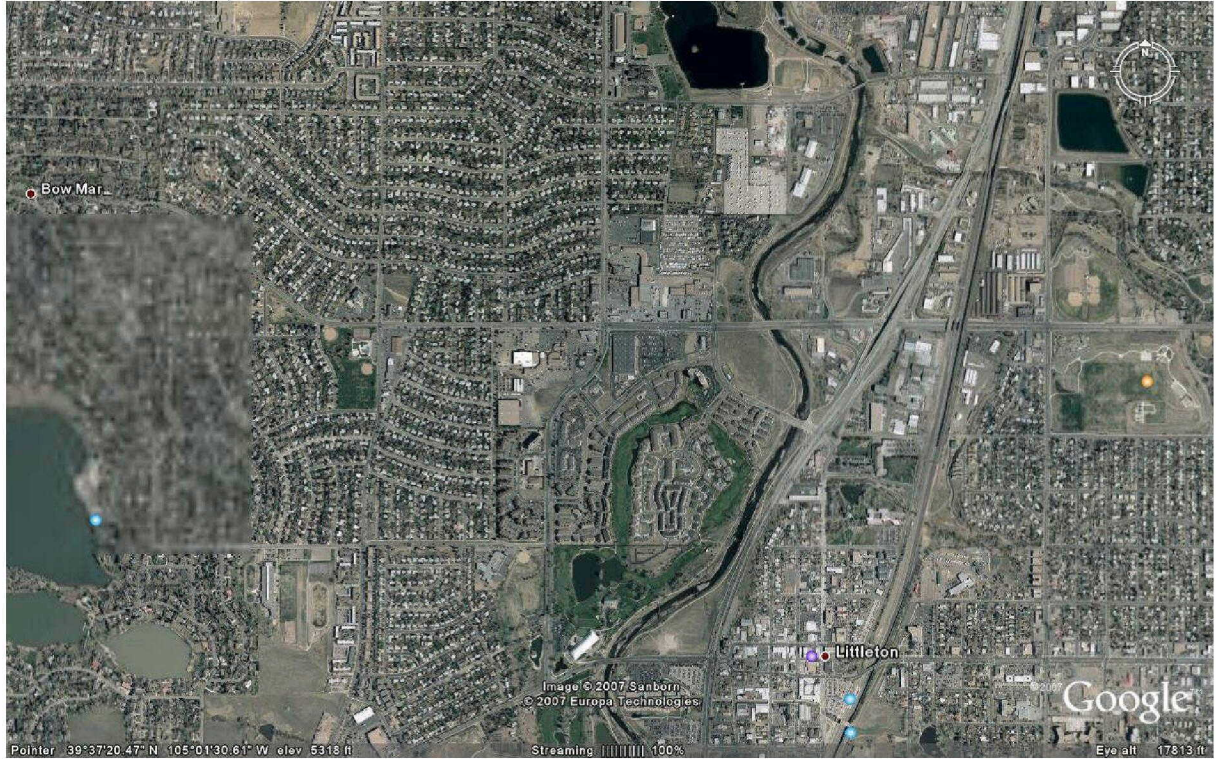
Map 3: Reach B) Bowles Avenue to West Union Avenue

Reach B) Bowles Avenue to West Union Avenue (Pilot Project Location)

Engineered Structures – Reach B includes a series of drop structures, ramps, culverts, and bridges. Vegetation – Riparian habitat is dominated by a narrow willow riparian fringe along the river in this highly urban and industrial location. The understory consists of cattails, sedge, rush, grass, and forbs. Deciduous trees were planted in the upland-riparian zone several years ago. Aside from the cottonwood gallery on the Oxbow property on the east bank of the river between W. Belleview Ave. and Big Dry Creek, few cottonwood galleries are found in this reach. Drainages into the channel occur along the reach and have dense wetland vegetation. Wildlife – This area provides breeding habitat for numerous species of resident birds, particularly Neo-tropical migrants. It is habitat for fish and invertebrates,

mammals, reptiles, and amphibians. Riparian ecosystems provide optimum shelter and food for wildlife and function as movement corridors. Potential listed species that may find suitable habitat in this site include the northern leopard frog, common garter snake, peregrine falcon, bald eagle, ferruginous hawk, western yellow-billed cuckoo, and Iowa darter.

Hydrology – Channel in this reach is sinuous but modified and has water features, Big Dry Creek and ponds at Centennial Golf Course. Soils – River alluvium consists of sand, gravel, and cobble with some large boulders. Bank soils have higher organic material.

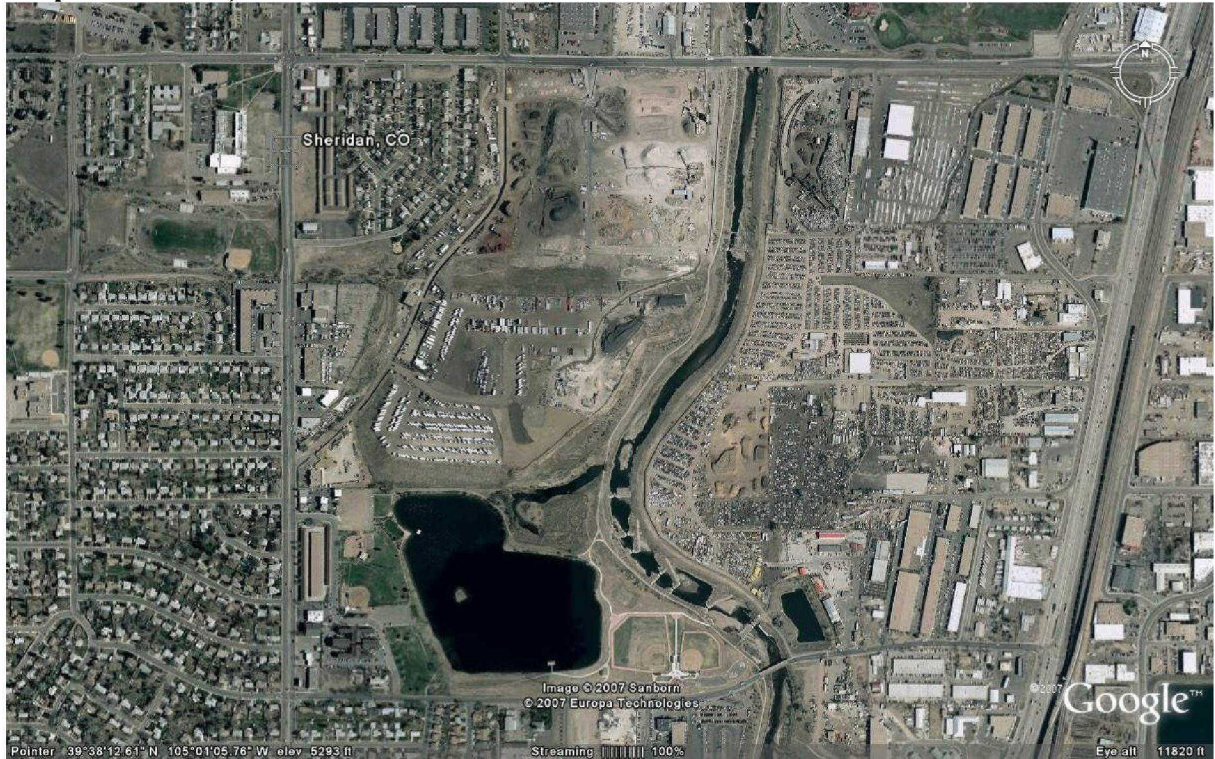
Map 4: Reach C) West Union Avenue – West Oxford Avenue

Reach C) West Union Avenue - West Oxford Avenue

Engineered Structures – Reach C includes a series of drop structures, ramps, culverts, and bridges. Vegetation – The riparian habitat is mainly a narrow willow corridor on the banks of the river. The riparian community in this highly industrialized reach has been significantly reduced. Long continuous sandbars occur on both banks of the river south of West Oxford Ave. The willow understory contains cattails, sedge, rush, grass, and forbs.

The upland habitat adjacent to the riparian fringe is planted with young deciduous trees.

Wildlife – The reach provides breeding habitat for birds, particularly Neo-tropical migrants. It has critical habitat for fish and aquatic invertebrates, and habitat for small mammals, reptiles and amphibians. Riparian ecosystems provide optimum shelter and food for wildlife and function as movement corridors. Potential listed species that may find suitable habitat in this site include the northern leopard frog, common garter snake, western yellow-billed cuckoo, and Iowa darter. Hydrology – Some drainages and ponds. Soils – River alluvium consists of sand, gravel, and cobble with some large boulders. This reach has been highly modified by engineered drop structures. Bank soils are higher in organic material.

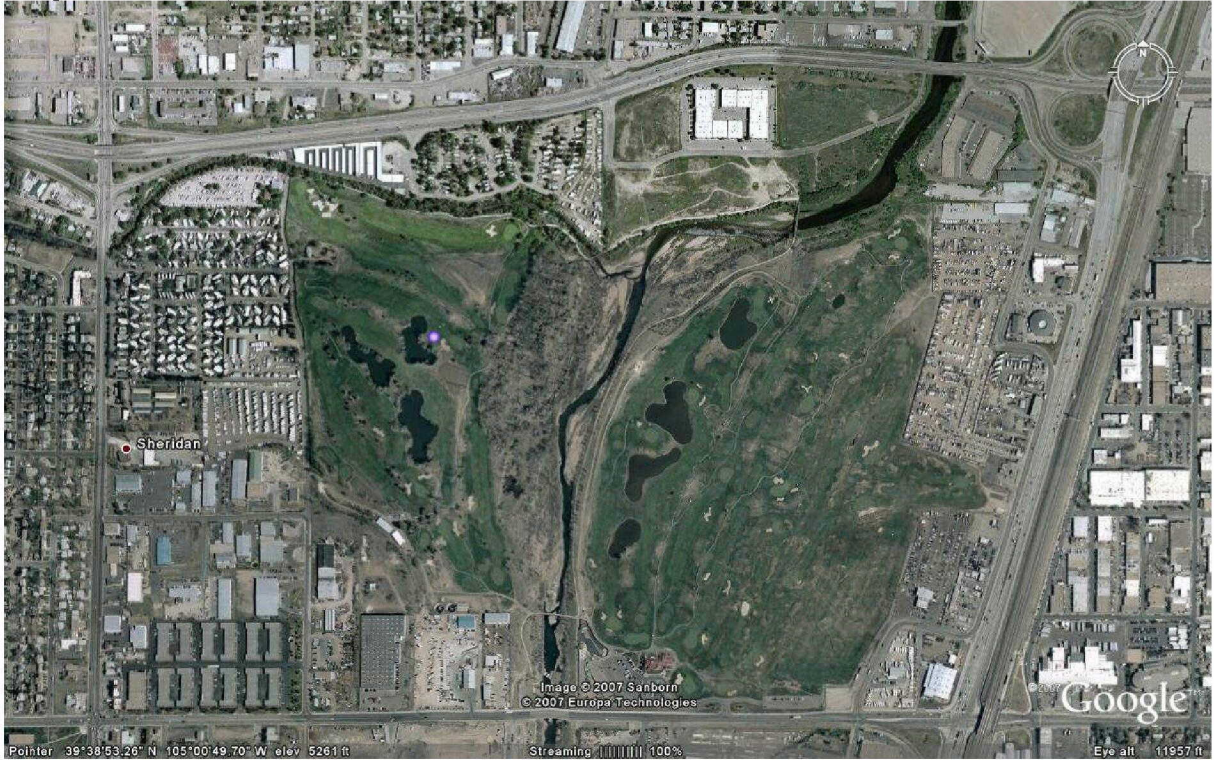
Map 5: Reach D) West Oxford Avenue – Hampden Avenue

Reach D) West Oxford Avenue - Hampden Avenue

Engineered Structures – Reach D includes a series of drop structures, ramps, culverts, and bridges. Vegetation – High quality riparian habitat in this reach is found in this reach and is dominated by large, undisturbed cottonwood gallery forest adjacent to wide continuous sandbars with willow thicket. The willow understory consists of cattails, sedge, rush, grass, and forbs. The upland-riparian understory is dominated with shrubs. This reach may contain suitable habitat for the Federal and State Listed Threatened Ute ladies’-tresses orchid. Wildlife – Essential breeding habitat for numerous of species of resident and migratory birds. Open sandbars provide critical foraging habitat for shorebirds. Mature cottonwood trees provide nesting, hunting, perching, and loafing habitat for raptors. The intact deciduous forest is important habitat for mammals. Wetlands, sandbars, and riparian shrublands are important habitat for reptiles and amphibians. Off-channel wetland and aquatic habitats are important nursery habitats for fish. Riparian woodland and shrubland ecosystems provide optimum shelter and food for wildlife. The Bear Creek tributary, which flows from the foothills to the plains, joins the South Platte River providing an important migratory corridor for wildlife such as, mule deer that migrate between the two ecosystems. Potential listed species that may find suitable habitat in this site include the Preble’s meadow jumping mouse, northern leopard frog, common garter snake, peregrine falcon, bald eagle, ferruginous hawk, western yellow-billed cuckoo, and Iowa darter. This reach is highly valuable to wildlife species. Hydrology – This reach includes the confluence of Bear Creek and the S. Platte River which creates a large flood plain which supports riparian cottonwood gallery forest. Several Englewood Golf Course Ponds occur in the reach as well. Soils – River alluvium consists of sand, gravel, and cobble with some large boulders. Bank soils are higher in organic material and include sandy clay silt.

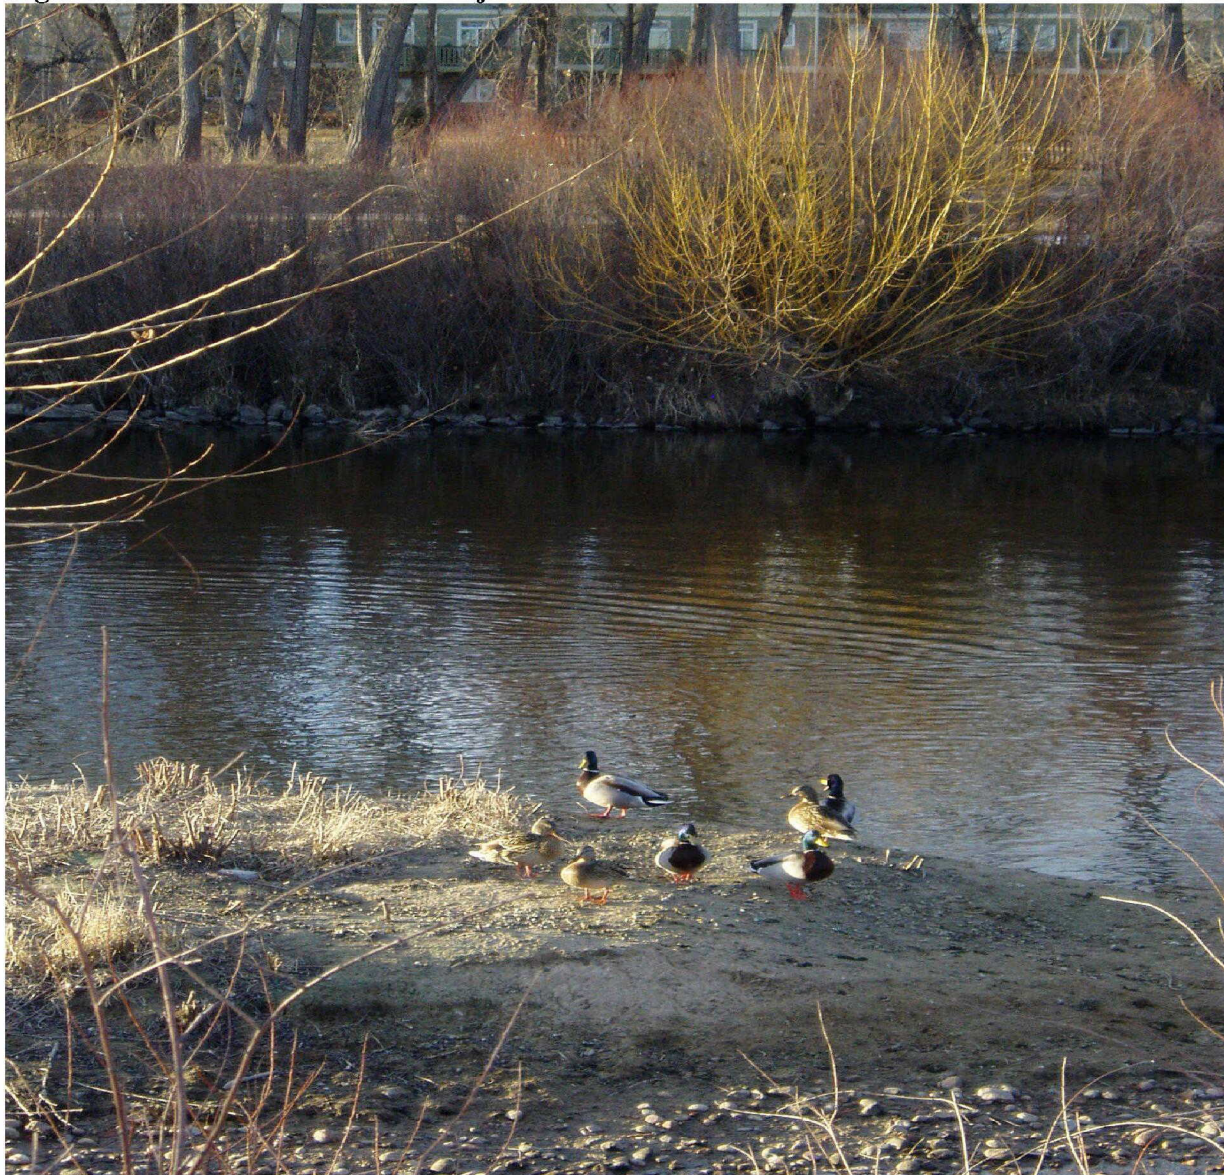
Figure A: Wildlife Use at Pilot Project Area

Bi-Monthly project monitoring surveys in September 2007, November 2007, and January 2008 reveal that the test plots have reduced vegetation, that aesthetics are still optimal, and that both recreationists and wildlife are using the area (Figure A). In fact, the additional use of park visitors may result in further environmental planning needs, as areas which were chock full of vegetation are now opened and available for use. This sudden use should be monitored and access points to the river may need to be established to reduce the chance of safety threats, vegetation trampling, and Neo-tropical migratory bird nesting disruption.

In addition to bi-monthly monitoring of the pilot project, detailed surveys of the entire project reach were conducted to identify sensitive habitats which may require protection, mitigation, or detailed assessment. These opportunities are further discussed in the following section on mitigation. In summary, off-channel areas and upland sites were explored for vegetation and habitat enhancement opportunities. Off-channel areas included natural drainage confluence such as Lee Gulch, Dutch Creek, Little's Creek, Big Dry Creek, and Bear Creek. Wetland/riparian areas adjacent to and off-channel of each reach included: Reach A) South Platte Park Wildlife area, Lee Gulch and pond, Dutch Creek, Watson Lake, Reach B) Bowles/Sante Fe Corner, Prince/Belview corner, Centennial Golf Course, Big Dry Creek, Reach C) Centennial Park and creek, long sandbars near industrial area, and Reach D) Englewood Golf Course and Bear Creek

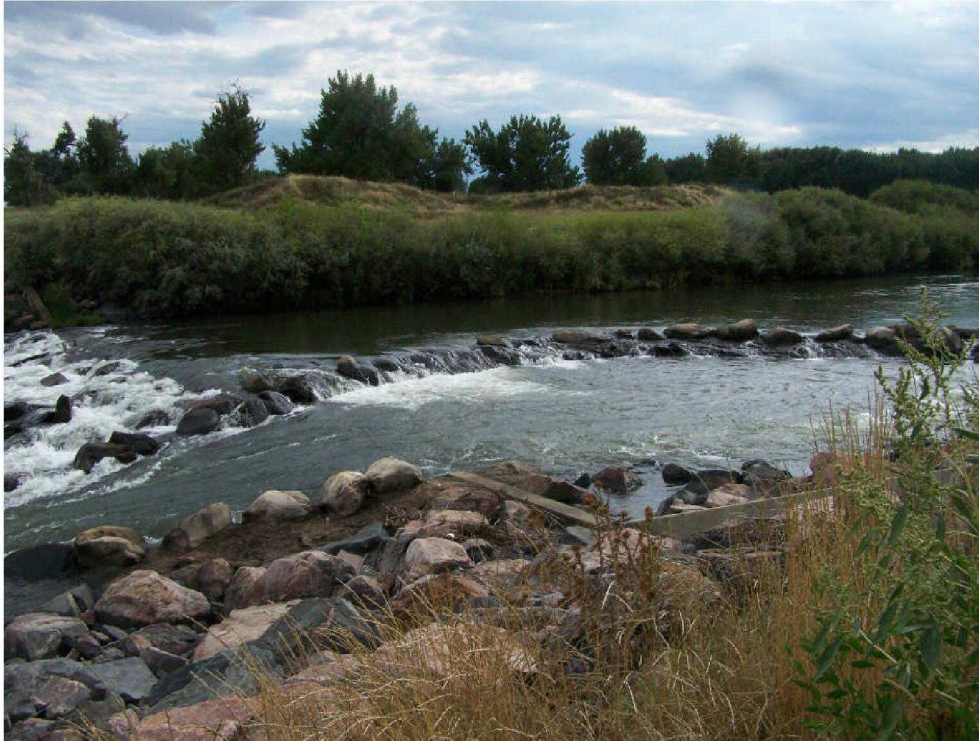
Reach A - Boat Chute

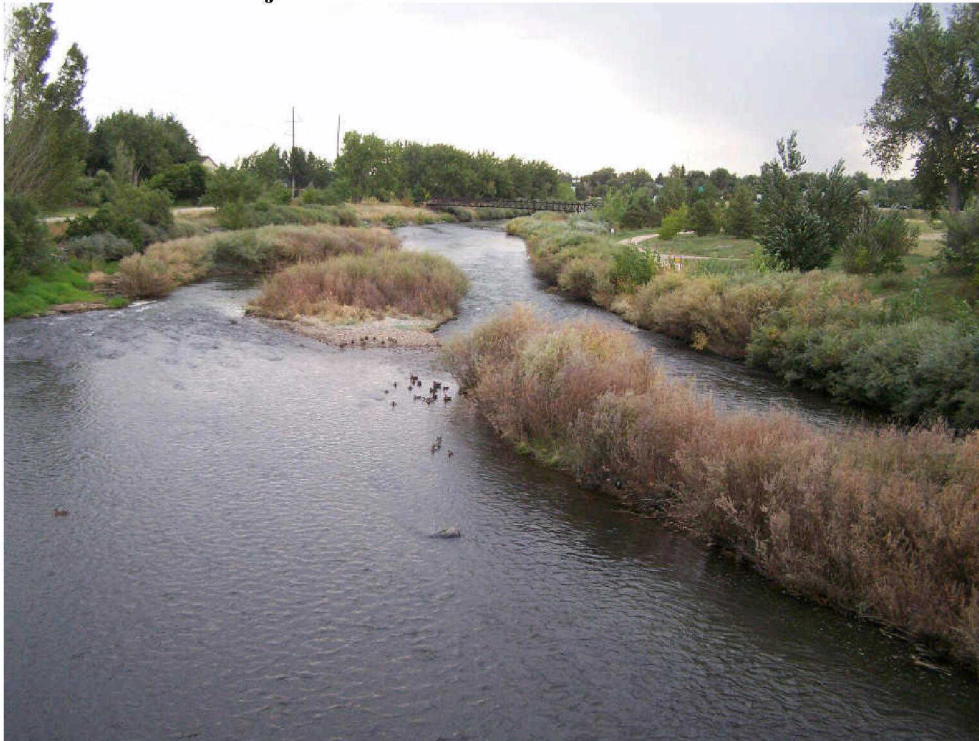
Reach B - Pilot Project Fall 2007

As previously stated, a Pilot Project was initiated late summer 2007 in an area documented as a Deficiency Location in the Corps inspection report (USACE 2007). Pilot test plots were sprayed in-channel on sandbars with FDA approved herbicide from Bowles Avenue to just upstream of the Union Avenue Boat Chutes, where an estimated 9 acres of vegetation was treated in the river channel bottom. Field surveys were conducted to monitor the Pilot Project success and plan for additional vegetation removal phases over a period of 4 years which prioritize Corps requests.

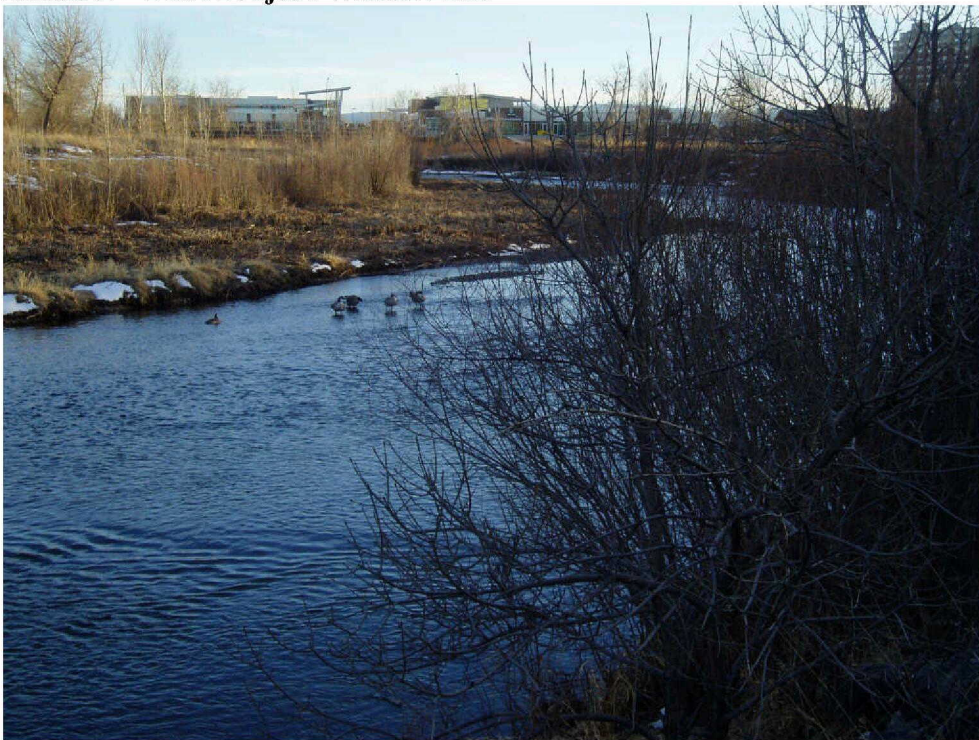
Reach B - Pilot Project Winter 2008

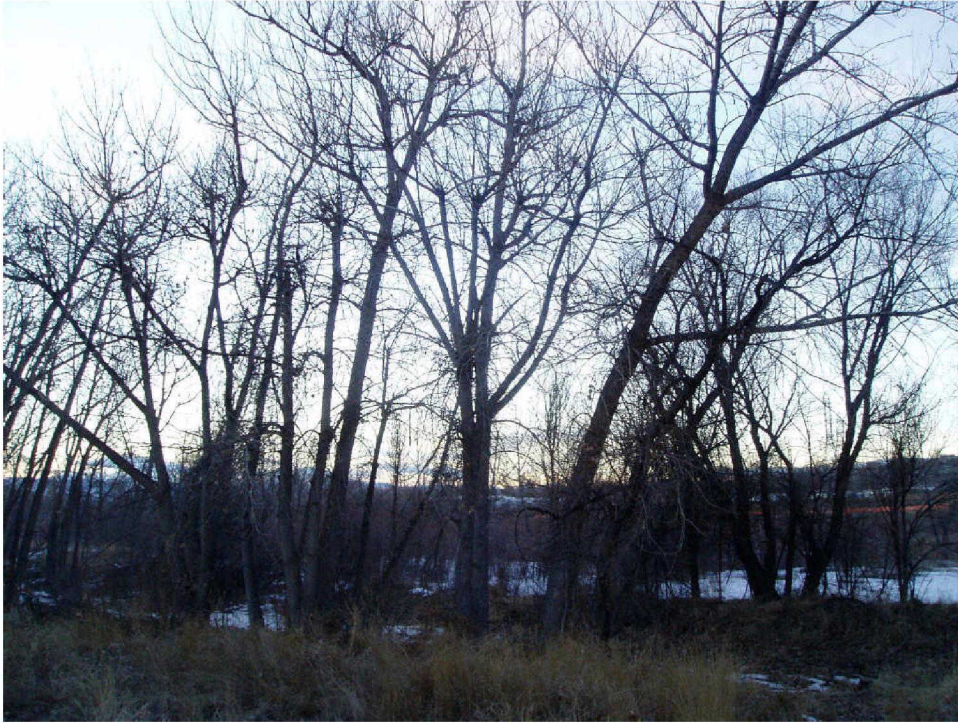
Reach D – Cottonwood Gallery near Bear Creek confluence
