**GEOTECHNICAL ENGINEERING STUDY  
FOR FINAL DESIGN PHASE**

**PROPOSED COLORADO STATE HIGHWAY 96A**

**4<sup>TH</sup> STREET BRIDGE**

**CDOT PROJECT NO. STA 0961-008/13141**

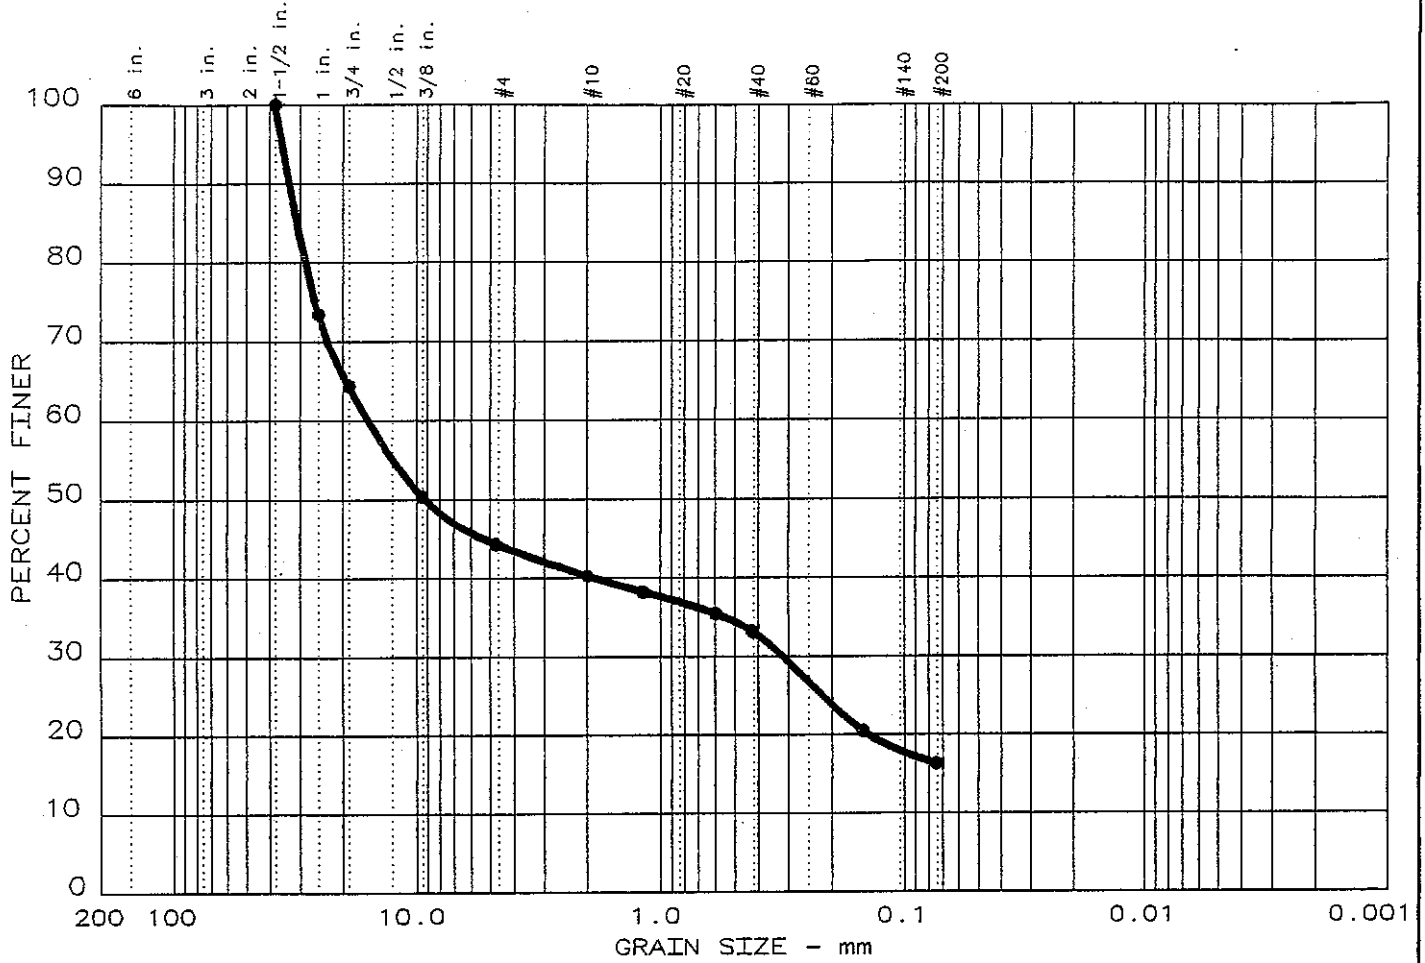
# GRAIN SIZE DISTRIBUTION TEST REPORT

% +3"	% GRAVEL	% SAND	% SILT	% CLAY
0.0	55.7	27.9	16.4

LL	PI	D <sub>85</sub>	D <sub>60</sub>	D <sub>50</sub>	D <sub>30</sub>	D <sub>15</sub>	D <sub>10</sub>	C <sub>c</sub>	C <sub>u</sub>
NV	NP	31.0	15.7	9.25	0.317

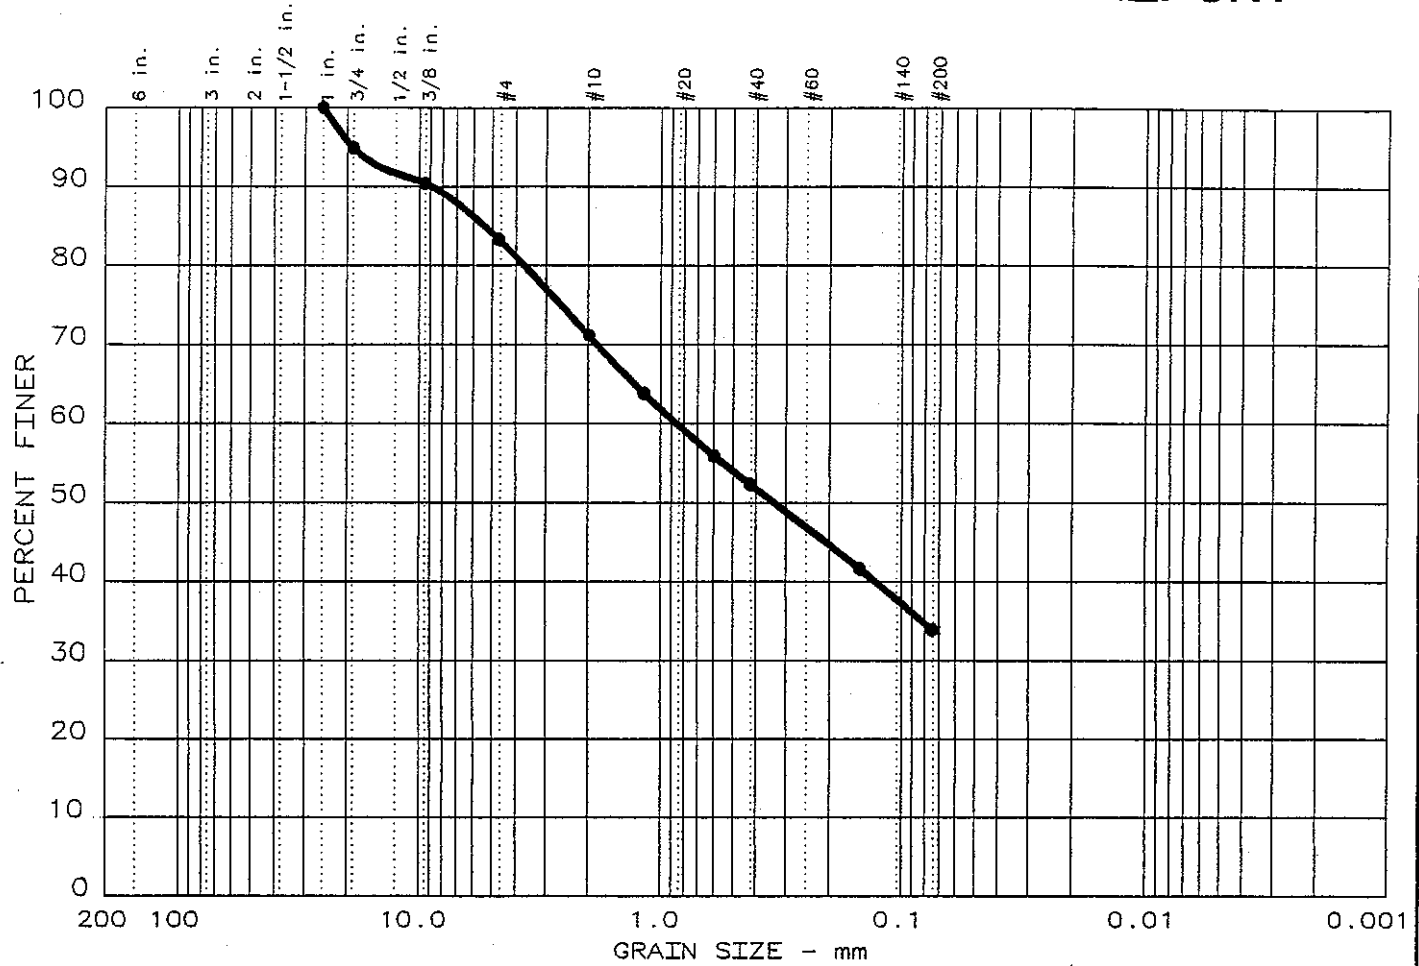
# GRAIN SIZE DISTRIBUTION TEST REPORT

% +3"	% GRAVEL	% SAND	% SILT	% CLAY
0.0	16.7	49.4	33.9

LL	PI	D <sub>85</sub>	D <sub>60</sub>	D <sub>50</sub>	D <sub>30</sub>	D <sub>15</sub>	D <sub>10</sub>	C <sub>c</sub>	C <sub>u</sub>
NV	NP	5.37	0.861	0.335

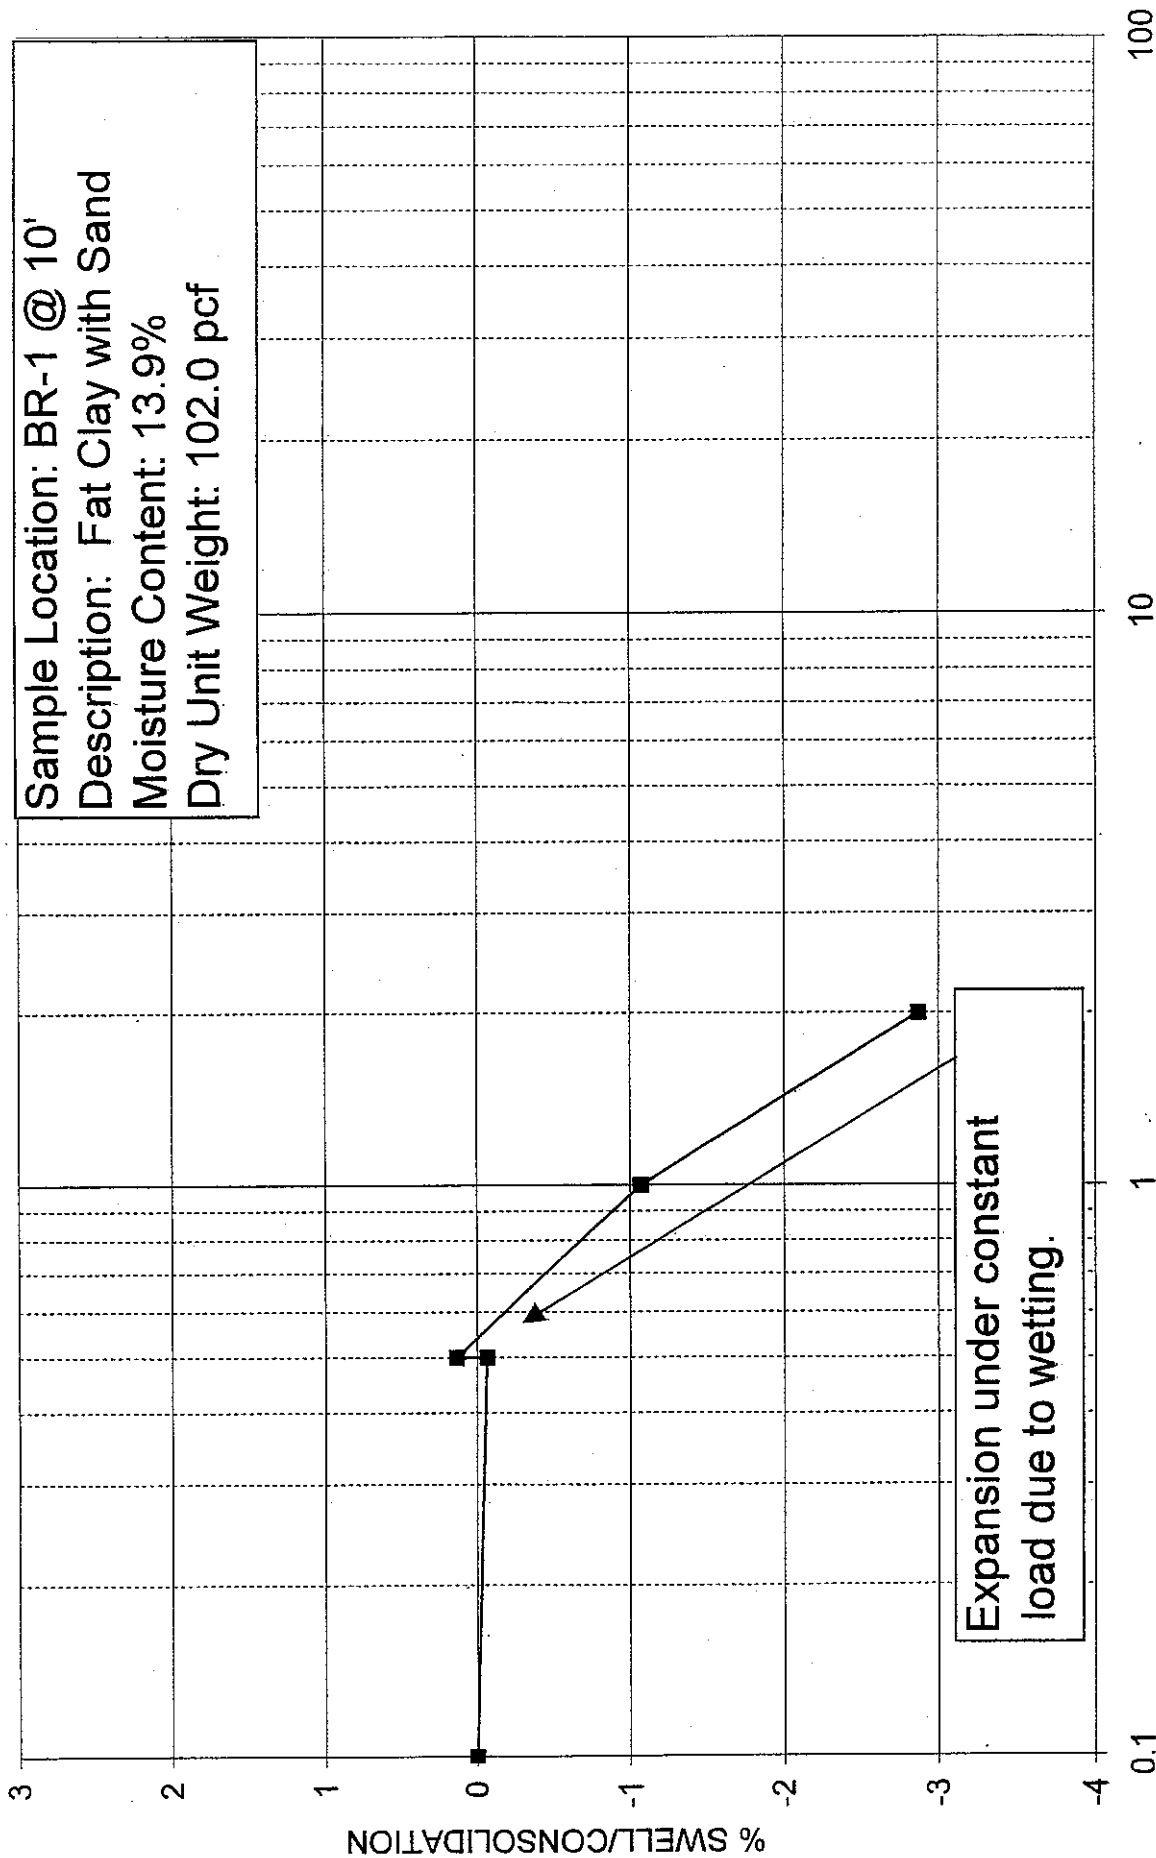
GOODSON & ASSOCIATES, INC.  
SWELL-CONSOLIDATION TEST

Sample Location: BR-1 @ 10'  
Description: Fat Clay with Sand  
Moisture Content: 13.9%  
Dry Unit Weight: 102.0 pcf

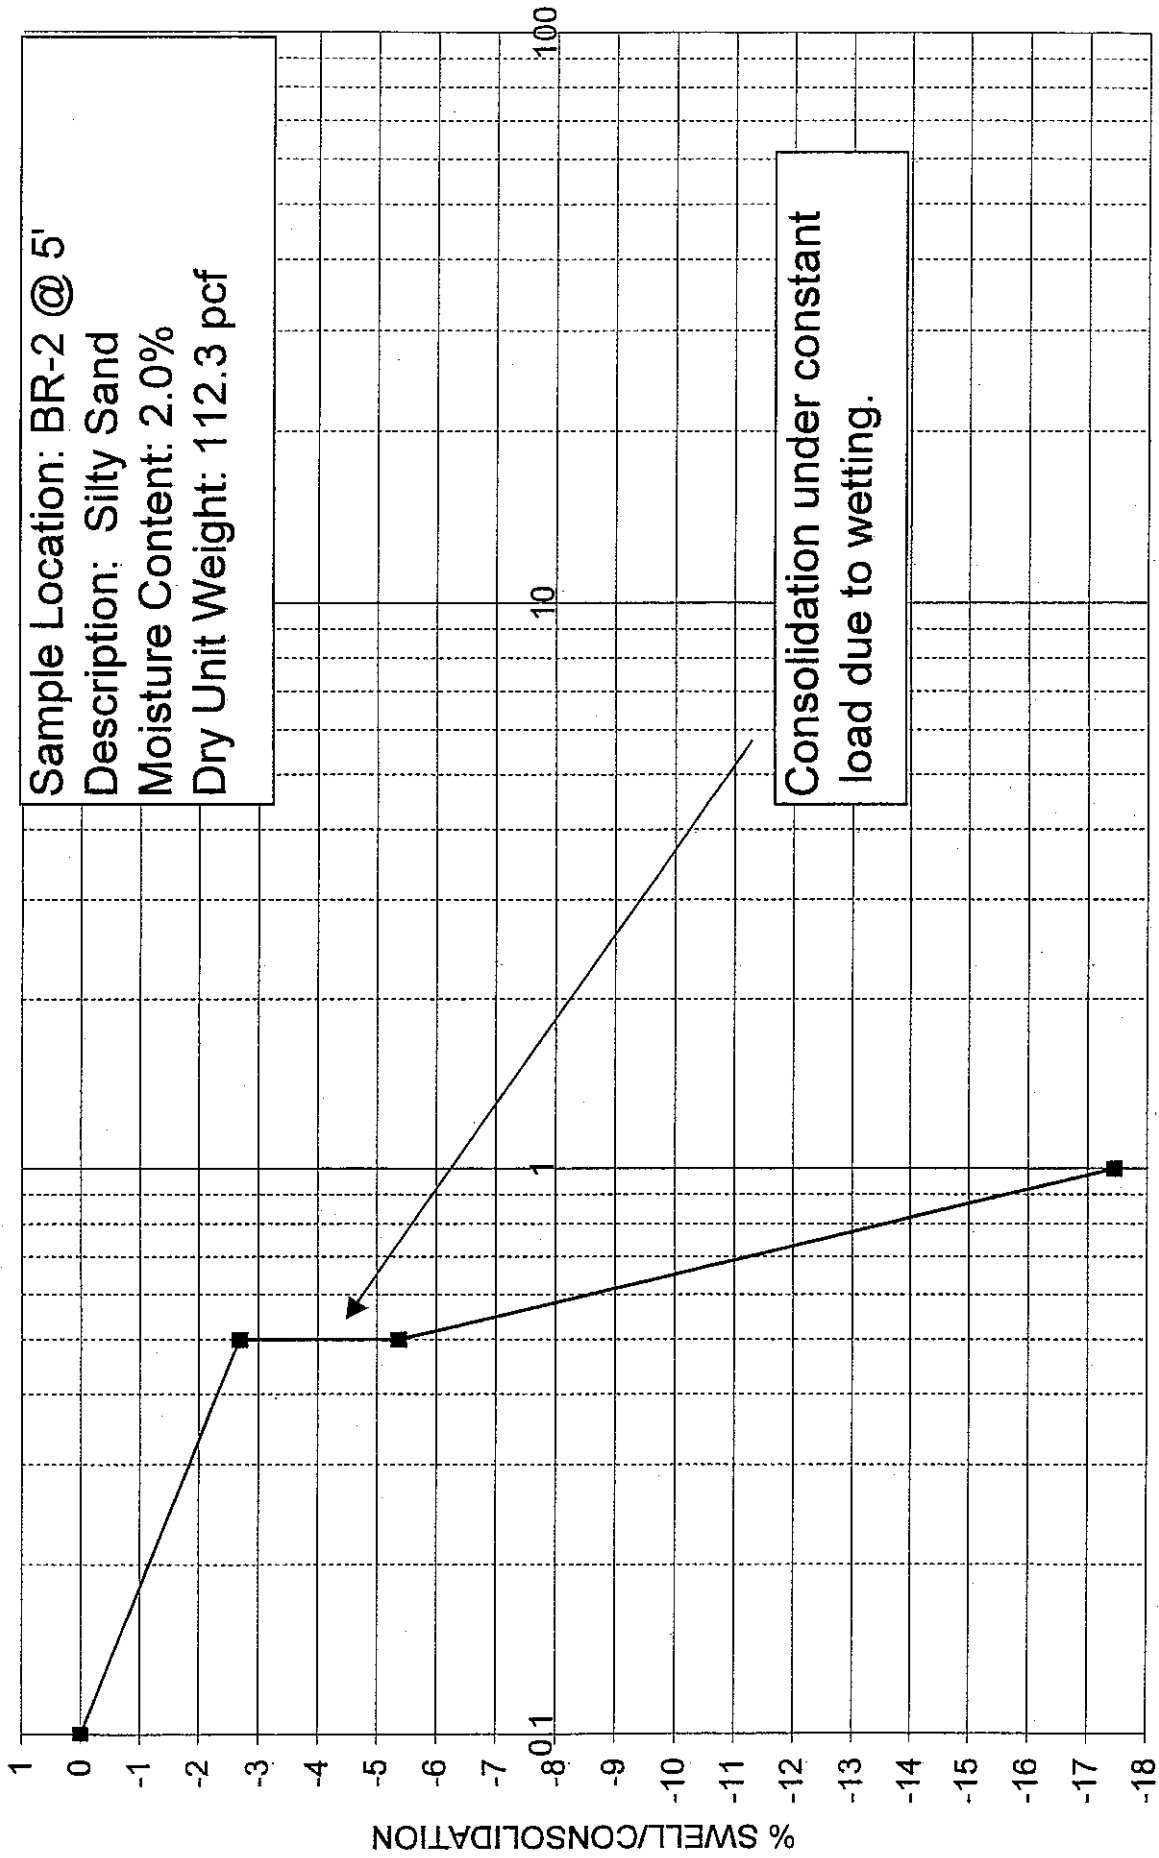
GOODSON & ASSOCIATES, INC.  
SWELL-CONSOLIDATION TEST

Sample Location: BR-2 @ 5'  
Description: Silty Sand  
Moisture Content: 2.0%  
Dry Unit Weight: 112.3 pcf

Consolidation under constant  
load due to wetting.

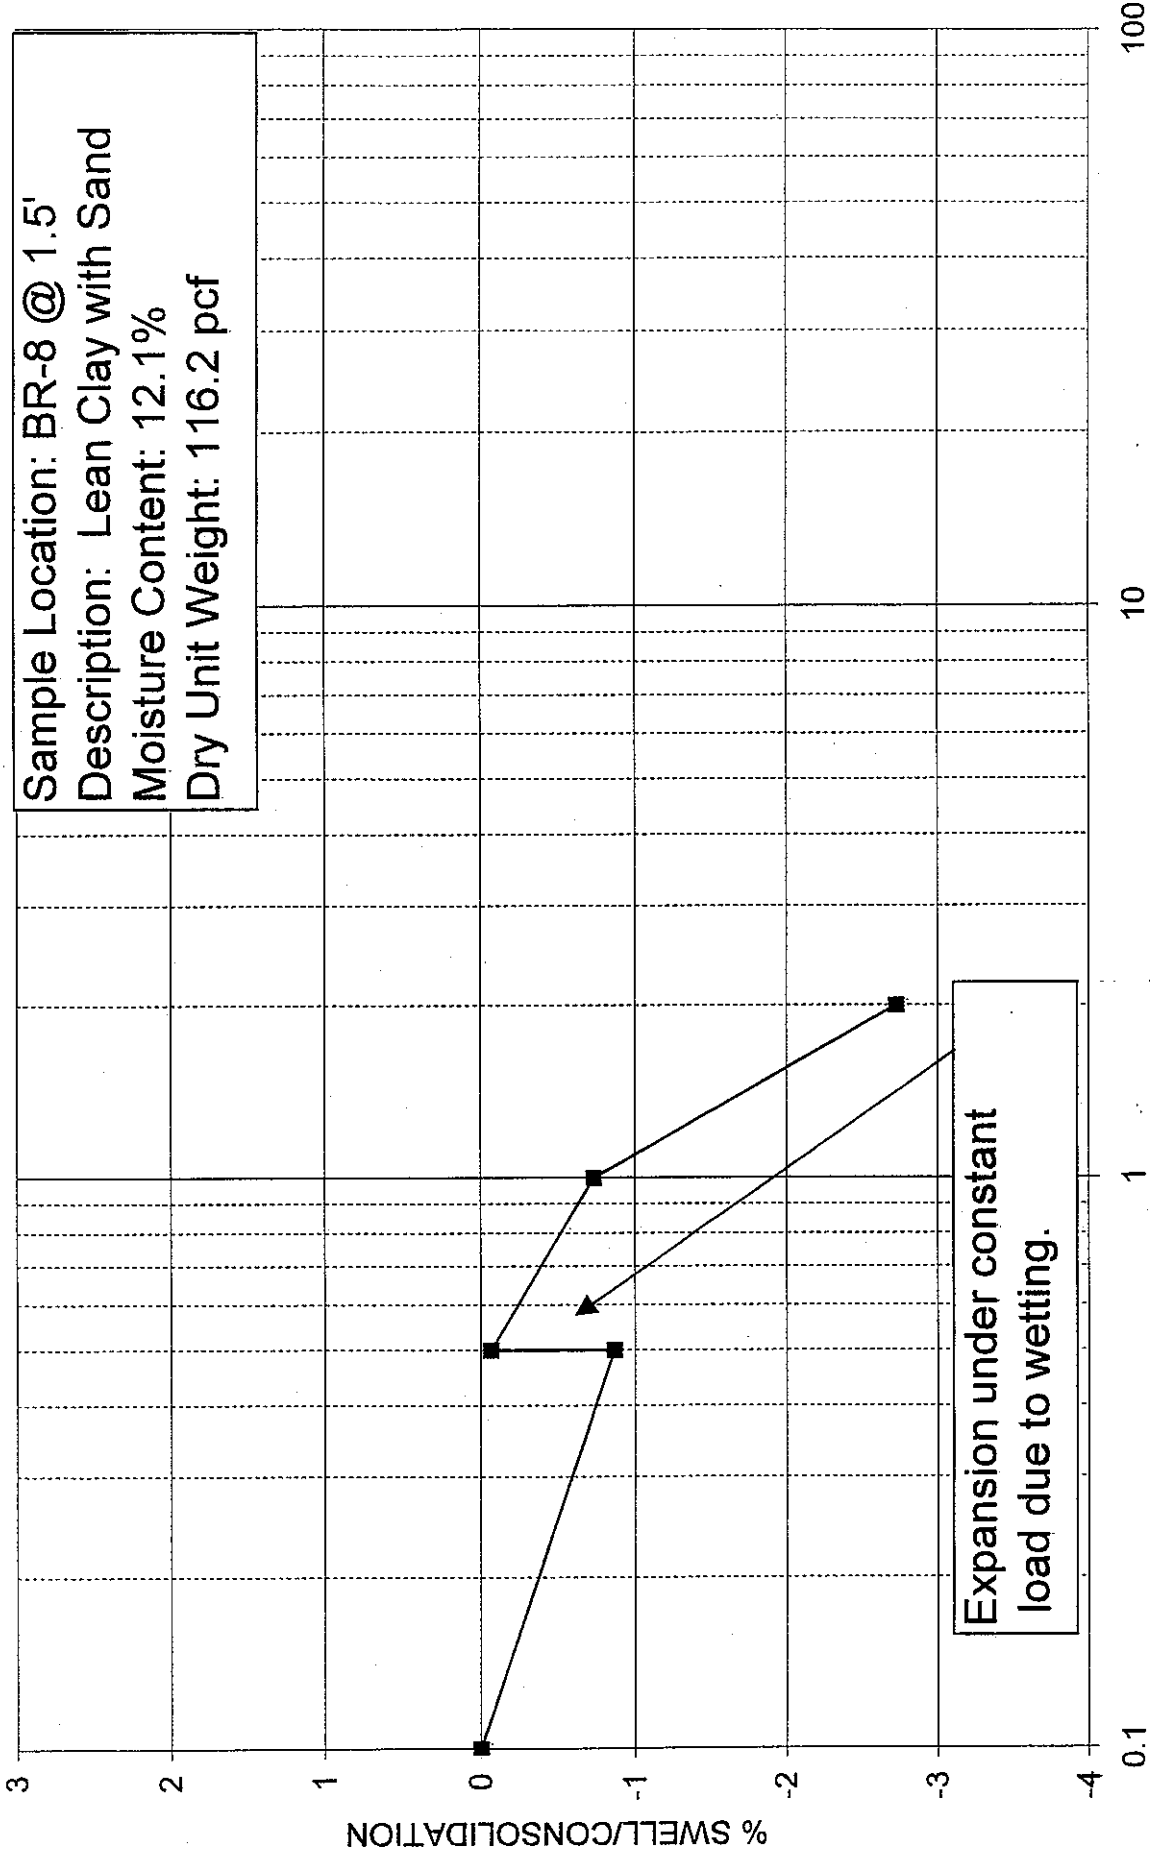
GOODSON & ASSOCIATES, INC.  
SWELL-CONSOLIDATION TEST

Sample Location: BR-8 @ 1.5'  
Description: Lean Clay with Sand  
Moisture Content: 12.1%  
Dry Unit Weight: 116.2 pcf

Expansion under constant load due to wetting.

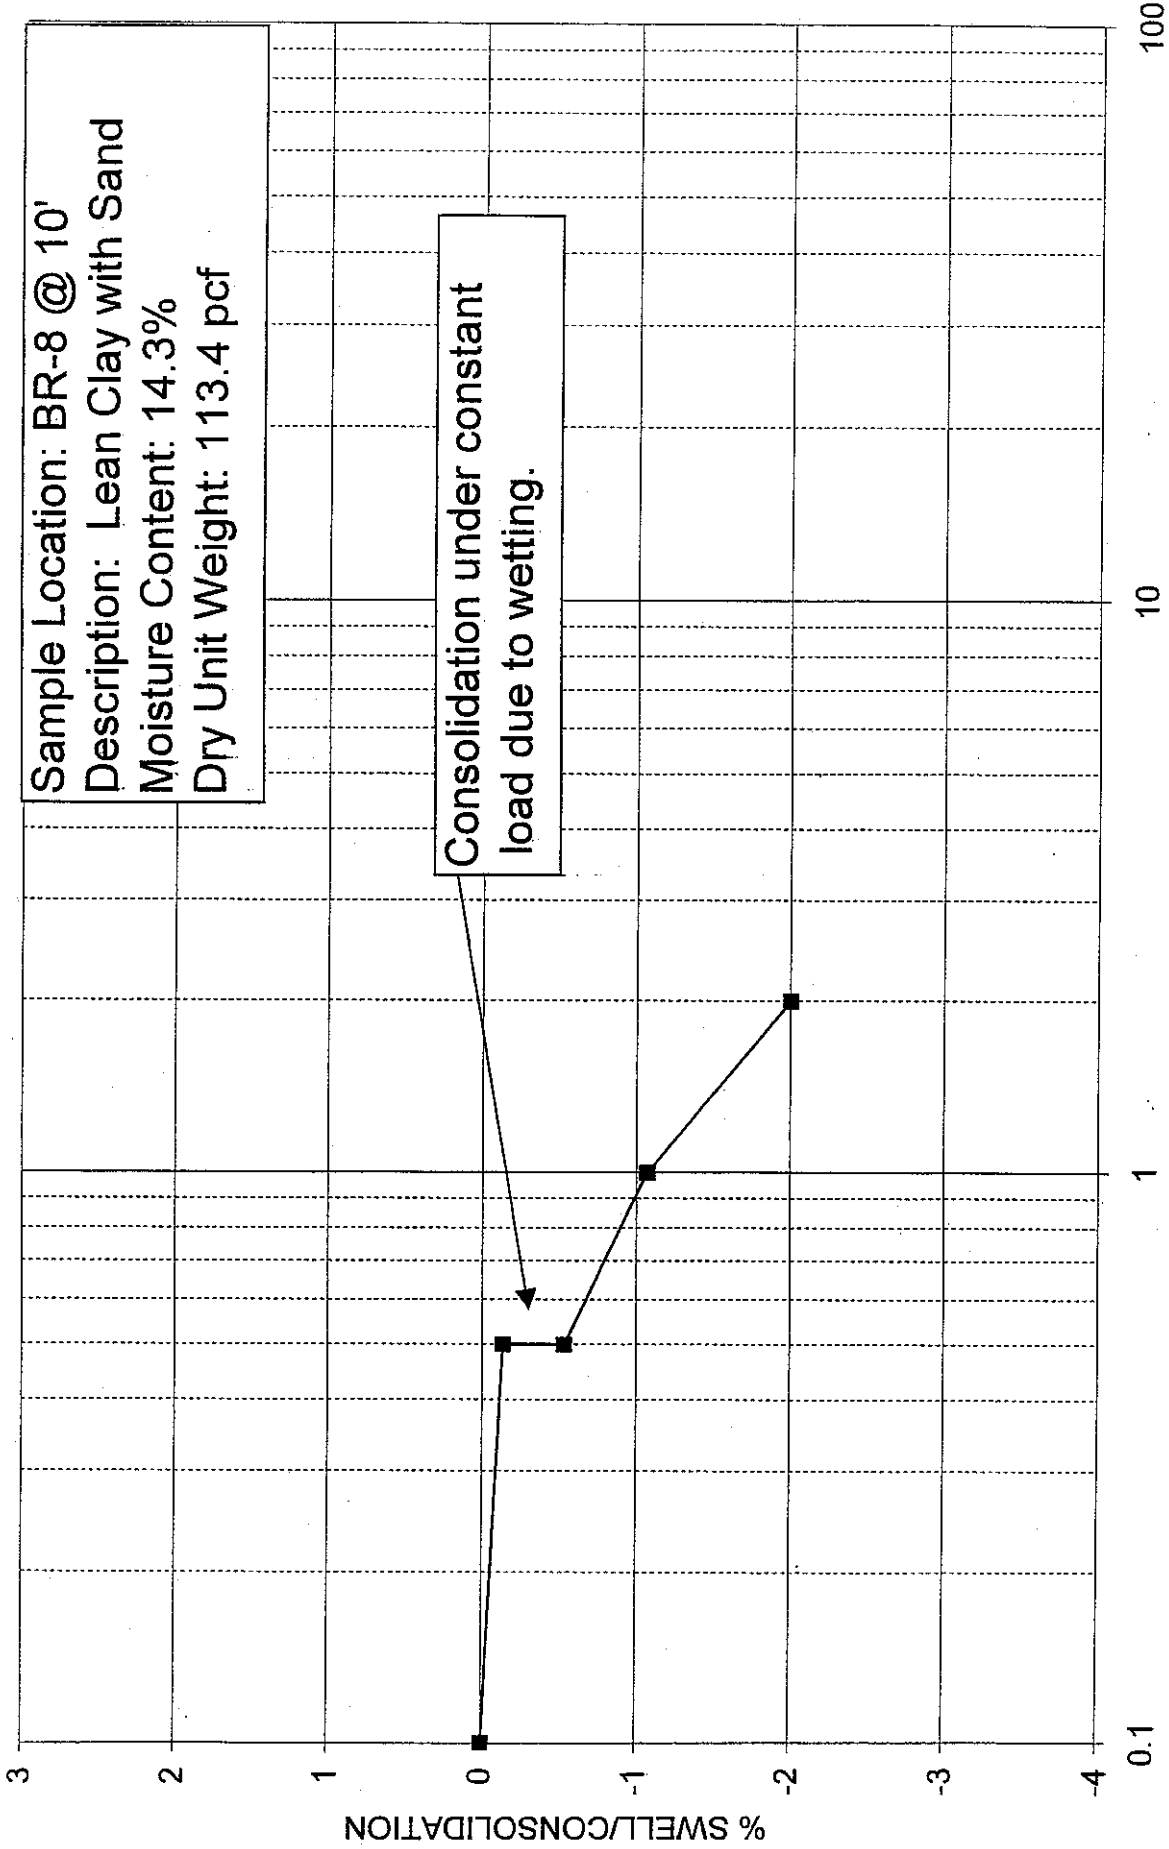
GOODSON & ASSOCIATES, INC.  
SWELL-CONSOLIDATION TEST

Sample Location: BR-8 @ 10'  
Description: Lean Clay with Sand  
Moisture Content: 14.3%  
Dry Unit Weight: 113.4 pcf

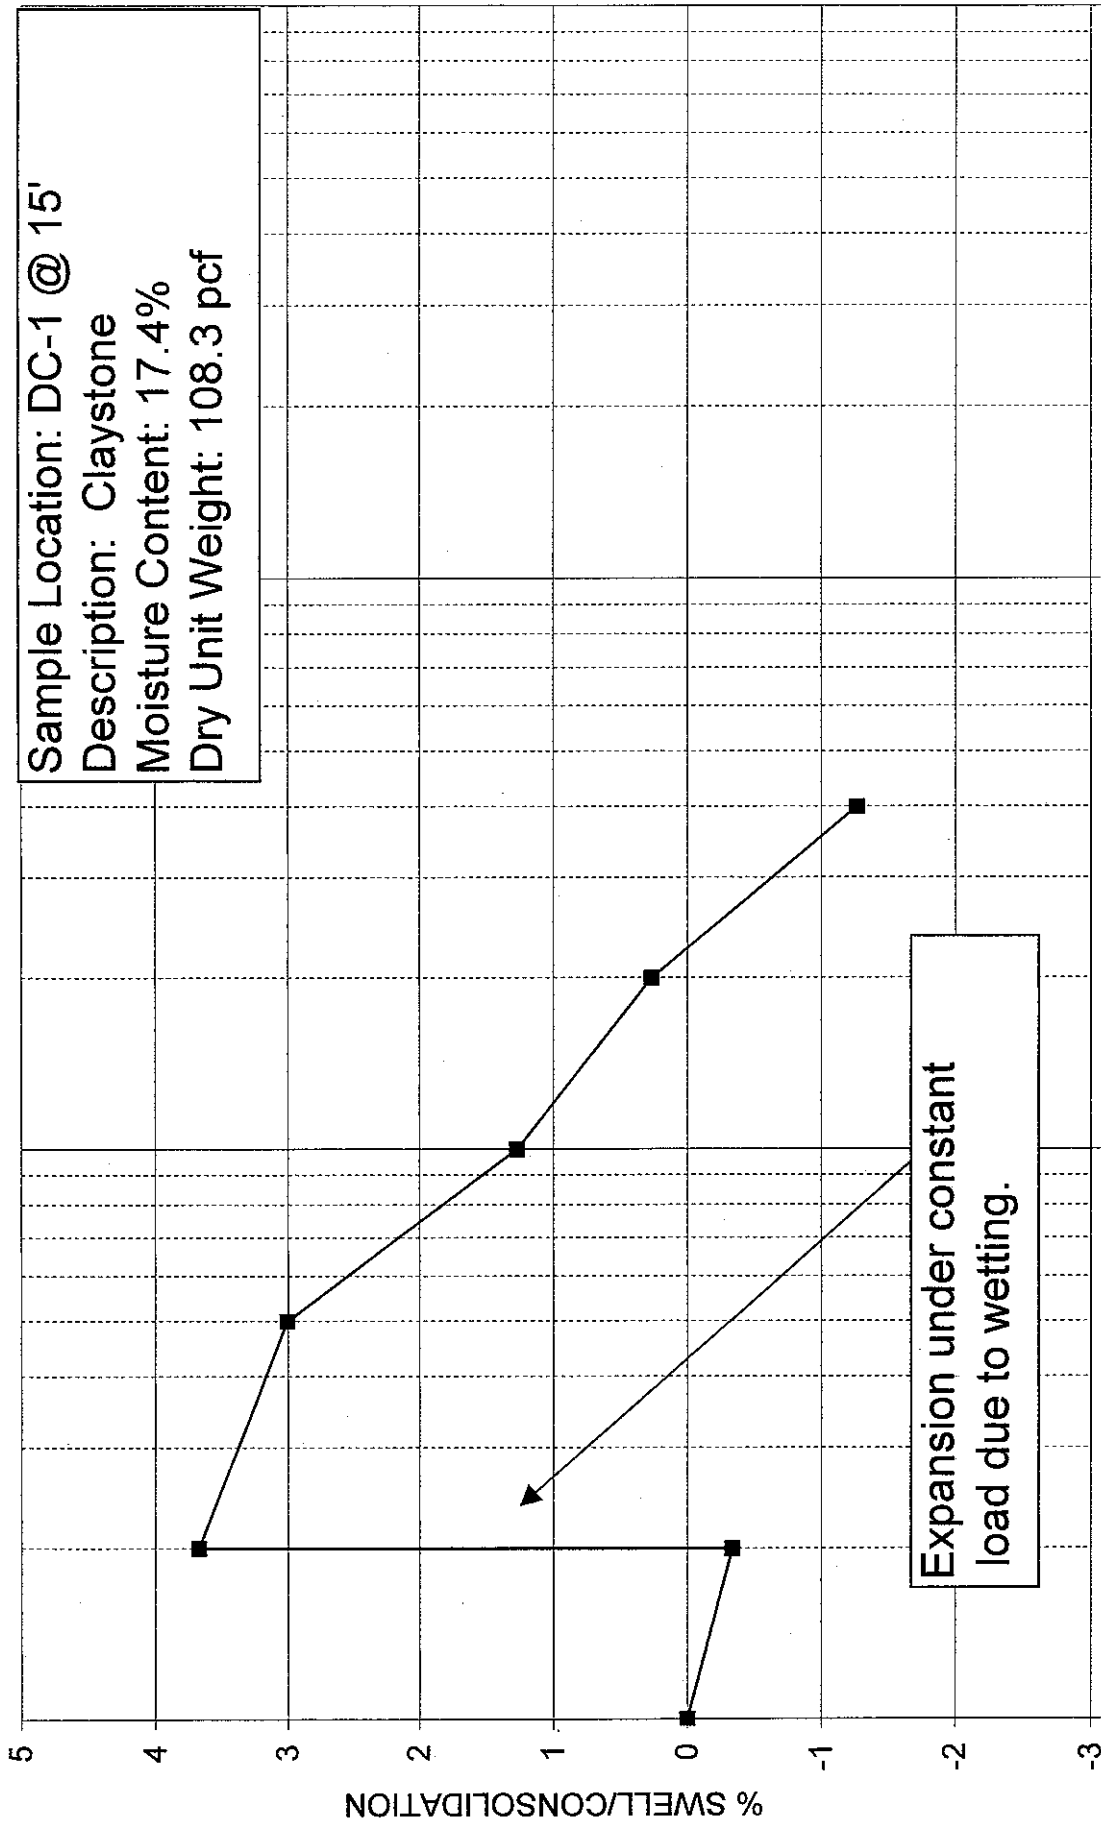
GOODSON & ASSOCIATES, INC.  
SWELL-CONSOLIDATION TEST

Sample Location: DC-1 @ 15'  
Description: Claystone  
Moisture Content: 17.4%  
Dry Unit Weight: 108.3 pcf

Expansion under constant  
load due to wetting.

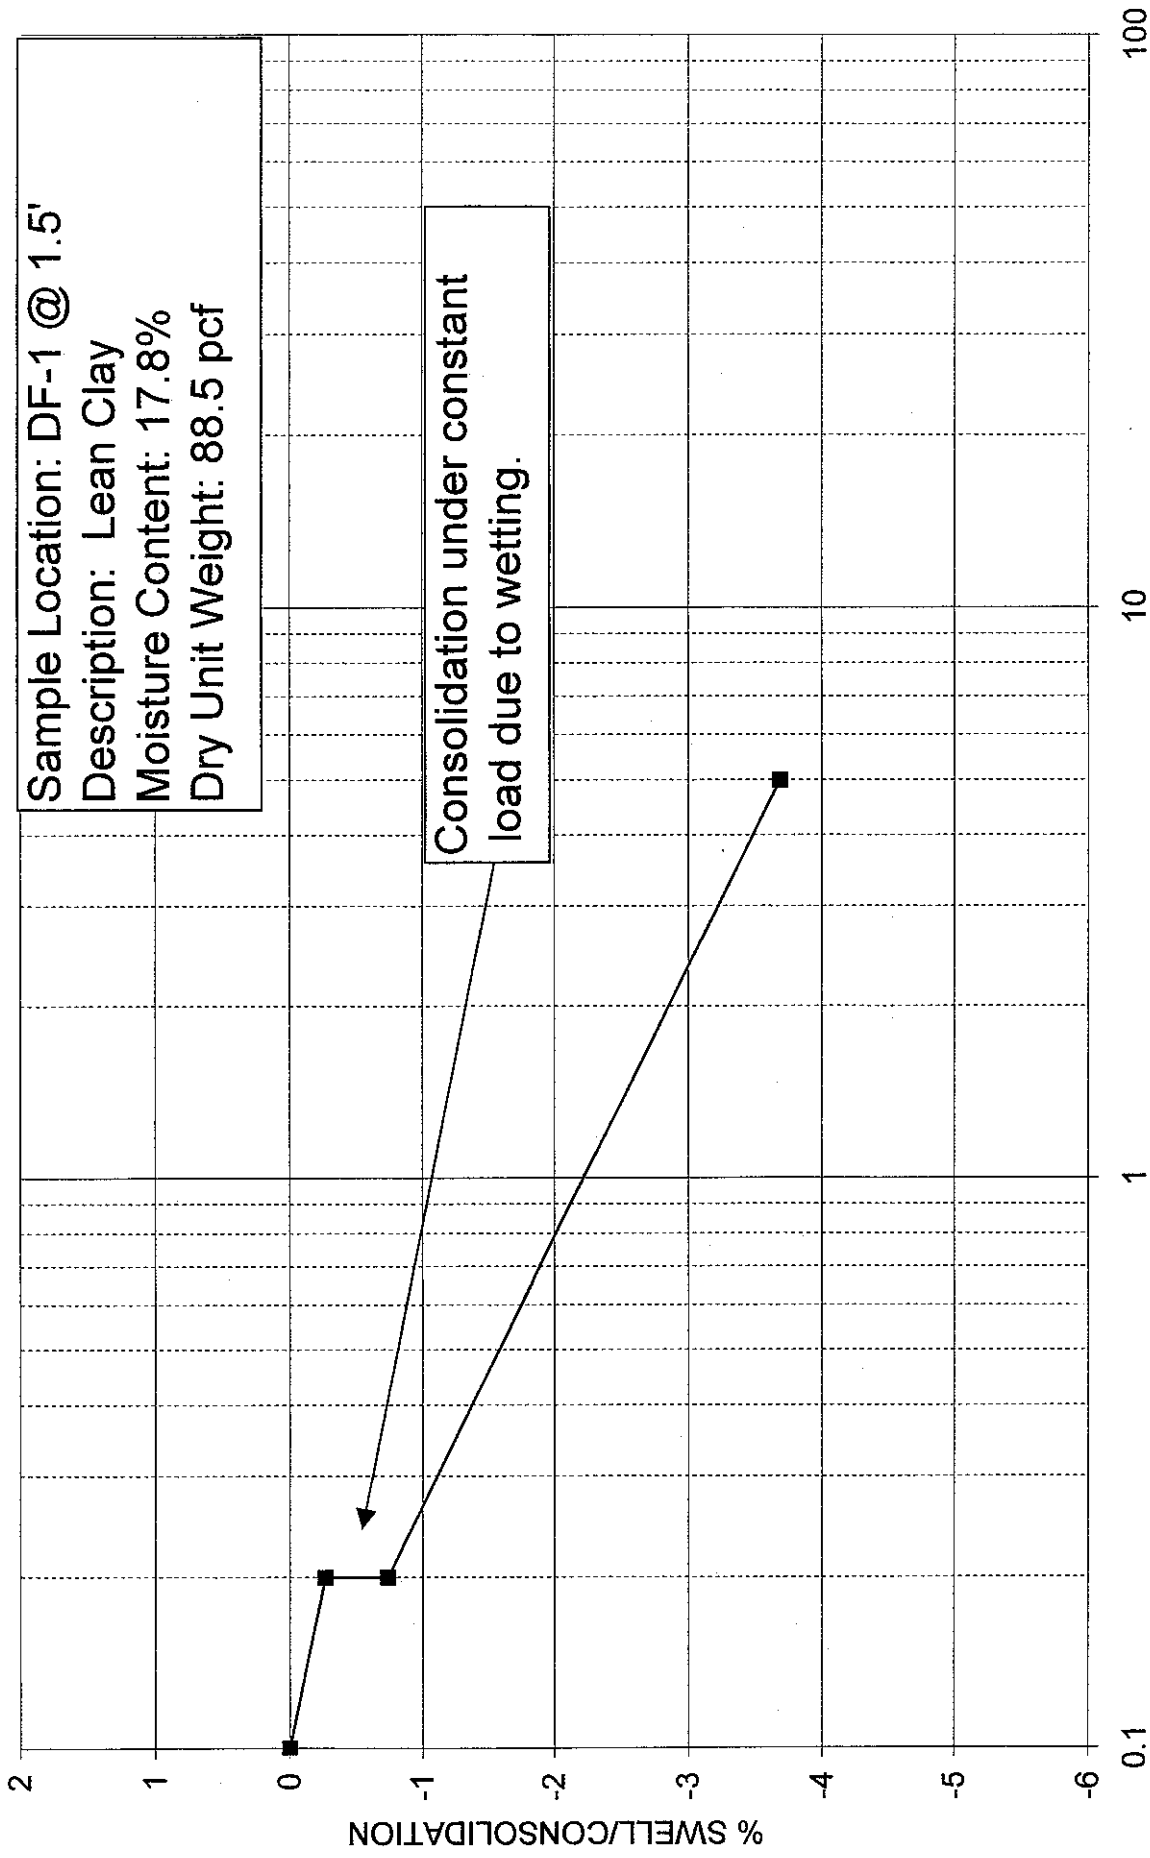
GOODSON & ASSOCIATES, INC.  
SWELL-CONSOLIDATION TEST

Sample Location: DF-1 @ 1.5'  
Description: Lean Clay  
Moisture Content: 17.8%  
Dry Unit Weight: 88.5 pcf

Consolidation under constant  
load due to wetting.

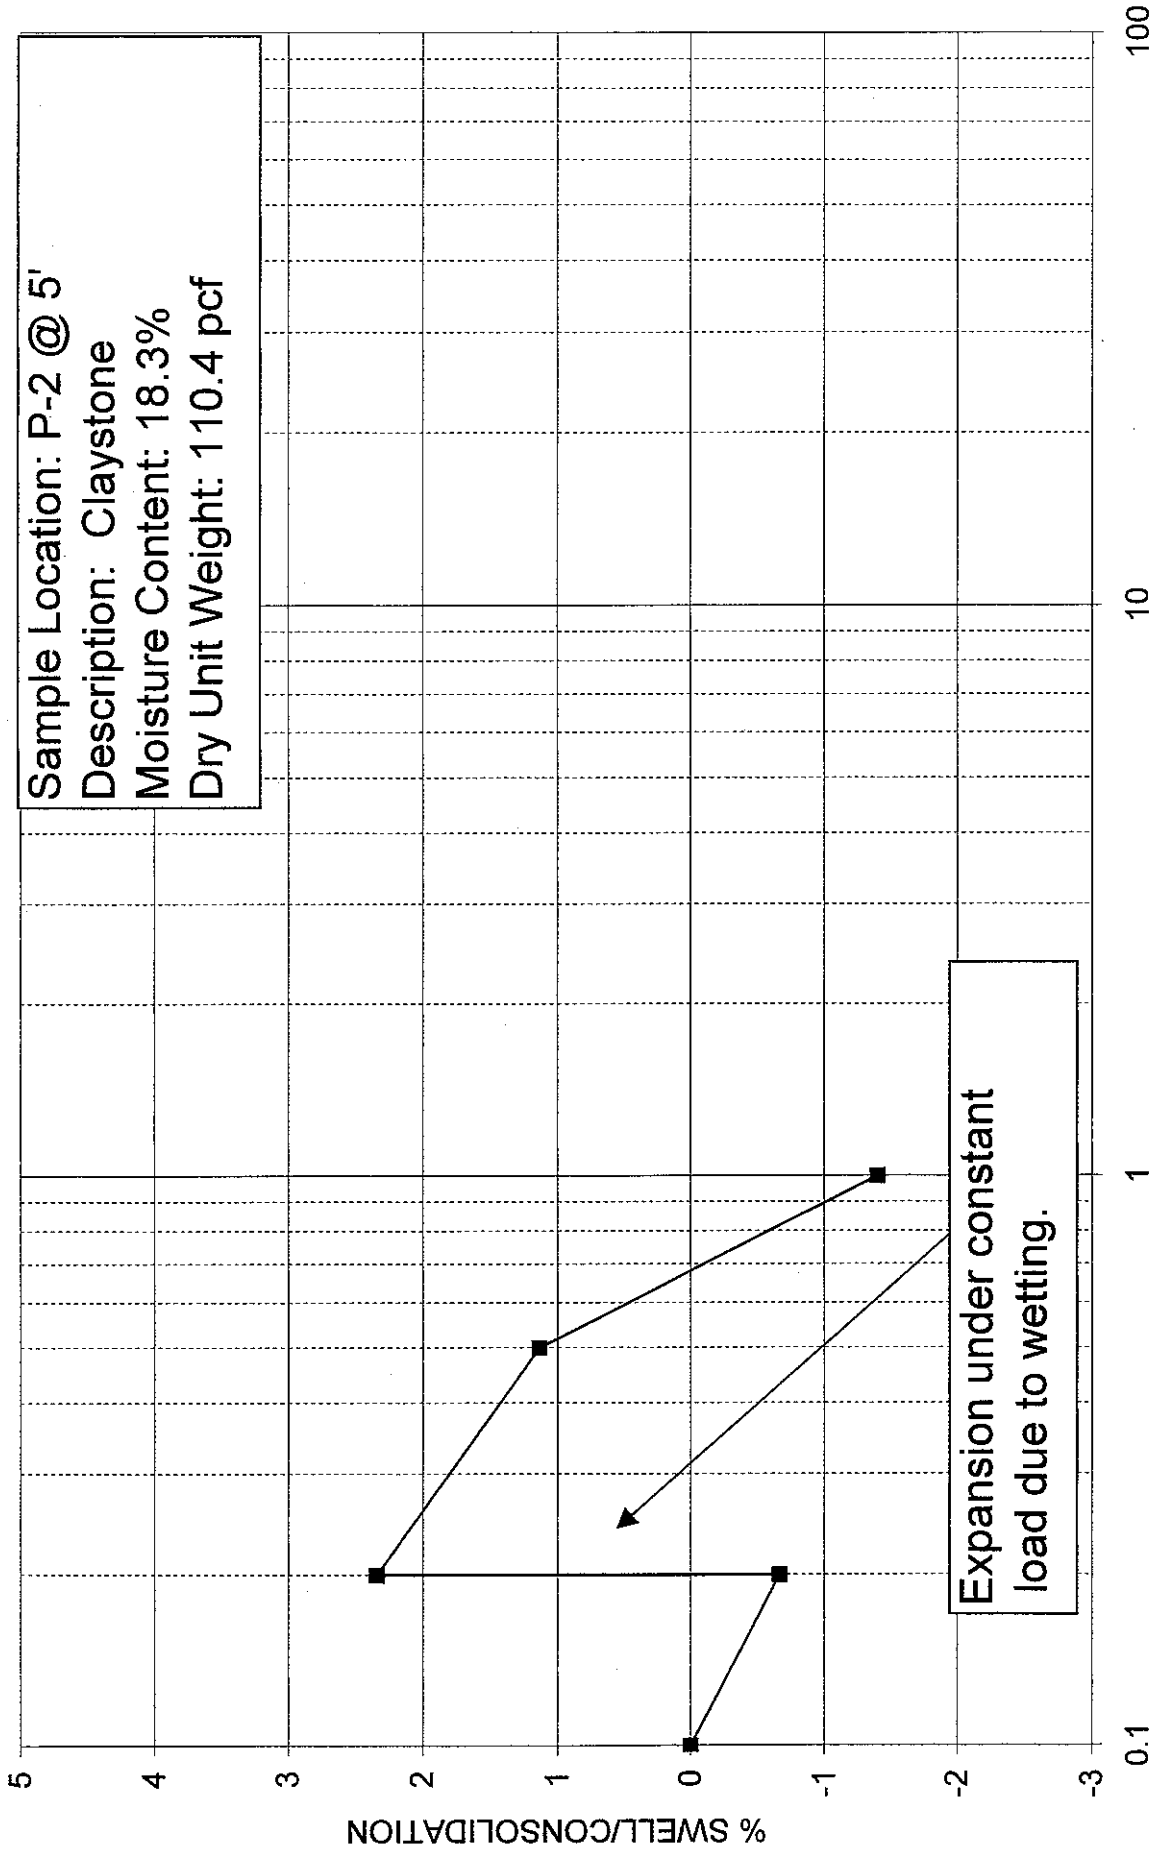
GOODSON & ASSOCIATES, INC.  
SWELL-CONSOLIDATION TEST

Sample Location: P-2 @ 5'  
Description: Claystone  
Moisture Content: 18.3%  
Dry Unit Weight: 110.4 pcf

Expansion under constant  
load due to wetting.

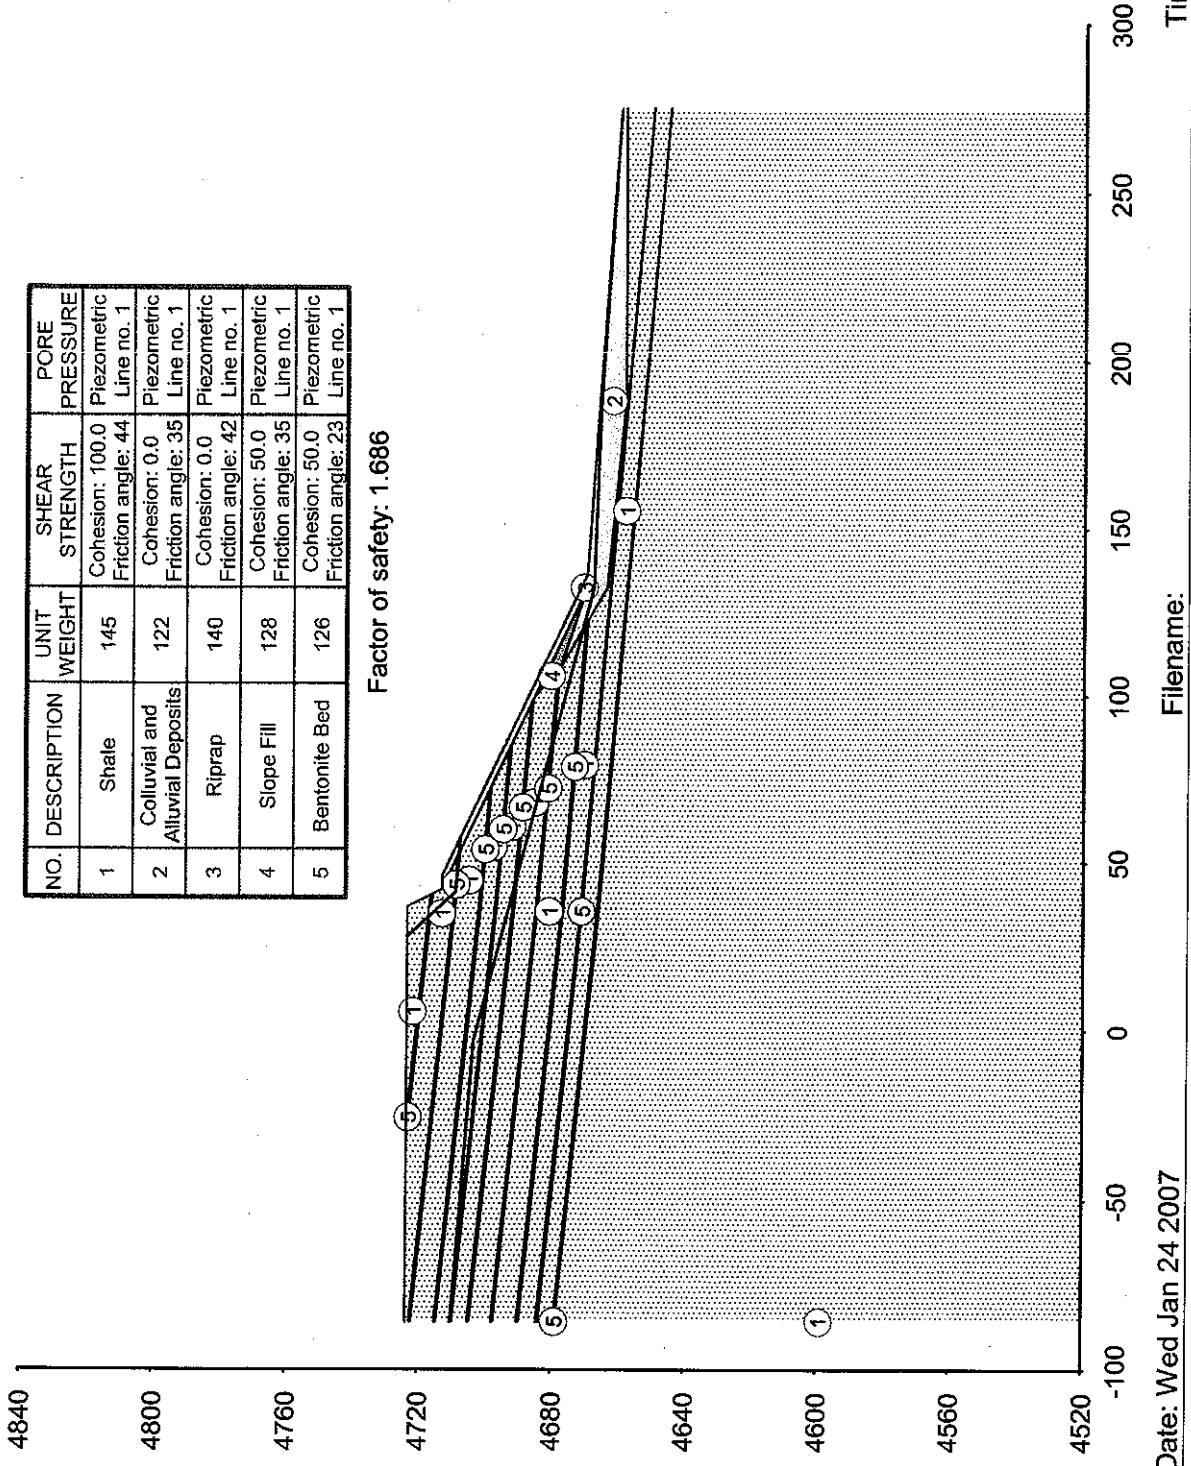
FIGURE 4

NO.	DESCRIPTION	UNIT WEIGHT	SHEAR STRENGTH	PORE PRESSURE
1	Shale	145	Cohesion: 100.0 Friction angle: 44	Piezometric Line no. 1
2	Colluvial and Alluvial Deposits	122	Cohesion: 0.0 Friction angle: 35	Piezometric Line no. 1
3	Riprap	140	Cohesion: 0.0 Friction angle: 42	Piezometric Line no. 1
4	Slope Fill	128	Cohesion: 50.0 Friction angle: 35	Piezometric Line no. 1
5	Bentonite Bed	126	Cohesion: 50.0 Friction angle: 23	Piezometric Line no. 1

Factor of safety: 1.686

4th Street Bridge - SW Abutment - Slope Stability (Case 2 with Bentonite bed)

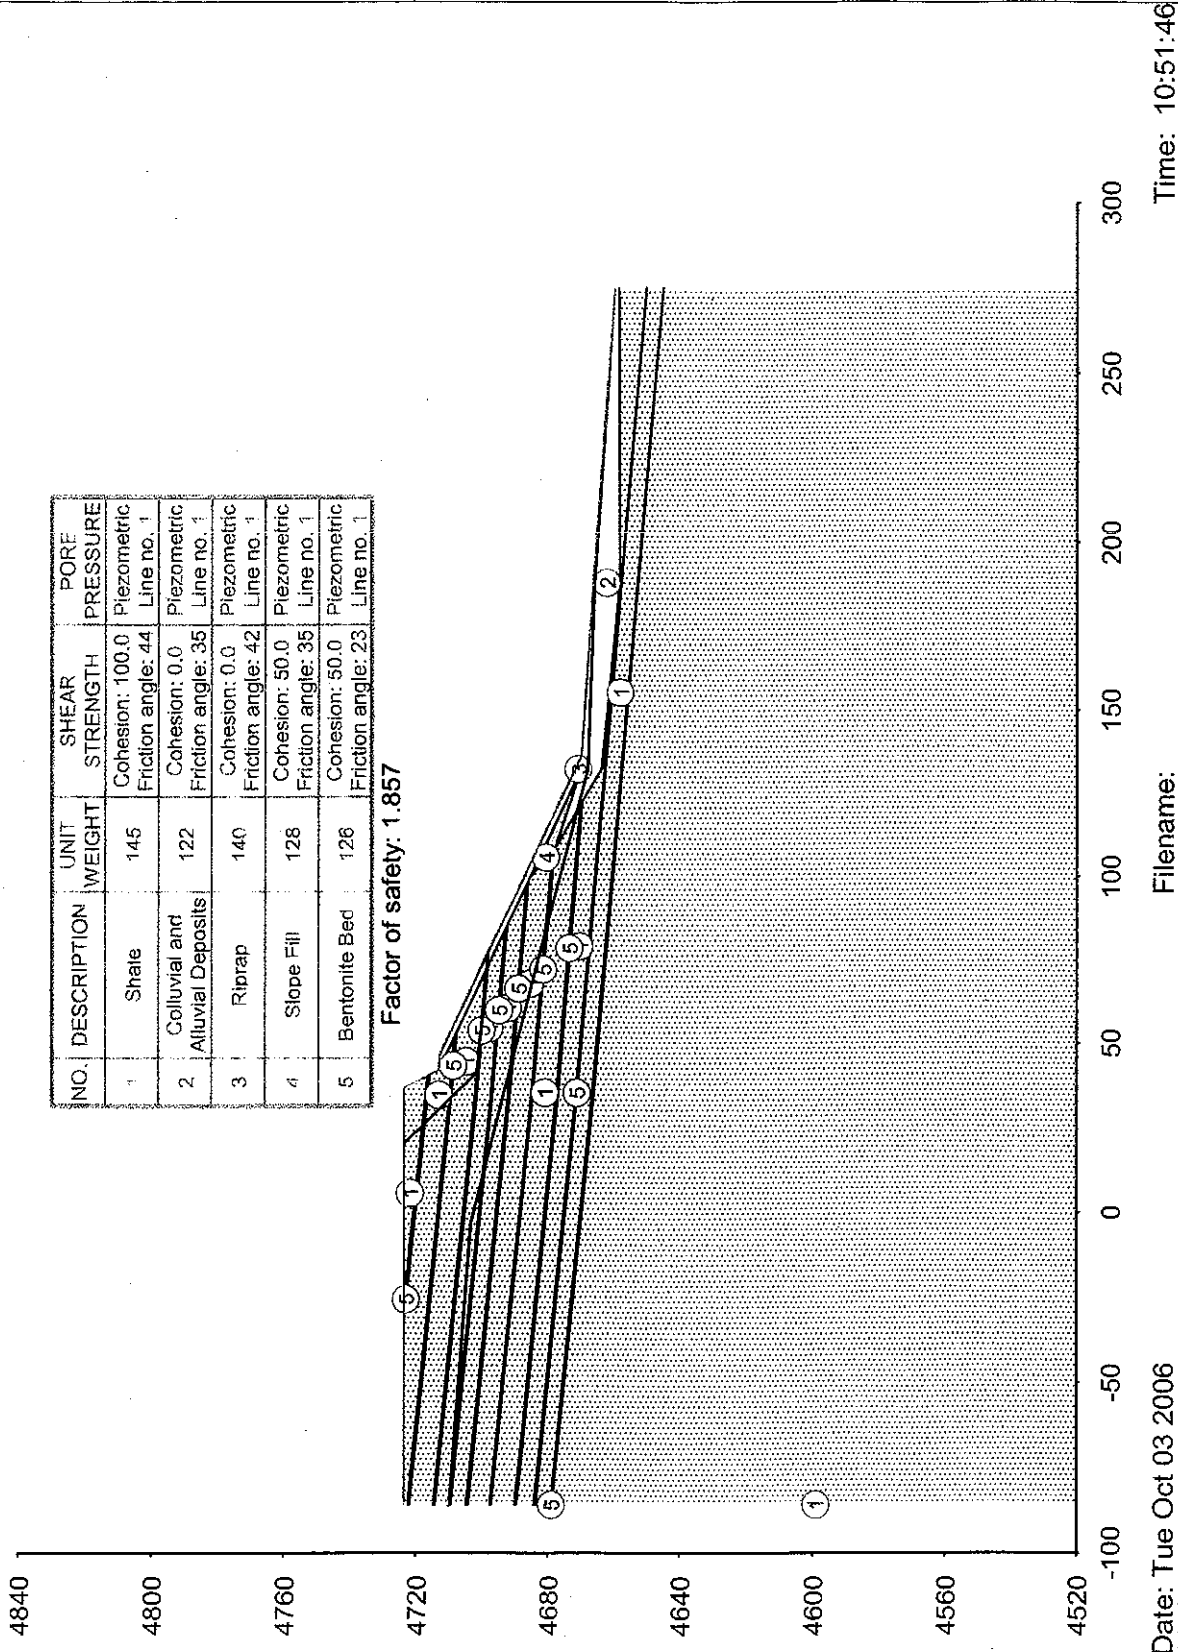
FIGURE 5

NO.	DESCRIPTION	UNIT WEIGHT	SHEAR STRENGTH	PORE PRESSURE
1	Shale	145	Cohesion: 100.0 Friction angle: 44	Piezometric Line no. 1
2	Alluvial Deposits	122	Cohesion: 0.0 Friction angle: 35	Piezometric Line no. 1
3	Riprap	140	Cohesion: 0.0 Friction angle: 42	Piezometric Line no. 1
4	Slope Fill	128	Cohesion: 50.0 Friction angle: 35	Piezometric Line no. 1
5	Bentonite Bed	126	Cohesion: 50.0 Friction angle: 23	Piezometric Line no. 1

4th Street Bridge - SW Abutment - Slope Stability (Case 3 with Bentonite bed)
