**GEOTECHNICAL ENGINEERING STUDY  
FOR FINAL DESIGN PHASE**

**PROPOSED COLORADO STATE HIGHWAY 96A**

**4<sup>TH</sup> STREET BRIDGE**

**CDOT PROJECT NO. STA 0961-008/13141**

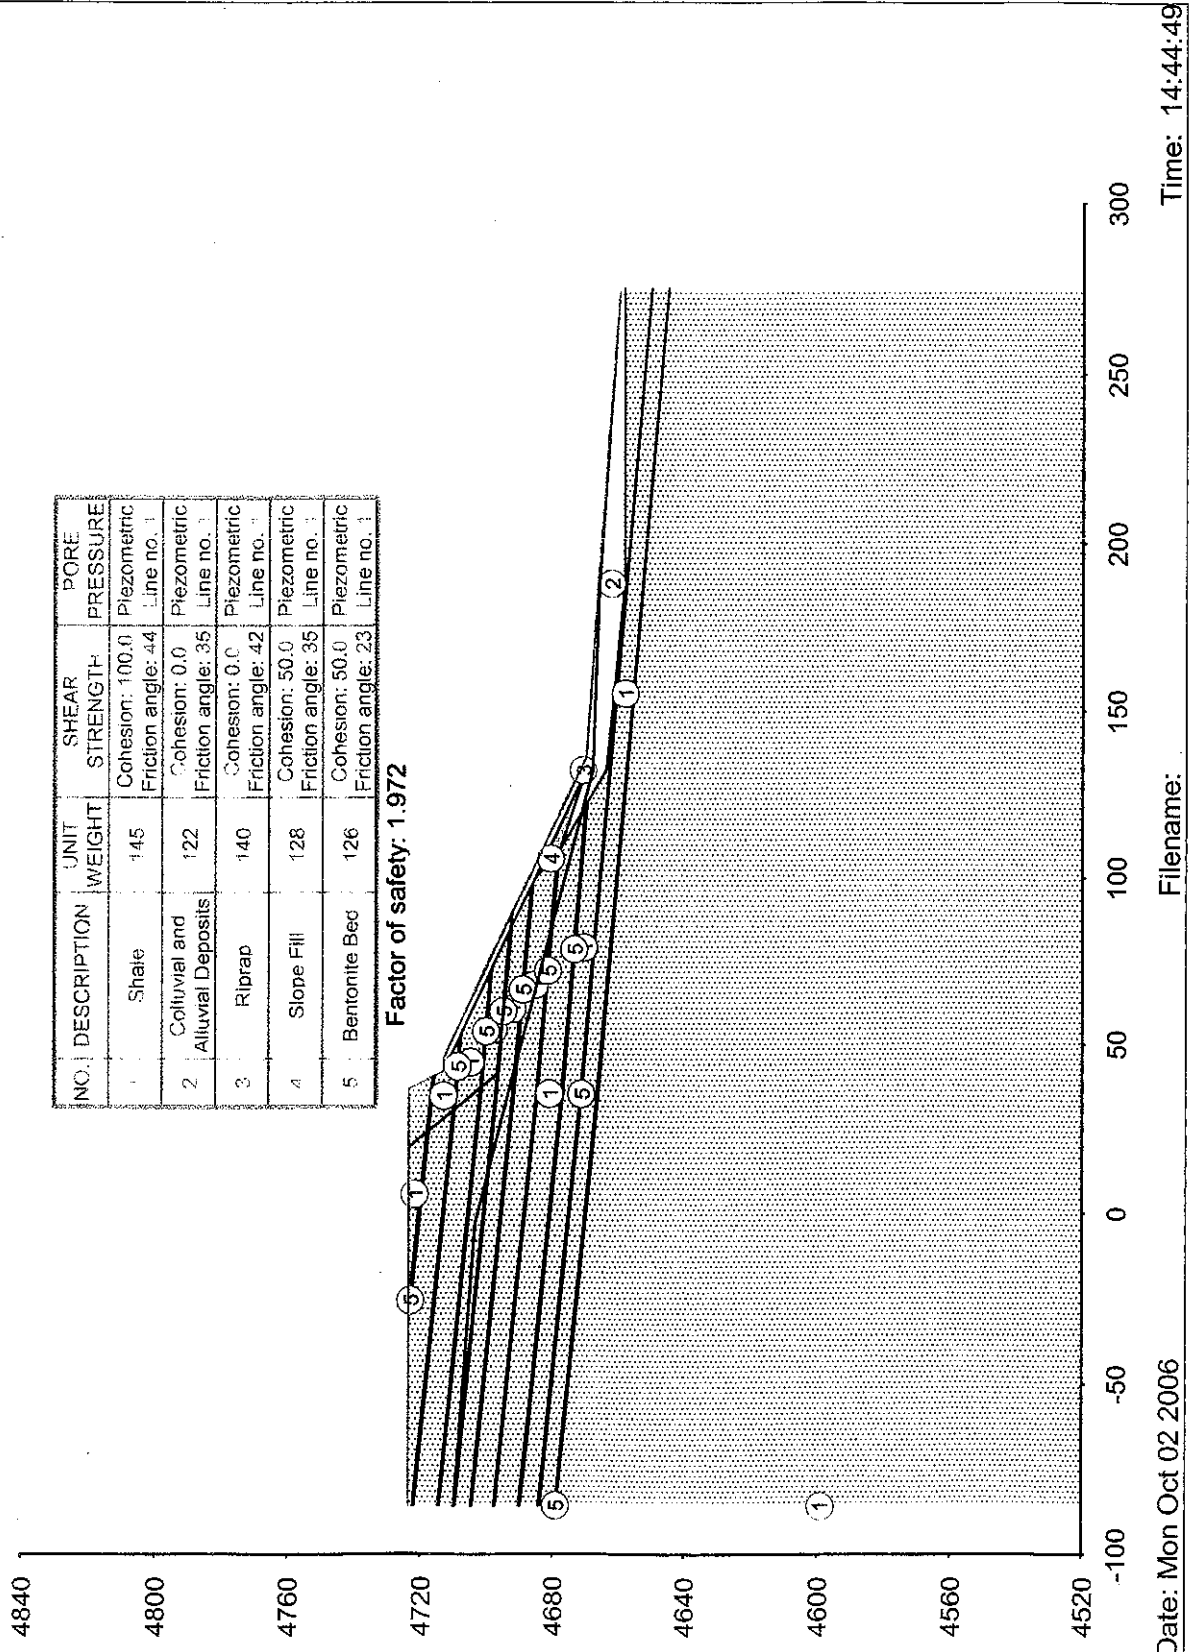
01/24/2007  
FIGURE 6

Slope Stability Analysis  
Noncircular Shear Surface  
Bentonite Bed Case 3

4th Street Bridge - SW Abutment - Slope Stability (Case 4 with Bentonite bed)

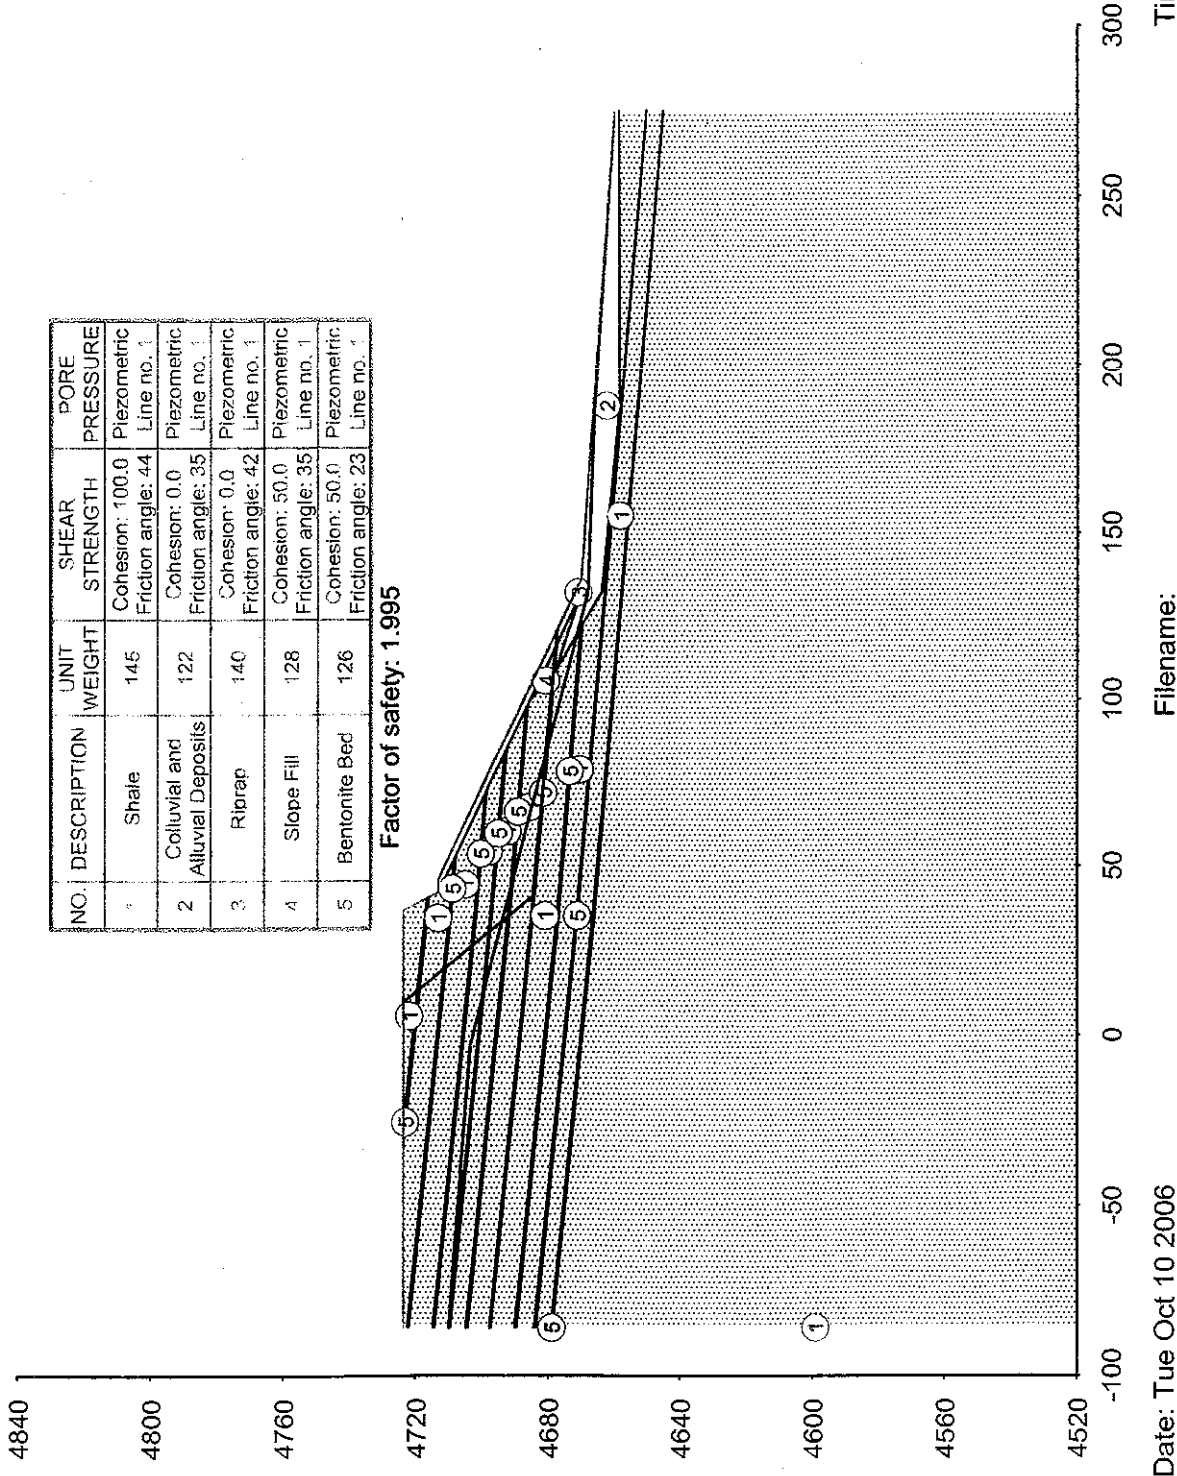
FIGURE 8

NO.	DESCRIPTION	UNIT WEIGHT	SHEAR STRENGTH	PORE PRESSURE
1	Shale	145	Cohesion: 100.0 Friction angle: 44	Piezometric Line no. 1
2	Colluvial and Alluvial Deposits	122	Cohesion: 0.0 Friction angle: 35	Piezometric Line no. 1
3	Riprap	140	Cohesion: 0.0 Friction angle: 42	Piezometric Line no. 1
4	Slope Fill	128	Cohesion: 50.0 Friction angle: 35	Piezometric Line no. 1
5	Bentonite Bed	126	Cohesion: 50.0 Friction angle: 23	Piezometric Line no. 1

Factor of safety: 1.995

4th Street Bridge - SW Abutment - Slope Stability (Case 6 with Bentonite bed)

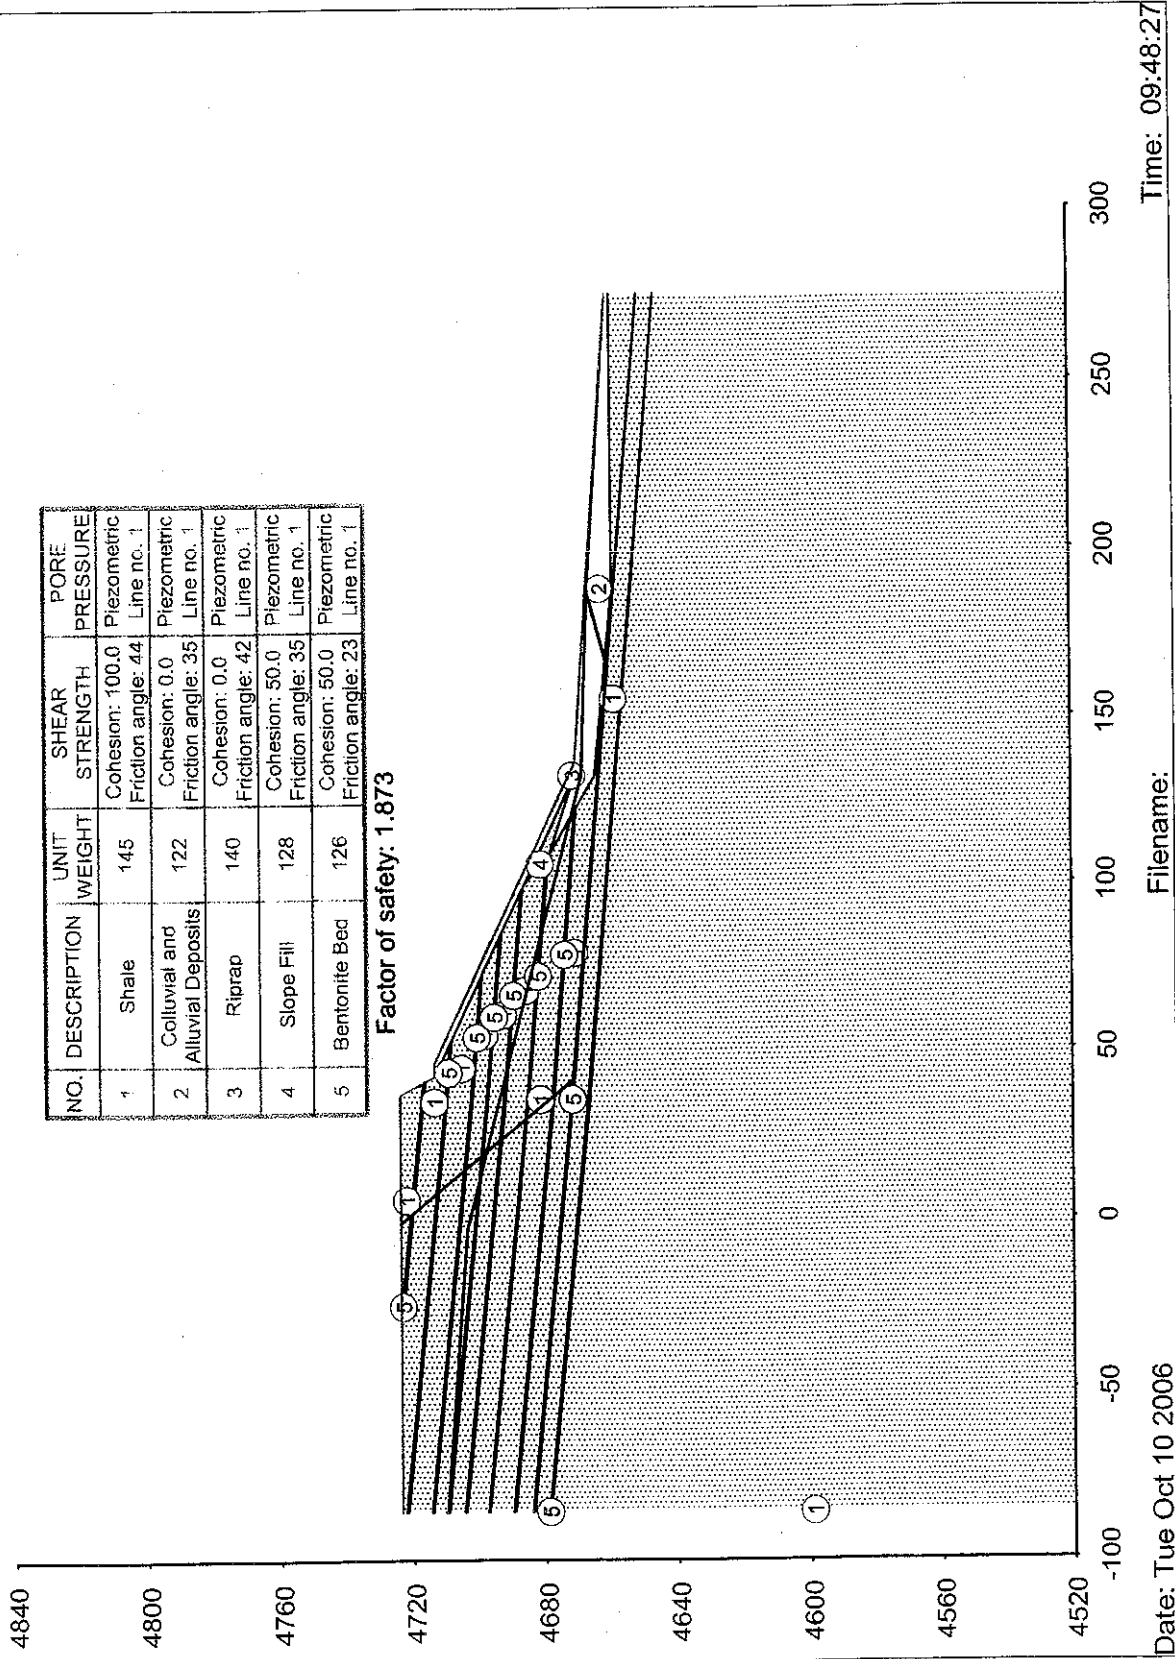
FIGURE 10

NO.	DESCRIPTION	UNIT WEIGHT	SHEAR STRENGTH	PORE PRESSURE
1	Shale	145	Cohesion: 100.0 Friction angle: 44	Piezometric Line no. 1
2	Colluvial and Alluvial Deposits	122	Cohesion: 0.0 Friction angle: 35	Piezometric Line no. 1
3	Riprap	140	Cohesion: 0.0 Friction angle: 42	Piezometric Line no. 1
4	Slope Fill	128	Cohesion: 50.0 Friction angle: 35	Piezometric Line no. 1
5	Bentonite Bed	126	Cohesion: 50.0 Friction angle: 23	Piezometric Line no. 1

Factor of safety: 1.873

4th Street Bridge - SW Abutment - Slope Stability (Case 8 with Bentonite bed)

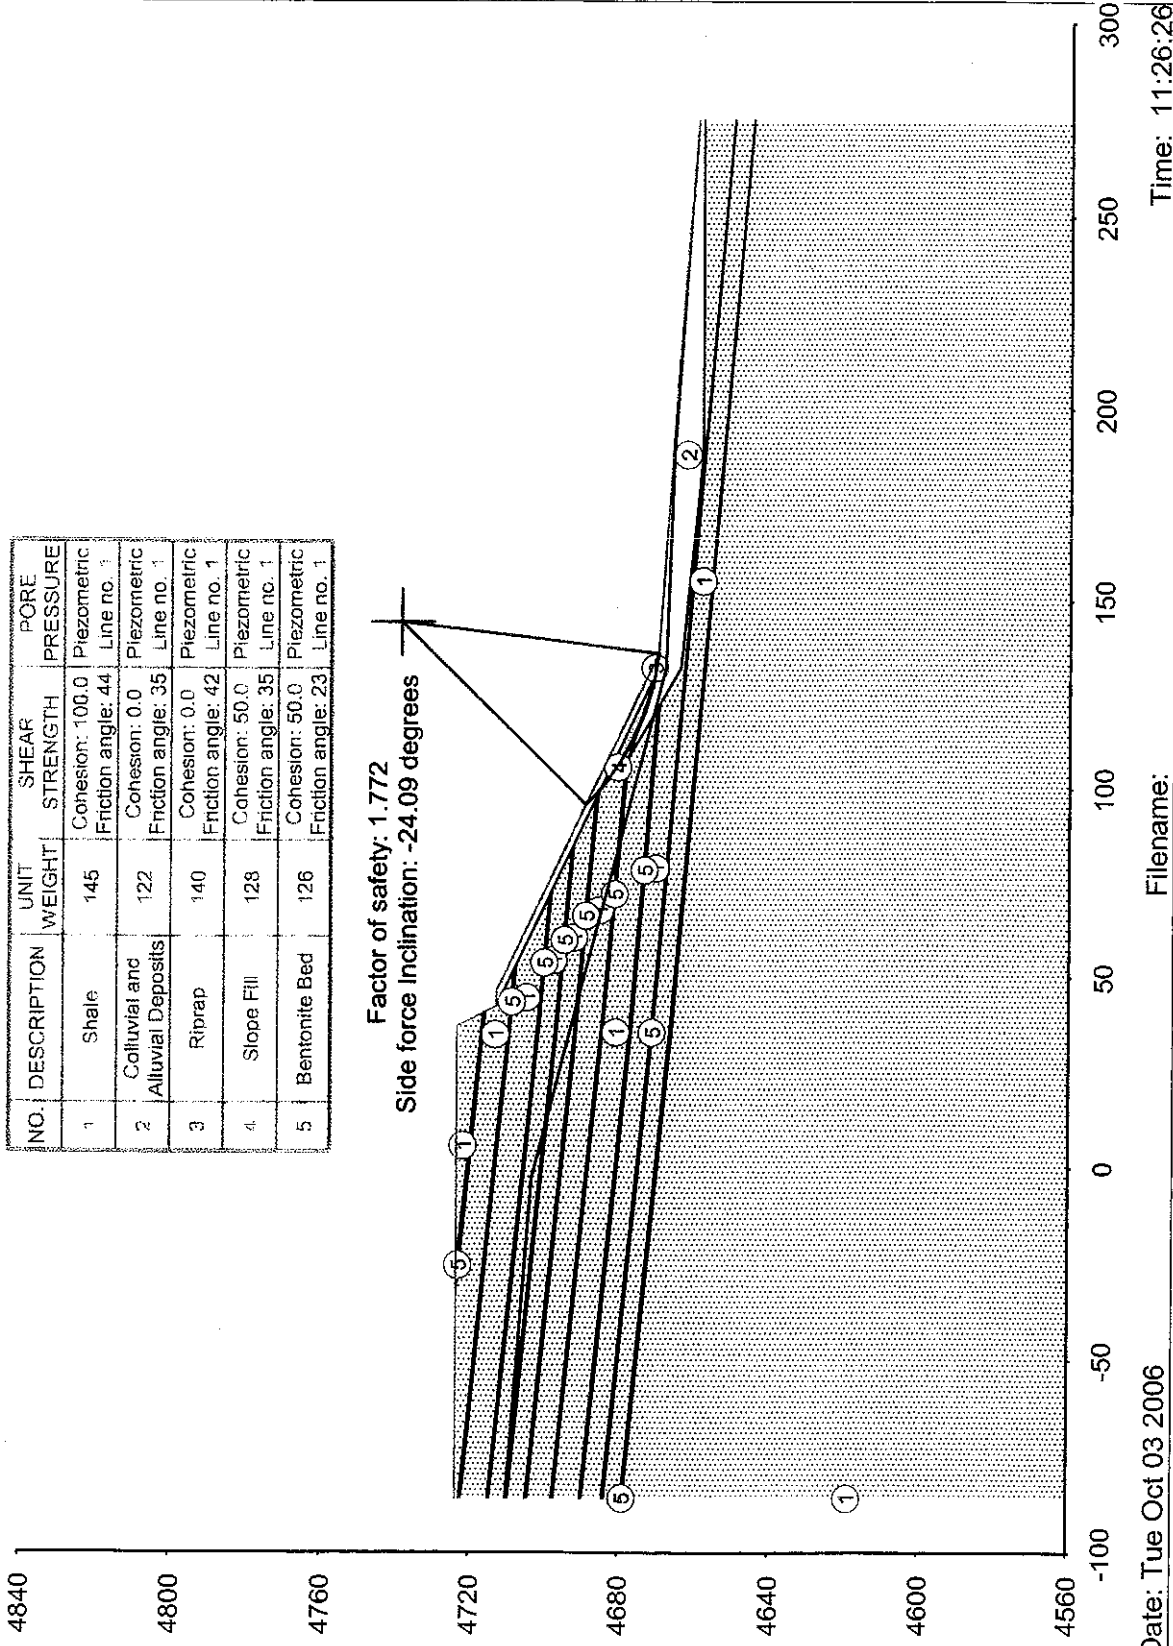
01/24/2007  
FIGURE 12

Factor of safety: 1.772

Side force Inclination: -24.09 degrees

# 4th Street Bridge - SW Abutment - Slope Stability (Case 5 with Bentonite bed)
