Report No. CDOT – R1-R-2001-9

**Noise and Skid Measurements on US285
in the Turkey Creek Canyon Area
Project NH 2854-068**

June 2001

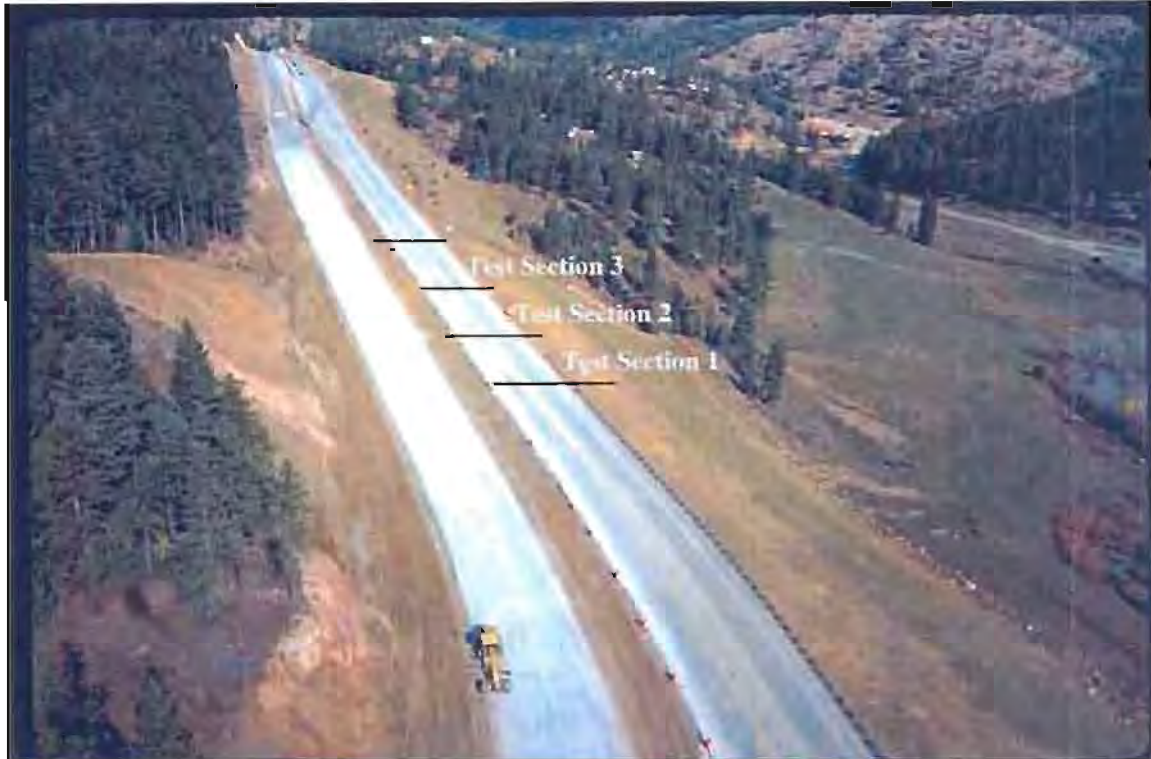
Figure 2. Oblique view looking east at Test Sections 1 through 3 along US285.

This site selective study was conducted in October 2000 under Project NH 2854-068. The study area is shown in Figure 1. The purpose of the project was to acoustically assess the impact of various paving surfaces inside a vehicle, at the tire of a vehicle, and at the roadside. Additionally, the skid numbers of both original and reconstructed pavement surfaces were compared to evaluate safety impacts due to noise reduction techniques. Region I planned to construct several test sections of roadway to evaluate possible treatments to address noise problems on Phase I and II of US285. Only one concrete treatment test section was constructed this fall. The concrete pavement surface was ground $\frac{1}{4}$ inch to remove the transverse tining. (See Figures 2 through 4.)

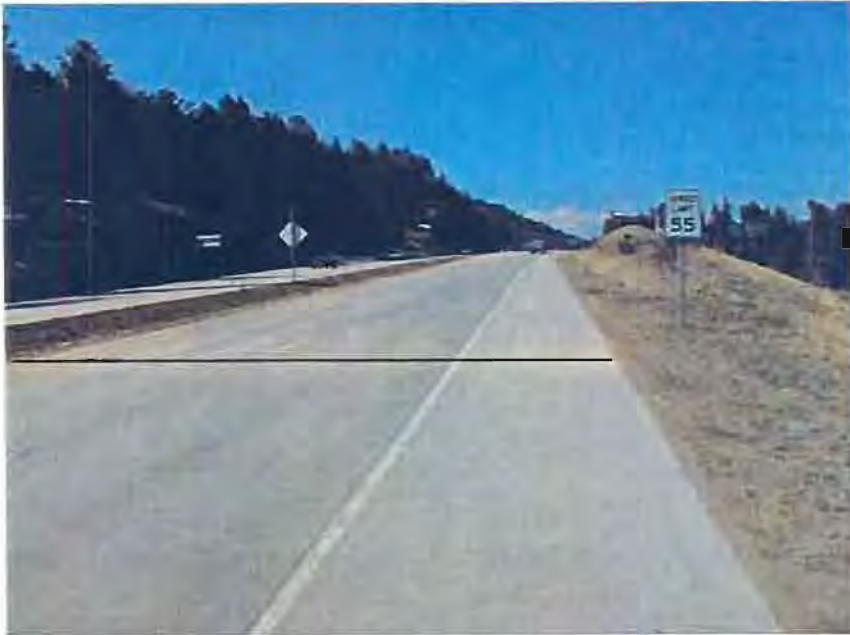
Figure 3. View looking east at transverse tining Test Sections 1, 2 and 3 along US285 mileposts 244.42 to 224.53.

Measurements were taken in Turkey Creek Canyon on US285 in the same manner and the same equipment used in the previous study conducted October 4, 2000. We conducted measurements for Test Section 1 only. This section of transverse tining had been ground down since previous measurements. See Figures 3 and 4. The weather was mild at 42 degrees Fahrenheit with no noticeable breeze. The road was dry.

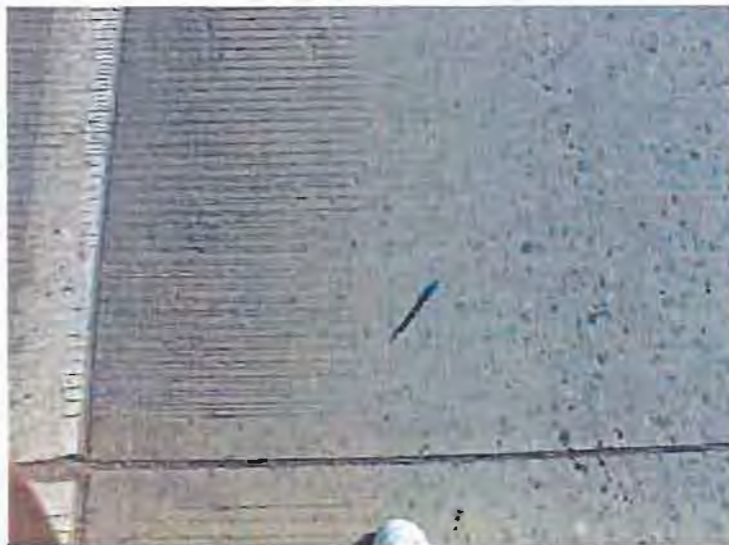
Figure 4. A detailed view of transverse tining at Test Section 1 between mileposts 244.42 and 244.45, east-bound US285. The right-hand ½ of the photograph shows where transverse tining has been ground. The grinding tapers to the left showing remnant transverse tining texture. Note pen for scale.

The result of grinding down ¼ inch of transverse tining at Test Section 1 was a net noise reduction of 6 dB. This is a noticeable noise reduction for the area residents. FHWA noise abatement criteria cites a 5 dB sound level reduction as significant for residential areas. The before and after grinding noise level comparisons for Section 1 are presented in Table 5 and the frequency spectra are plotted as Graphs 5-7. The roadside before and after grinding noise frequency spectra comparisons are charted as Graph 8.
