**Report No. CDOT-DTD-R-2004-13**  
**Final Report**

# **RECESSED STRIPING IN CONCRETE PAVEMENT**

**COLORADO DEPARTMENT OF TRANSPORTATION  
RESEARCH BRANCH**

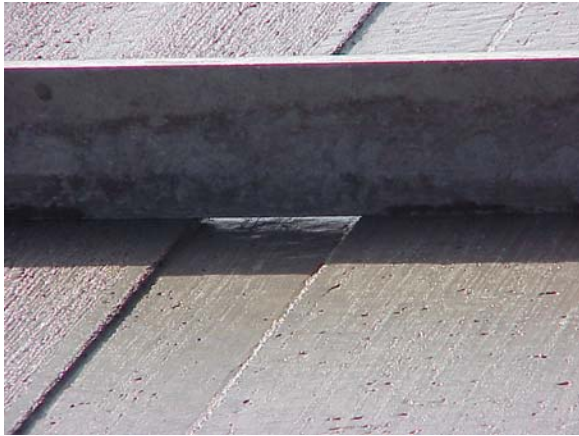
**Figure 1. Shoulder stripe groove formed in plastic concrete.**

reduced and their useful lives considerably increased by placing them in shallow grooves in the surface of the pavement. In the past, the grooves (1/8" – 1/4" deep) have been cut with diamond grinding equipment – a relatively slow and costly process. Now there is another way – on concrete at least.

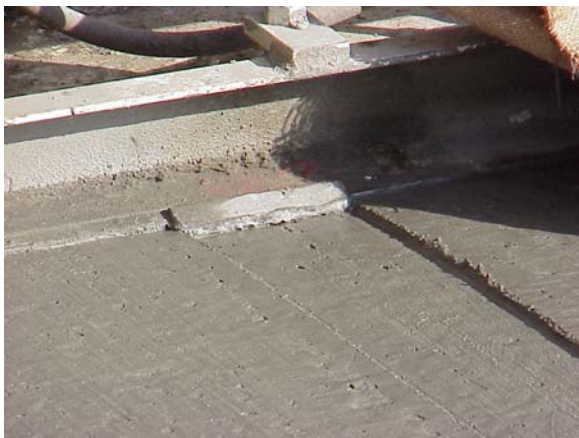
**Figure 2. Small pieces of steel welded to the screed formed the grooves.**

the paving machine in the appropriate locations, formed three continuous grooves – one for each shoulder stripe and one for the skip stripe – as the pavement was being placed. The two shoulder grooves were formed 4-1/2 inches wide and the skip stripe groove was formed 8 inches wide to accommodate hi-visibility black-edged tape. The only other changes that had to be made in the paving operation were: 1. At the groove locations, cut gaps in the texturing drag behind

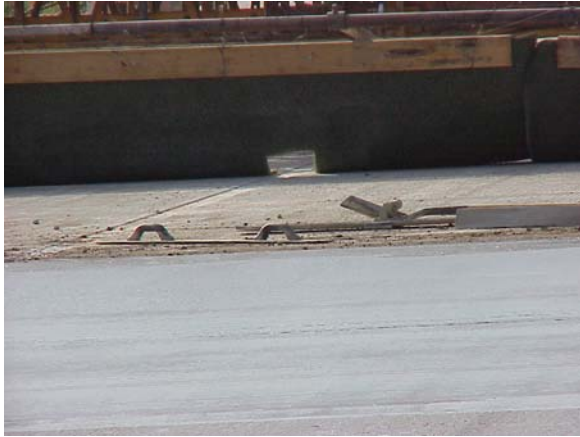
**Figure 3. Gaps were cut in the drag to keep the groove smooth.**

the paver so the drag didn't round the edges of the grooves. 2. At the grooves, remove the tines from the tining machine so the bottoms of the grooves would provide a smooth surface for paint and tape.

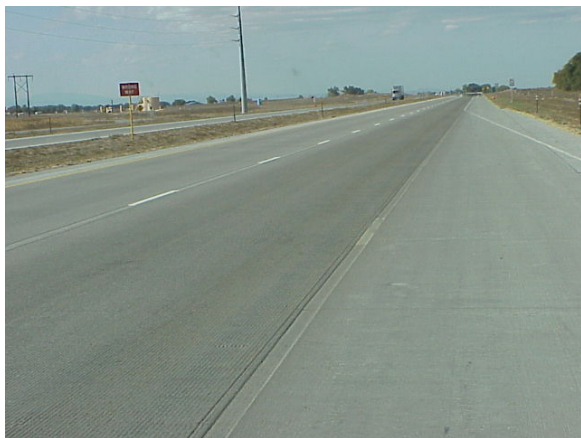
**Figure 4. At accel/decel lanes the stripes were placed outside the grooves.**

When an extra lane is added for a short distance to serve as an accel/decel lane at an intersection, the shoulder stripe curves outward to a new position nearer the outside edge of the pavement. Since the positions of all of the grooves are permanently set at a fixed distance from the edge of the pavement by their welded locations on the screed, there is no way to adjust the position of the shoulder stripe groove to allow for the extra

lane. At these locations, whether they are on the left or right shoulder, the groove continues at its fixed location relative to the edge of the concrete. The painted stripe leaves the groove at the beginning of the new lane and is painted on the surface of the concrete for the length of the additional lane. The shoulder stripe then bends back toward the center of the concrete at the end of the acceleration lane and rejoins the shoulder stripe groove when the lane ends.

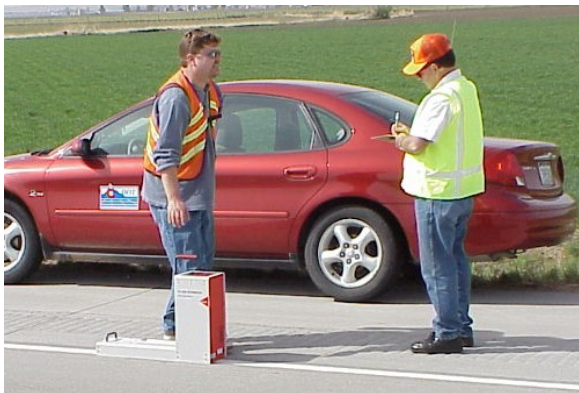
**Figure 5. The Delta LTL2000 measures retroreflectance in any light condition.**

Both types of pavement markings went through several winters with no noticeable wear from traffic or snowplows. Retroreflectance measurements were taken using a Delta LTL2000 Retrometer. This description is on the first page of the Delta Retrometer manual: “The LTL2000 Retrometer is a portable field instrument, intended for measuring the retroreflection properties of road markings in car headlight illumination, the value R1 (coefficient of retro reflected luminance)

is used. R1 is a measure of the lightness of the road marking as seen by drivers of motorized

vehicles in car headlight illumination. The road is illuminated at an angle of 1.24° and the reflected light is measured at an angle of 2.29°. which corresponds to an observation distance of 30 meters. Thus relevant for a motorist viewing situation under normal conditions.” The retroreflectance numbers generated by the LTL2000 are milli-candellas per lux per square meter. Typically, when marking tape is applied to the surface of the pavement, the tops of the raised

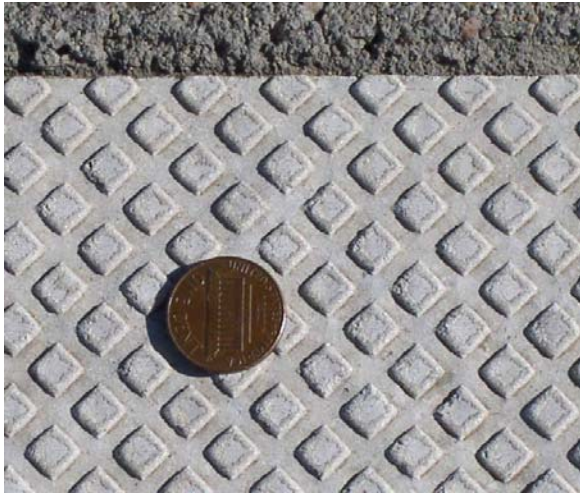
**Figure 6. Even after 3 years, the tape was still bright.**

diamonds are quickly damaged by snowplows. In the eastbound lanes, the tape in the grooves remained in excellent condition with no plow damage to the raised diamonds. **Figure 6** shows the right shoulder tape after three winters. There is no visible wear; however, the surface appeared slightly less bright than when it was new, possibly due to the tape being a little dirty – it had been exposed to the elements for three years. After three winters, retrometer readings averaged 514 for the white tape in the right shoulder and 479

After three winters all of the tape in the eastbound lanes remained in very good condition. There was only one very small – about six inches long – piece that had been damaged by something being dragged over the tape and tearing it. As **Figure 6** shows, the reflective tape was slightly dirty; however, the retroreflectance numbers for the three-year-old tape were higher than those for new epoxy paint.

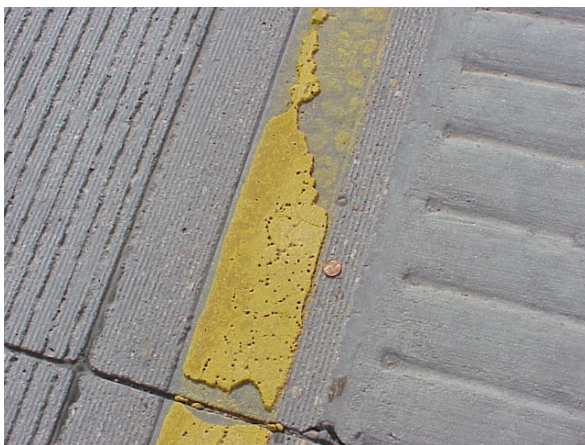
**Figure 7. The thermoplastic failed due to adhesion loss.**

The thermoplastic markings in the grooves in the westbound lanes had good retroreflectivity readings, 299 to 378 for white and 154 to 209 for yellow, and showed no traffic or snowplow damage. However, the thermoplastic material, which was between 1/8<sup>th</sup> inch and 3/16<sup>th</sup> inches thick, was extensively cracked and had started to separate from the surface of the pavement.

Postage stamp-sized pieces were easily picked

up off the pavement. There were extensive areas of the skip stripe where the wind blast from passing traffic had removed nearly all of the thermoplastic material.

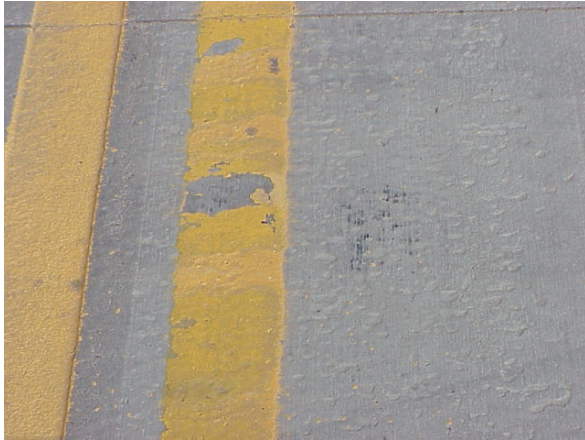
**Figure 8. Epoxy paint in a groove in perfect condition next to damaged paint on the surface.**

At about mp 123.5 in the eastbound lanes, the left shoulder stripe is a double yellow of epoxy paint. The left stripe in **Figure 8** is in a groove; the right stripe is on the surface of the pavement.

Retroreflectivity readings for the two stripes are nearly the same – the one in the groove averaged 69.8 for five readings; the one on the surface

averaged 70 for five readings. However, as can be seen in the photo, the paint on the surface of the pavement has begun to come off of the concrete.

The areas of the surface stripe (the one on the right) that appear brighter yellow are where the stripe was scraped by snowplows. The places where the paint is gone seem to be part of the scraped areas. However, it is impossible to say whether the snowplows directly caused the missing paint or simply removed paint that was already loose. Most of the paint that shows evidence of scraping was still firmly stuck to the concrete. It is not known whether the same method was used to clean the surface for both stripes before the epoxy was installed; however, the paint and beads in the stripe in the groove were completely undamaged after repeated plowing operations and showed no signs of losing adhesion to the concrete.
