**Report No. CDOT-DTD-R-2006-9
Final Report**

IMPLEMENTATION OF PROVEN PCCP PRACTICES IN COLORADO

Ahmad Ardani, P.E

April 2006

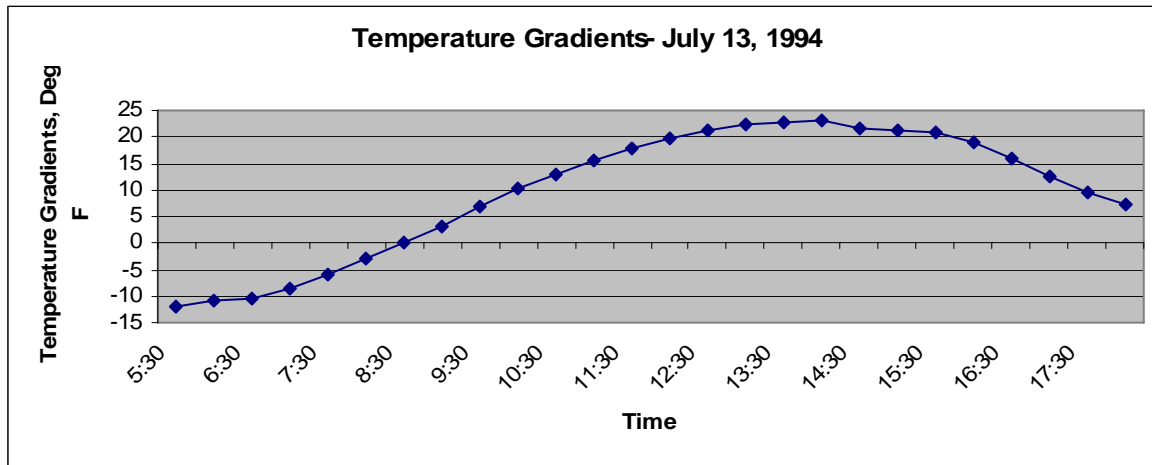
Figure 15: Temperature Gradients

Temperature differences between the top and bottom of concrete slabs cause the pavement slab to curl. The direction (upward lifting or downward dropping of the slab corners) and the magnitude of curling depend on the sign and magnitude of the temperature gradient. Downward curling happens when the slab surface is hotter than the bottom (as typically is the case during a sunny day); if the surface is colder than the bottom, the slab curls upward (corners lifted). The amount of curling depends on the temperature gradient and slab length.

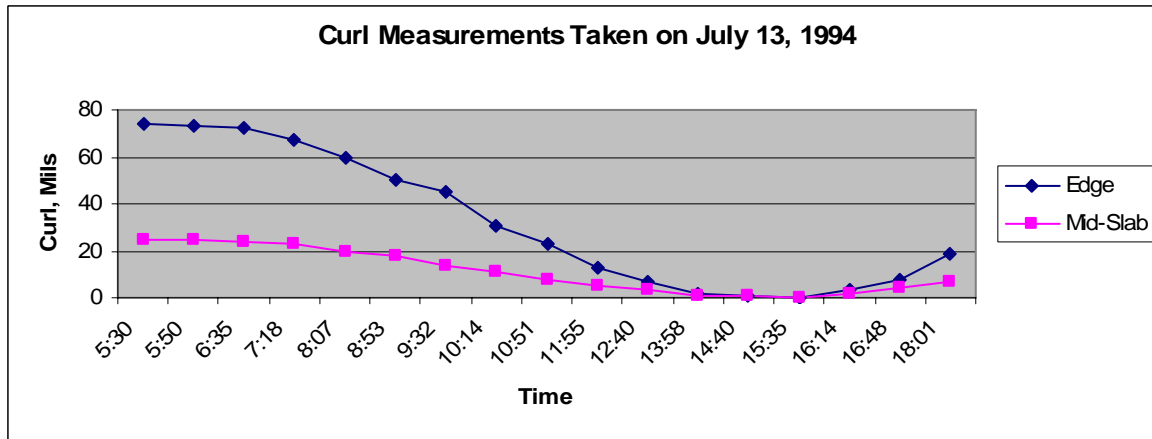
Figure 16: Curl Measurements

In this study, curling was measured directly using dial gauges installed at the corners and middle of the slabs. This was accomplished by anchoring reference rods 6 foot below the pavement surface, thus isolating the rods from the movements of the upper layers. The movement of the middle slab and corners were measured with respect to the reference rods. Measurements were acquired at approximately 30 minute intervals throughout the day, starting at about 6:00 am and continuing to 5:30 pm.

Large positive or negative temperature gradients during the placement of the concrete could result in built in curling. In addition, moisture gradients in the slabs (a difference in the moisture content between the top and bottom also causes the slab to curl. Typically, moisture contents in pavement slabs are higher at the bottom than the top, causing upward curling (negative built in curling) of the slabs.

- The measured curling is consistent with the calculated values if the slabs are assumed curled up in their relaxed state. Such a phenomenon is not uncommon, and may be the result of the temperature conditions at the time of concrete placement, or presence of moisture gradients, or both. The amount of equivalent temperature gradient needed to produce the initial curling necessary to match the field data was about -20 Deg F.

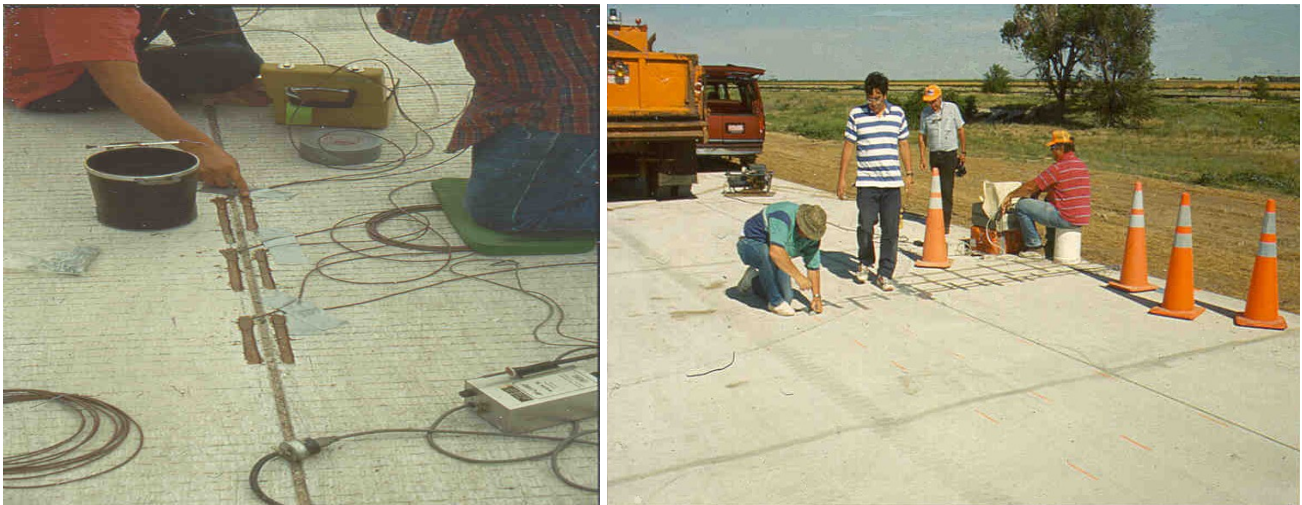
Figures 19 and 20: Surface Mounted Strain Gauges

Surface-mounted strain gauges were installed at selected locations to measure load-induced strains at the free edge (shoulder edge), at longitudinal edges of lane-shoulder joint (for the 12 ft tied, 14 ft tied, and 14 ft untied) as shown in the instrumentation layout above.

A loaded truck of 18-kip rear axle was used to acquire static and creep strains throughout the day to evaluate the effects of temperature variations on load-induced strains. The strain data were obtained using an automated data acquisition system capable of sampling data at 20,000 times per second. In general, the analysis of the load strains data revealed no appreciable difference for different temperature gradients. Strains were much higher for the free edge.

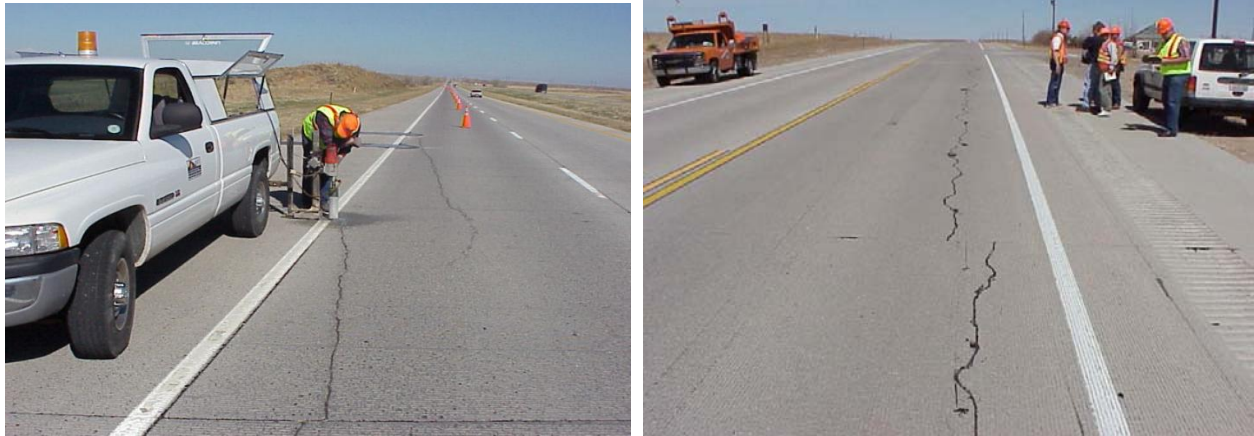
Figures 22 and 23: Longitudinal Cracks Due to Improper Depth of Saw Cut

Examination of cores from several locations on US-287 and I-70 revealed longitudinal joints with sawcut depth that were less than 1/3 of the thickness of the pavement, i.e., not deep enough to instigate the weakened plane cracking. As a result, longitudinal cracks developed to relieve the internal stresses in the concrete. This discovery eliminated the 14-foot-wide slabs as a possible cause of these longitudinal cracks.

- Premature longitudinal cracking due to improper depth of the longitudinal saw-cut can be prevented by adhering to CDOT's present specification, which requires saw-cut depth of $D/3$ for 12-foot slabs and $0.4D$ for 14-foot slabs. It is recommended that project engineers in the field measure saw-cut depth at intervals of 1 per 1/10 of a mile (528 feet). This specification has already been incorporated into CDOT's Field Materials Manual.

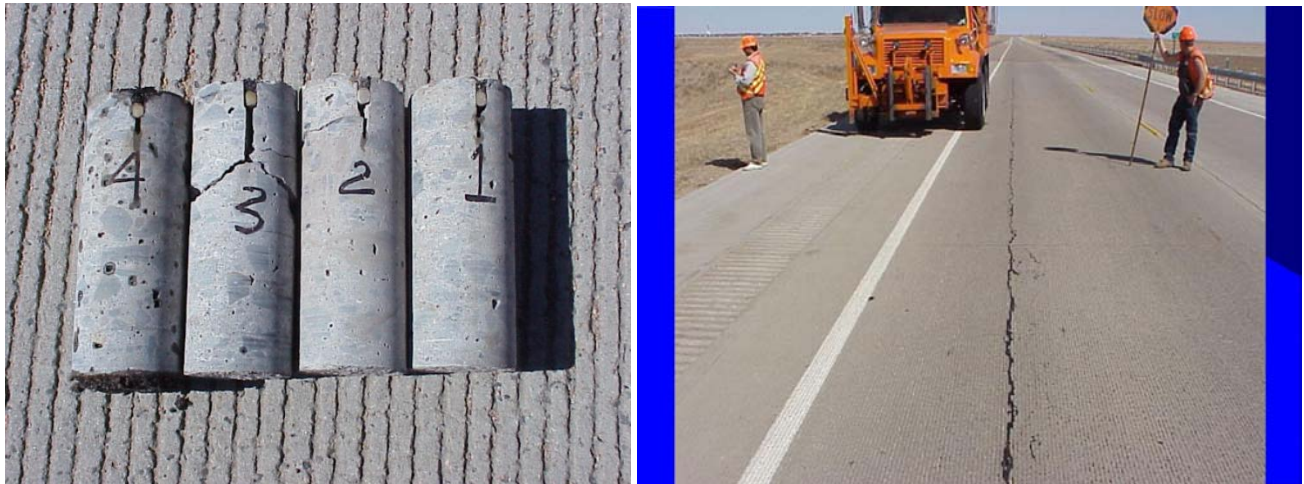
Figure 24: Cores Showing Non-Working Joints

Figure 25: Vibrator Trails

Some of the longitudinal cracks on US-287 were assumed to be due to vibrator trails created by malfunctioning of paver vibrators. Laboratory testing revealed a definite relationship between

improper vibration practices and longitudinal cracking in the path of the vibrators. Cores taken from three different locations on and next to the vibrator trails were sent to Construction Technology Laboratories (CTL) for petrographic analysis. Air-void system analysis was performed in accordance with the modified point-count method of ASTM C 457-98, “Standard Test Method for Microscopical Determination of Parameters of the Air-Void System in Hardened Concrete.” The cores were cut longitudinally and one of the resulting surfaces was finely lapped (polished) and analyzed using a computerized apparatus.

The results showed the air content of the cores taken on the vibrator trails to be consistently lower (30-60 percent lower) than the air content of the cores taken next to the vibrator trails. Visual examination of the cores taken on the vibrator trails revealed non-uniform dispersion of the aggregate, indicating segregation of the mix caused by malfunctioning of the vibrators. High vibrator frequencies and/or prolonged vibrations at lower paver speed were determined to be the main factors that caused segregation and eventually longitudinal cracking along the vibrator trails.

- It is strongly recommended that the paving contractors equip their paving machines with frequency monitoring devices for the vibrators. These monitoring devices provide the transportation agencies and the paving contractor a necessary tool to help achieve a quality concrete pavement that is long-lasting. CDOT has already adopted and fine tuned the Iowa DOT's specification for monitoring the frequencies of the vibrators. This specification was fully implemented at the completion of this study. To view this specification visit CDOT's website.

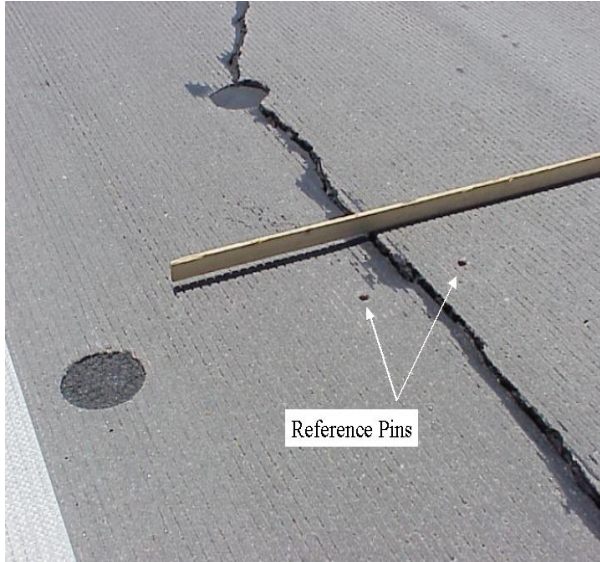
Figure 26: Differential Settlement

Longitudinal cracks with differential settlement at I-70 near Agate were said to be attributed to improper treatment of swelling soils with high plasticity index and lower R-value. Undisturbed soil samples were taken in the Agate area where the concrete pavement had undergone differential settlement as shown in the following photo. The soil samples were sent to the CDOT Central Laboratory for testing. These test results confirmed the results of the previous soil survey and laboratory tests. The soil plasticity and the swelling potential are high (PI = 30-39) and fraction passing No. 200 sieve is very close to 100 %. Soils having that much swelling potential are very sensitive to moisture change and can undergo substantial movement with moisture penetration.

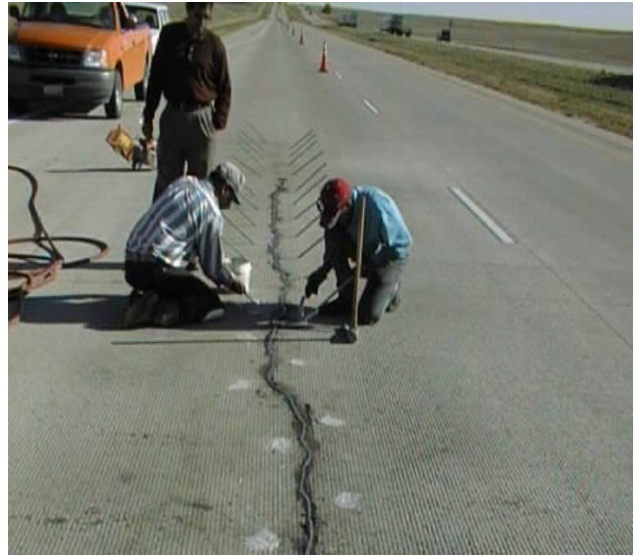
Figure 27: Cross Stitching

To alleviate the problem, slurry injection in conjunction with cross stitching was used to temporarily seize the swelling. To properly address the problem of swelling soil, Region 1 is planning on removing the existing subsurface materials and replacing them with choice materials.
