**Report No. CDOT-DTD-R-2002-2
Final Report**

**CONSTRUCTION AND MONITORING OF
POST-TENSIONED
MASONRY SOUND WALLS**

**CDOT Project BR 287-3(061)
US 36 and Federal Blvd.
Westminster, Colorado**

EXECUTIVE SUMMARY

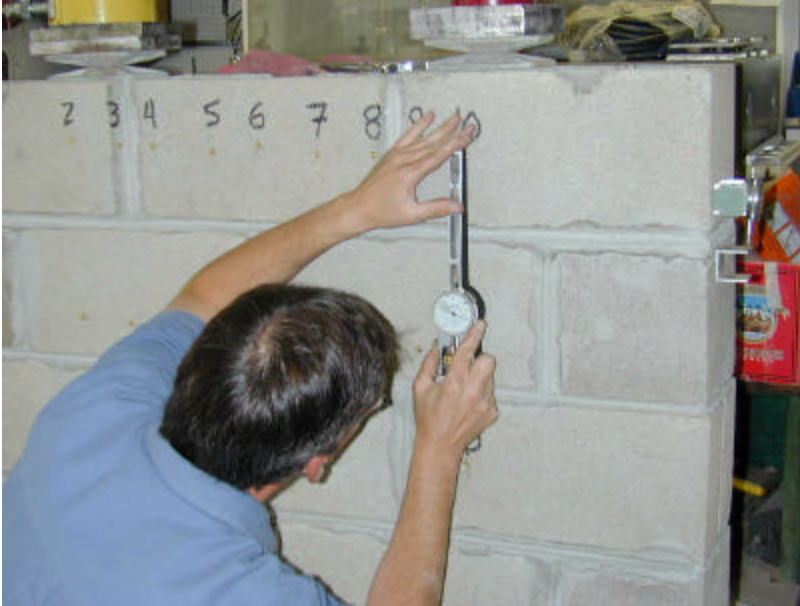
Figure 2. Laboratory tests of bond beam anchorage. The top course is a fully grouted, horizontally reinforced bond beam constructed with 8-inch concrete block. Strains were measured with a dial gage at 10 points between the two tendons (top of photograph).

Anchorage testing was conducted to evaluate the adequacy of the bond beam top anchorages. In order to test the anchorages, a small 4 foot by 4 foot wallette was built that contained a bond beam at the bottom and top course. Each bond beam was horizontally reinforced with two #4 bars to provide an anchorage for two 11/16-inch diameter tendons. The tendons were installed vertically at 24-inch centers using standard Dur-o-Wal anchorage plates. Load-indicating washers were installed at the top anchorage to indicate when the maximum rod tension had been reached. As the tendons were tensioned, deflection readings were taken on the face of the masonry immediately below the anchorage and at intervals between the two tendon anchorages (see Figure 2). Measurements were taken with a Demec gage with resolution of 0.0001 inch. The displacement readings were plotted along with calculated values for the displacement (Figure 3). The displacement calculations follow the classical solution by Timoshenko for a beam on an elastic foundation and agree well with the measured displacements assuming typical concrete masonry material properties.

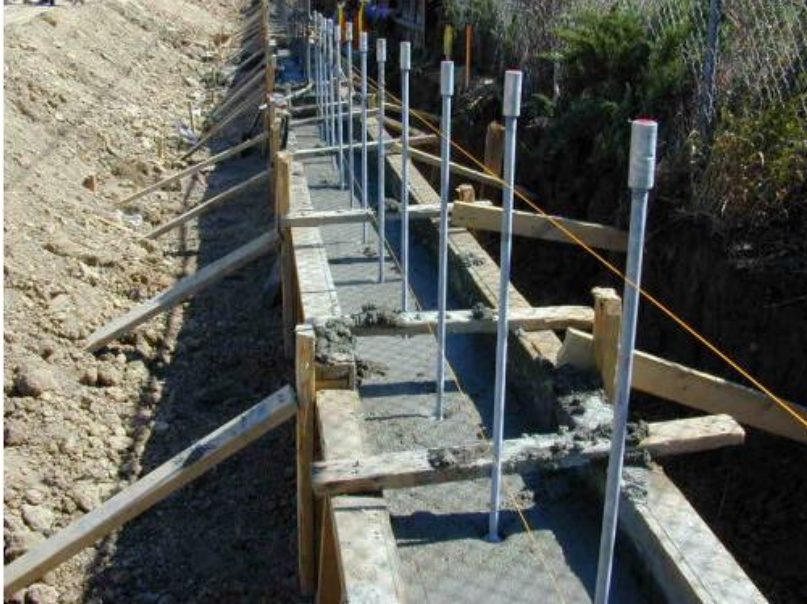
Figure 4. Photograph of grade beam with tendon anchorages installed.

The concrete grade beams at the base of the CMU wall were cast on August 11, 2000. Immediately after the pour, the anchorage assemblies (Dur-o-Wal D/A-790F Sure-Stress) were inserted in the fresh concrete and vibrated to ensure consolidation around the anchorage. The anchorage assembly, consisting of the anchorage and a 36-inch tendon, were aligned to a string line to ensure that the tendons would be located along the center line of the wall. Figure 4 shows the layout of the tendons in the grade beam prior to building the wall.

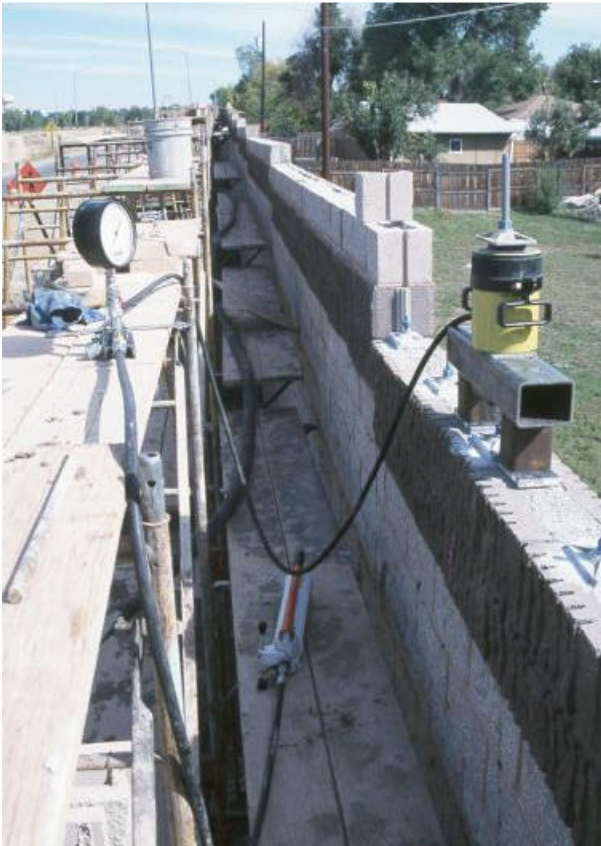
Figure 5. A hand hydraulic pump was used with a hydraulic ram to accurately tension the instrumented and intermediate tendons.

The tendons were tensioned October 2, 2000. The tensioning began at the north end of the test wall with gage #1 and proceeded to the south (gage #8). The instrumented tendons, installed at 4 ft. centers (every other tendon), were tensioned first and the intermediate (non-instrumented) tendons were tensioned in a secondary operation. Figure 5 shows the tensioning equipment consisting of steel shims, a tubular steel beam, an open cylinder hydraulic ram, and hydraulic pump. The tendon force is distributed into the bond beam upon final tensioning by 4 by 6 inch cast bearing plates (Dur-o-Wal D/A 790BP Sure-Stress).

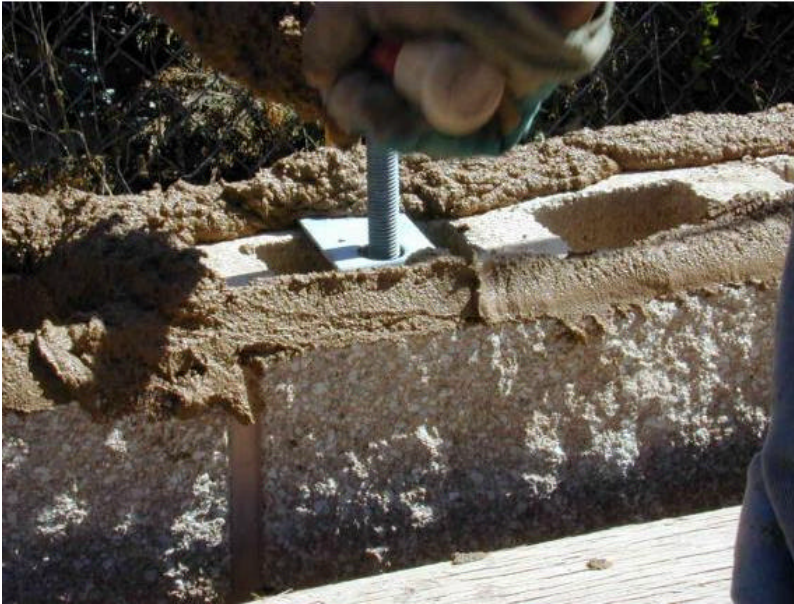
Figure 7. Photograph of the wall under construction. A tendon restraint plate can be seen in the center of the photograph.

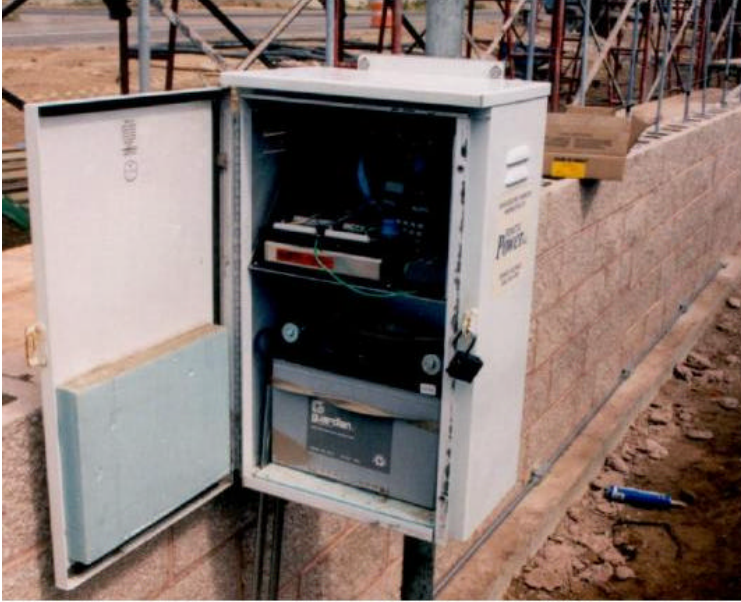
Figure 8. View of the instrument cabinet and the partially built post-tensioned wall in the background.

The lower portion of the wall was constructed the week of August 21, 2000 and the vibrating wire strain gages were installed late during the same week. The vibrating wire strain gages were preinstalled on 36-inch sections of tendons by Geokon, Inc. Eight tendons were instrumented and leads from the strain gages were routed down the cell to the bottom of the wall where the wire exited the wall. Electrical conduit was run from each instrumented cell to an instrument cabinet to protect the wiring. The electrical cabinet housed a Campbell Scientific CR-10 data recorder, 8-channel multiplexer, vibrating wire interface for the CR-10, and a 12 Volt deep-cycle battery to power the system. The data recorder was programmed to record both the strain and temperature of each tendon once per hour.

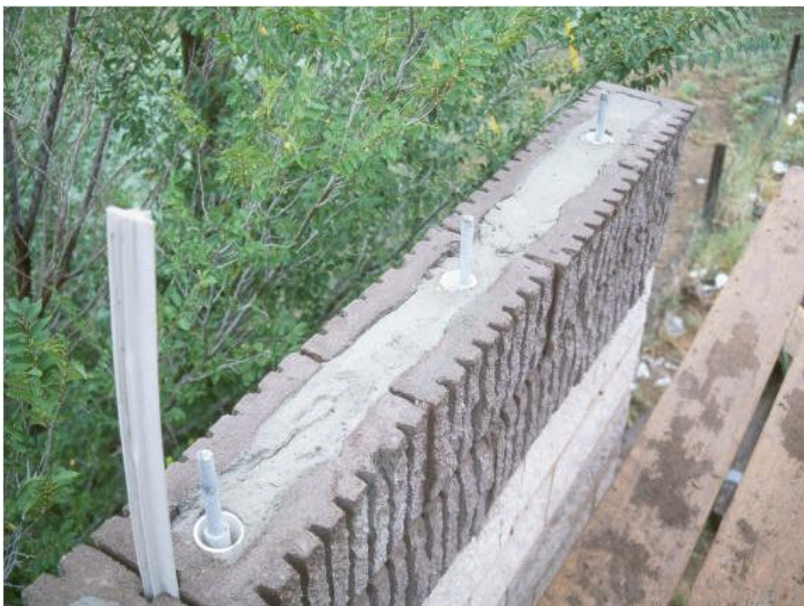
Figure 9. View of the top of the post-tensioned wall showing the sleeve inserted into the bond beam to prevent bonding of the tendon. Mortar beds were placed beneath the bearing plates to form the anchorage at this course. An additional ungrouted course was placed above the anchorage and the wall was topped with a precast concrete cap.
