**Report No. CDOT-DTD-R-2005-20  
Final Report**

# **PERFORMANCE OF COLORADO'S FIRST RUBBLIZATION PROJECT ON I 76 NEAR STERLING**

**Robert LaForce, P.E.  
Yeh and Associates**

**January 2006**

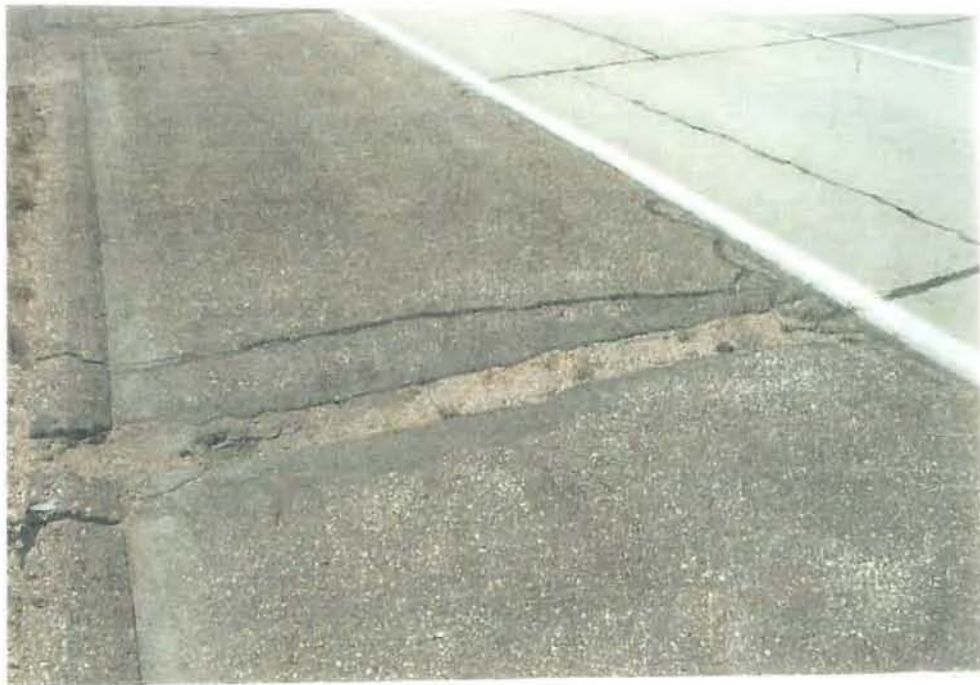
**Figure 2. Pre-construction Roadway and Shoulder Condition**

The existing asphalt shoulders had extensive cracking and major deterioration. A Bomag CMI 650 Reclaimer was used to break the shoulder material to approximately a minus 1-inch size. This process was used to eliminate any voids present under the old shoulders that might have been caused by erosion over the years. The material was then compacted and graded prior to placement of the asphalt overlay. Figure 2 shows the condition of the asphalt shoulders before they were broken up with the Bomag as well as typical longitudinal cracking on the concrete pavement prior to rubblization.

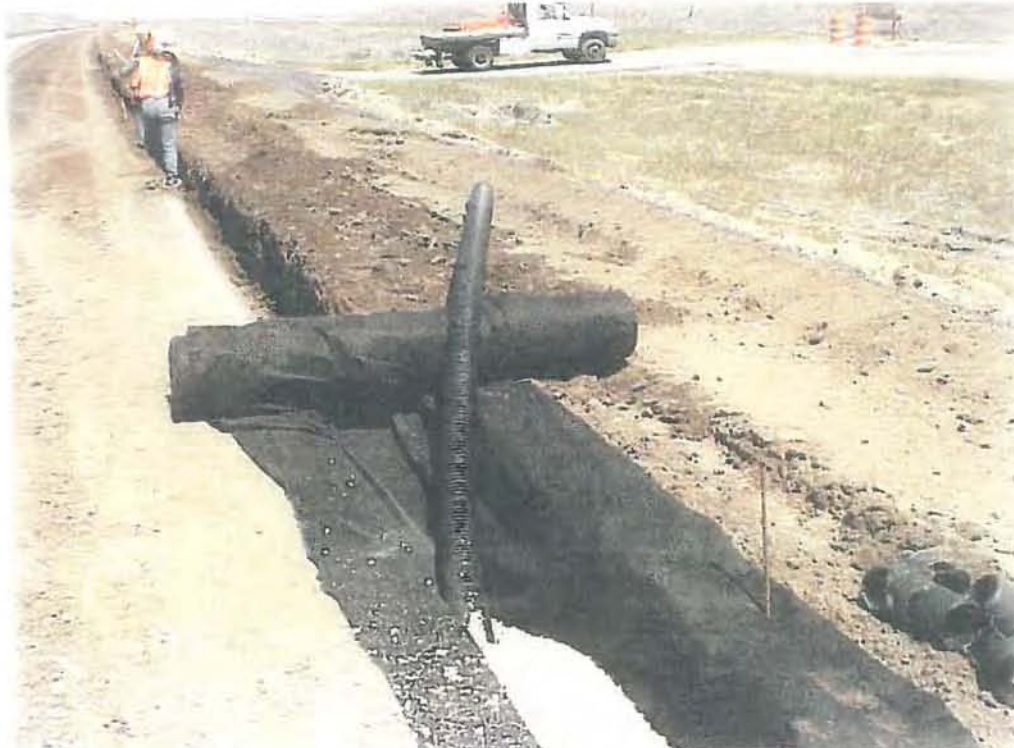
**Figure 3. Typical Edge Drain Construction**

Edge drains used in conjunction with the rubblization are a recommended feature to control subgrade moisture. Preventing moisture buildup in the subgrade is important for the long-term performance of the pavement as well as during the construction phase. Although this section of highway was built on a permeable sandy subgrade, edge drains were installed as part of the roadway design in the event that there was any subgrade moisture. The edge drains were specified and installed according to CDOT M-Standard M 605-1. Figure 3 shows typical edge drain installation.

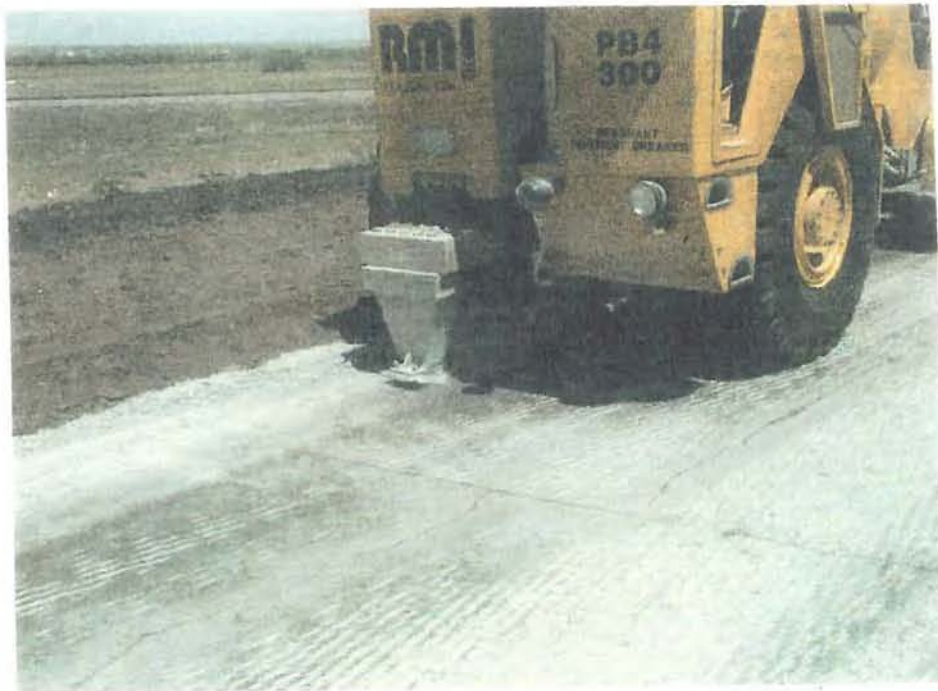
**Figure 5. Resonant Breaker**

The specifications for this type of process required that the concrete pavement be broken up with a self-contained, self-propelled, resonant frequency pavement-breaking unit capable of producing low-amplitude 2,000-pound force blows at a rate not less than 44 cycles per second. The majority of rubblized concrete pieces should be 1 to 3 inches nominal size. (Specification in Appendix A of the Construction Report)

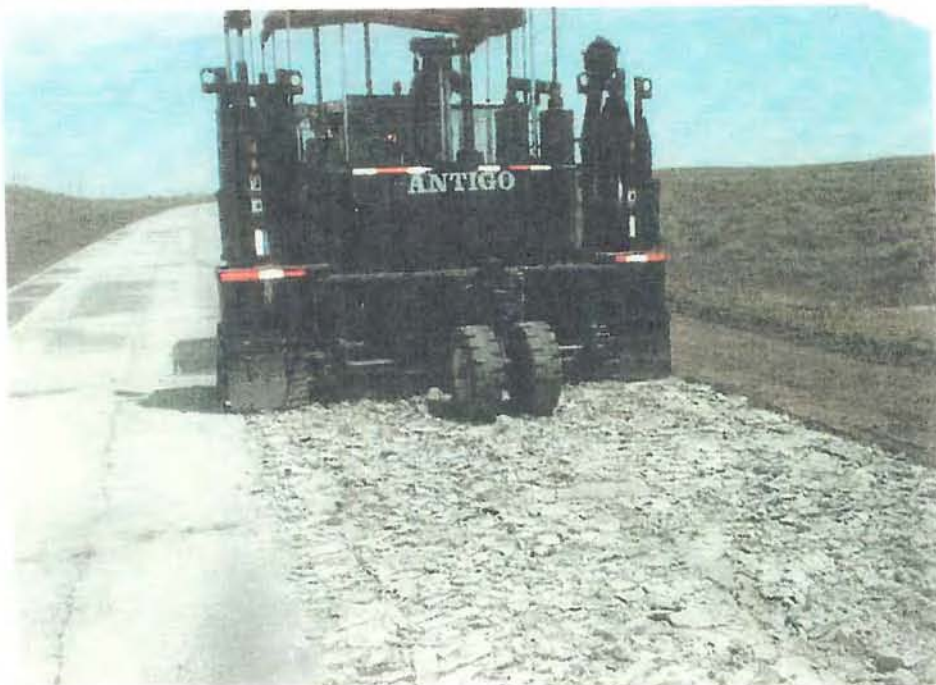
**Figure 6. Multi-head Hammer**

With this process, the concrete pavement is broken up with a self-contained, self-propelled unit with hammers mounted laterally in pairs with half of the hammers in a forward row and the remainder diagonally offset in a rear row, so there is continuous breakage from side to side. The equipment was capable of rubblizing a 13-foot lane in a single pass. The existing concrete was broken into pieces ranging from sand size to pieces generally 3 inches or less in size in the top half of the concrete pavement, and 9 inches or less in the bottom half of the concrete pavement. (The specification is Appendix B of the Construction Report)

As with the resonant breaker sections, a 4-foot by 4-foot test section was excavated to visually inspect and verify that the multi-head hammer was producing the specified sizes. A steel vibratory roller fitted with “Z” pattern grid on the drum face operating in the vibratory mode was used to seat the rubblized pavement. Figure 6 and 7 shows the multi-head hammer and the Z-pattern roller. This equipment was provided by Antigo Construction Company of Antigo, Wisconsin.

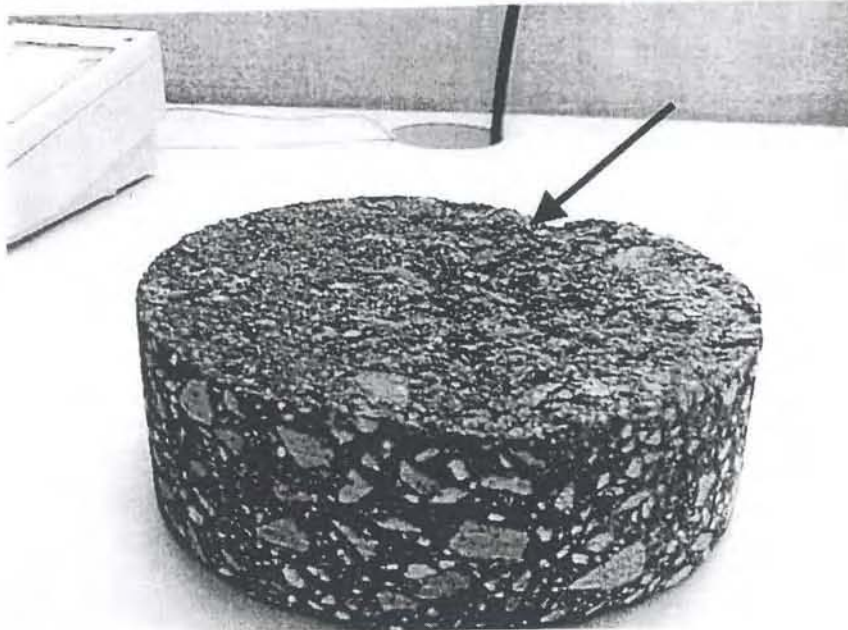
After the 2001 evaluation, this asphalt pavement was identified as suffering from top-down cracking that was confirmed by coring later that year. Much of the current longitudinal cracking is attributed to top-down cracking. Figures 8 and 9 show the early crack and the core follow-up. As noted in the 2001 field notes, the crack was only 1/8 inch in depth at the time the core was taken (9/01).

**Figure 9. Core of Top-Down Cracking, 9/16/2001.**

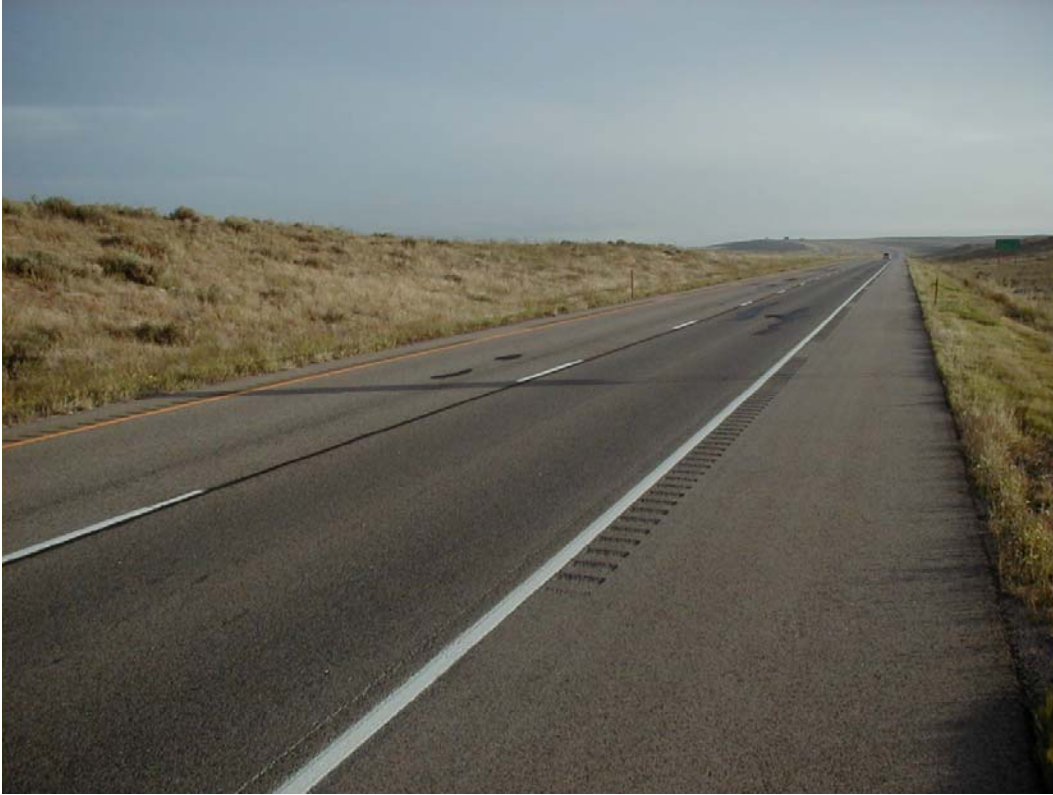
As a final note on cracking, the project was visited in September 2005. Figures 10 and 11 document the condition of the rubblization test sections. The top-down cracking has progressed in both directions with the eastbound lanes having more severe deterioration than the westbound lanes.

**Figure 10. Typical EB Condition (9/24/05)**

CDOT Maintenance forces have sealed most of the longitudinal cracking and the centerline of paving joint in both directions. The longitudinal joint between the shoulder and driving lane is now opened throughout the project length and will be sealed in the future.

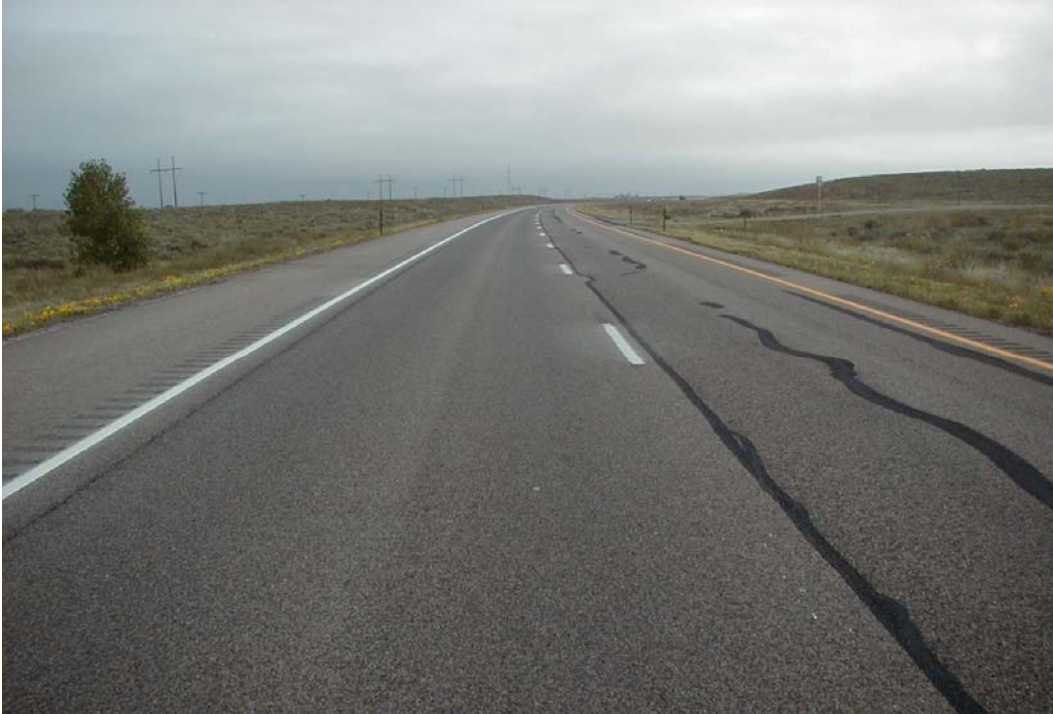
**Figure 11. Typical WB Condition (9/24/05)**

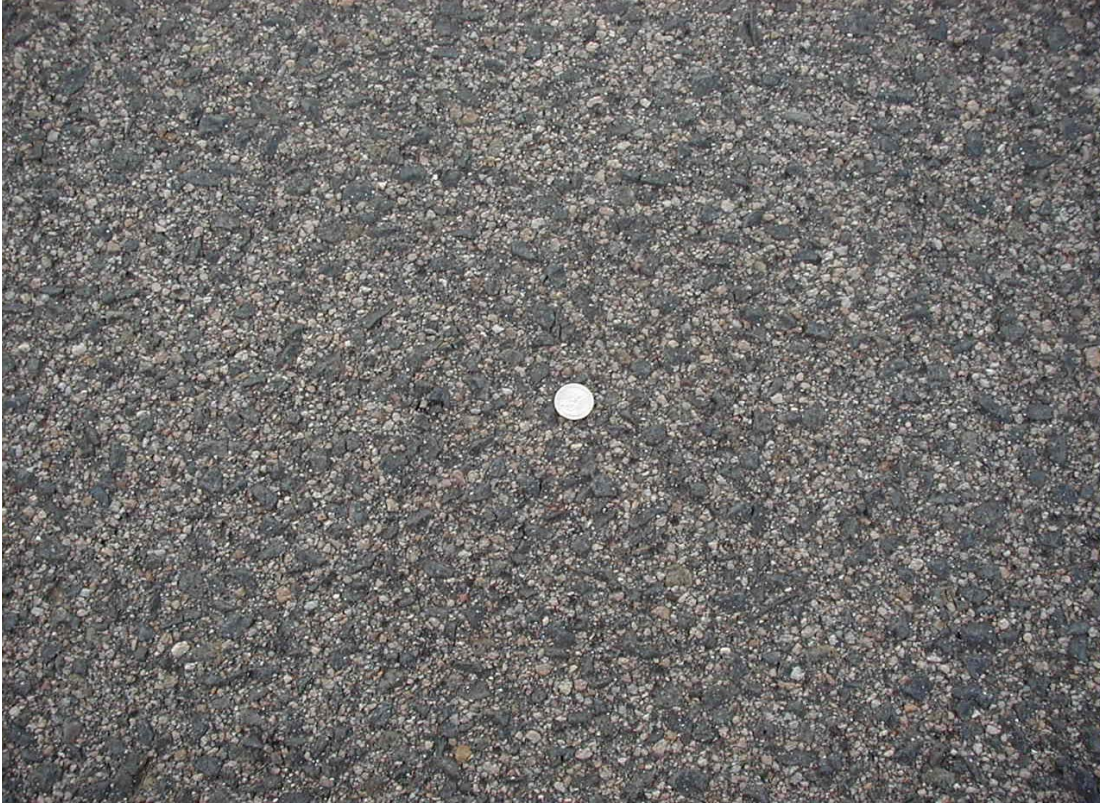
Maintenance forces have also spot sealed the wheel paths in some locations because the surface has started to ravel. Spot sealing has occurred in approximately 60% of the east-bound lanes and 25% of the westbound lanes. Figure 12 shows a close-up view of the surface texture of I 76 in the project area. The loss of fines was first noted in the 2002 field notes and has become a maintenance problem although this distress is not associated with the rubblization process. The loss of fines over time on this pavement supports the need for a wearing course relatively early in the life of a new pavement to protect the structural lower layers, and extend the useful life of a pavement. Both mixes used on this project passed all of the Lottman tests as well as the Hamburg Wheel Tracking tests.

**Figure 12. Raveled Pavement Surface**
