Report No. CDOT-DTD-R-2003-10

Final Report

MAILBOXES AND MOUNTING SYSTEMS

**COLORADO DEPARTMENT OF TRANSPORTATION
RESEARCH BRANCH**

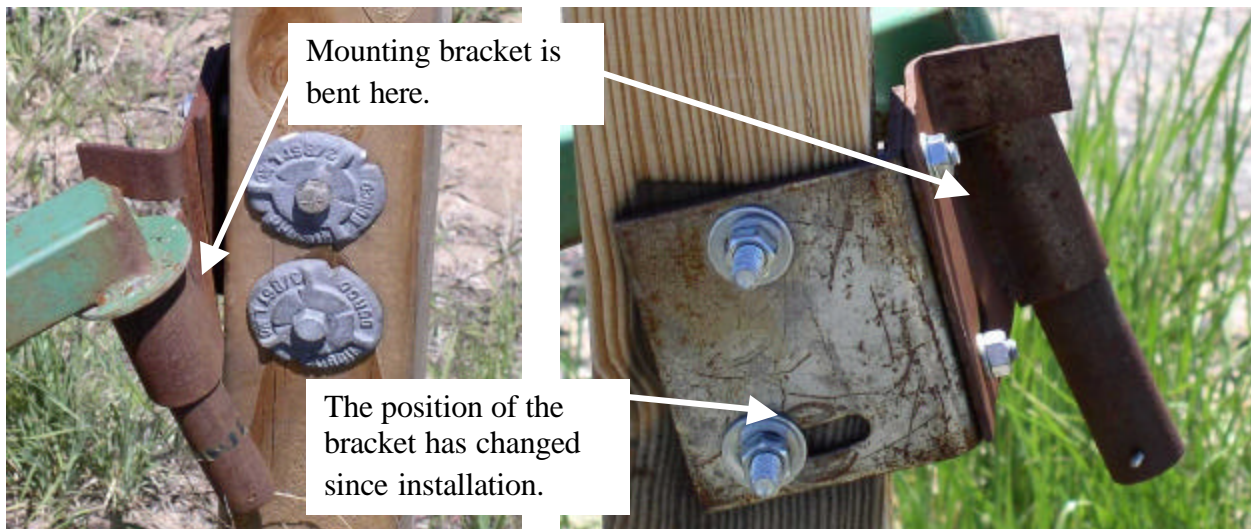
Figure 4. Close-up pictures of the two mounts in Figure 3. Both brackets are bent. The bracket in the right picture has gone out of adjustment at the bolts facing the camera.

problems with the system. The first is due to the fact that on both mounts in **Figures 3 and 4** there is some bending in the mounting bracket piece that holds the pivot sleeve. The bracket on the left post is bent so the pivot sleeve tilts to the left as viewed from the highway; the bracket on

the right is bent at the same point but so the pivot tilts to the right viewed from the highway. The bent bracket changes the angle of the pivot sleeve which changes the normal position of the pivot arm and the mailbox.

The second problem is with the adjustments to locate the normal position of the arm and box. Initial position adjustment of the system is done by setting the relative angles of the two-piece mounting brackets that bolt to the wood post. The adjustments, made by two pairs of bolts, set the initial positioning of the pivot sleeve so the arm returns to the centered position after it is pushed to the side. In the picture on the right of **Figure 4**, marks made on the bracket by the pair of bolts facing the camera show the initial position of the bracket and that the position has changed. Natural expansion and contraction of the wood post, due to changes in its moisture level as the weather changes, will make it nearly impossible to keep these two bolts tight enough to hold this adjustment. This system has the longest arm of the mountings evaluated. That long arm provides considerable leverage against the two adjustments held only by friction between the mount pieces and the wood post.

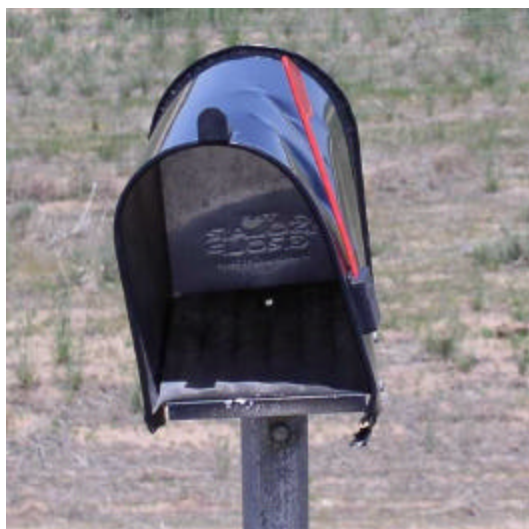
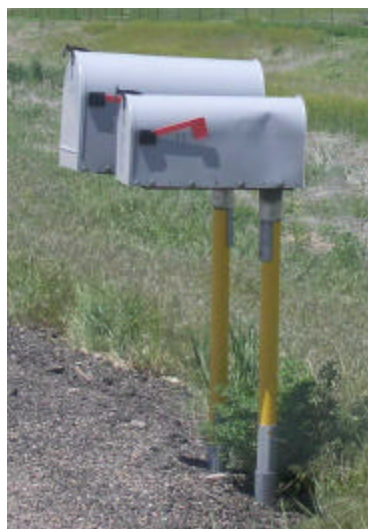
Figure 6. Damaged metal boxes on rigid post mounts. The post on the left is set at the edge of the pavement, while the two on the right are set about 8' from the edge of the shoulder with a small gravel turn-out to allow close access to the boxes.

Figure 6 shows new metal boxes mounted on straight rigid posts. The post in the picture on the left is at the edge of the pavement. The box was replaced

last fall but, as the picture shows, did not stand up well to the winter. The two boxes in the right picture are set about eight feet from the edge of the pavement with a small gravel turn-out to allow mail carrier and homeowner access to them. The near box, while not as severely damaged as the one in the left picture, is slightly bent. Possibly the extra distance from the highway provided a measure of additional protection for these two boxes – the small one almost certainly provided some protection for the large one behind it.
