I-70 / CENTRAL PARK BOULEVARD I N T E R C H A N G E

WETLAND FINDINGS REPORT

PREPARED FOR:
CITY AND COUNTY OF DENVER

PREPARED BY:
**PINYON ENVIRONMENTAL
ENGINEERING RESOURCES, INC.**

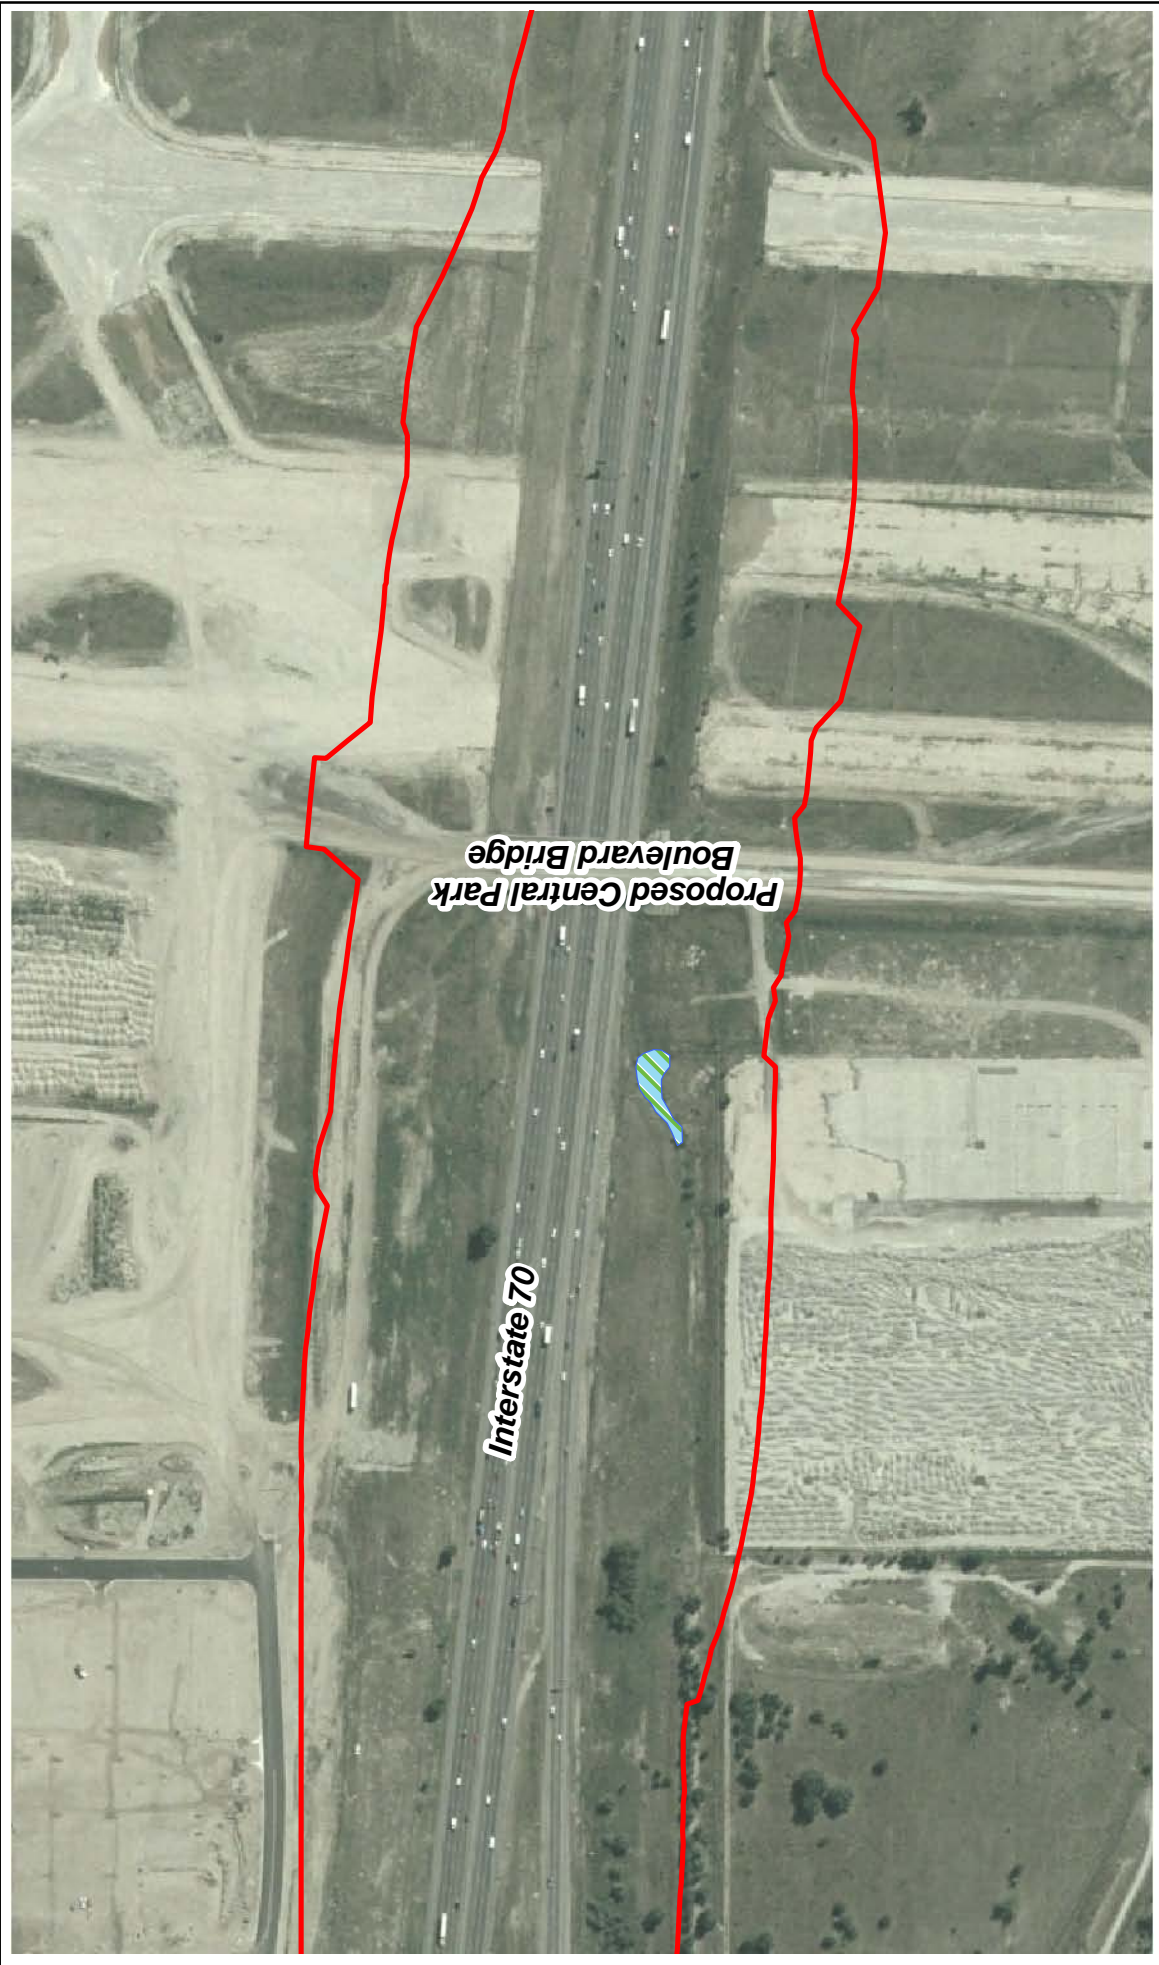
Drawn By: MJS Figure 1

The project area, shown on Figure 1, extends along I-70 and Interstate 270 (I-270) from Quebec Street to Havana Street, bisecting the Stapleton Redevelopment area, in Sections 21 and 22, Township 3S, Range 27W. CPB, a planned and funded project of the Park Creek Metropolitan District (PCMD) now under design and proposed for construction in 2010, will provide a new arterial connection across I-70, connecting the existing and planned development areas of Stapleton.

No ephemeral or perennial surface water features have been identified within the project limits (Figure 1).

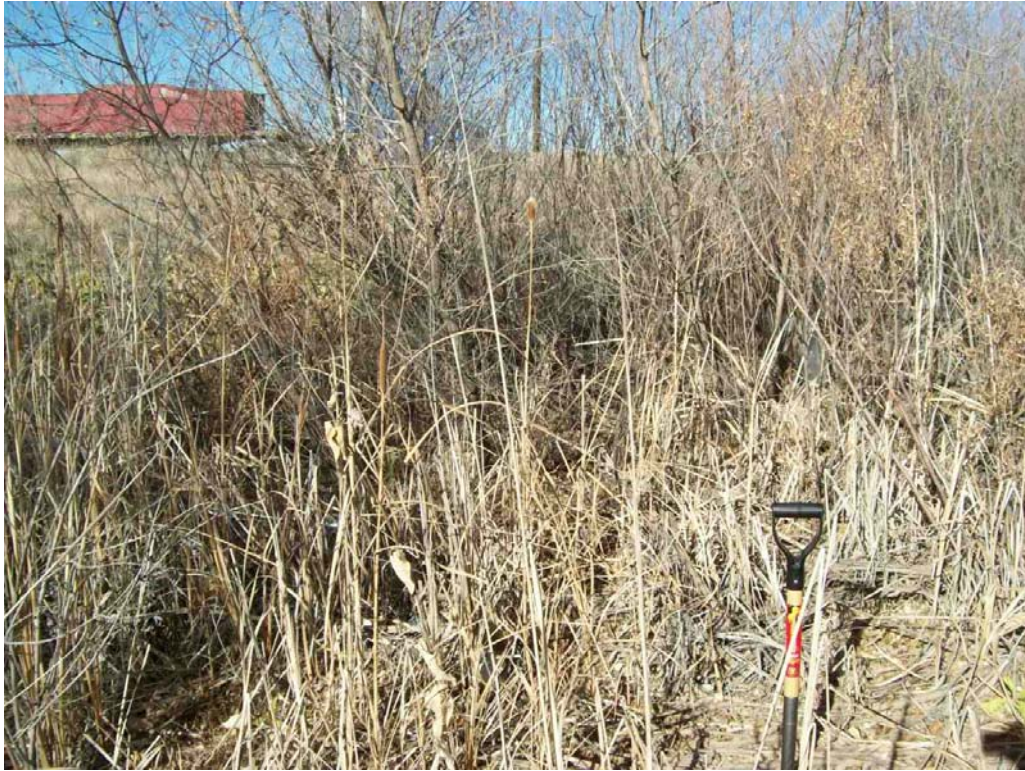
Wetland at location of Data Point Wet-01

Vegetation in this area was dominated by an understory of wetland plants including cattails and reed canarygrass. Shrubs present included sandbar willows, and small narrow-leaved cottonwood trees bordered the wetland in this area. The soil in this area was generally consistent with the upland soils encountered in soil pit UP-01; however, subtle redox conditions were observed, and were likely a function of hydraulic inputs and the presence of hydrophytic vegetation. The color of the soil at this location was brown (10YR 4/3), and consisted of sand with clay. Hydrological indicators included saturation at a depth of 12 inches.

The wetland is located southwest of the Interchange, and was determined to have a total area of 0.146 acre. Hydrology within the wetland feature is primarily associated with an underground culvert which formerly drained the Stapleton Airport employee parking lot historically located southwest of the Interchange. Surface runoff from the surrounding uplands appears to be a secondary source of water. Ground-water seepage is not considered a significant hydrologic source. The entire wetland is located within the current boundaries of CDOT ROW.

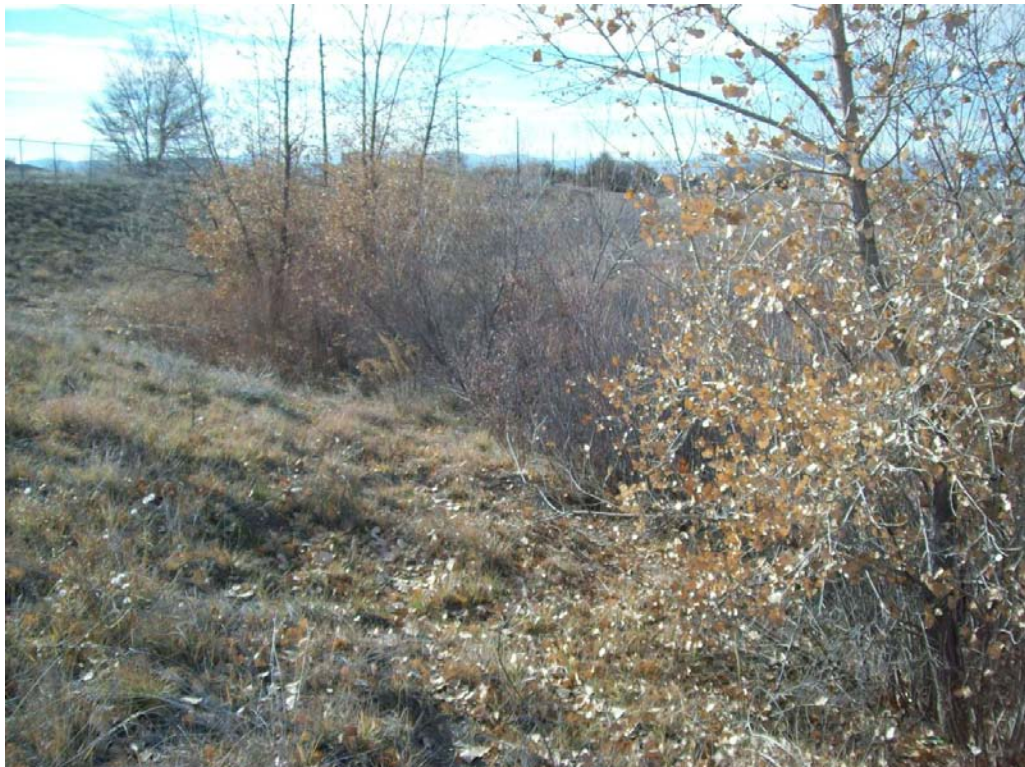
Wetland and Upland Boundary, View to the West

There is a well defined wetland-upland line. Upland species surrounding the wetland are dominated by herbaceous species including crested wheatgrass and cheatgrass.

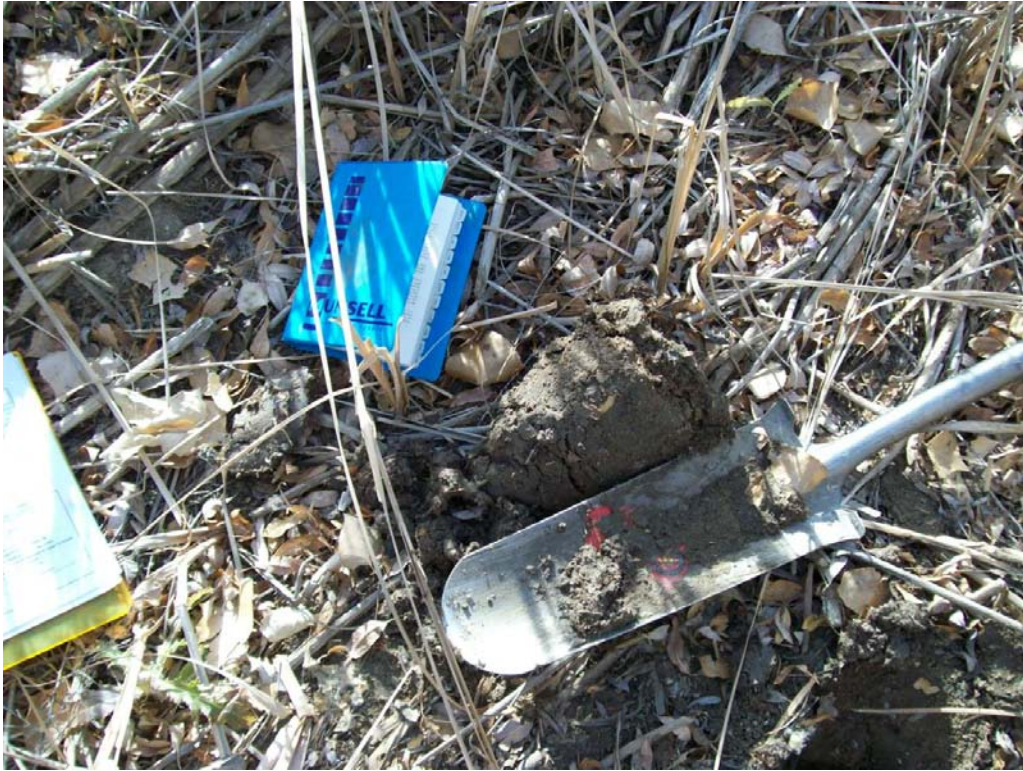
Soil at Data Point Wet-01

Depth (inches)	Matrix		Redox Features				Texture	Remarks
	Color (moist)	%	Color (moist)	%	Type ¹	Loc ²		
0-14	10YR 4/3	100					Sand with clay	Redox Matrix (subtle)

Remarks: Area naturally located in upland area created as a result of discharge from a stormwater culvert. Soils appear moderately-well drained, subtle redox matrix observed in soil sample showing influence of hydrology and Hydrophytic vegetation on the soils in this area.

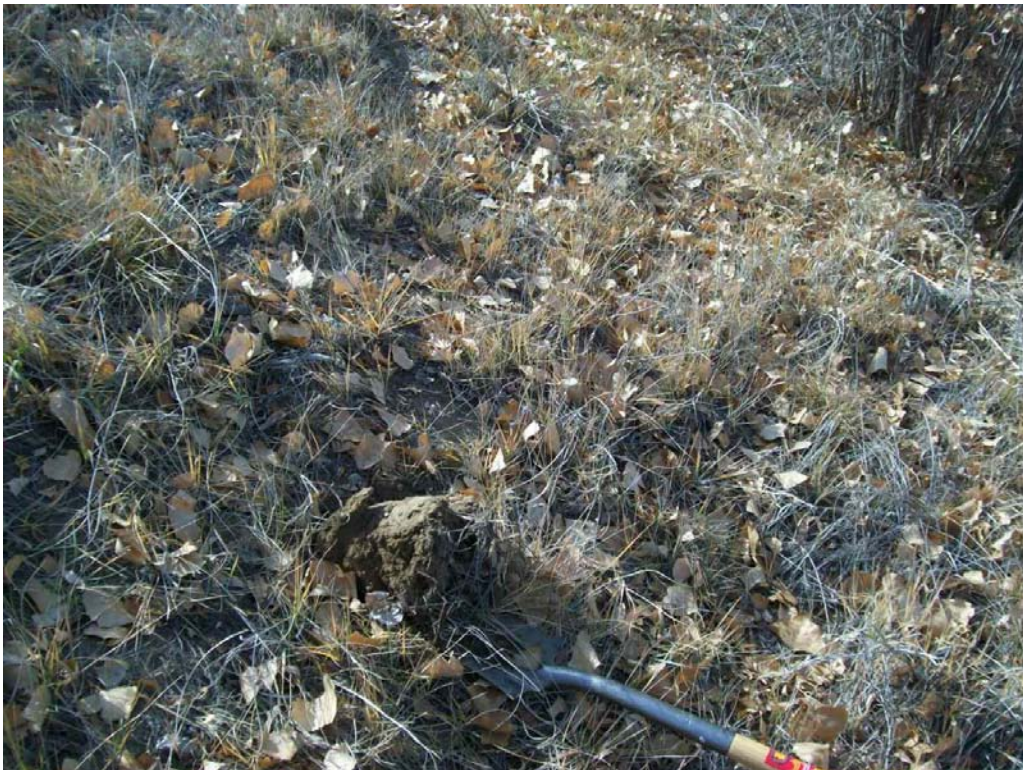
Soil at Data Point Up-01

This soil pit was excavated in an upland area on a terrace above, and south of, the wetland area (Figure 2). Vegetation in this area was consistent with the Disturbed Community described in Section 3.1, and was dominated by crested wheatgrass and cheatgrass. Soil at this point consisted of one horizon, was composed of sand with clay, and was brown (10YR 4/3). No hydrological indicators were present at this location.

Profile Description: (Describe to the depth needed to document the indicator or confirm the absence of indicators.)								
Depth (inches)	Matrix		Redox Features				Texture	Remarks
	Color (moist)	%	Color (moist)	%	Type ¹	Loc ²		
0-12	10YR 4/3	100					Sand with clay	Redox not prevalent
