# ENGINEERING TECHNICAL REPORT

## EFFECTS OF RAINSTORMS ON WATER AND SEDIMENT RUNOFF FOLLOWING THE 1996 WILDFIRE BUFFALO CREEK, COLORADO

**Robert D. Jarrett, Ph.D.**  
U.S. Geological Survey

**Thomas W. Browning, P.E.**  
Colorado Water Conservation Board

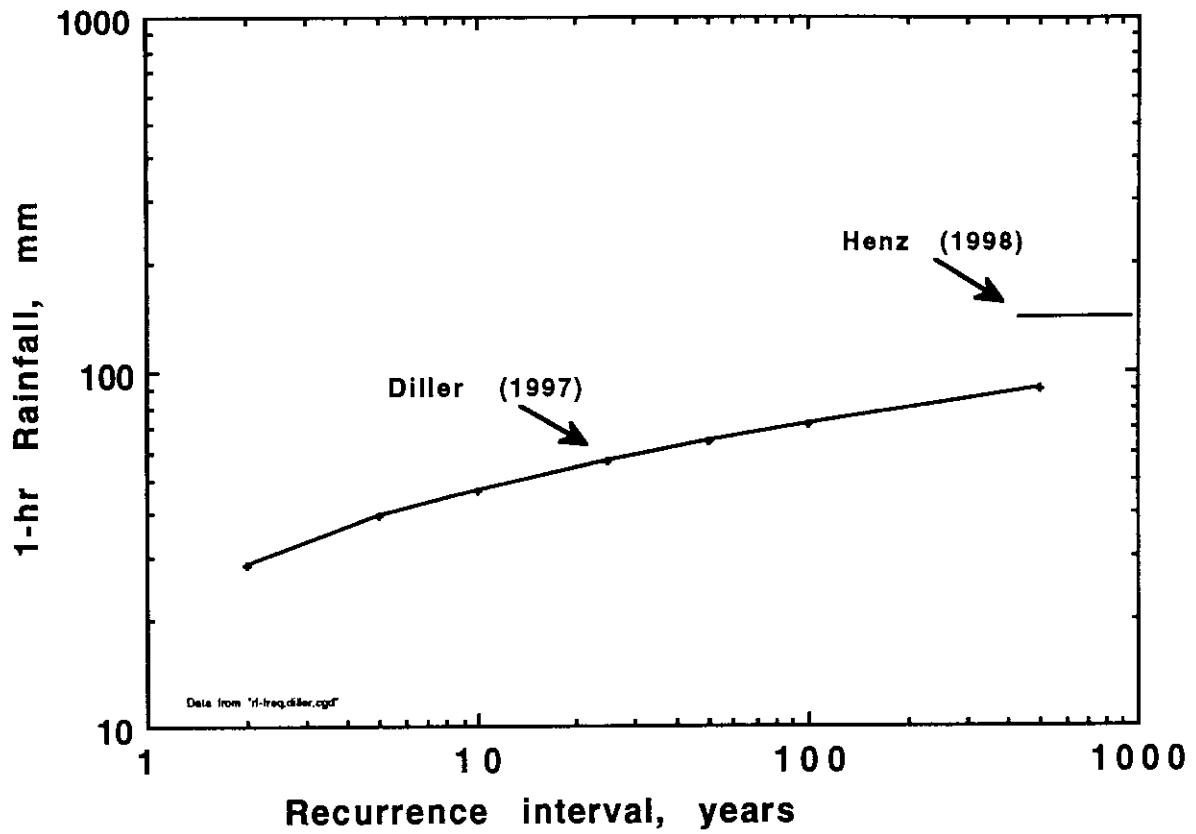
Fig. 5

5. One-hour rainfall frequency relation for Buffalo Creek developed by Diller (1997) including the estimated maximum 1-hr rainfall of about 160 mm for Buffalo Creek on July 12, 1996 (Henz, 1998).

The 100-year, 1-hr rainfall is about 55 mm for the Buffalo Creek area (Miller et al., 1973). Diller (1997) analyzed 24-hr, annual maximum rainfall values for 50 stations near Buffalo Creek having a similar climate regime. He conducted a regional rainfall-frequency analysis using the method of L-moments (Hosking and Wallis, 1997). The regional 1-hr rainfall frequency curve developed by Diller (fig. 5) is within 5 percent of the rainfall-frequency relation of Miller et al. (1973). The recurrence interval was about 1,000 years for the July 12, 1996 maximum rainfall (130 mm) in about 1-hr in Buffalo Creek.

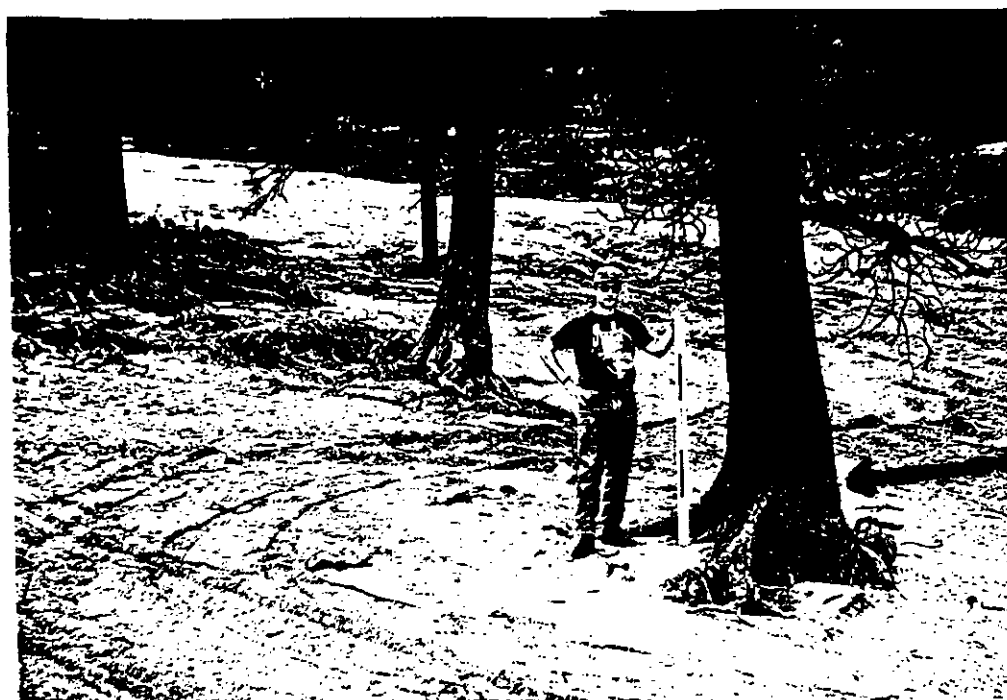
Fig 9

9. Upstream view of Sand Draw about 1 km upstream from Buffalo Creek showing distinct black, burn boundary from the May 18, 1996 wildfire. The boundary was used to define pre-fire, channel-bed levels and estimates of the amount of channel change at this flood (about 0.5 m here).

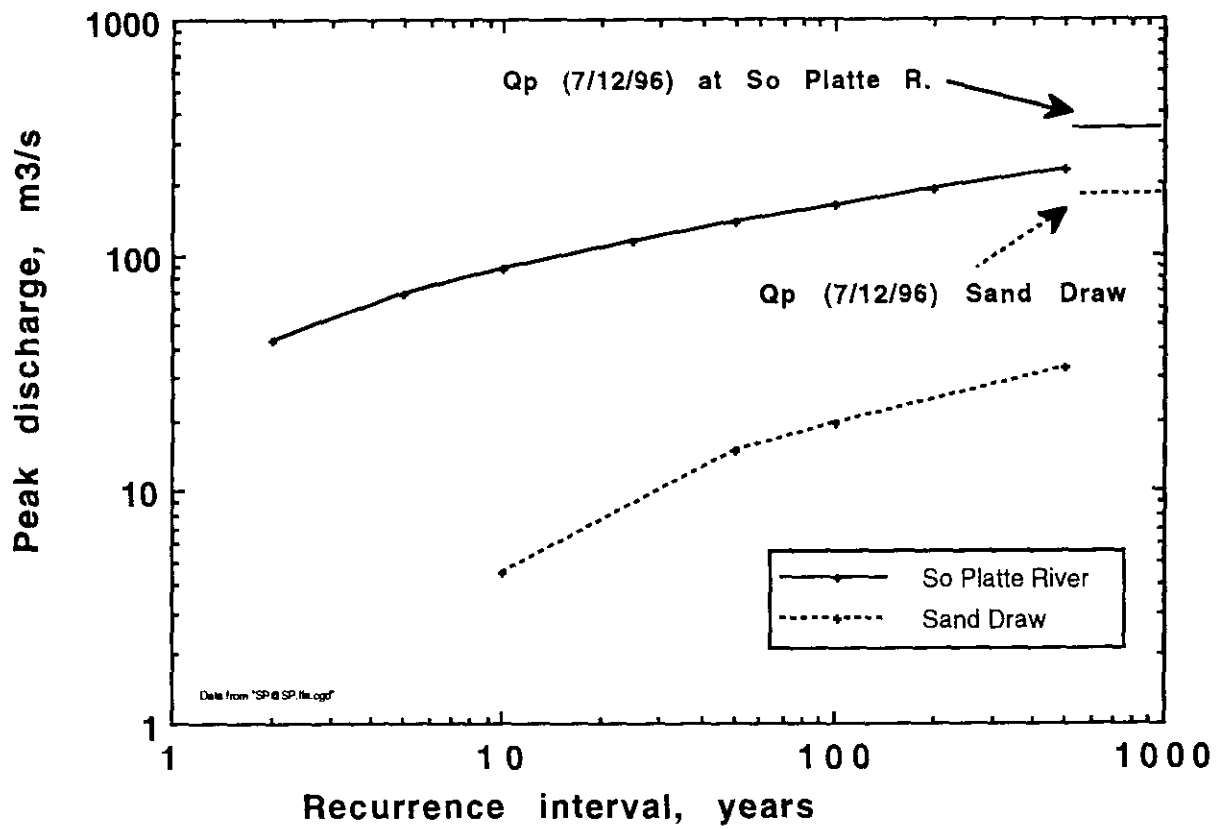
FIG. 11

11. Flood-frequency relations for pre-fire basin conditions for Sand Draw at Buffalo Creek (FEMA, 1986) and the South Platte River at South Platte (06707500) from an frequency analysis of annual peak-flow data. Peak discharges for the July 12, 1996 flood for Sand Draw and at the South Platte River at South Platte also are shown.

Flood-frequency relations for Sand Draw and the South Platte River at South Platte with corresponding July 12, 1996, peak discharges are shown on figure 11. Trans-basin diversions were assumed to be negligible on large flood peaks and hence the upper end of the frequency relation for the South Platte River. On July 12, 1996, peak discharges in small, burned basins such as Sand Draw, Spring Creek, Spring Gulch, and Shinglemill Creek were about 10 times larger than the 100-year flood. On Sand Draw, and other small tributaries in burned basins near the center of the storm, peak discharges exceeded the 1,000-yr flood.
