STREAM HABITAT INVESTIGATIONS AND ASSISTANCE PROJECT SUMMARY

2021 Progress Report

Colorado Parks & Wildlife

Upper Arkansas River Habitat Restoration Project, Arkansas River

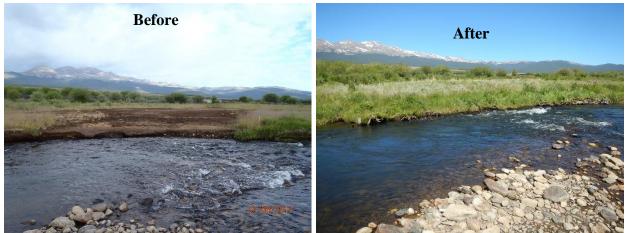
Figure 1. Before and after photos of wood toe treatment and fluvial tailings remediation.

Progress towards project goals for primary monitoring targets was summarized in Table 1 and brief descriptions of monitoring results for fish populations, benthic macroinvertebrates, riparian vegetation, habitat quality, and instream habitat structures were provided below. Select before and after photos were presented in Figures 1-3.

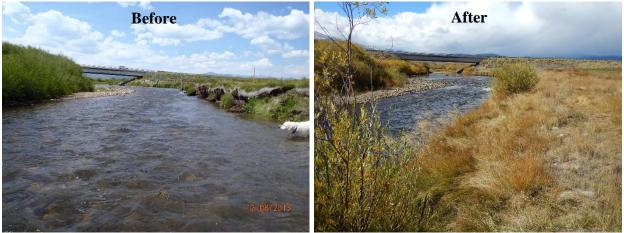
Figure 2. Before and after photos of an eroding bank that was stabilized with a riparian bench.

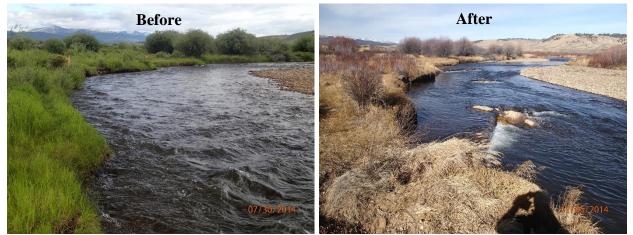
Figure 3. Before and after photos showing log vanes, habitat boulders, and channel narrowing.
