Reconnaissance Field Investigation of
**SURFACE-WATER
SPECIFIC CONDUCTANCE**
in the Snowmass–Glenwood Springs Area,
West-Central Colorado

Information Series 49

**State of Colorado, Bill Owens, Governor
Department of Natural Resources, Greg E. Walcher, Director
Colorado Geological Survey, Vicki Cowart, Director
Denver, Colorado
1999**

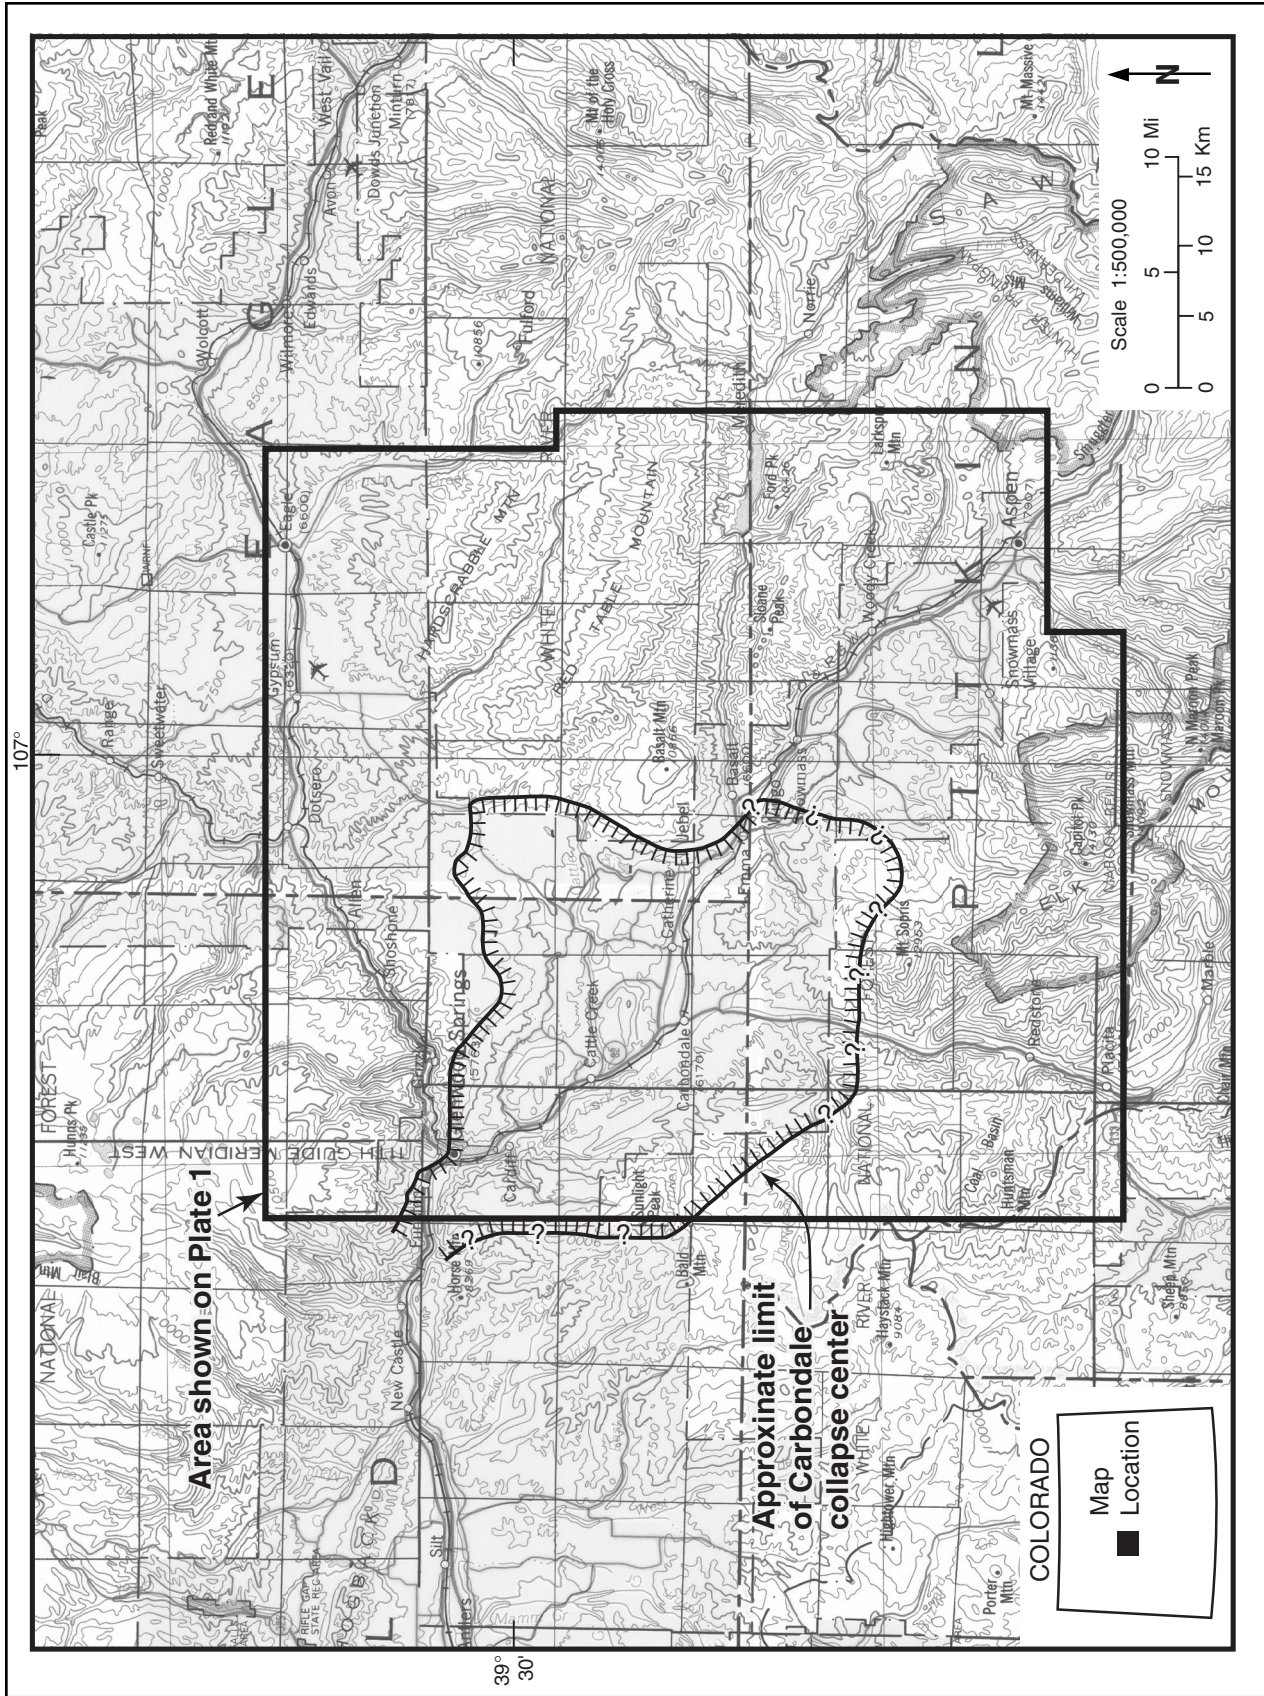
Figure 1. Location map of study area and approximate limits of the Carbondale Collapse Center.

The boundaries of the Carbondale collapse center are poorly constrained in this area. The Roaring Fork River probably enters the Carbondale collapse center somewhere near its confluence with Sopris Creek (Figure 1 and Plate 1), and part of the Sopris Creek drainage basin may lie within the collapse center. The collapse center coincides with the area in which evaporite has dissolved or plastically flowed during the late Cenozoic Era, a process continuing to the present. The salt load in the Roaring Fork River generally increases within the collapse center boundaries.

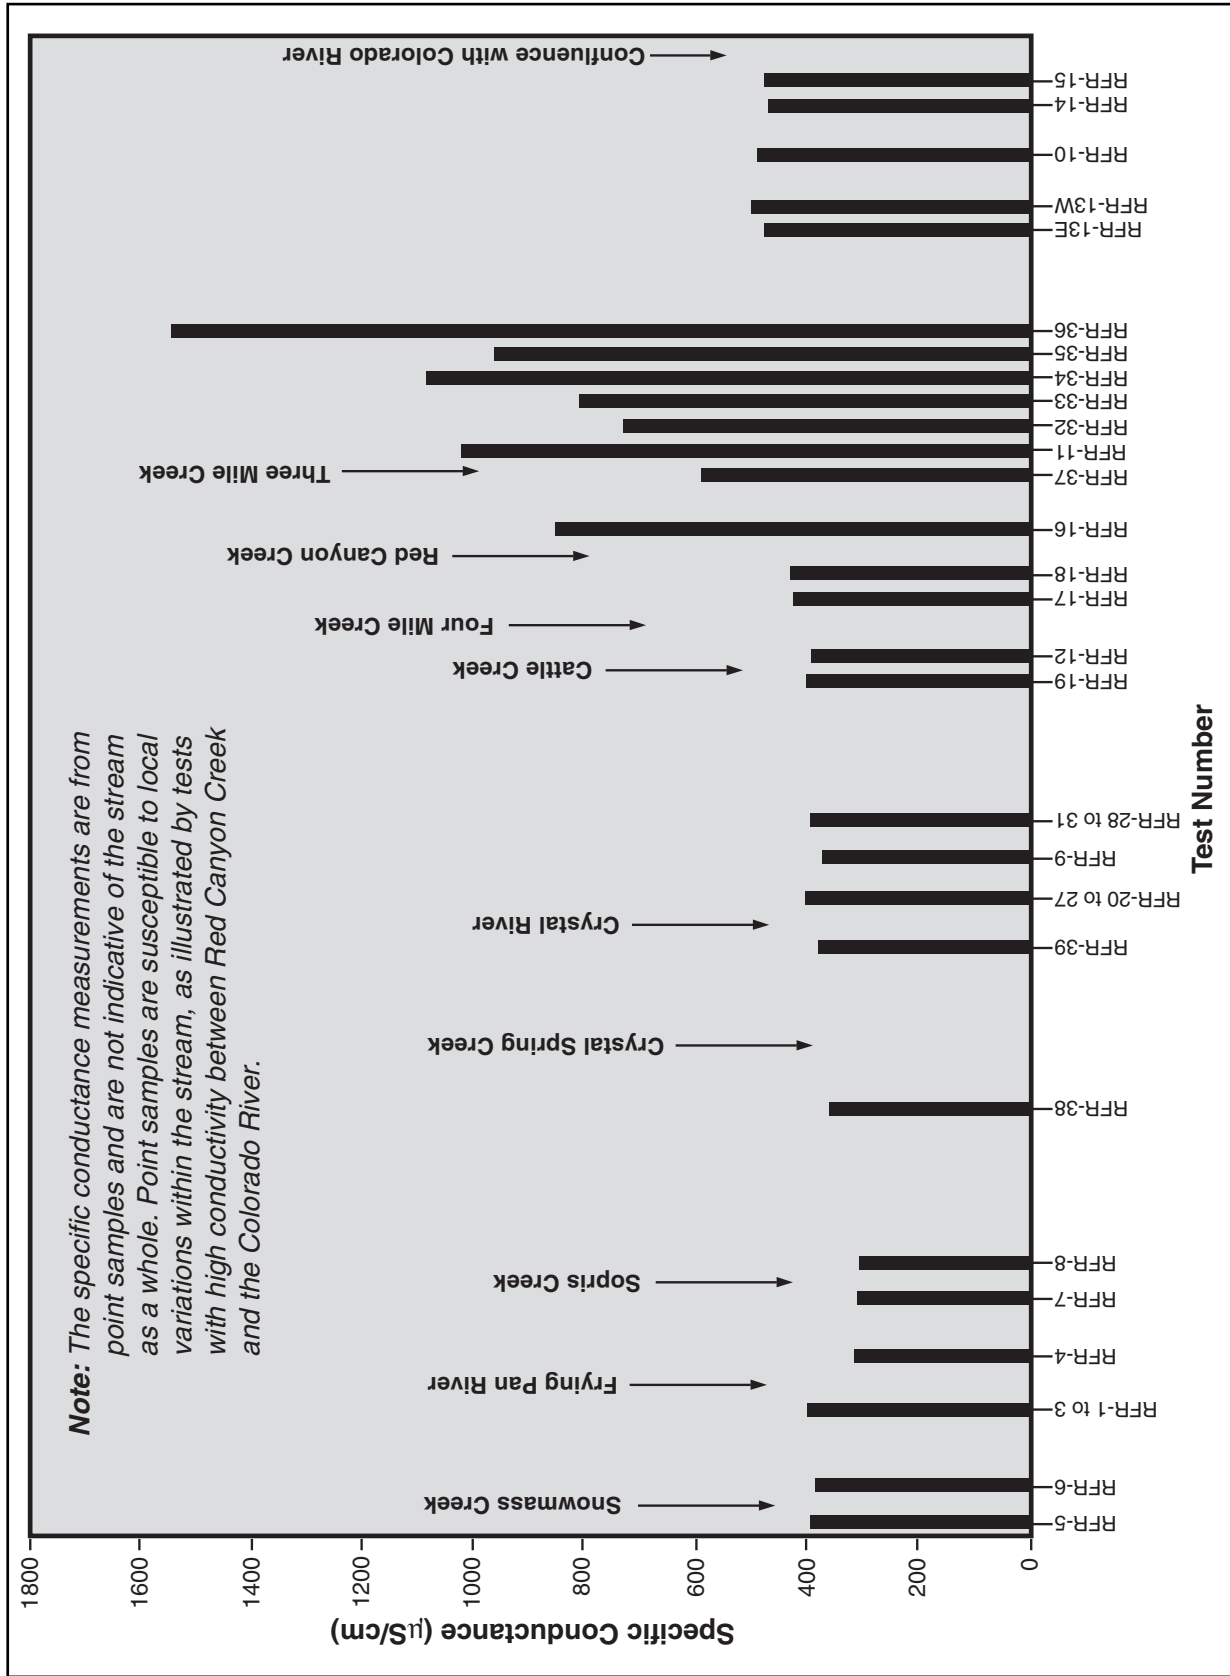
Figure 2. Graph showing specific conductance at test locations in the Roaring Fork River between Snowmass and Glenwood Springs (arrows indicate where various tributaries join the river).

Specific conductance in the Roaring Fork River was around 400 $\mu\text{S}/\text{cm}$ at the confluence with Snowmass Creek at the furthest upstream test site of this study. Downstream of inflows from the Fryingpan River and Cedar Brook Lake, which had specific conductance of about 200 $\mu\text{S}/\text{cm}$ each, tests of specific conductance in the Roaring Fork River dropped to around 310 $\mu\text{S}/\text{cm}$. Between Sopris Creek and Fourmile Creek, near the southern edge of Glenwood Springs, specific conductance tests in the Roaring Fork River gradually increased to about 400 $\mu\text{S}/\text{cm}$. From Fourmile Creek to the confluence with the Colorado River, specific conductance of the stream increased to around 480 $\mu\text{S}/\text{cm}$. In this lower portion of the Roaring Fork River, a reach extending from the Glenwood Springs airport downstream past the mouth of Threemile Creek had significantly elevated specific conductance values along the southwestern bank of the river. Specific conductance at test locations in this reach ranged up to 1,550 $\mu\text{S}/\text{cm}$.

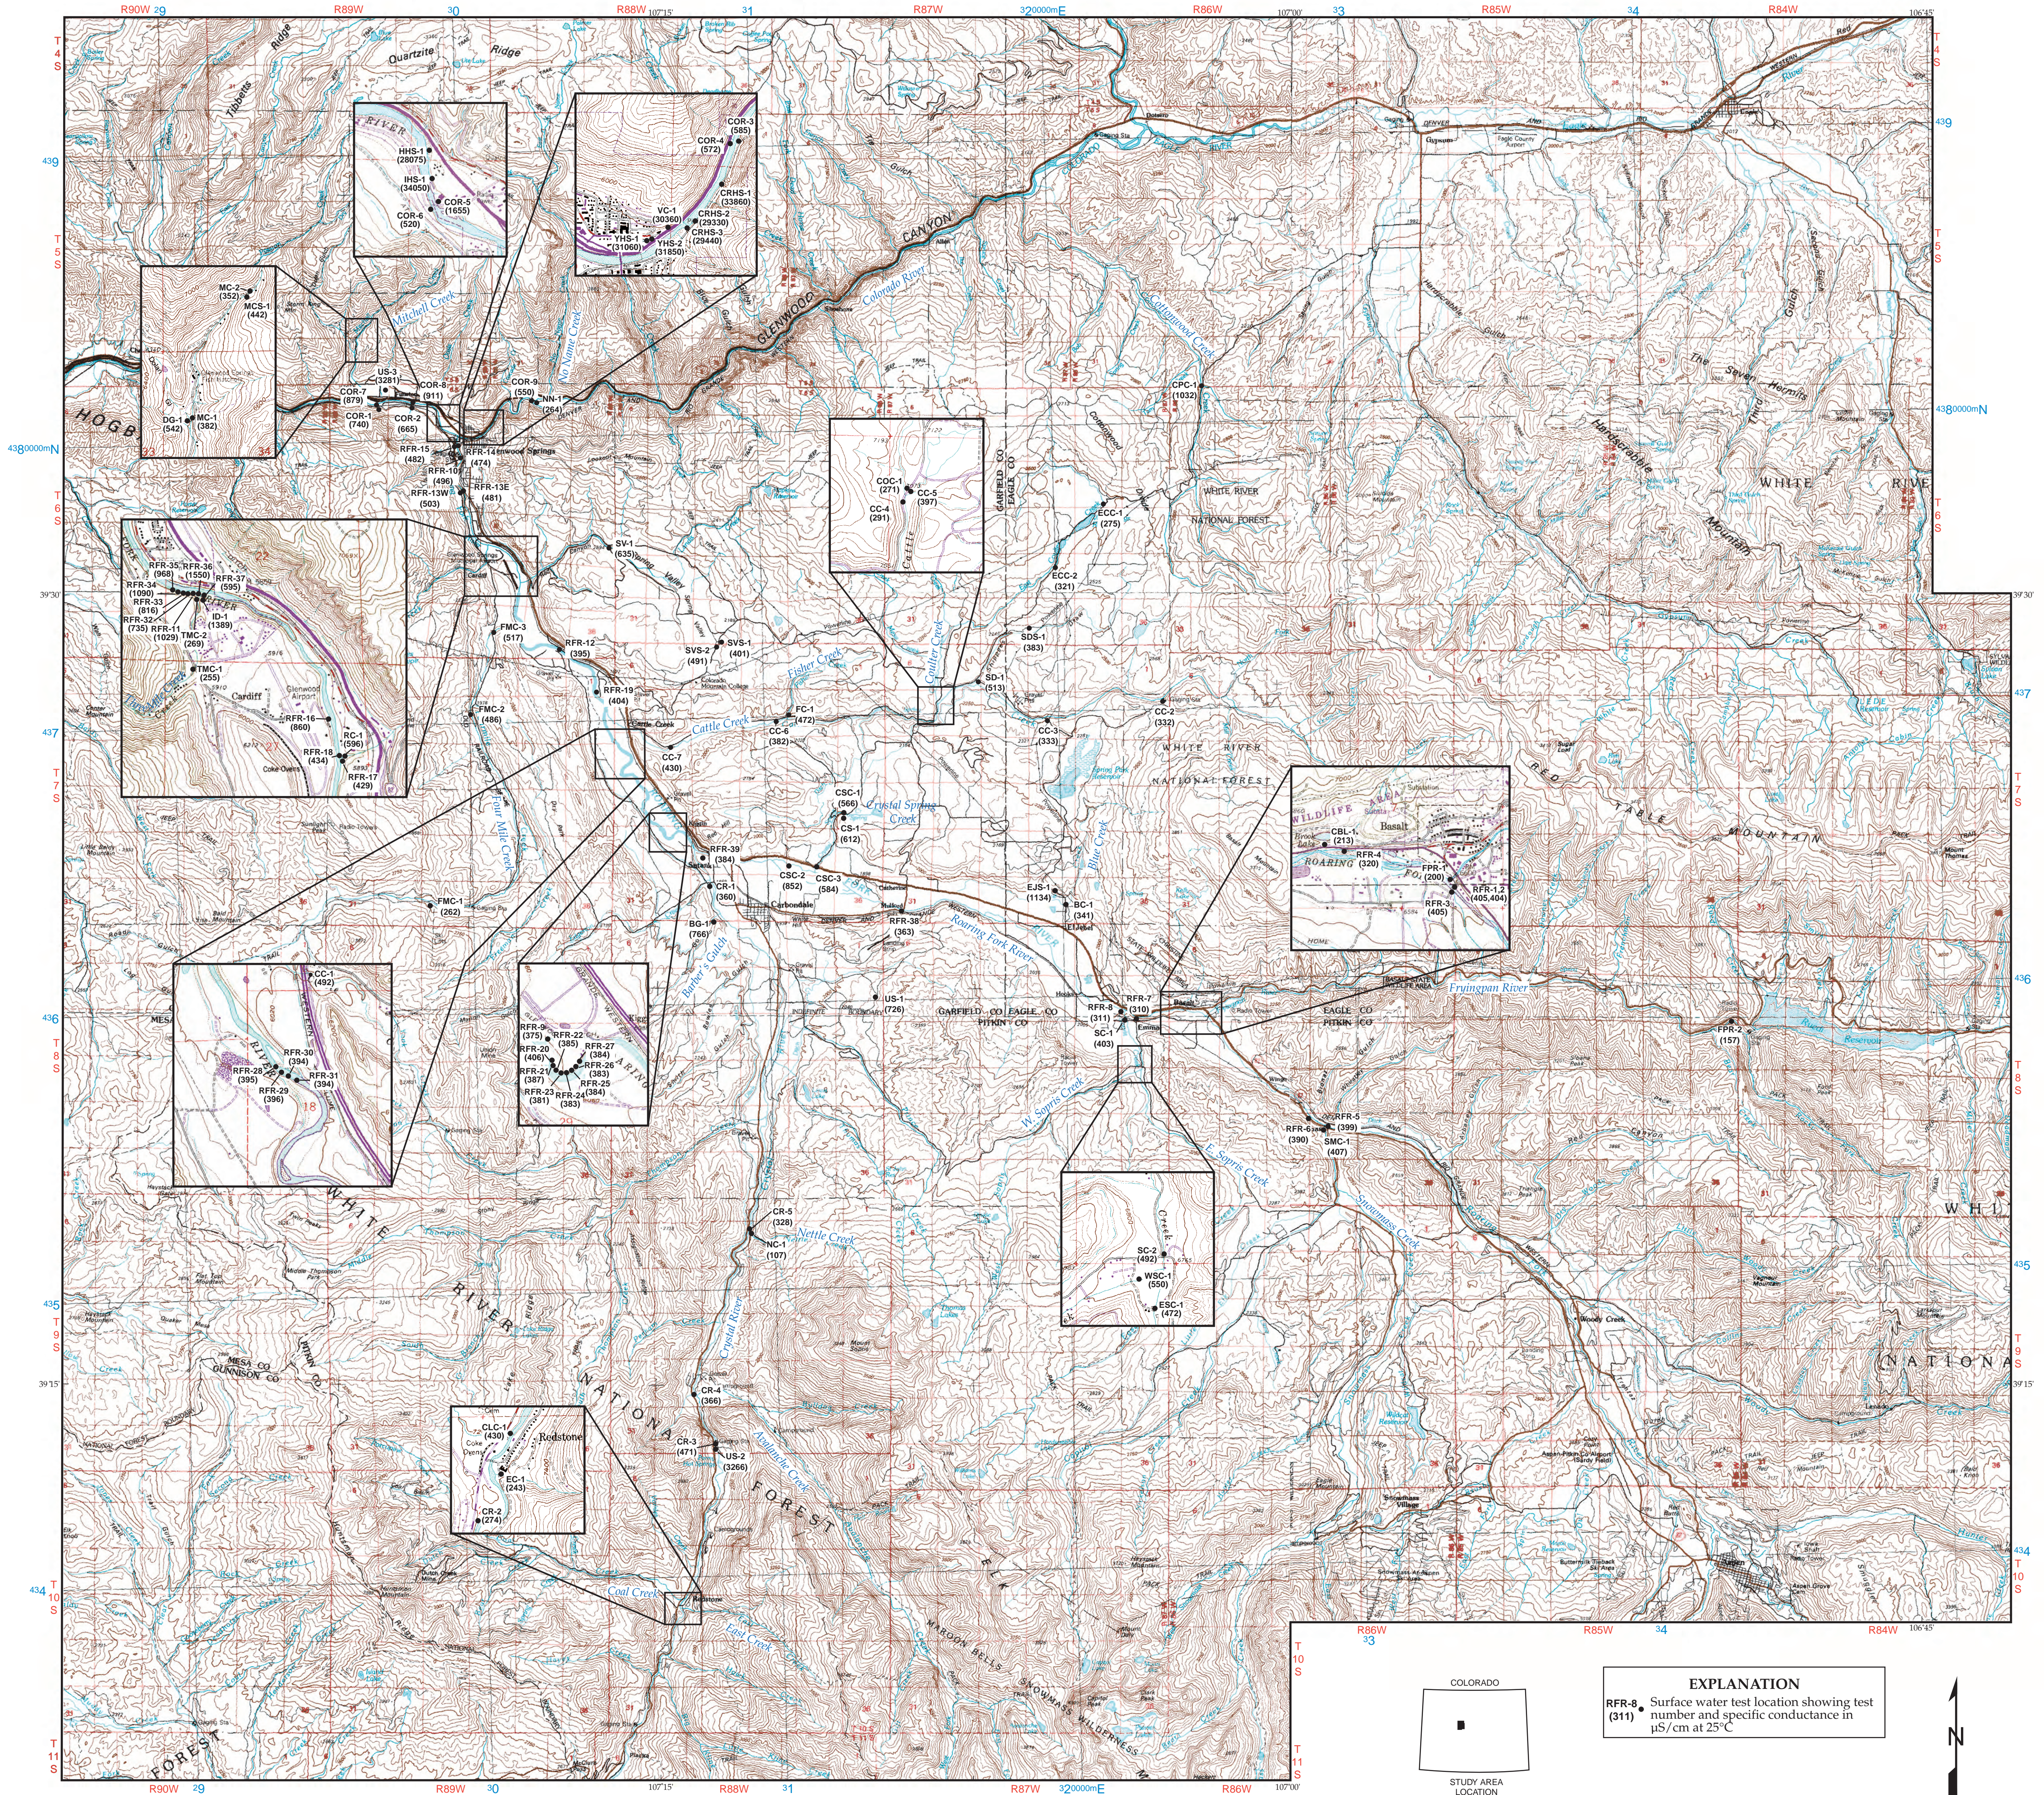
MAP SHOWING TEST LOCATIONS WITH SPECIFIC CONDUCTANCE VALUES, SNOWMASS-GLENWOOD SPRINGS AREA, WEST-CENTRAL COLORADO

EXPLANATION
RFR-8 (311) Surface water test location showing test number and specific conductance in $\mu\text{S}/\text{cm}$ at 25°C

and for a cold spring in Mitchell Creek northwest of Glenwood Springs. Test locations are shown on Plate 1, along with specific conductance data for each site. This information may be used to qualitatively assess the potential significance of individual springs and tributaries to the salinity of the Roaring Fork River, particularly springs that discharge from evaporitic rocks and tributaries that drain basins underlain by evaporitic rocks at or near the surface.
