Aerial Photograph/GIS Analysis and Field Studies
of the Grand Valley and Ruby-Horsethief Canyon of
the Colorado River

Department of Geography
University of Colorado
Boulder, Colorado 80309

June, 1995

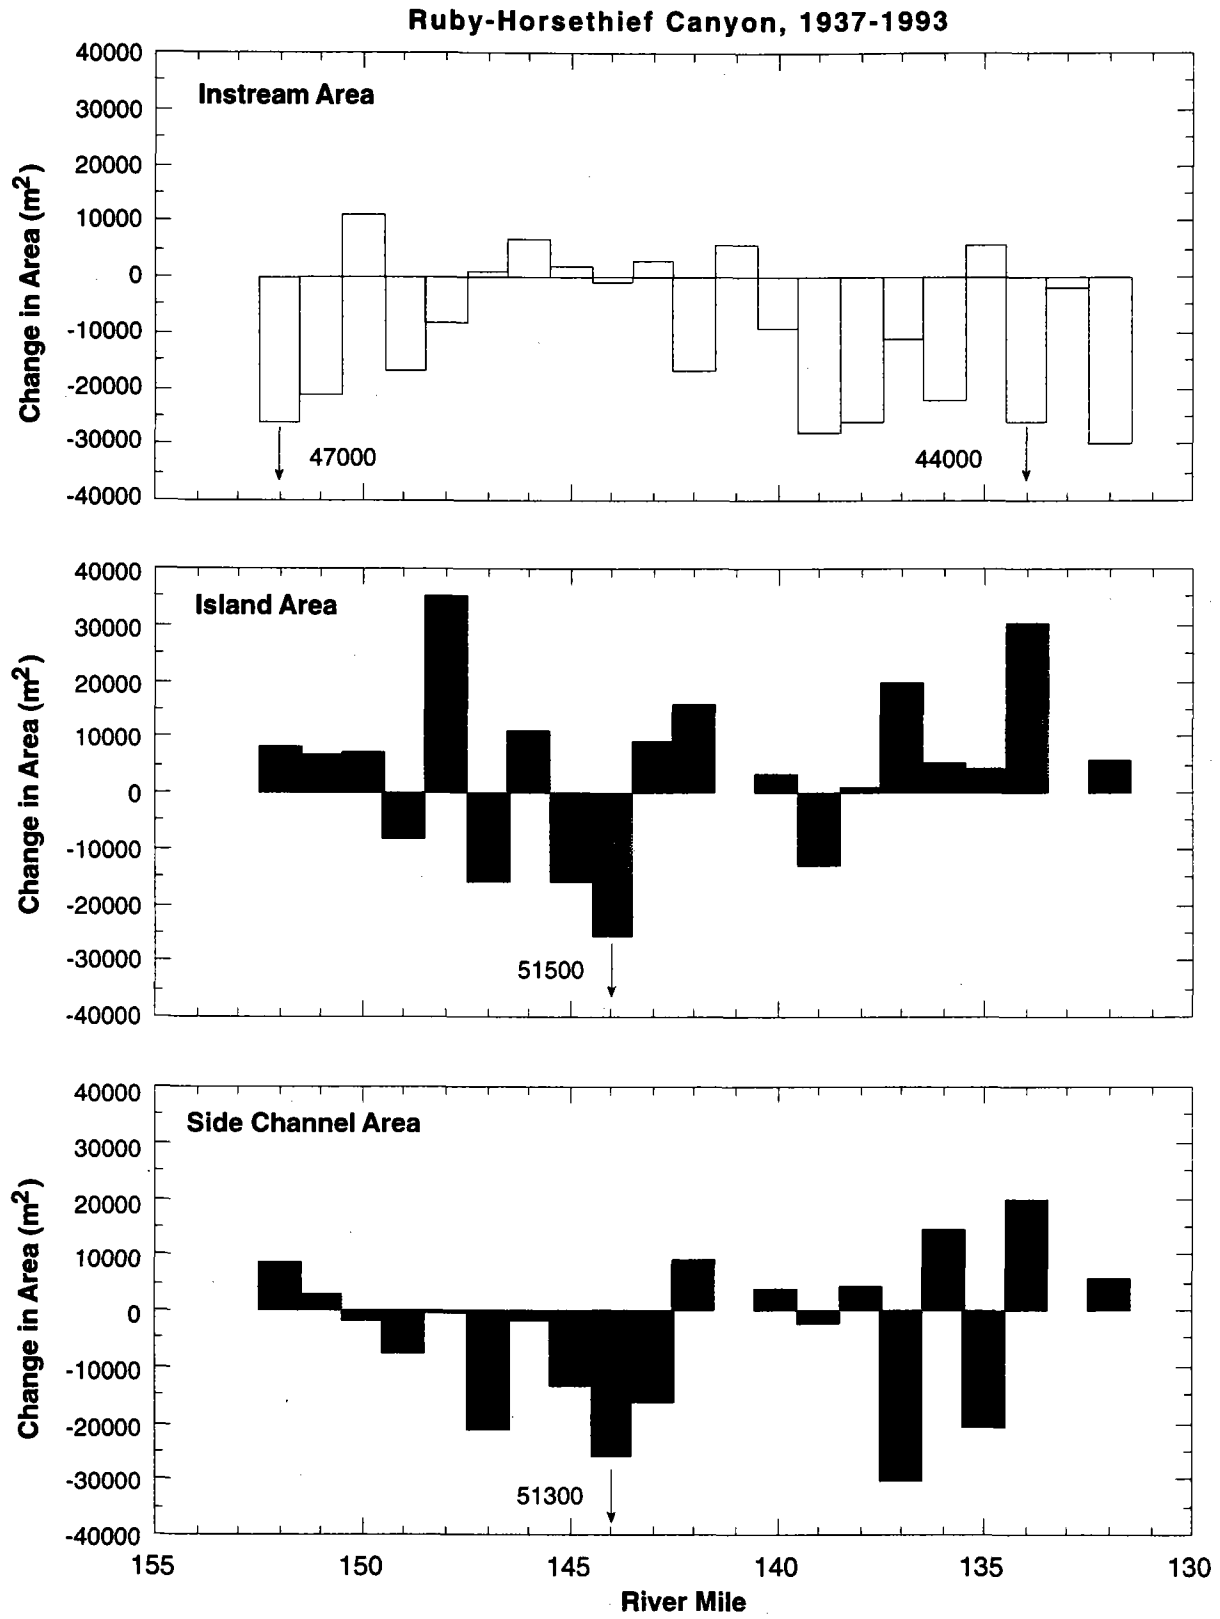
Figure 6. Changes in instream area, island, and side channel area in Ruby-Horsethief Canyon between 1937 and 1993

Results of the analysis of Ruby-Horsethief Canyon for 1937-1993 show a decrease of 6.5% for water area, a 9.5% increase in island area, and a 23.2% decrease in side channel/backwater area (Fig. 6, Table 2). For 1954-1968 there was a 3.4% decrease in water area, a 4.2% increase in island area, and a 2.4% decrease in side channel/backwater area (Fig. 7, Table 3). Mile by mile maps of channel change are located in Appendix I and II.

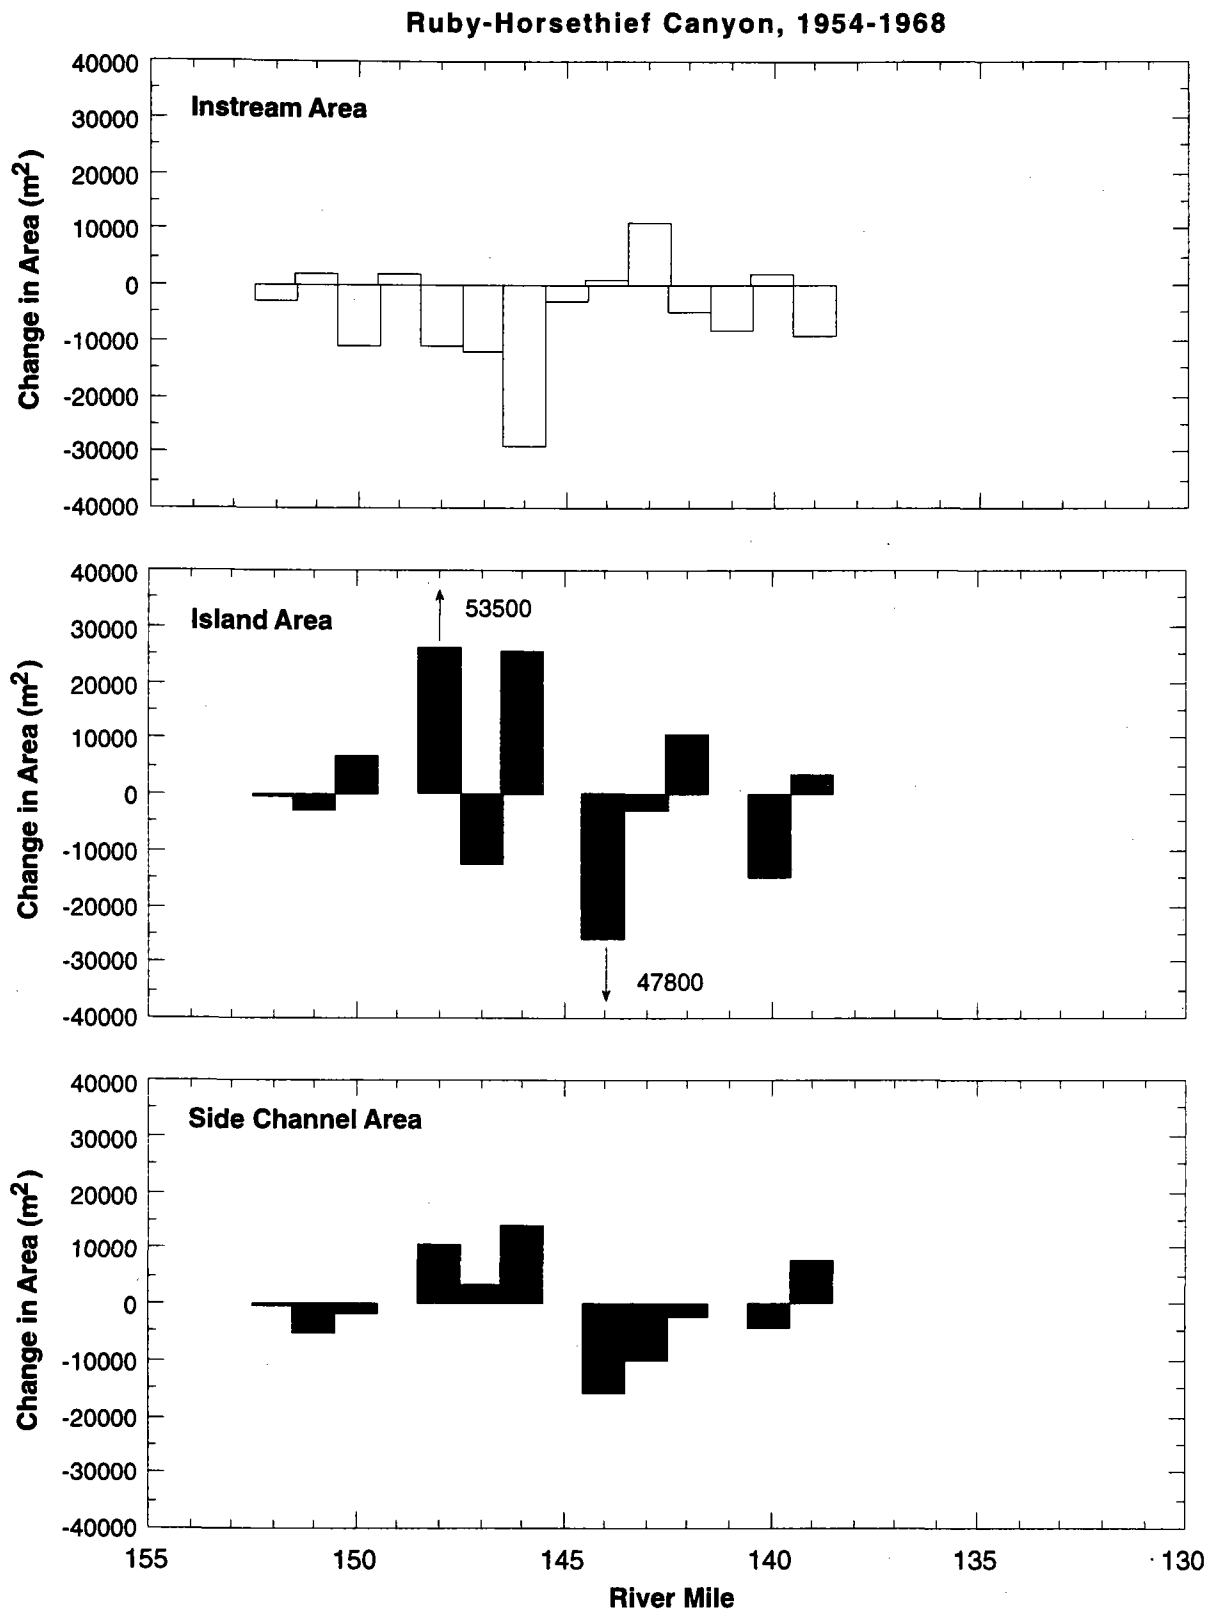
Figure 7. Changes in instream area, island, and side channel area in Ruby-Horsethief Canyon between 1954 and 1968

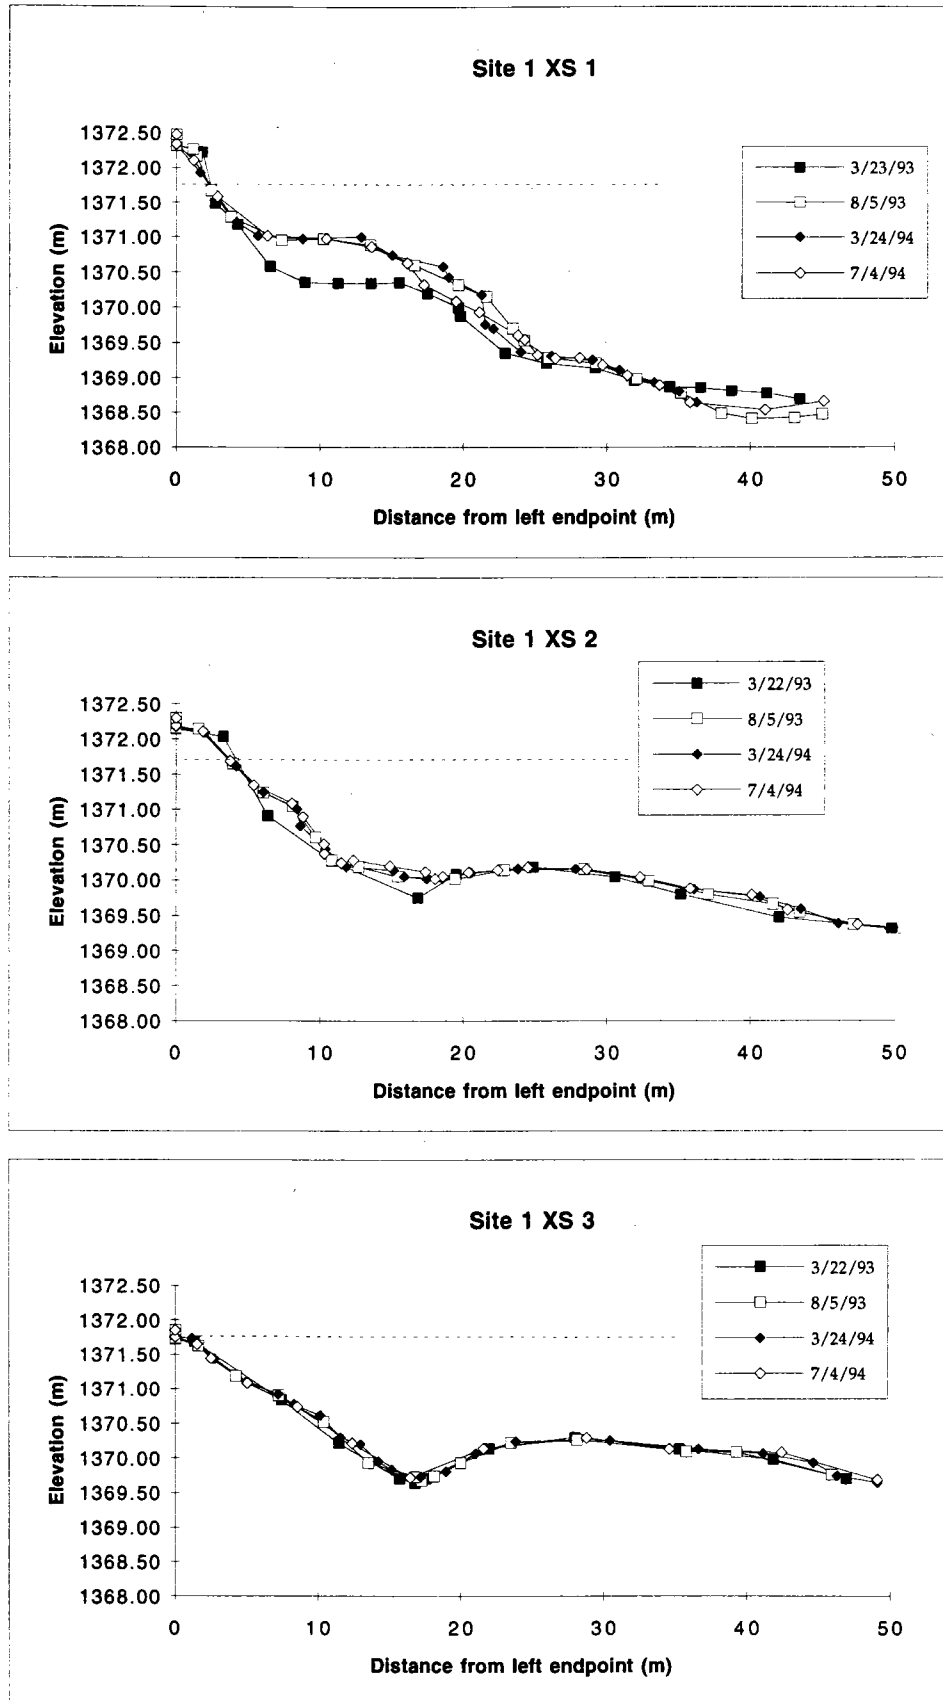
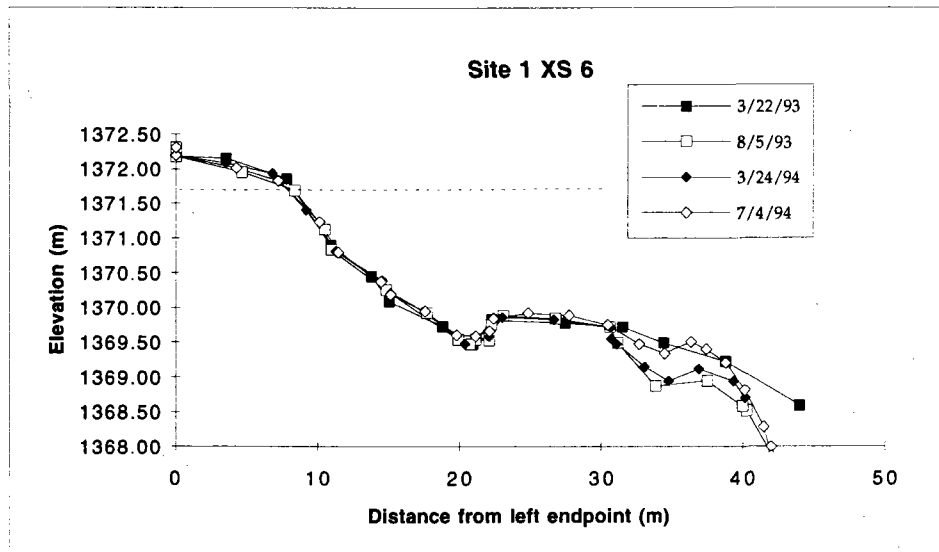
Figure 9. Channel cross-sections of Site 1. Cross-sections 1-3 are at the upstream end and 4-6 are at the downstream end

The flows of 1994 were low and only small amounts of scour and deposition were observed. There was 0-1.7m of deposition of fine sediment at the mouths of these backwaters, but other changes were minor. These trends are most evident at site 3 (Fig. 11). Site 2 showed fewer changes because it is a side channel even at moderate flows and substantial amounts of fine sediment do not accumulate (Fig. 10). Site 1 shows minimal changes at its mouth because of dense root mats of grasses which stabilize sediment (Fig. 9).

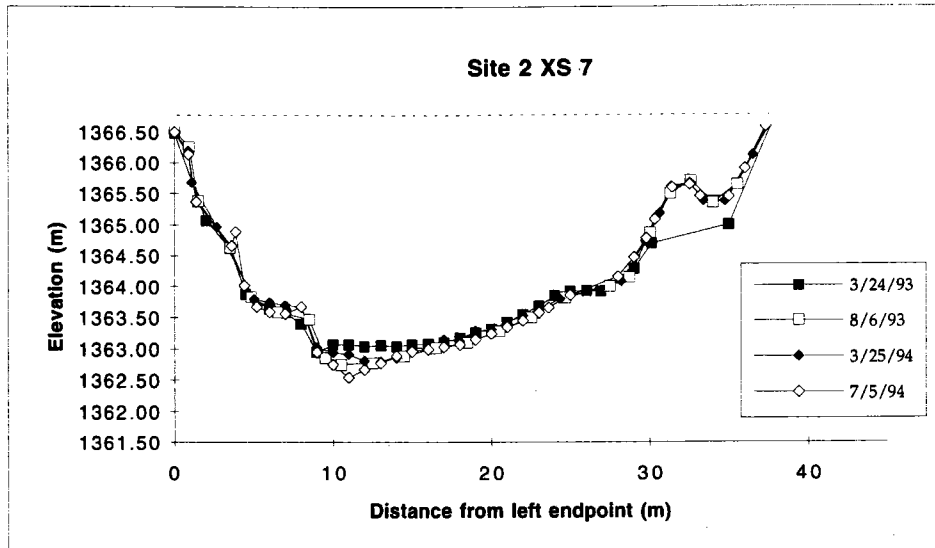
Figure 10. Channel cross-sections of Site 2. Cross-sections 1-4 are at the upstream end, 5-7 are intermediate, and 8-10 are at the downstream end

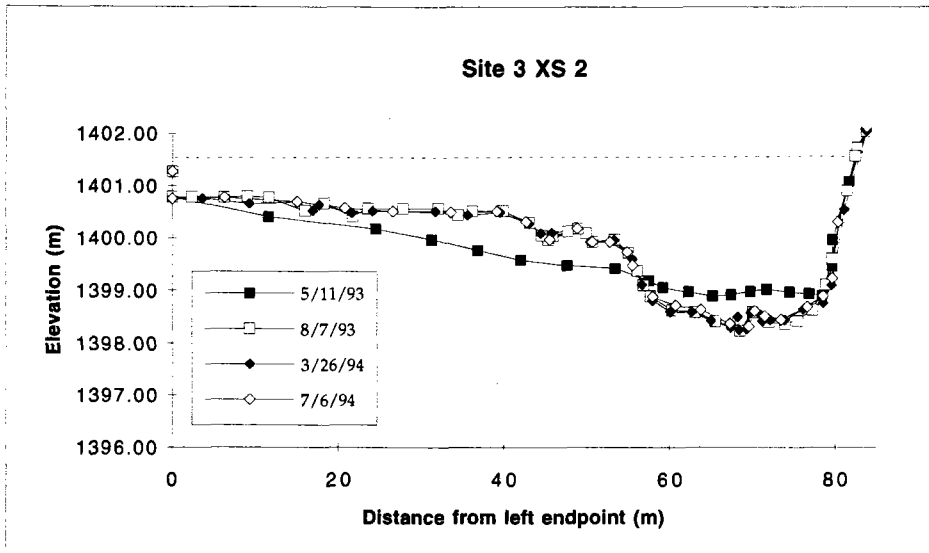
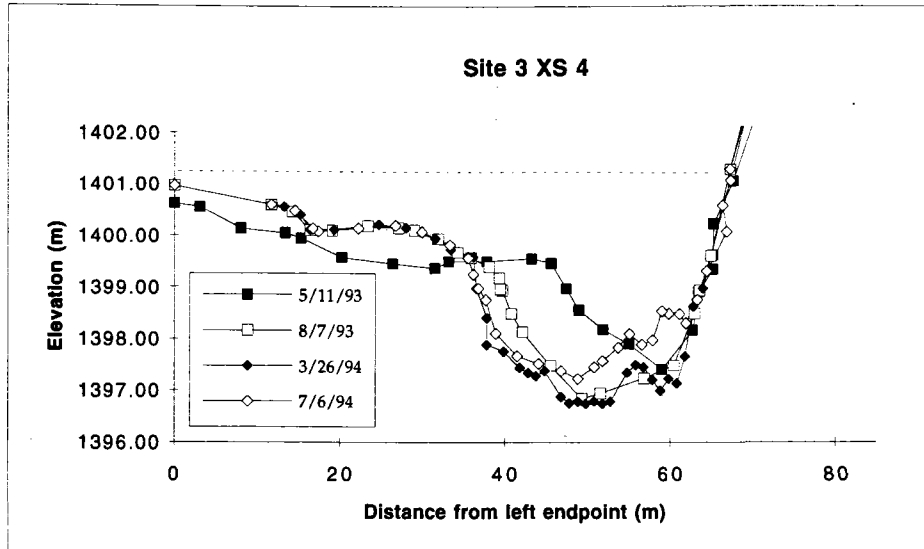
Figure 11. Channel cross-sections of Site 3. Cross-sections 1a-1c are at the upstream end, 1 and 2 are intermediate, and 3-5 are at the downstream end

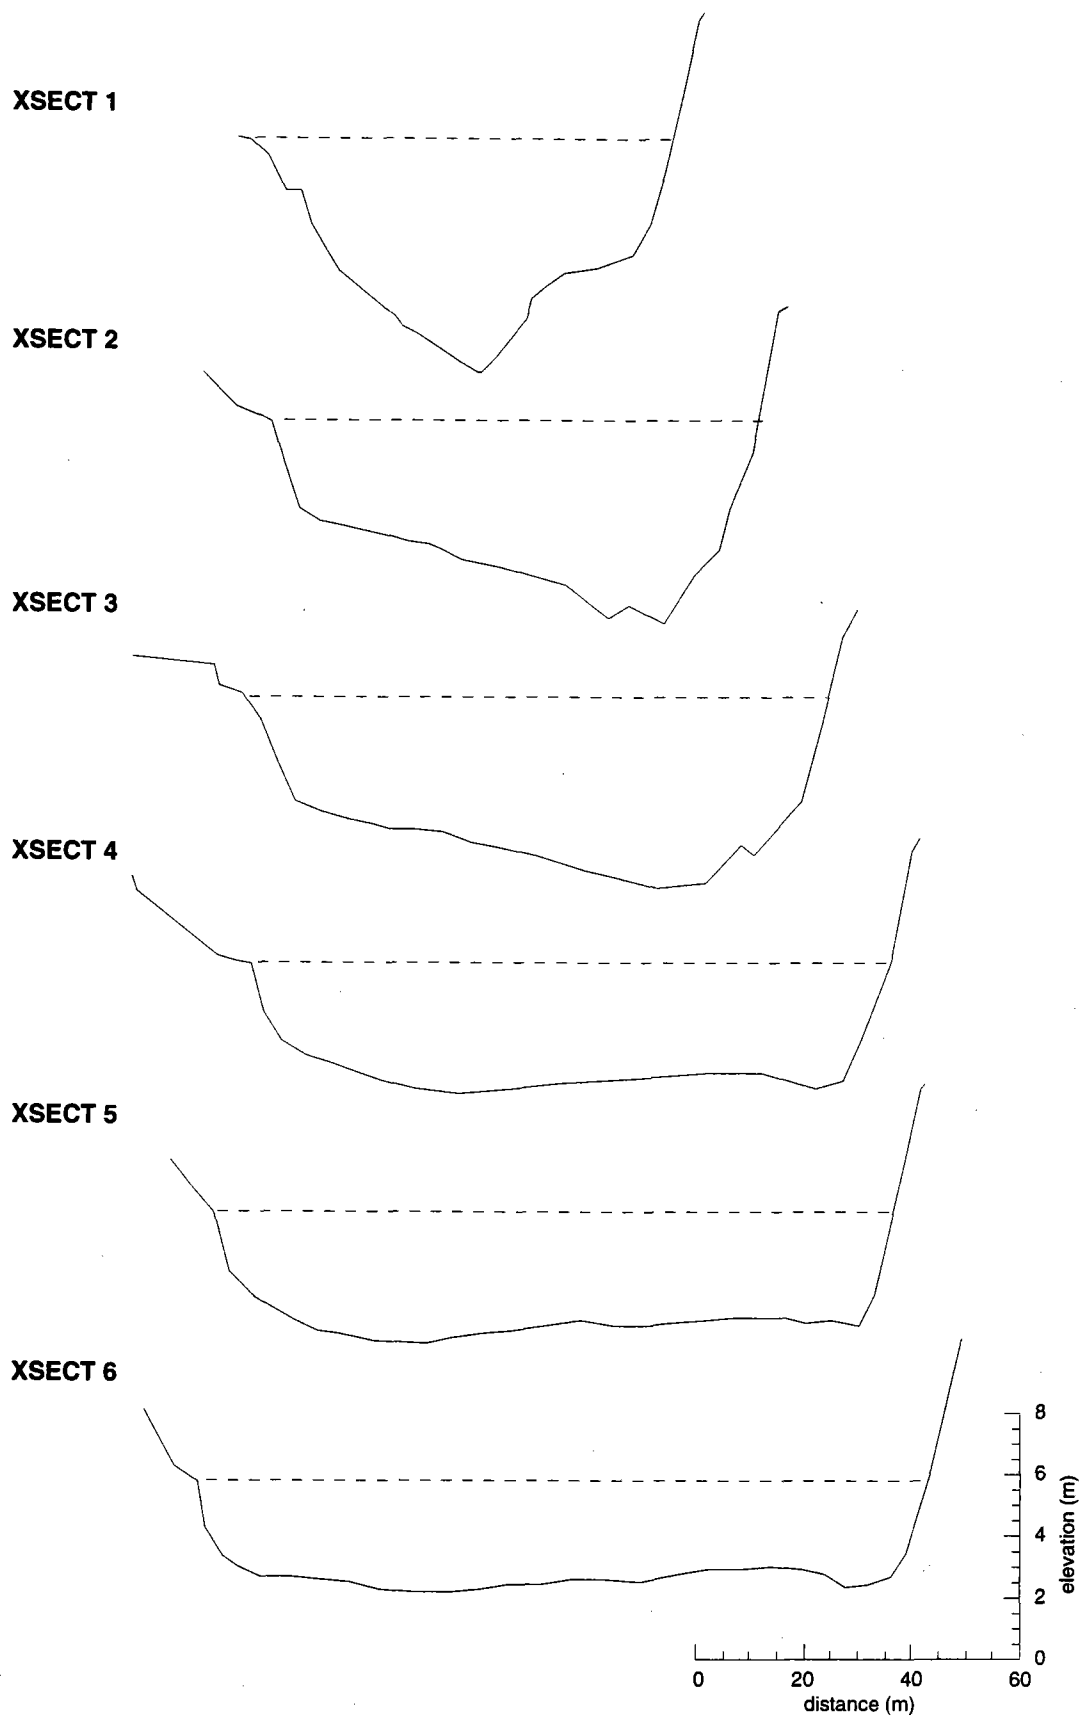
Figure 16. Main channel cross-sections of the Old Gauge site
