Report No. CDOT-DTD-R-92-11

COMPARISON OF RESULTS OBTAINED FROM THE FRENCH RUTTING TESTER WITH PAVEMENTS OF KNOWN FIELD PERFORMANCE

Final Report
October 1992

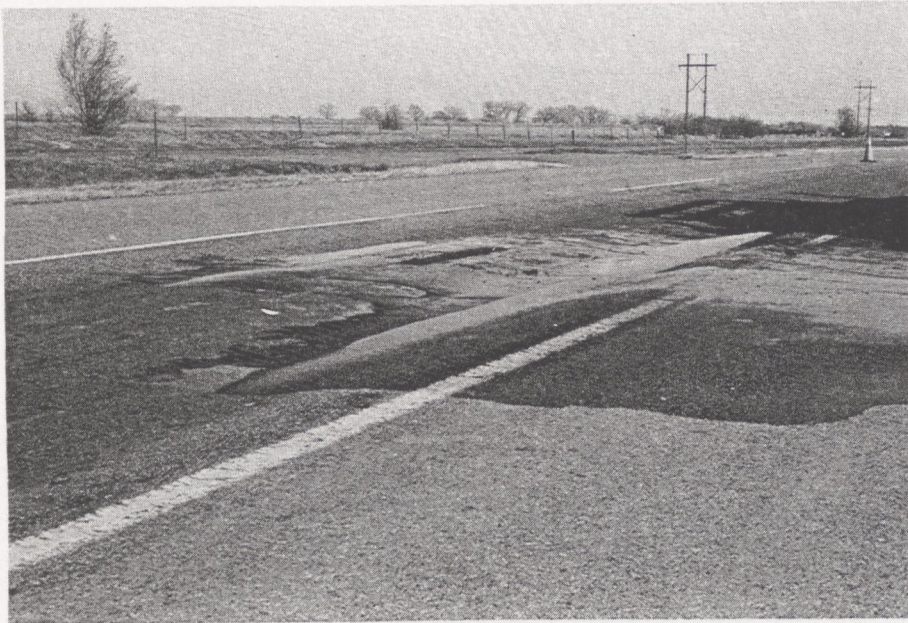
Photo 2

Sites were sawed between the wheels paths and parallel to the direction of travel.

third slab was tested at 50° or 60°C to measure repeatability. Plots of the rutting Cores and slabs were obtained from each selected site. Slabs were sawed between the wheel paths and parallel to the direction of travel. Three slabs were obtained at each location (Photos 2 and 3, Appendix A). Five, 4-inch diameter cores were obtained between the wheel paths and three, 4-inch diameter cores were obtained in the wheel paths. The thickness of lifts at each site was identified by observing and measuring the slabs.

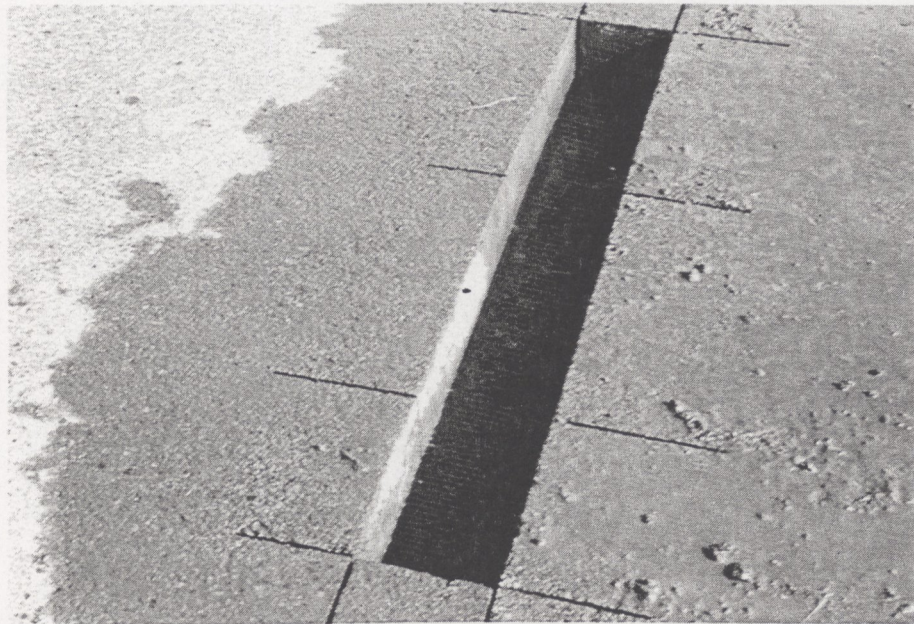
Photo 3

Three slabs were obtained at each location. The slabs cut in the field were 7.1" wide and 19.7" long. The depth of the slab varied depending on the thickness of the pavement.
