Miscellaneous Publication 8

Engineering Geologic Factors of the Marble Area, Gunnison County, Colorado

By
William P. Rogers,
Engineering Geologist
and
John W. Rold,
Director and State Geologist

Colorado Geological Survey
Department of Natural Resources
Denver, Colorado
1972

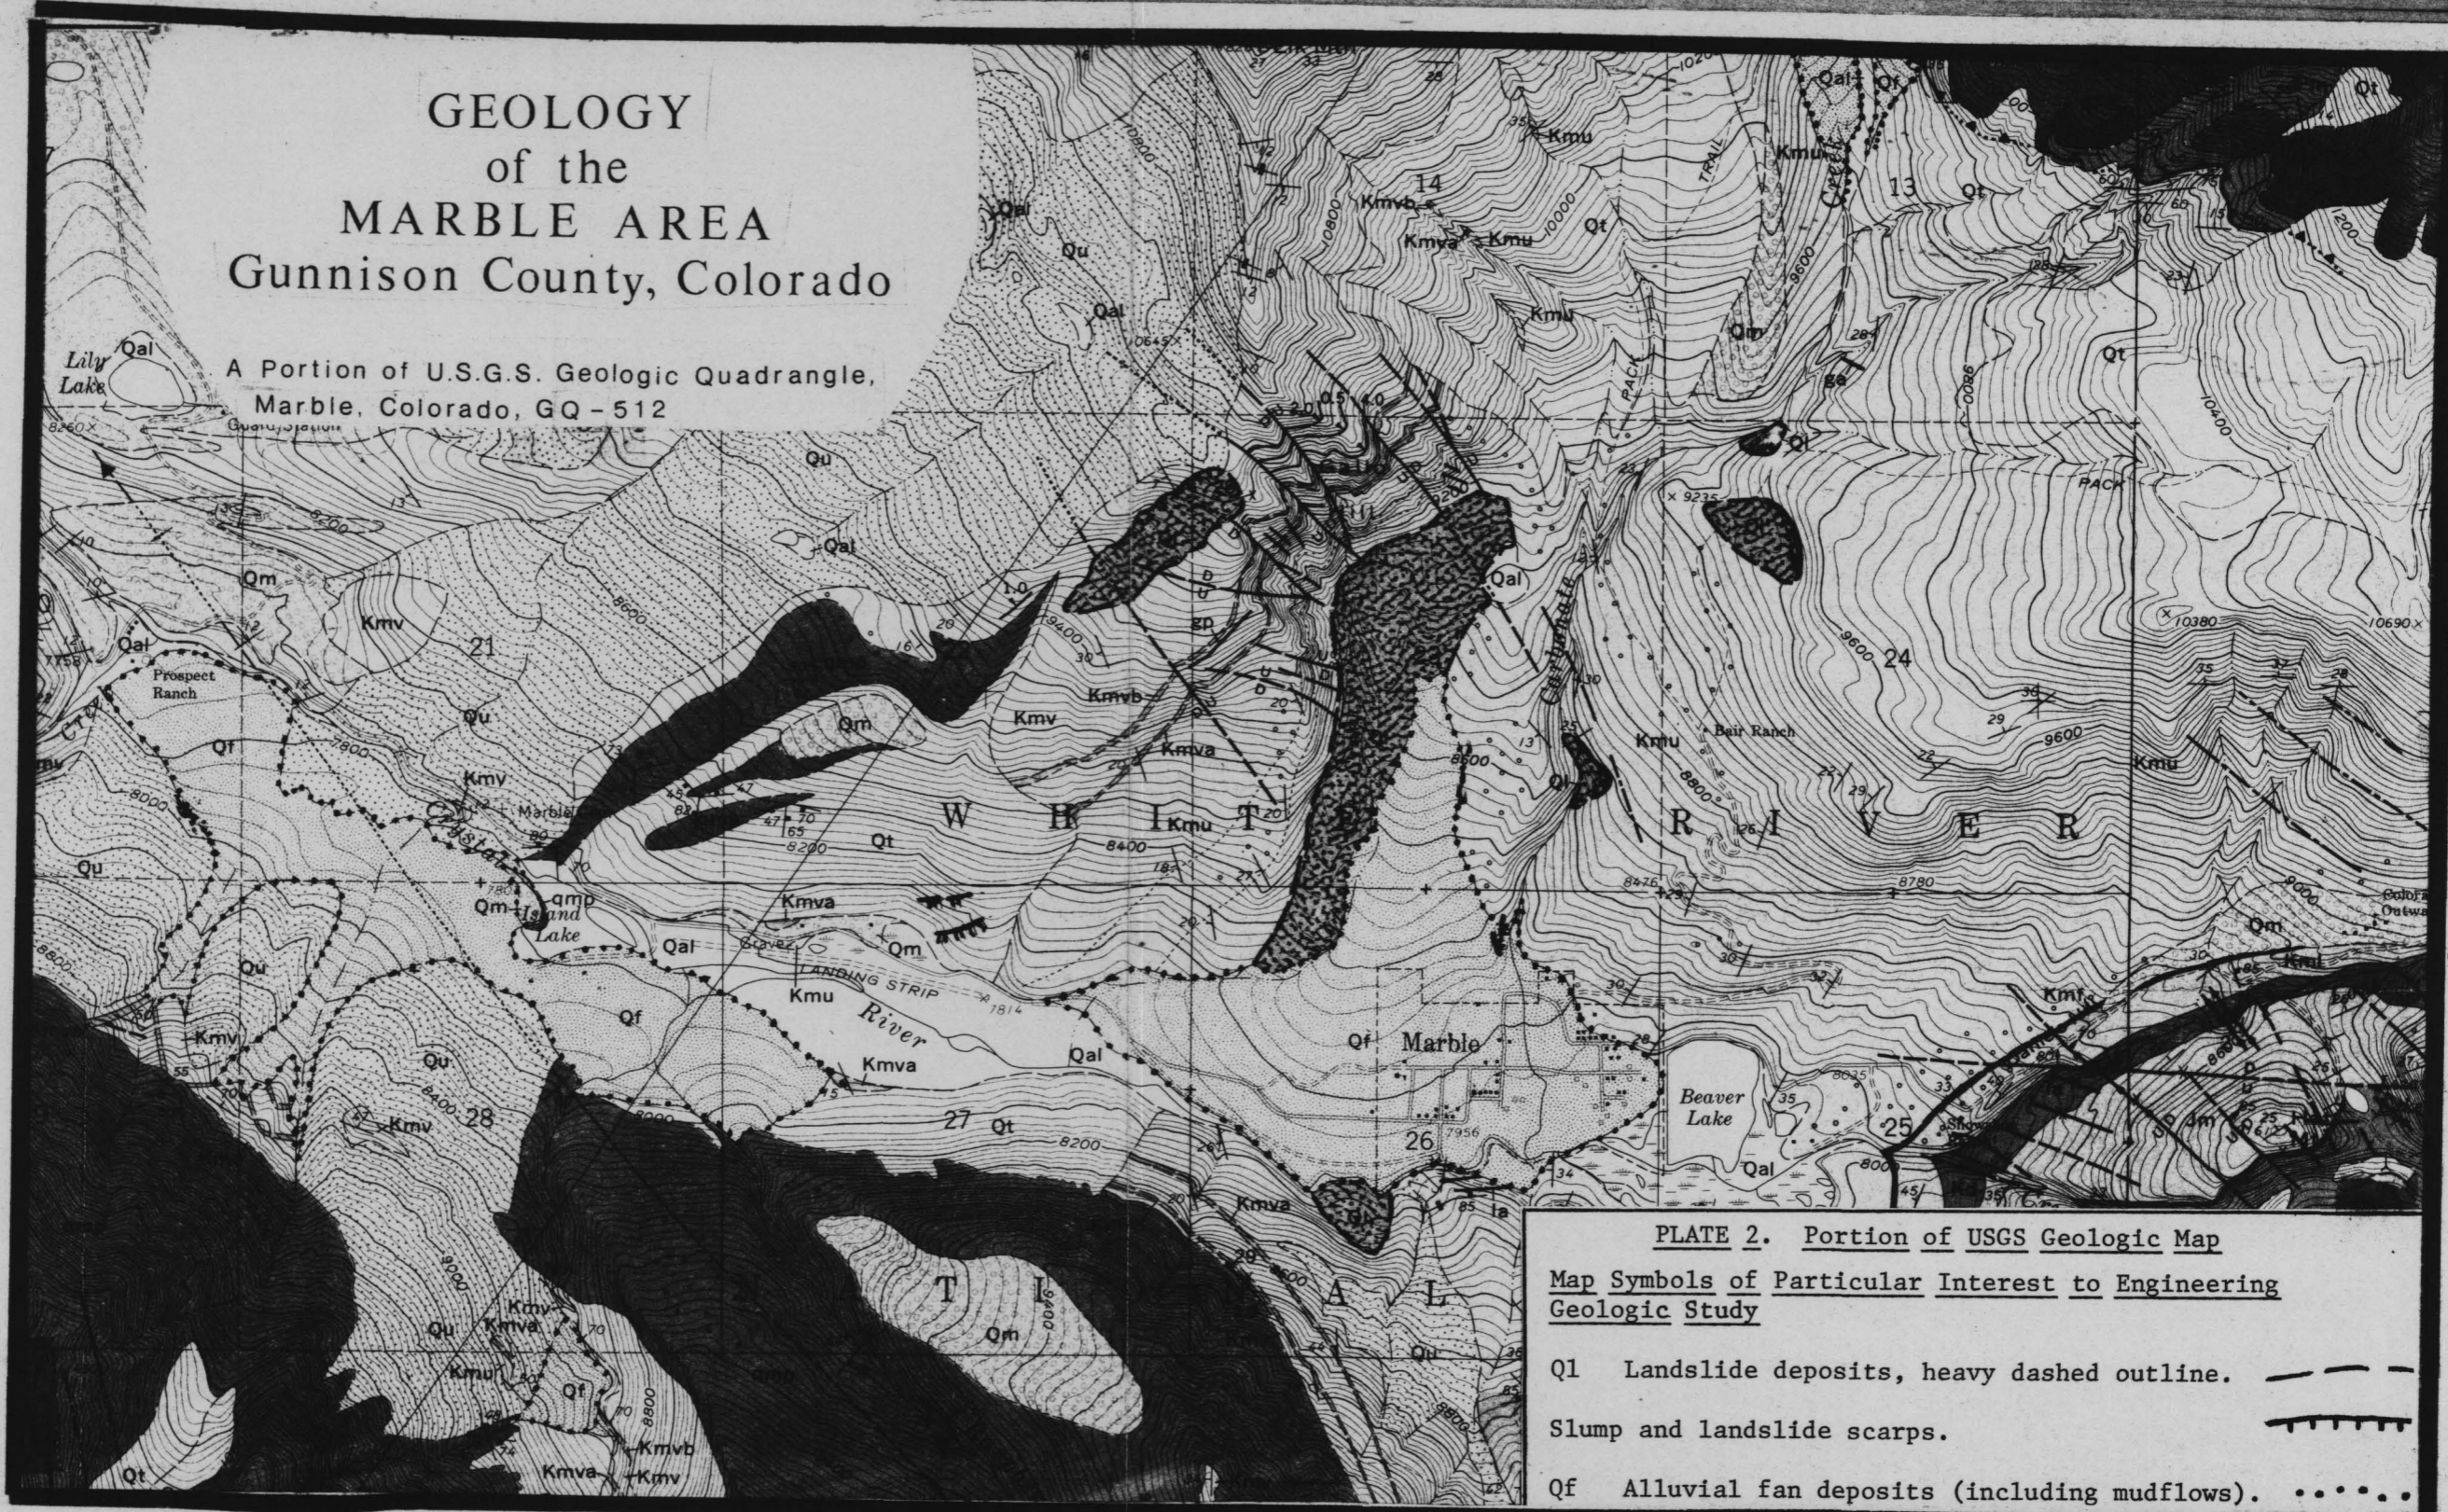
PLATE 2. Portion of USGS Geologic Map
Map Symbols of Particular Interest to Engineering
Geologic Study

Gaskill's geologic map indicates that the area south of the Crystal River in the vicinity of Marble is composed of the same Cretaceous shales and sandstones that were described on Gallo Bluff (plate 2). Slopes of this area are in the range of 40% to 100%. Both photographic and field observation indicate that the western part of this slope is an area of long standing and still active snow avalanching (4a, plate 1; figures 1, 4, 14). There are seven avalanche tracks across the area, and photo studies indicate that the accumulation areas have enlarged by erosion considerably since 1945. At the foot of each avalanche chute, there is a talus of fresh rock debris. In view of the steepness, the nature of the bedrock and the active avalanching and rockfall, these areas do not appear to be suitable for development.

The eastern part of the area south of Crystal River looks somewhat more favorable, but there are still several reasons for carefully considering any construction in the area. The geologic map (plate 2),

indicates strongly dipping Mancos shale beds with vertical jointing. These facts together with the generally steep slopes are enough to indicate the need for careful geologic and engineering studies and extreme caution. The lower part of this area is on the Crystal River flood plain, and just opposite the confluence with Carbonate Creek (4c, plate 1). Possible hazards from flooding and mudflows should be carefully evaluated before construction on this part of the site is planned.

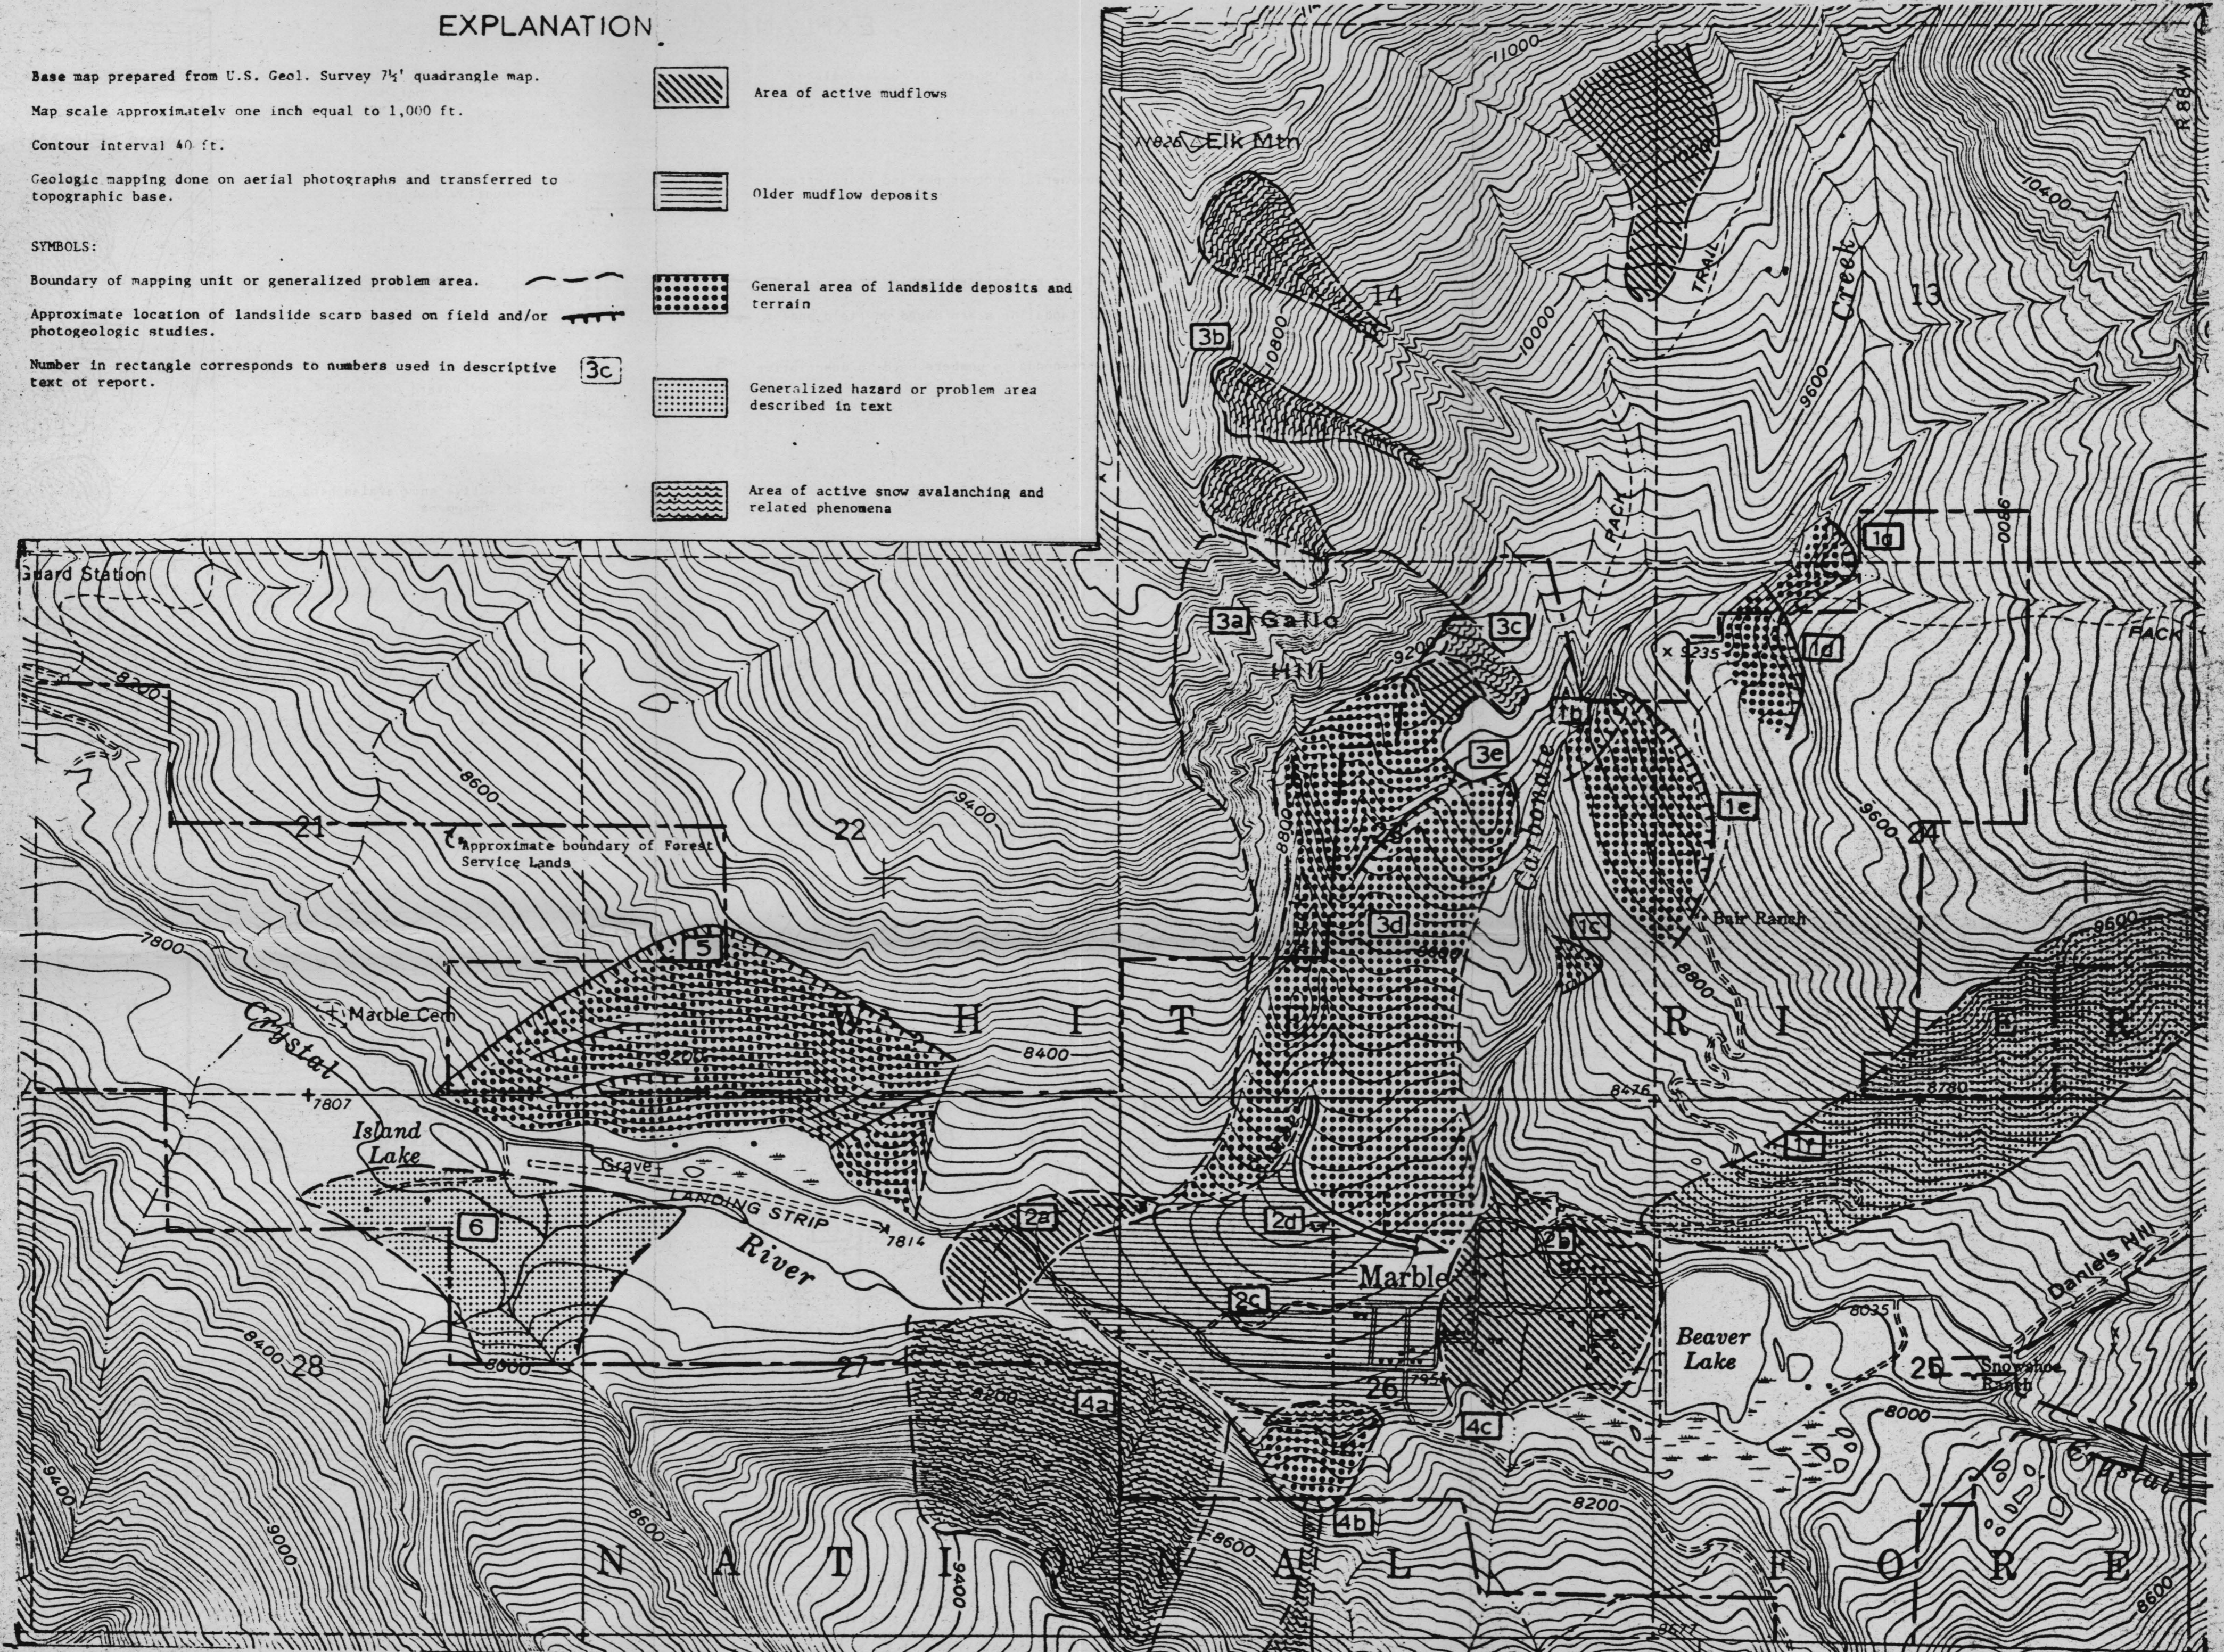
PLATE 1. ENGINEERING GEOLOGIC MAP, MARBLE AREA

Some of the larger and more extensive channels represent former through-flowing channels of Slate Creek as it shifted from one temporary position to another in building the mudflow fan. One major former channel in particular (2d, plate 1) has in the very recent past crossed the older fan and discharged mudflows into the Marble townsite from the northwest. According to local reports, this channel was artificially plugged and diverted to its present course by Marble residents to prevent Slate Creek mudflows from entering the town. From our field and photo inspections, it appears that the diversion is indeed man-made, which serves to show how temporary and easily diverted the channel location is at any given time. In our opinion, the re-entry of Slate Creek into this former channel is only one large landslide or mudflow away - provided the landslide is of the required size and location, or the flood of the necessary volume, viscosity, and erosive energy. The detailed

The central part of the area south of Crystal River (which is directly opposite the old marble works) is also very steep except for a large and fairly recent landslide mass (4b, plate 1) which has locally deflected the course of the river northward. There are also large accumulation areas and avalanche tracks above the landslide mass. These avalanches do not at the present time appear to be as active as those to the west, but the historic record describes many damaging avalanches which affected the marble works until a protective dike of waste marble was built. We feel that this part of the area also has many serious problems which would have to be resolved before construction of any kind is advisable.
