**Report No. CDOT-2007-7**  
**Final Report**

# **FORENSIC INVESTIGATION OF PAVEMENT FAILURE ON VASQUEZ BOULEVARD**

**May 2007**

**COLORADO DEPARTMENT OF TRANSPORTATION  
RESEARCH BRANCH**

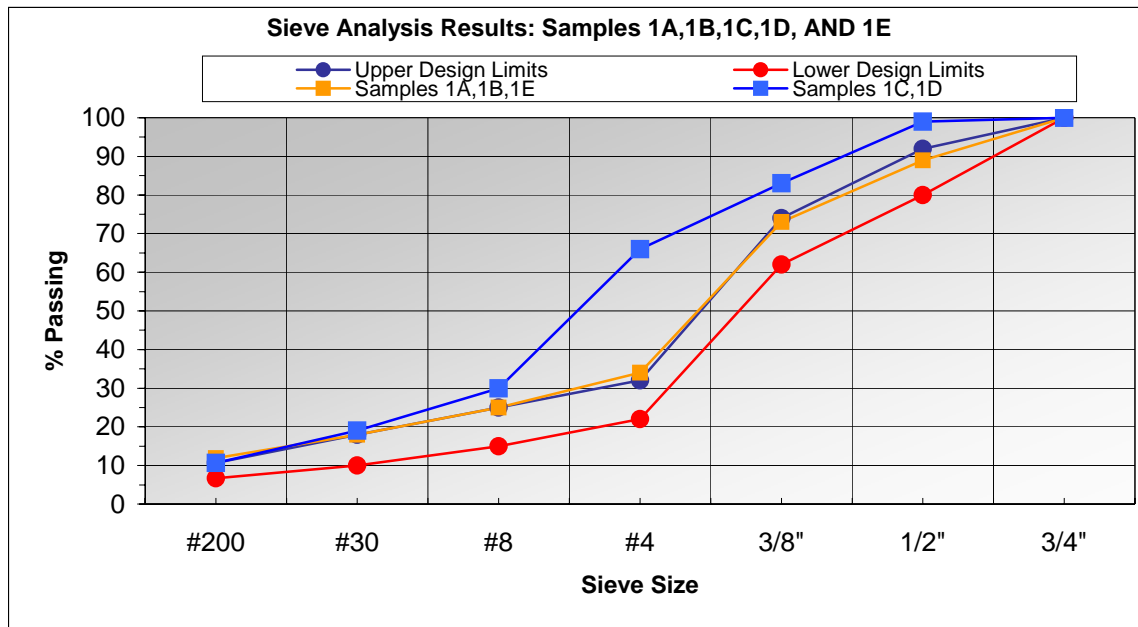
Figure 4: Sieve Gradation Results – Core Set 1

\* Out of Specification

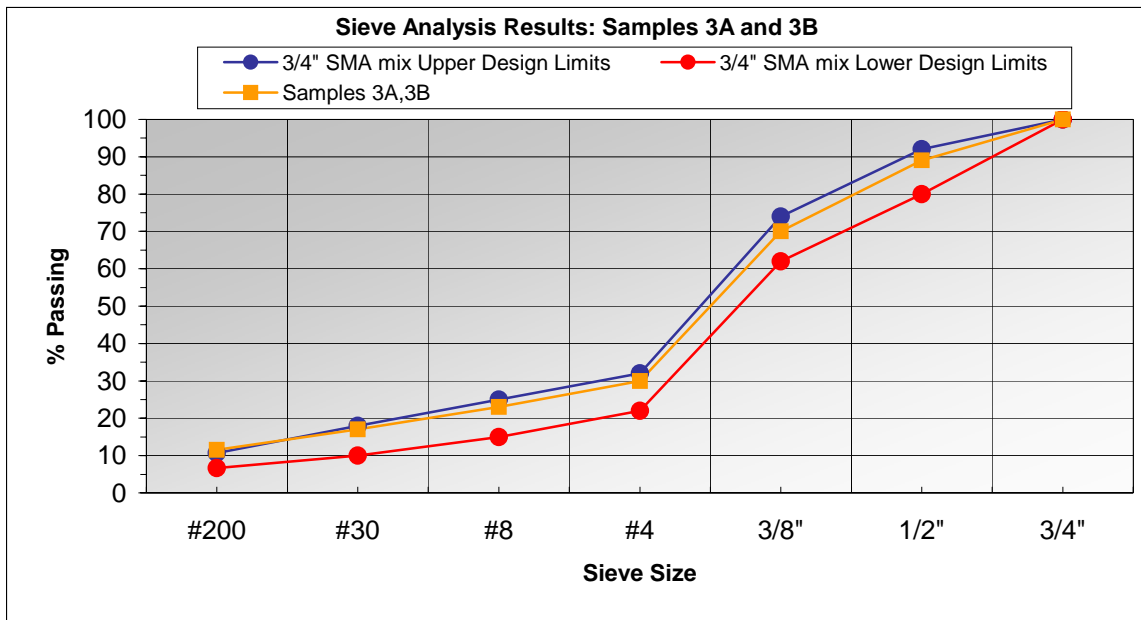
Figure 5: Sieve Gradation Results – Core Set 3

<b>3/4" SMA Mix Cores</b>	<b>3A</b>	<b>3B</b>	
<b>Size - In.</b>	<b>% Passing</b>	<b>% Passing</b>	<b>Job Mix Formula</b>
3/4"	100	100	100
1/2"	89	89	80-92
3/8"	70	70	62-74
#4	30	30	22-32
#8	23	23	15-25
#16	19	19	N/A
#30	17	17	10-18
#50	15	15	N/A
#100	13	13	N/A
#200	11.6*	11.6*	6.7-10.7

\* Out of Specification

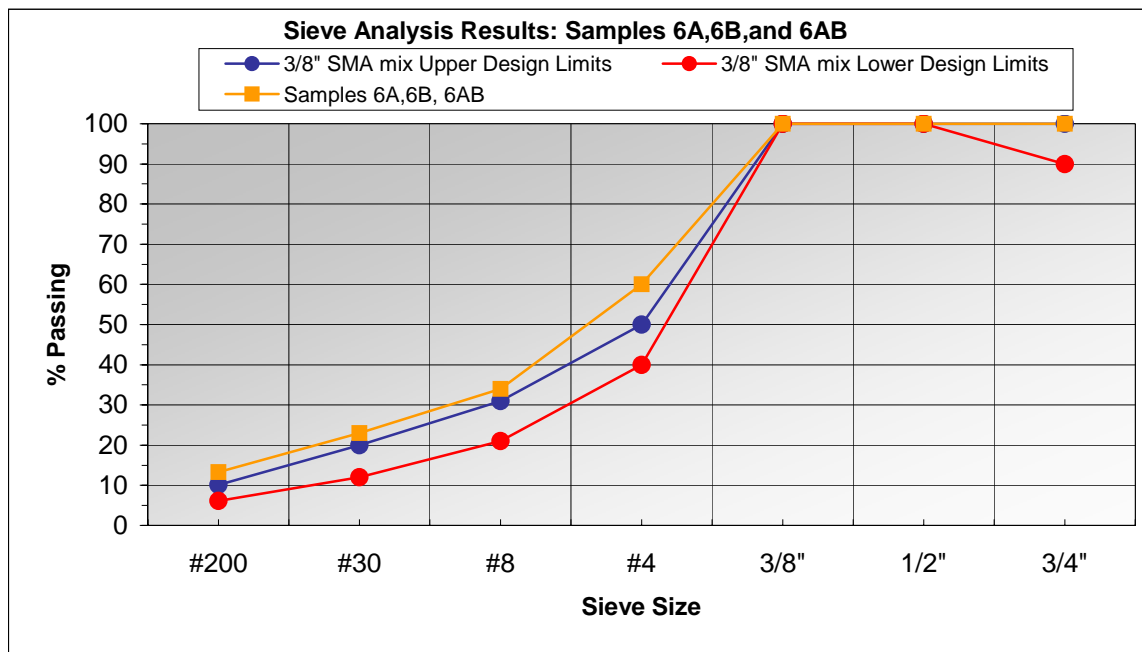
Figure 6: Sieve Gradation Results – Core Set 6

3/8" SMA Mix Cores:	6A,6B	6AB	Job Mix Formula
Size - In.	% Passing	% Passing	
3/4"	100	100	100
1/2"	100	100	100
3/8"	100	100	90-100
#4	60*	60*	40-50
#8	34*	34*	21-31
#16	27	27	N/A
#30	23*	23*	12-20
#50	19	19	N/A
#100	15	15	N/A
#200	13.3*	13.3*	6.1-10.1

\* Out of Specification

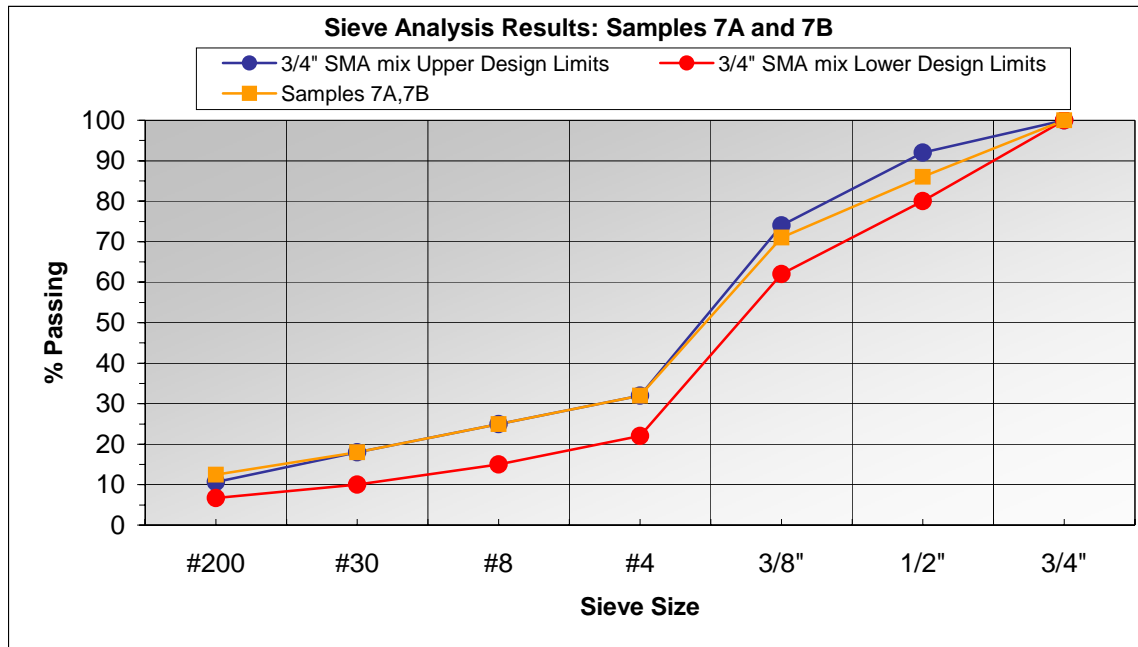
Figure 7: Sieve Gradation Results – Core Set 7

<b>3/4" SMA Mix Cores:</b>	<b>7A</b>	<b>7B</b>	
<b>Size - In.</b>	<b>% Passing</b>	<b>% Passing</b>	<b>Job Mix Formula</b>
3/4"	100	100	100
1/2"	86	86	80-92
3/8"	71	71	62-74
#4	32	32	22-32
#8	25	25	15-25
#16	21	21	N/A
#30	18	18	10-18
#50	16	16	N/A
#100	13	13	N/A
#200	12.5*	12.5*	6.7-10.7

\* Out of Specification

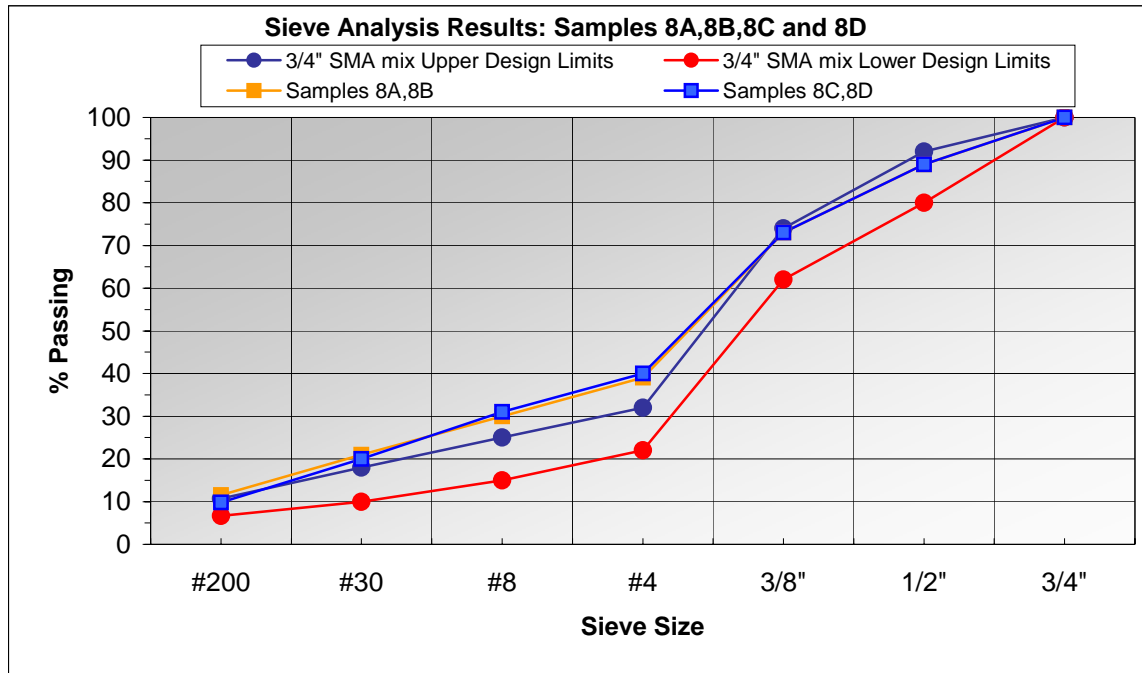
Figure 8: Sieve Gradation Results – Core Set 8

3/4" SMA Mix Cores:	8A,8B	8C,8D	Job Mix Formula
Size - In.	% Passing	% Passing	
3/4"	100	100	100
1/2"	89	89	80-92
3/8"	73	73	62-74
#4	39*	40*	22-32
#8	30*	31*	15-25
#16	25	25	N/A
#30	21	20*	10-18
#50	17	16	N/A
#100	14	12	N/A
#200	11.5*	9.8	6.7-10.7

\* Out of Specification

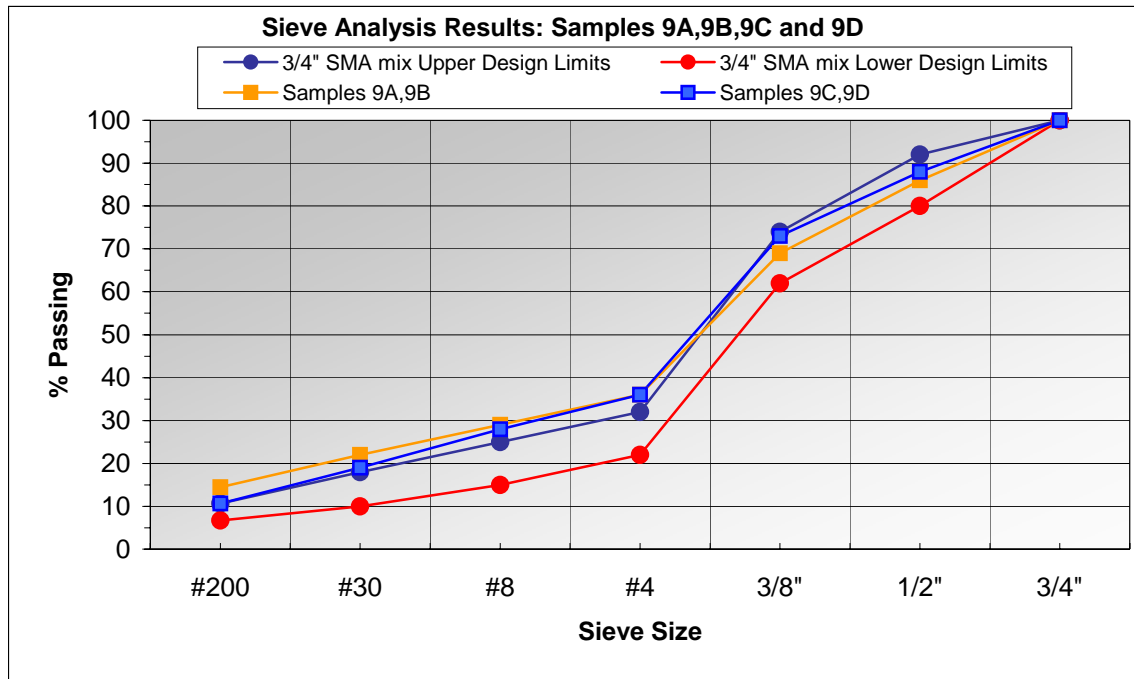
Figure 9: Sieve Gradation Results – Core Set 9

<b>3/4" SMA Mix Cores:</b>	<b>9A,9B</b>	<b>9C,9D</b>	
<b>Size - In.</b>	<b>% Passing</b>	<b>% Passing</b>	<b>Job Mix Formula</b>
3/4"	100	100	100
1/2"	86	88	80-92
3/8"	69	73	62-74
#4	36*	36*	22-32
#8	29*	28*	15-25
#16	25	23	N/A
#30	22*	19*	10-18
#50	19	16	N/A
#100	17	13	N/A
#200	14.5*	10.7	6.7-10.7

\* Out of Specification

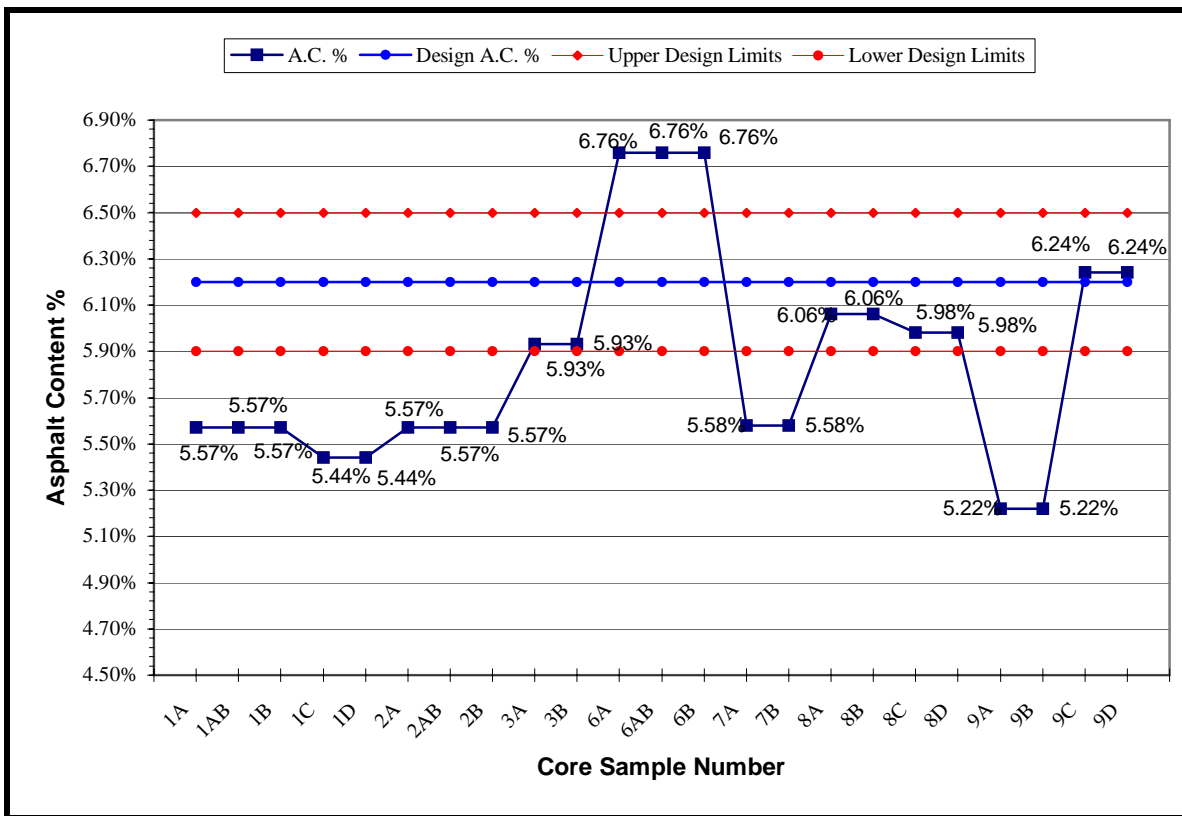
Figure 10: Asphalt Content Testing Results

Asphalt Content was measured in core samples from areas 1, 2, 3, 6, 7, 8, and 9. Results from these tests show that only 8 of the core samples tested had an asphalt content within the 6.20% +/-0.3 formula mix design specifications. 3 samples, 6A, 6AB, and 6B, exceeded the upper design limits for asphalt content. 12 samples, 1A, 1AB, 1B, 1C,AD, 2A, 2AB, 2B, 3A, 3B, 7A, 7B, 9A, and 9B did not meet the lower asphalt content tolerances.

Asphalt Content Ranges from 5.22% to 6.76%

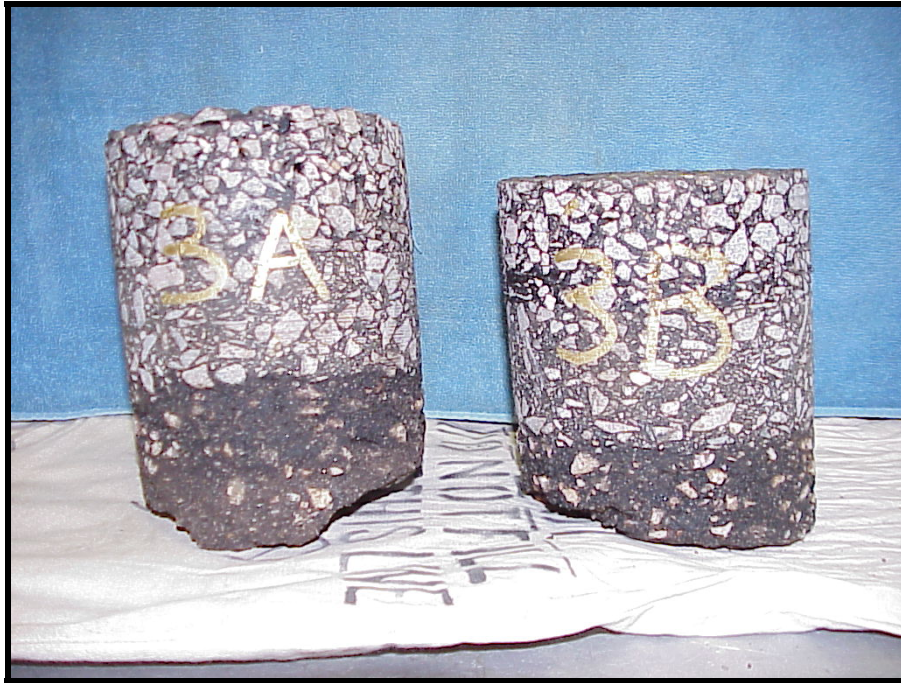
Figure 18: Core samples 3A and 3b from coring site 3

SMA only maintains its thickness to follow the contours of the failed HMA

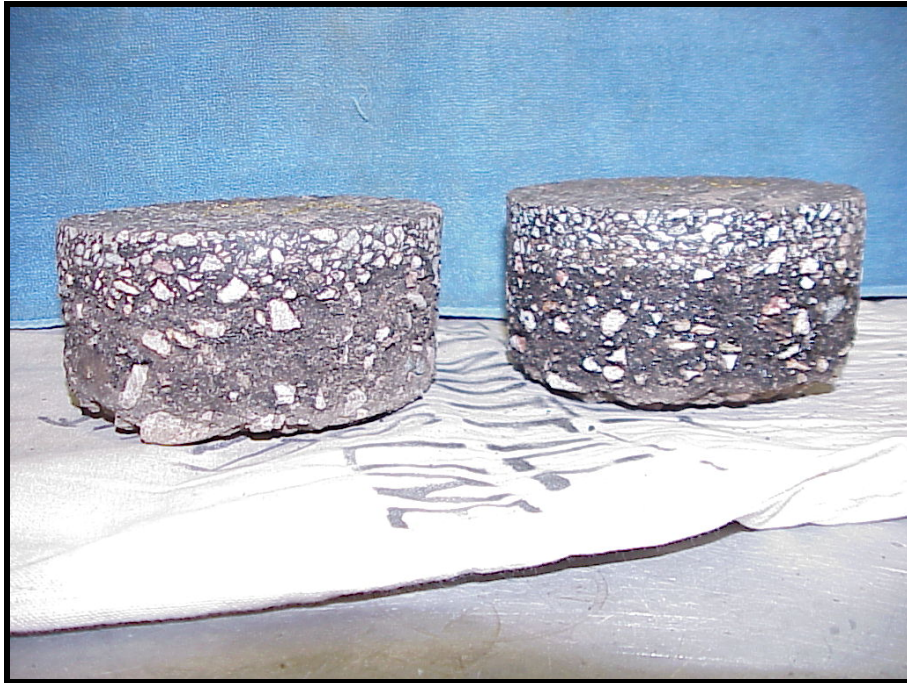
Figure 20: Core samples 5A and 5B from coring site 5

No rutting was discovered in the SMA lifts over existing PCCP pavement

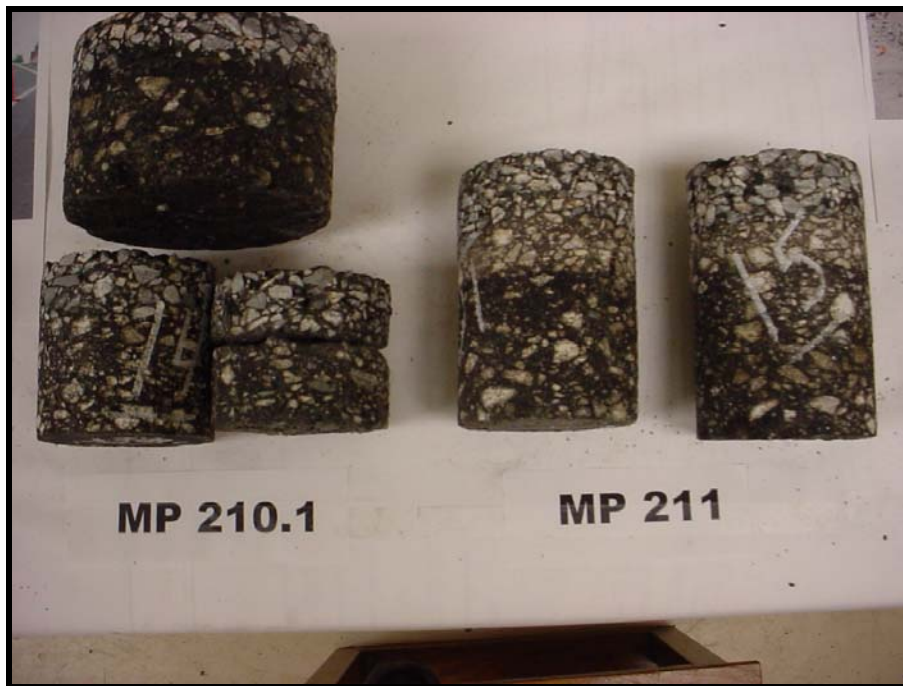
Figure 35: Core Samples MP 210.1 and MP 211

Core samples showing stripping from moisture damage

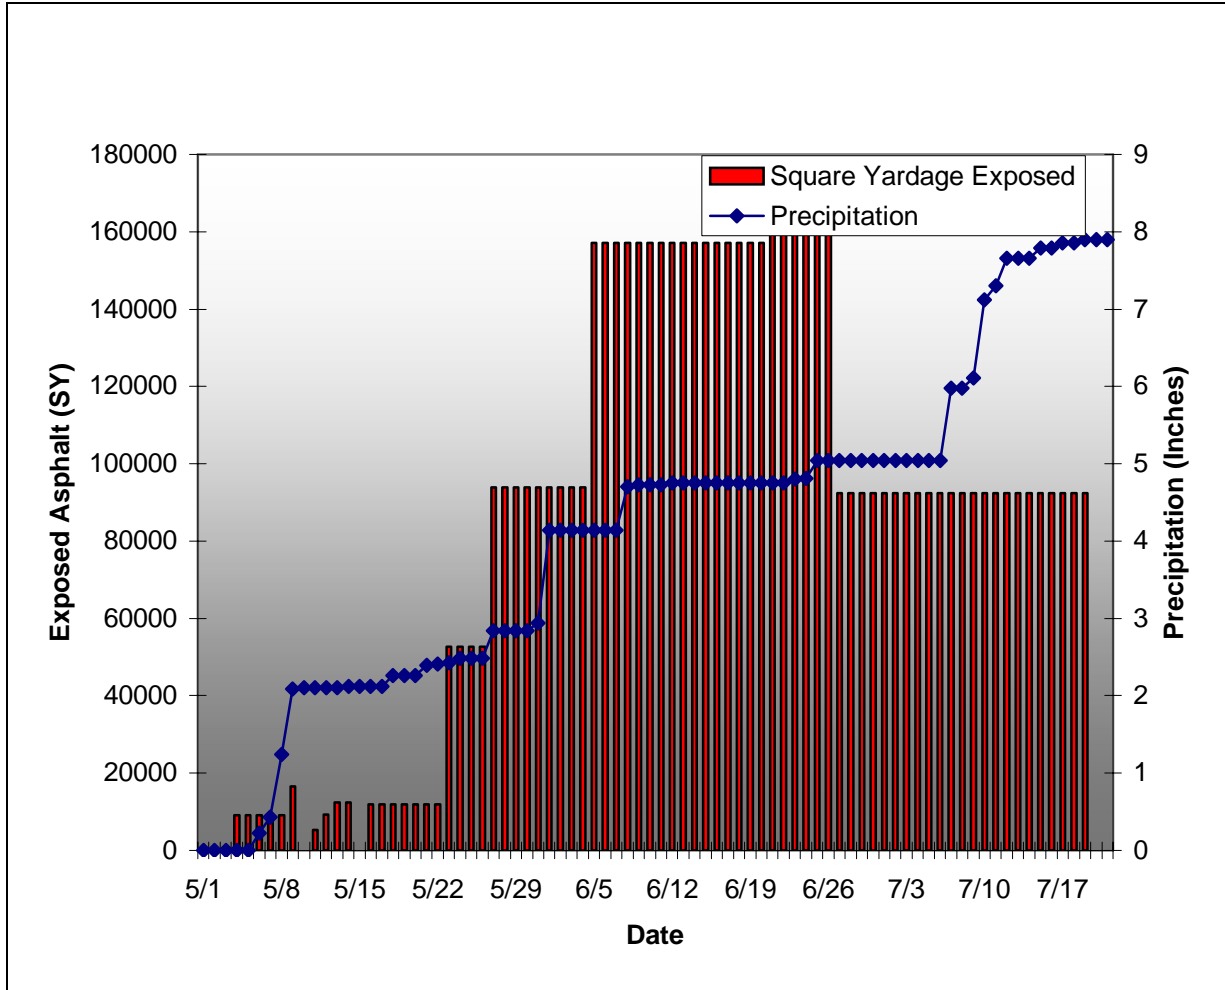
Figure 41: Exposed Area of HMA Vs. Precipitation Accumulation

It was learned that during construction, the milled surface was exposed to prolonged and unusual weather conditions. There was approximately 7.5 inches of precipitation during the months of planing and paving and the temperature varied between 30 and 100 degrees. This coupled with the SMA layer acting as a moisture sealant accelerated the base asphalt failure. Similar occurrences in Georgia and Virginia also showed moisture trapped in the bottom layers leading to the failure of the pavement.
