Report No. CDOT-DTD-R-2003-5

**CRACK REDUCTION STRATEGIES ON A
PAVEMENT WARRANTY PROJECT
(INTERSTATE 25 AT FOUNTAIN,
COLORADO)**

**March 2003
Final Report**

**COLORADO DEPARTMENT OF TRANSPORTATION
RESEARCH BRANCH**

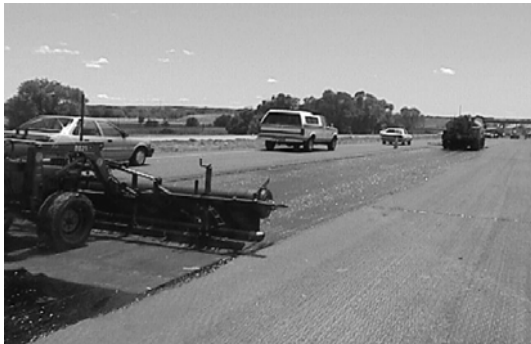
In the first two sections adjacent to the control section, Petromat paving fabric was placed in the driving lane as shown in Figure 6. Petromat is a geotextile paving fabric manufactured by Amoco using needle-punched polypropylene. Two weights of Petromat were placed. Petromat 4597 is a higher strength version (120 psi tensile) than Petromat 4599 (90 psi tensile). The 4599 is the most commonly used Petromat product, and the one used routinely by Lafarge for much rehabilitation work. Both products come in rolls approximately 12-feet-wide and were applied to the milled pavement surface using an AC10 tack coat. As shown in Table 1 (page 11), Petromat 4597 was placed over cracks located at 594 through 1,187 feet and 4,211 through 4,740 feet in the evaluation section. Petromat 4599 was placed over cracks located at 1,343 through 1,752 feet and 4,799 through 5,653 feet in the evaluation section.

Figure 6 – Placement of Petromat material.

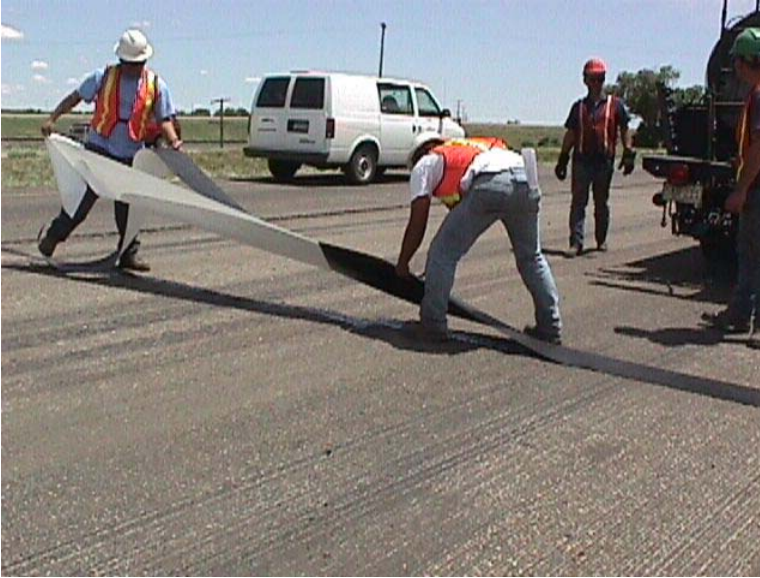
The next section is self-adhering Petrotac. Figure 7 shows the placement of Petrotac over existing severely cracked sections of roadway. Amoco also produces this product for use in reflection cracking reduction. Petrotac is a self-adhesive asphalt tape approximately 12 inches wide. It was applied over transverse cracks located at 1,930 through 2,171 and 5,747 through 6,048 feet in the evaluation section (Table 1).

Figure 7 – Petrotac placement.

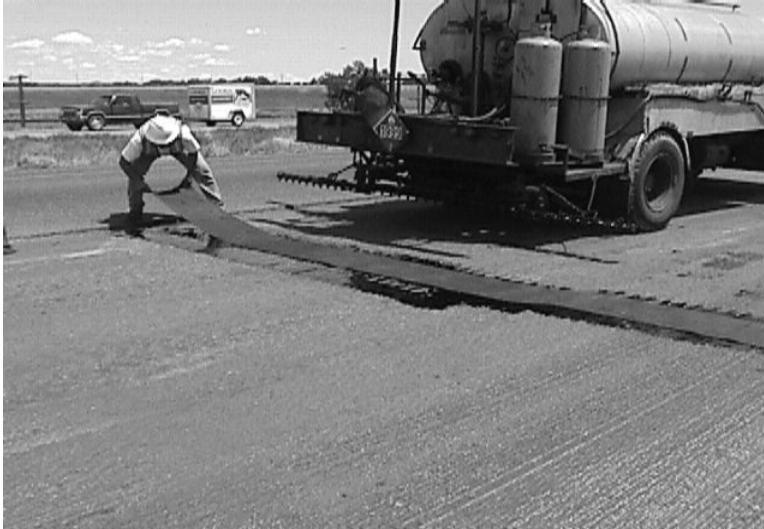
tack coat for cracks located between 6,083 to 6,416 feet in the evaluation section. However, instead of applying the tack with the distributor, the material was painted on the Proguard with a broom. This was the most successful method of attachment. Figure 8 shows the placement of Proguard.

Figure 8 – Proguard placement.

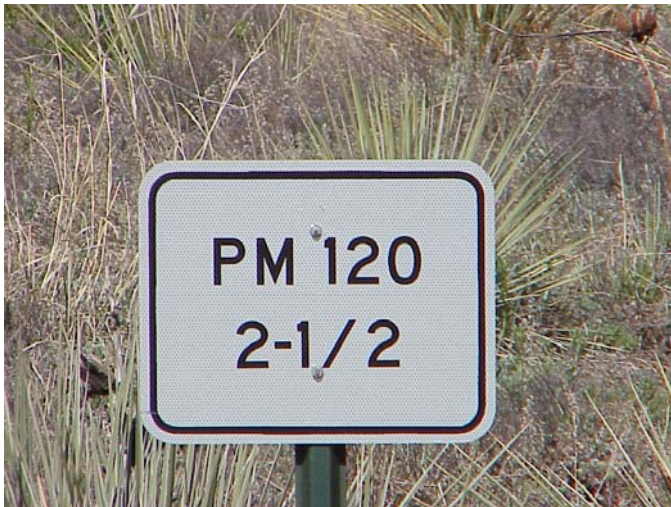
Figure 12 – Signs were placed in the right of way to identify each evaluation section.
