***Treatment of Swelling Soils  
West of Agate, Colorado  
Project I 70-4(48)347***

Burrell B. Gerhardt  
Colorado Division of Highways  
Planning and Research Division  
4201 E. Arkansas Avenue  
Denver, Colorado 80222

Final Report  
December 1975

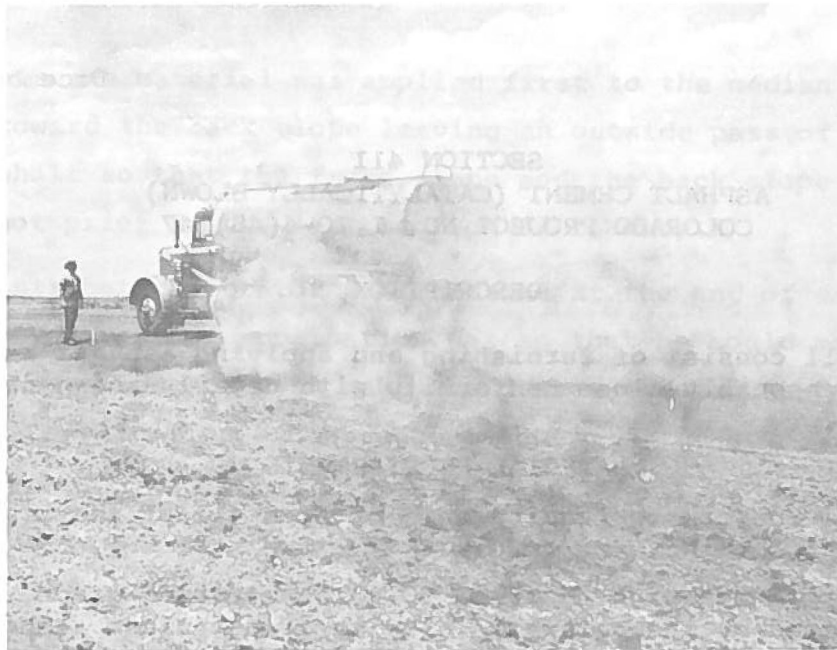
**Figure 4. Distributor Applying Asphalt Membrane**

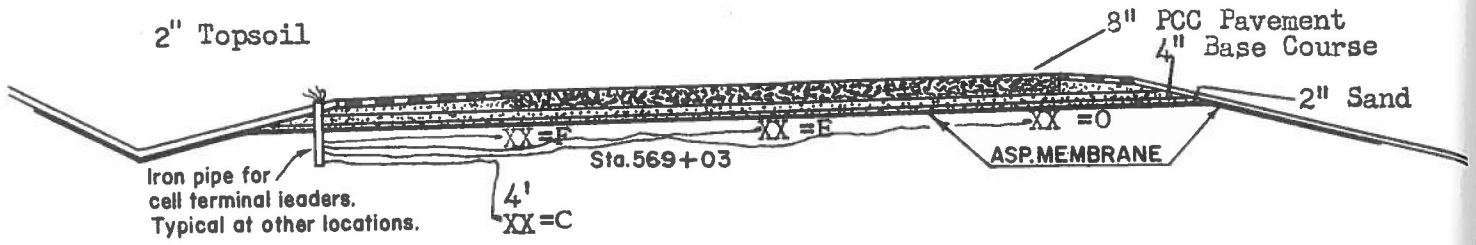
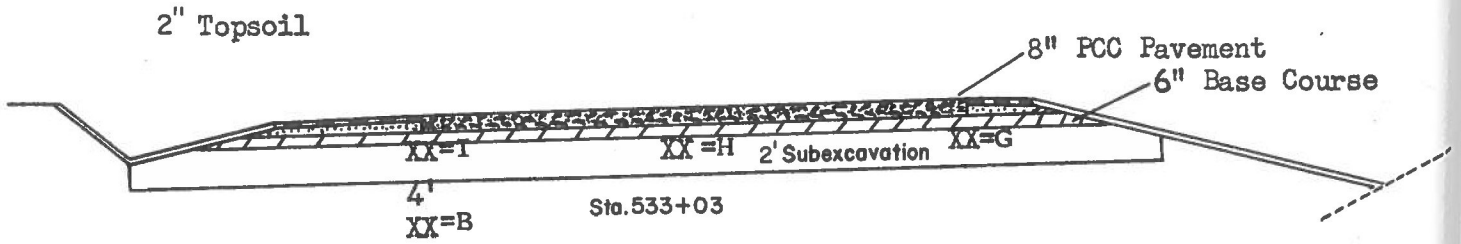
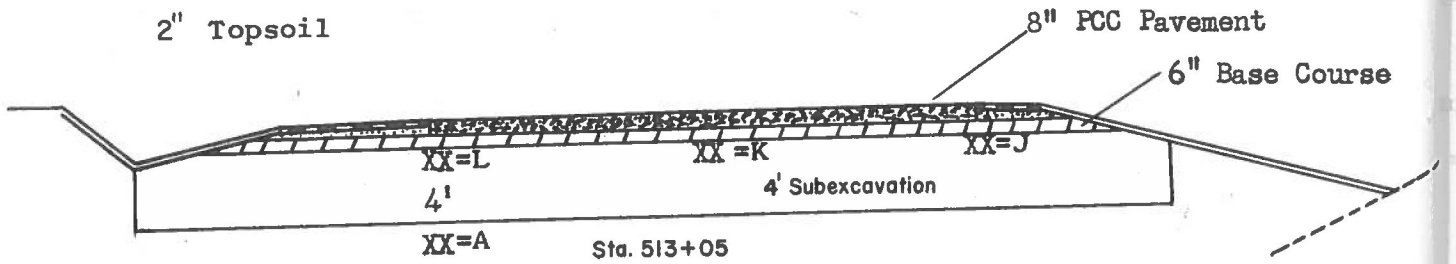
ROADWAY CROSS SECTIONS SHOWING LOCATION OF MOISTURE CELLS

Figure 7 shows the location of the 4 moisture cells placed in each of the 3 areas of treatment. Neoprene covered wire leads were run to 4" (10 cm) diameter pipes set vertically with the top end flush with the shoulder surface approximately 12" (30 cm) toward the ditch from the edge of the asphalt shoulder. From terminals in these 12" pipes, the resistance of the moisture cells may be determined at Station 513+05 for the 4' (1.3 m) Sub-excavated Section, at Station 533+03 for the 2' (.6 m) Subexcavated Section and at Station 569+03 for the membrane treated Section.

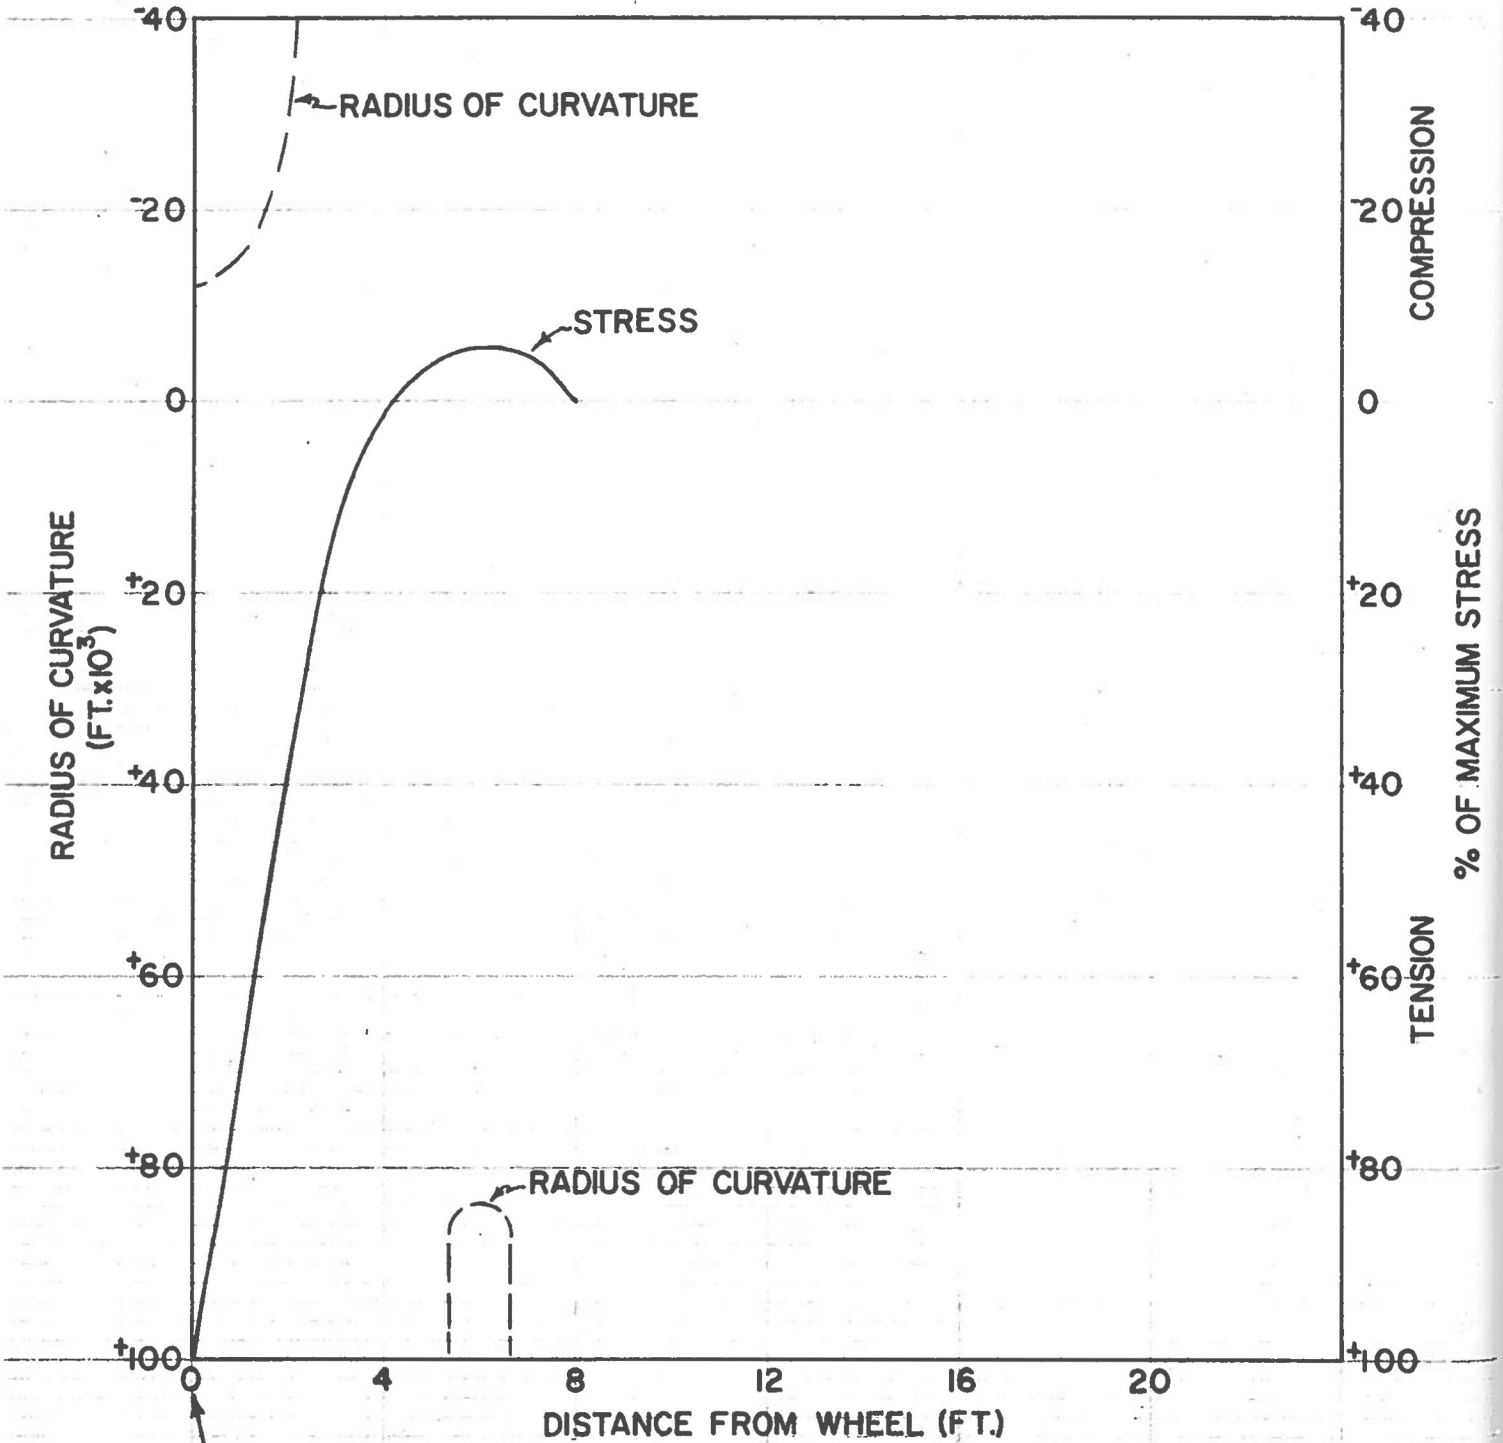
TYPICAL CURVES OF STRESS  
AND  
RADIUS OF CURVATURE

MAXIMUM FLEXURAL STRESS = 112 P.S.I.

7 1/2 FT. FROM  
TRANSVERSE JOINT

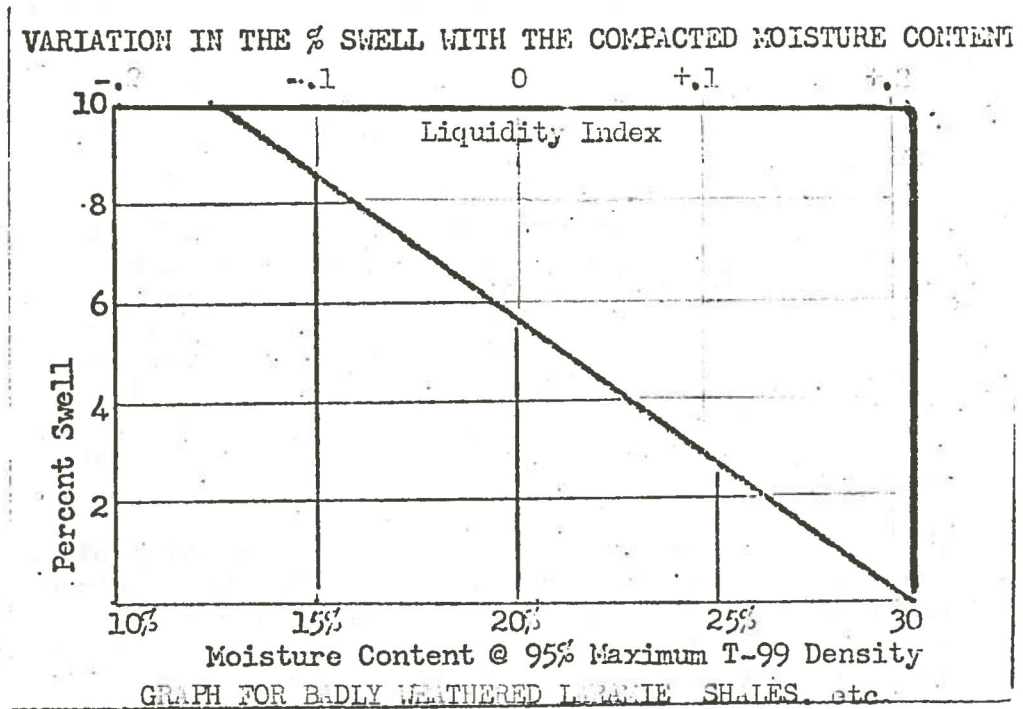
the Agate area the natural moisture content tended to dry out to 15% despite the wetting operations to place subgrade soils at 25%. These values would result in a Liquidity Index of  $\frac{15 - 20}{65 - 20} = \frac{-5}{45} = -.11$  and according to the graph below, the subgrade would swell approximately 8.5%.

In the 1968 construction season the same material would have been placed during the rainy season, and with a natural moisture content of 29, the Liquidity Index would have been  $\frac{29 - 20}{45} = \frac{9}{45} = +.2$  which calls for no special treatment for volume changes. Although these climatic changes taken for illustration were 8 years apart, in Colorado they could have been only 8 days or even 8 hours apart. It would be impossible to change the design of the roadway to counteract this swell potential in such a short period of time.
