Re: Lonetree Reservoir Dam (CO 01734)  
W. Div. 1 W. Dist. 4

## SUMMARY OF ASSESSMENT AND RECOMMENDATIONS

### LONETREE DAM AND DIKE

INSPECTION ON 20 OCTOBER 1978

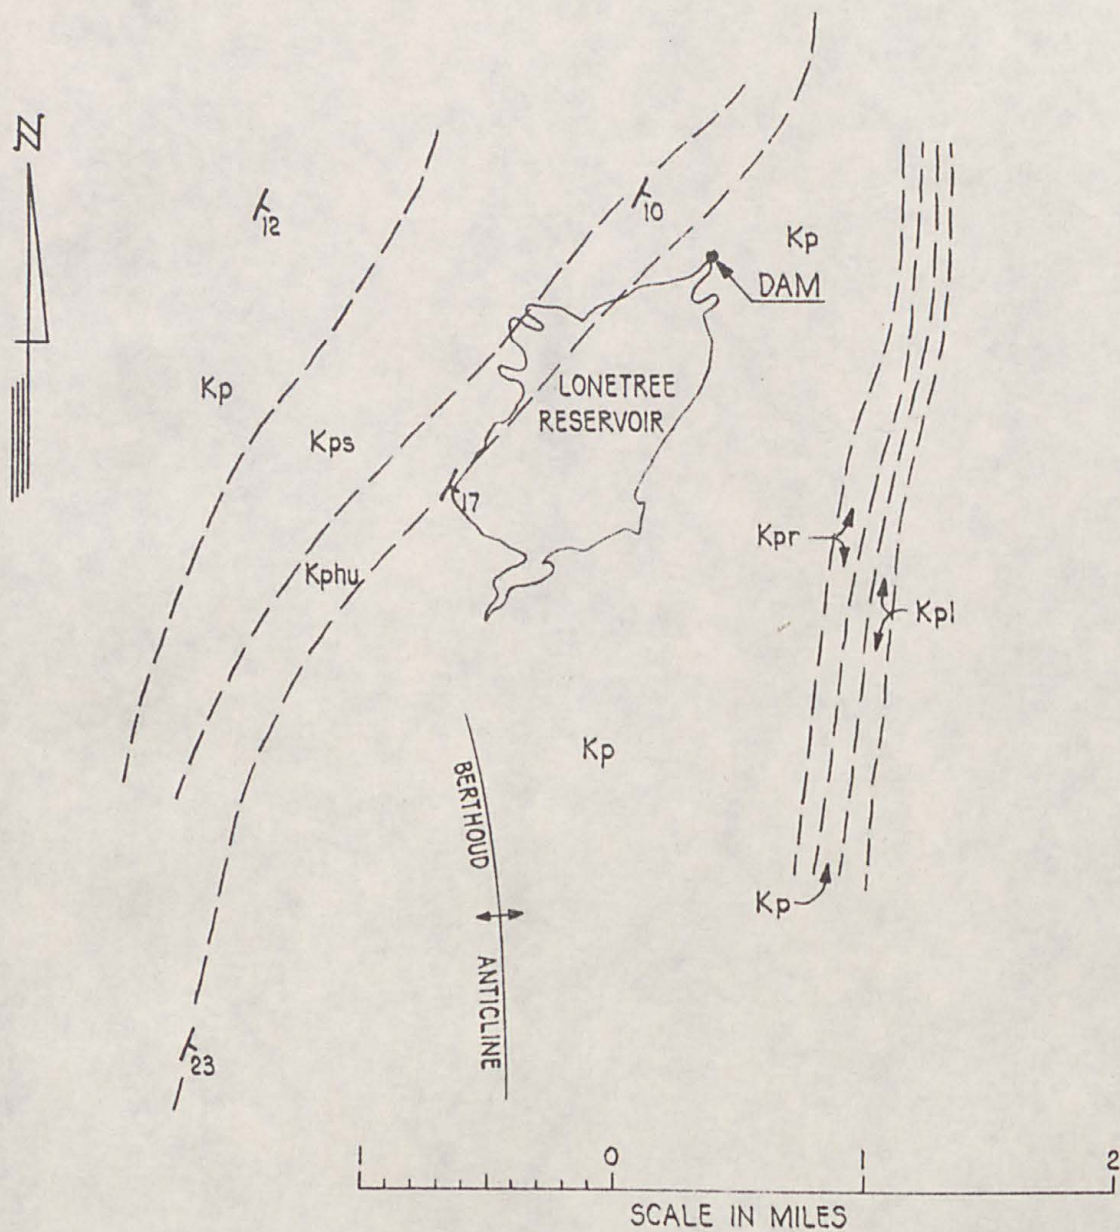
e. Geology and Soils. The Pierre Shale which crops out at Lonetree Dam represents sediments of over 8000-foot-thick marine shale laid down during a widespread invasion of Late Cretaceous seas (about 110 million years ago). Alternating retreats and advance of these seas resulted in deposition of interbeds of both relatively thick and thin sandstone/siltstone units in the predominately shale formation. The Hygiene Sandstone Member, which is exposed in the reservoir rim represents one of these units. Deposition essentially ceased in the damsite area as the seas retreated eastward as the Rocky Mountains rose to the west. The elevation of these mountains tilted the sediments eastward. The beds at the damsite dip about  $15^{\circ}$  to the east-southeast. The present topography represents the result of erosion of the Pierre Shale and younger sediments during and subsequent to glacial activity in the mountains west of the site. Figure 3 shows the geologic units in the Lonetree Dam and Reservoir area.

At the dam outlet, dark gray, thin-bedded shale crops out in the 28-foot-deep approach channel. Bed thickness is less than 0.03 feet which is reflected by the fine talus of broken material on the cut slopes. Jointing, other than along bedding planes, is not well developed.

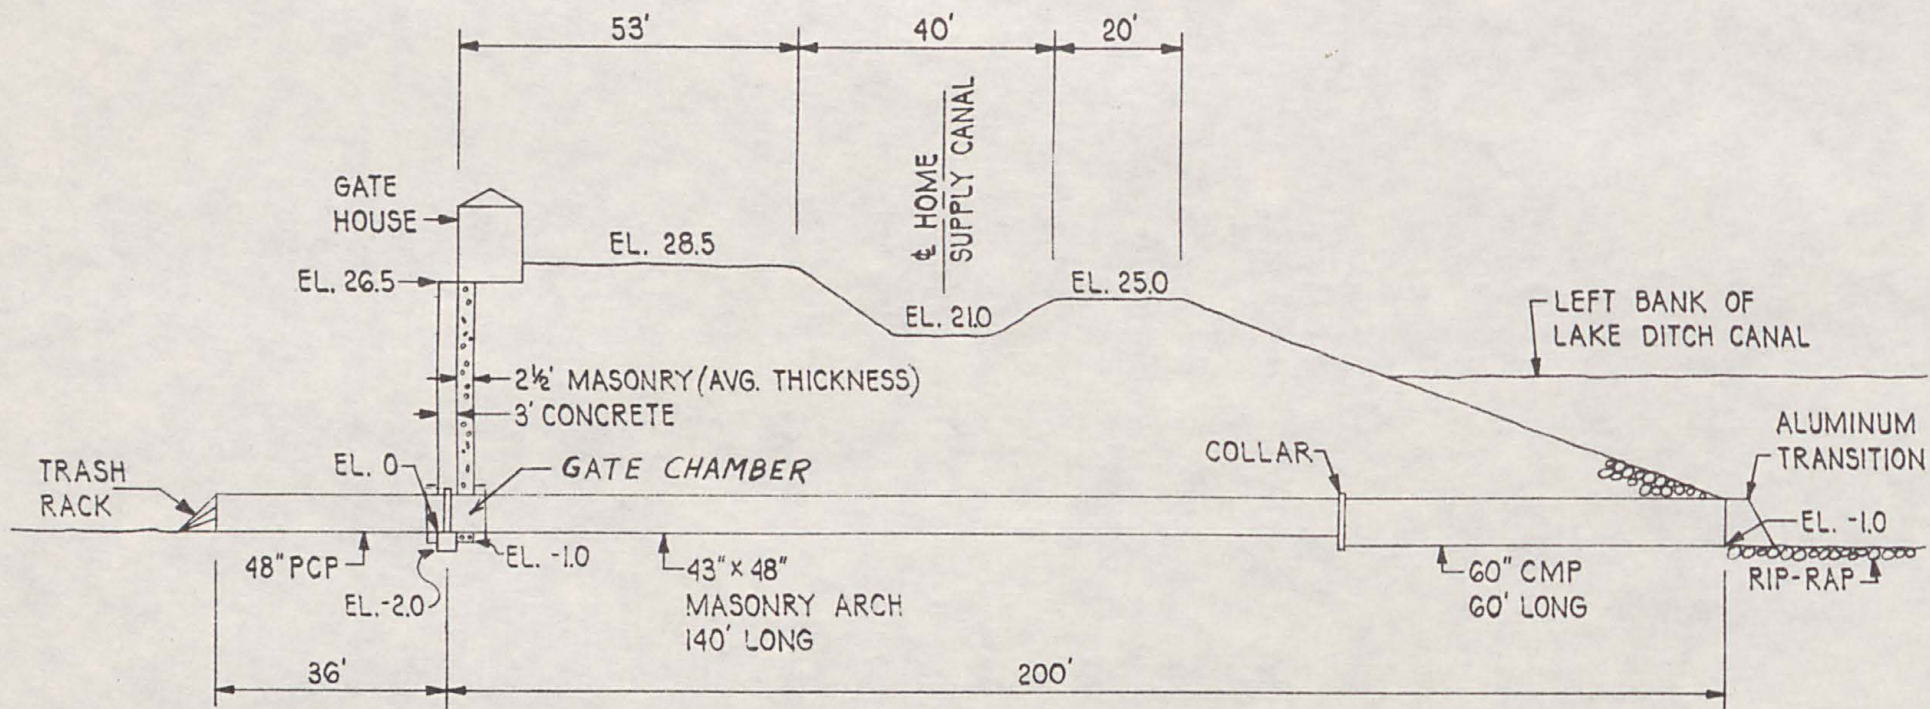
SKETCH OF SECTION THROUGH OUTLET WORKS FOR LONETREE DAM  
(DIMENSIONS ESTIMATED BY VISUAL OBSERVATIONS AND PACING)

A sketch of a section through the embankment along the centerline of the outlet works is shown in Figure 4. The Home Supply Canal diagonally crosses the embankment as shown in Plate 4, Appendix C.

No drawings or construction records on the dam and outlet works are available. The dam may have been constructed by leaving a shale plug embankment between the terminus of the reservoir channel and the beginning of the Lake Ditch Canal and driving a tunnel through the plug for the outlet conduit. However, W. R. Keirnes who has been associated with this project for many years believes that it is more likely that the outlet was constructed using cut and cover methods. Regardless of which of these two methods was used, compacted fill was placed over the outlet and adjacent area to raise the crest of the dam to elevation 28.5 (gage).

Although the masonry blocks were mortared, the wall was not sufficiently watertight. As a result, a concrete wall about three feet thick was cast against the masonry wall. This wall was reportedly keyed into the hard shale about two feet below the outlet invert. The top of the concrete wall is at elevation 26.5, two feet below the crest of the embankment. The length of the concrete wall is 53' 4". The length of the embankment crest is about 165 feet. The crest of the embankment runs from the barrier wall constructed on top of the check in the Home Supply Canal at Station 0+70, on a line approximately normal to the centerline of the outlet works, to the 28.5 (gage) natural ground contour on the right abutment. The left abutment ties into the shale mass forming the left bank of the reservoir extension channel and the right bank of the Home Supply Canal. The barrier wall shown in Photo No. 7 extends beyond the check sidewalls and one end ties into the crest of the dam near the left abutment and the other ties into the crest of Lonetree Dike formed by the left bank of the Home Supply Canal. When the spillway is operating the check, concrete barrier, and downstream bank of the Home Supply Canal become an effective part of the dam in containing the water in the reservoir and spillway channel. However, because of their limited service and height they will be referred to as the outer dike and discussed further in the next subsection.

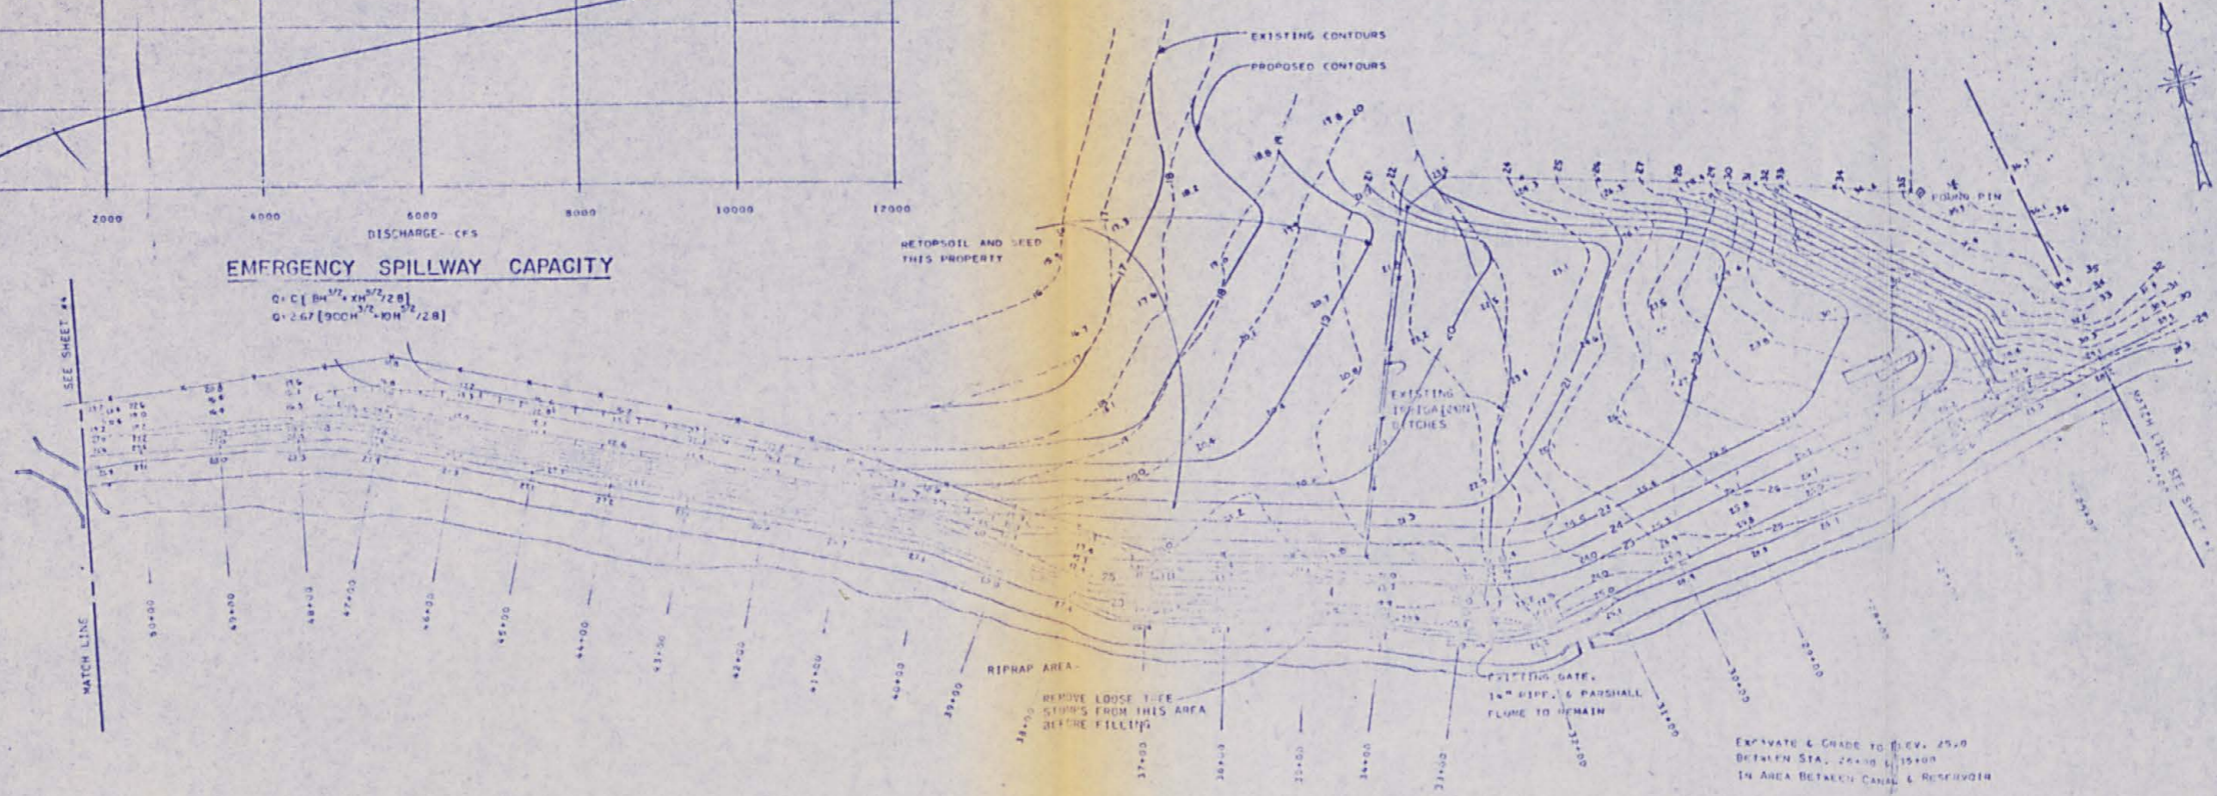
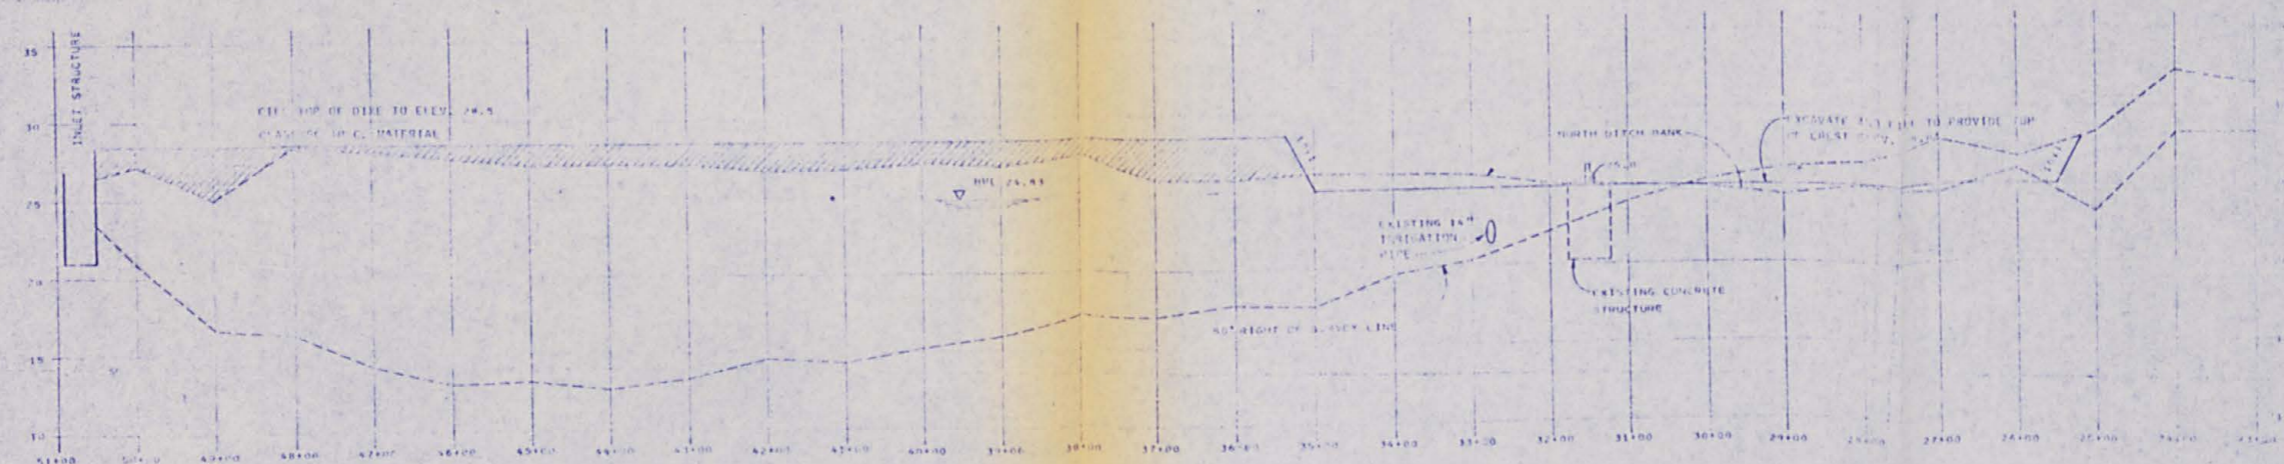
PLAN AND PROFILE: STATION 25+00 TO 50+00, AND SPILLWAY DISCHARGE CURVE

g. Spillway. Recent construction has provided a 950-foot-wide uncontrolled emergency spillway, shown in Photo No. 5, with a crest elevation of 25.0 (gage). As shown on Plate 5, Appendix C, the spillway crest is located on the dike between Station 25+50 and 35+00. If the reservoir rises above elevation 25.0 (gage) it would spill over the right bank of the Home Supply Canal, inundate the diversion structure at Station 31+50, flood the canal to the barrier at Station 0+70, then discharge over the spillway crest. Outflow exiting from the spillway crest would turn sharply to the left in a broad channel about 1100 feet long cut largely in sandstone rock. From the end of the constructed channel the flow would enter Ryan Gulch. After passing through Ryan Gulch Lake, shown in Photo No. 6, about three miles north of the spillway, the discharge would continue northward to the Big Thompson River. An inhabited farmhouse, shown in Photo No. 6, and several small buildings lie within the flood path and would be subjected to severe damage by a large spill.

f. Spillway. The spillway crest was cut and filled to gage height 25.0 in 1977. Details of the crest construction are shown on Plate 5, Appendix C. The crest is both compacted fill and bedrock (sandstone). The bedrock was relatively smooth (bedding planes) and its excavation to the present level was reported to be "difficult" during construction. A few inches of rolled fill were required in portions of the crest to maintain the desired crest elevation. The fill consisted of broken Pierre Shale.
