## **Appendix D. Traffic Safety Report**

**US 85 PEL  
SAFETY ASSESSMENT**

Colorado Department of Transportation  
Region 4  
10601 West 10<sup>th</sup> Street  
Greeley, CO 80634  
970/350-2148 or 970/350-2163

March 2016

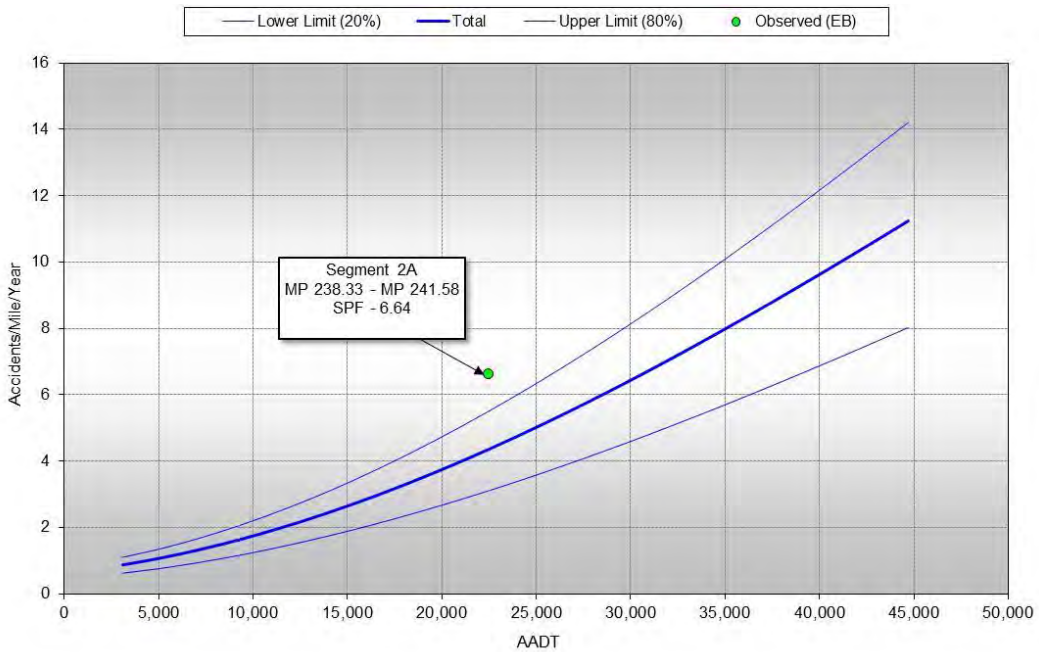
**Figure 11**  
**Segment 2A (MP 238.33 - MP 241.58) – Total Crashes per Year**  
**Rural Flat and Rolling Four-Lane Divided Highway**

Since Segment 2A is classified as a rural, four-lane rolling (U-4-R) facility, SPF's have been calibrated by CDOT. **Figure 11** shows that frequency of total crashes over the five-year study period indicates a high potential for crash reduction (LOSS IV). **Figure 12** shows that the severity of crashes is about the mean for this roadway type (LOSS II-III).

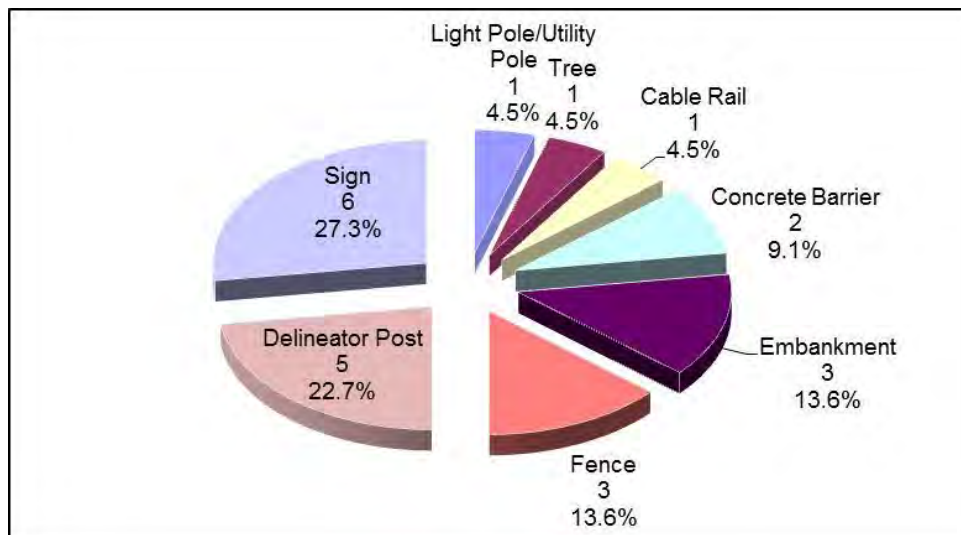
**Figure 15**  
**Fixed Object Crash Types**  
**(Segment 2B: MP 241.59 – MP 243.00)**

The frequency of fixed object type crashes was higher than expected for this type of roadway. A review of the fixed object type crashes indicated that 14 crashes occurred northbound and eight crashes occurred southbound. Only 11 of the 22 crashes occurred with dry roadway conditions. The fixed object type crashes were throughout Segment 2B. It can be seen in **Figure 15** that of the fixed object type crashes, sign type crashes (27.3%) were the predominant crash type followed by delineator post type crashes (22.7%). A review of the crash history indicates that there is no current pattern. It should be noted that this segment has barriers in the median (either concrete Type 7 or cable rail) as well as rumble strips along the outside shoulders.

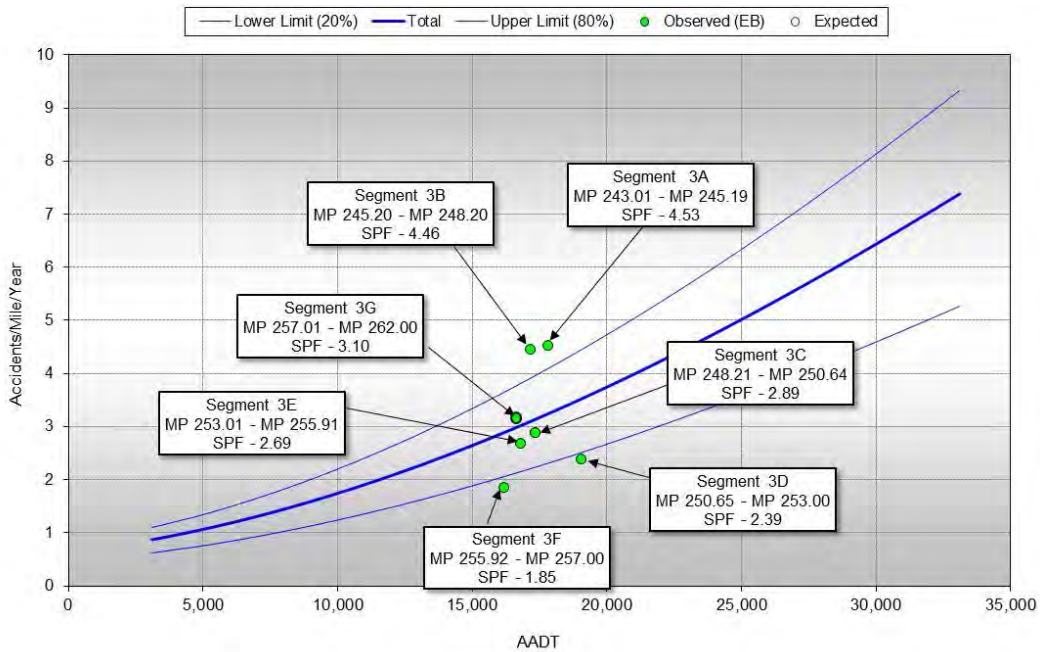
**Figure 17**  
**Segment 3 (MP 243.01 – MP 262.00) – Total Crashes per Year**  
**Rural Flat and Rolling Four-Lane Divided Highway**

Since Segment 3 is classified as a rural, four-lane rolling (U-4-R) facility, SPFs have been calibrated by CDOT. **Figure 17** shows that the frequency of total crashes over the five-year study period indicates a high potential for crash reduction (LOSS IV) for Segments 3A and 3B and a moderate to high potential for crash reduction (LOSS III) for Segment 3G. **Figure 18** shows that the severity of crashes indicates a moderate to high potential for crash reduction (LOSS III) for Segment 3B.

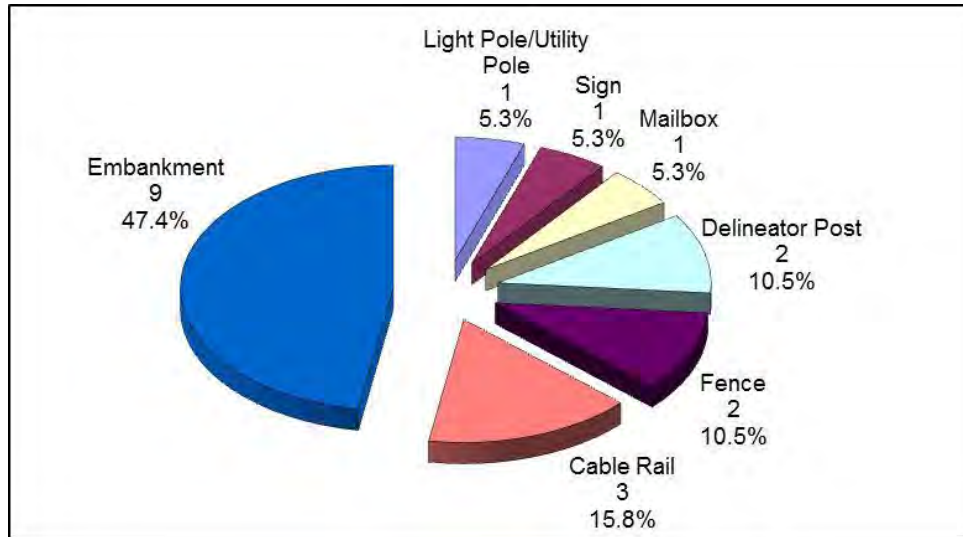
**Figure 20**  
**Fixed Object Crash Types**  
**(Segment 3A: MP 243.01 – MP 245.19)**

The frequency of fixed object type crashes was higher than expected for this type of roadway. It can be seen in **Figure 20** of the fixed object type crashes, embankment type crashes (47.4%) were the predominant crash type. Of those embankment crashes, one crash occurred northbound and eight crashes occurred southbound. Three of the nine crashes occurred with dry roadway conditions. Five of the crashes occurred during icy roadway conditions. Overall, there was a concentration of crashes between MP 243.9 and MP 244.0. A review of these crashes as well as all fixed object crashes in Segment 3A indicates that there is no current pattern to the crashes. There are no suggestions for improvement at this time.

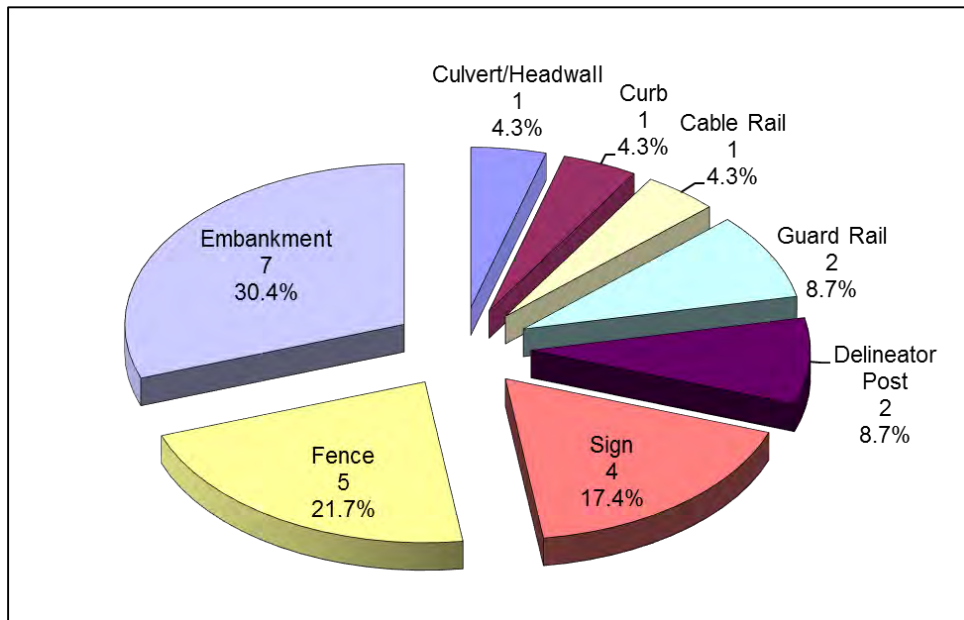
**Figure 22**  
**Fixed Object Crash Types**  
**(Segment 3B: MP 245.20 – MP 248.20)**

The frequency of fixed object type crashes was higher than expected for this type of roadway. It can be seen in **Figure 22** of the fixed object type crashes, embankment type crashes (30.4%) were the predominant crash type. Of those embankment crashes, six crashes occurred northbound, and one crash occurred southbound. Five of the seven crashes occurred with dry roadway conditions. Two of the crashes occurred during icy roadway conditions. Five of the fixed object crashes were fence type crashes. A review of the crash history indicates that there is no current pattern to the fixed object type crashes. At this time, there are no suggestions for improvement beyond the recently installed cable rail median barrier.

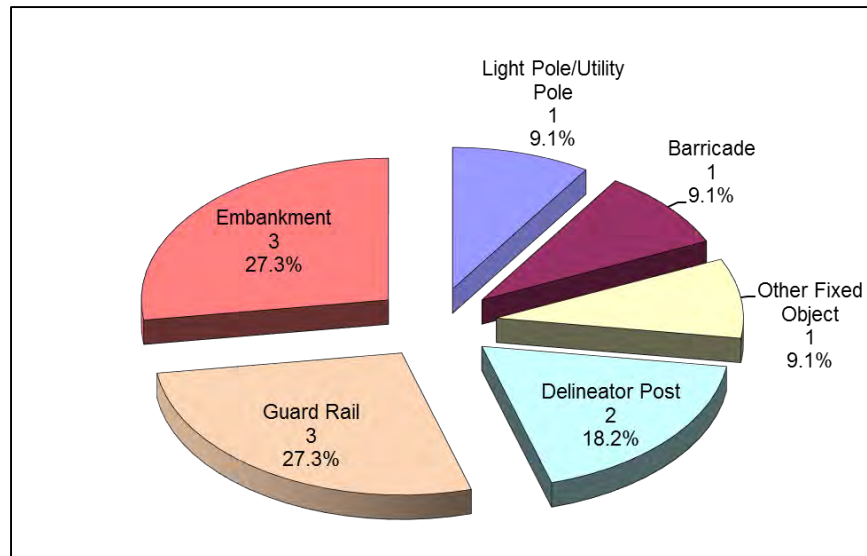
**Figure 24**  
**Fixed Object Crash Types**  
**(Segment 3C: MP 248.21 – MP 250.64)**

The frequency of fixed object type crashes was higher than expected for this type of roadway. It can be seen in **Figure 24** of the fixed object type crashes, embankment type crashes (27.3%) were the predominant crash type. Of those embankment crashes, two crashes occurred northbound and one crash occurred southbound. All three of the crashes occurred during dry roadway conditions. Three of the fixed object crashes were guardrail type crashes. A review of the crash history indicates that there is no current pattern to the fixed object type crashes. There are no suggestions for improvement at this time.

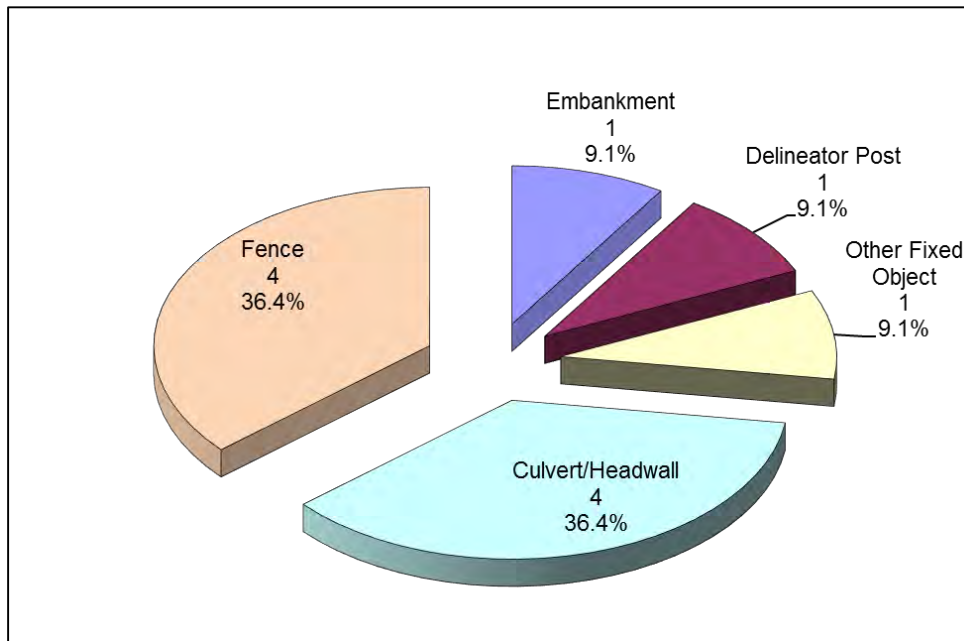
**Figure 26**  
**Fixed Object Crash Types**  
**(Segment 3D: MP 250.65 – MP 253.00)**

The frequency of fixed object type crashes was higher than expected for this type of roadway. It can be seen in **Figure 26** of the fixed object type crashes, fence type crashes (36.4%) and culvert/headwall type crashes were the predominant crash types. Of the fence crashes, three crashes occurred northbound, and one crash occurred southbound. All four of the fence type crashes occurred during snowy/icy/slushy roadway conditions. Of the culvert/headwall type crashes, three crashes occurred northbound, and one crash occurred southbound. Only one of the culvert/headwall type crashes occurred during dry roadway conditions. A review of the crash history indicates that there is no current pattern to the fixed object type crashes. There are no suggestions for improvement at this time.

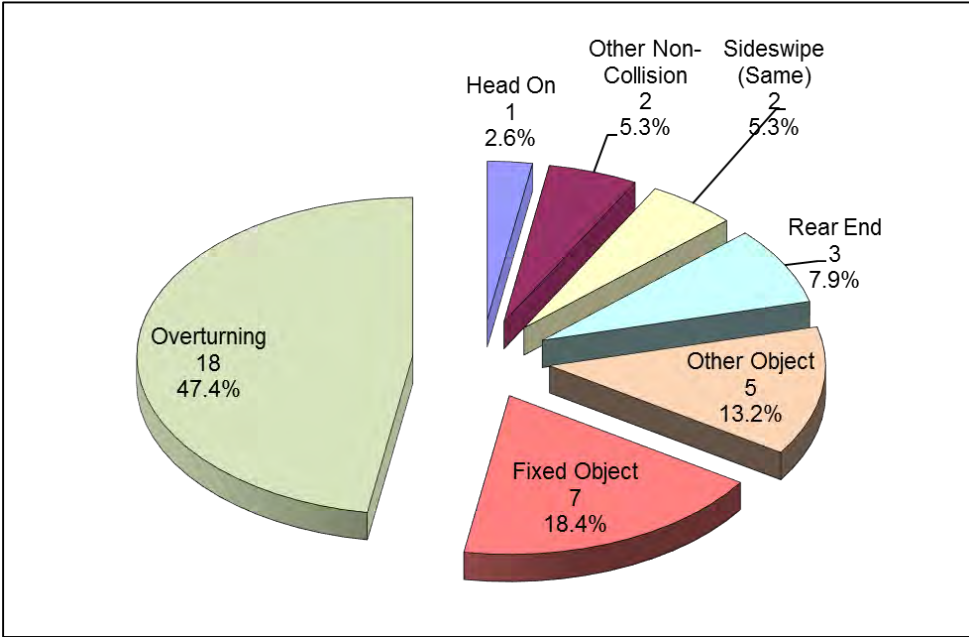
**Figure 27**  
**Non-Intersection Crash Types**  
**(Segment 3E: MP 253.01 – MP 255.91)**

Segment 3E begins approximately one-quarter mile south (MP 253.01) of the intersection with CR 36 and extends north to the intersection with CR 40 (MP 255.91). There were a total of 38 non-intersection crashes along this sub-segment of US 85C: 22 PDO crashes and 16 injury crashes. **Figure 27** presents a graphical representation of the non-intersection crash types for this sub-segment. Overturning type crashes (47.4%) were the predominant crash type followed by fixed object type crashes (18.4%) and other object type crashes (13.2%).

The frequency of overturning type crashes was higher than expected for this type of roadway. A review of the overturning type crashes indicated there were 12 crashes northbound and six crashes southbound. Seven of the crashes occurred in dry roadway conditions. Eleven of the 18 vehicles that overturned went off the left side of the road. These crashes occurred throughout Segment 3E. It should be noted that this sub-segment has rumble strips along the outside shoulders, and a cable rail barrier has recently been constructed in the median. The barrier should help reduce the number and severity of overturning crashes into the median. Thus, there are no further suggestions for improvement at this time.

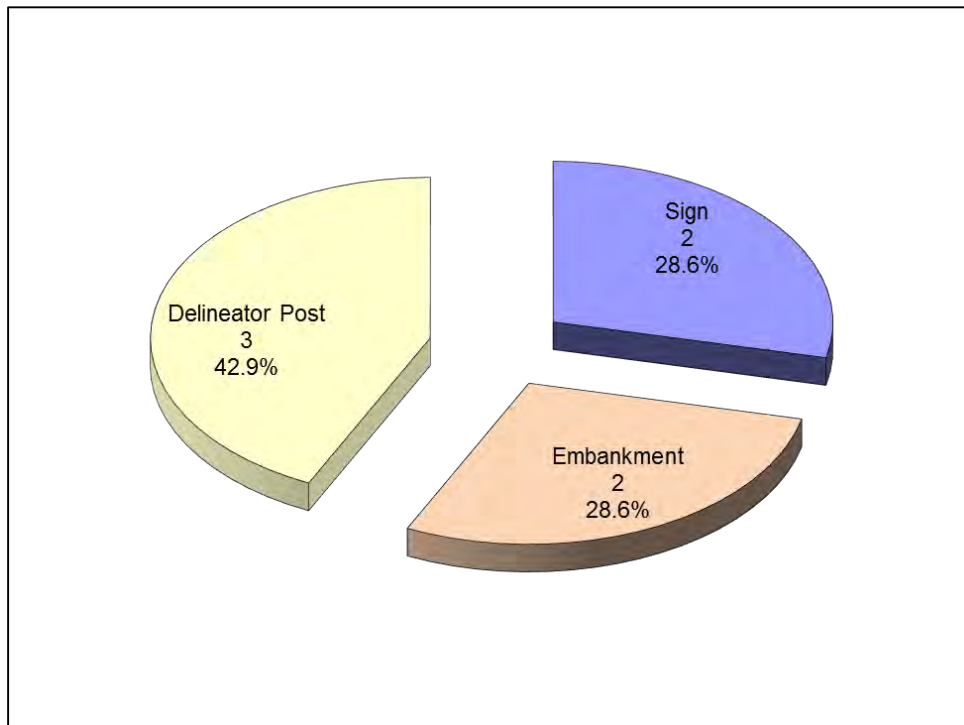
**Figure 28**  
**Fixed Object Crash Types**  
**(Segment 3E: MP 253.01 – MP 255.91)**

The frequency of fixed object type crashes was higher than expected for this type of roadway. It can be seen in **Figure 28** of the fixed object type crashes, delineator post crashes (42.9%) were the predominant crash type. Of the delineator crashes, two crashes occurred northbound, and one crash occurred southbound. Two of the crashes occurred during dry roadway conditions. A review of the crash history indicates that there is no current pattern to the fixed object type crashes. There are no suggestions for improvement at this time.

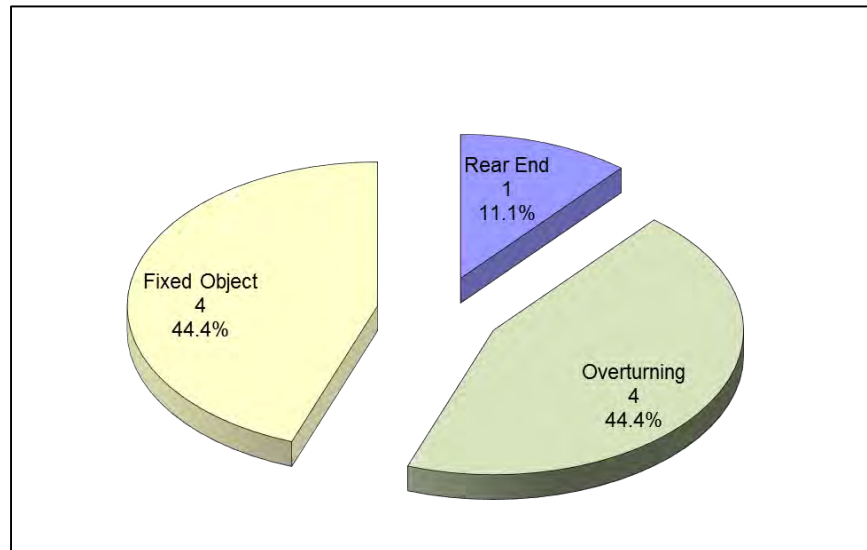
**Figure 29**  
**Non-Intersection Crash Types**  
**(Segment 3F: MP 255.92 – MP 257.00)**

Segment 3F begins at the intersection with CR 40 (MP 255.92) and extends north to approximately one-quarter mile south (MP 257.00) of the intersection with CR 42. There were a total of nine non-intersection crashes along this sub-segment of US 85C: eight PDO crashes and one injury crash. **Figure 29** presents a graphical representation of the non-intersection crash types for this sub-segment. Fixed object type crashes (44.4%) and overturning type crashes (44.4%) were the predominant crash types.

Although the frequency of crashes was not higher than expected for this type of roadway, and four of each fixed object overturning crashes in a five-year period is not considered a pattern. Therefore, there are no suggestions for improvement at this time.

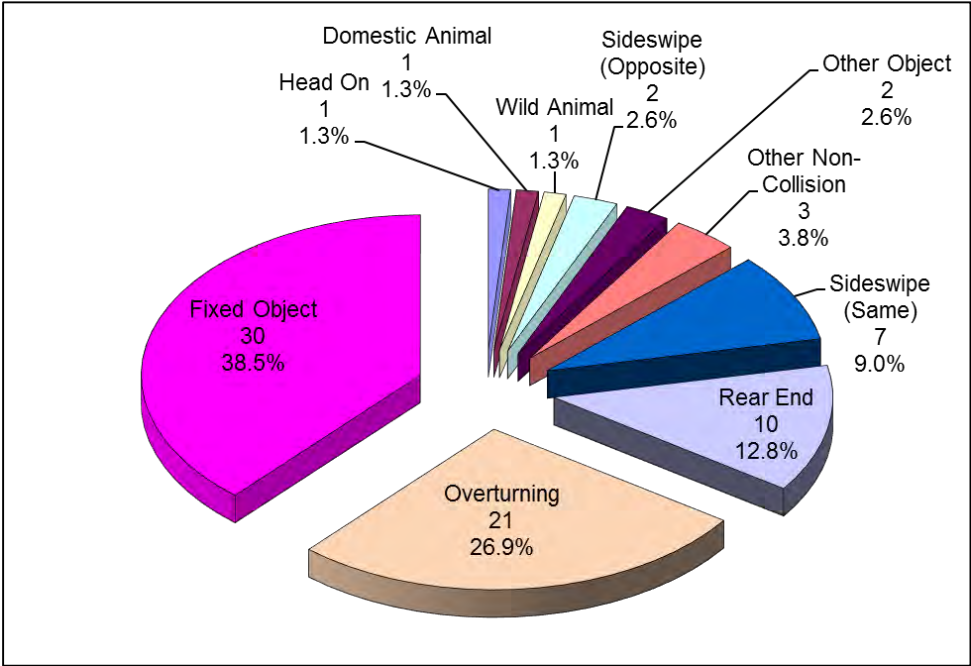
**Figure 30  
Non-Intersection Crash Types  
(Segment 3G: MP 257.01 – MP 262.00)**

Segment 3G begins approximately one-quarter mile south (MP 257.01) of the intersection with CR 42 and extends north to approximately 600 feet north (MP 262.00) of the UPRR overpass in south LaSalle. There were a total of 78 non-intersection crashes along this sub-segment of US 85C: 50 PDO crashes and 28 injury crashes. **Figure 30** presents a graphical representation of the non-intersection crash types for this sub-segment. Fixed object type crashes (38.5%) were the predominant crash type followed by overturning type crashes (26.9%) and rear end type crashes (12.9%).

The frequency of overturning type crashes was higher than expected for this type of roadway. A review of the overturning type crashes indicated there were 14 crashes northbound, six crashes southbound, and one crash westbound. Thirteen of the crashes occurred in dry roadway conditions. Twelve of the 21 vehicles that overturned went off the left side of the road; six went off the right side. These crashes occurred throughout Segment 3G. It should be noted that this sub-segment has rumble strips along the outside shoulders, and a cable rail barrier has recently been constructed in the median. The barrier should help reduce the number and severity of overturning crashes into the median. Thus, there are no further suggestions for improvement at this time.

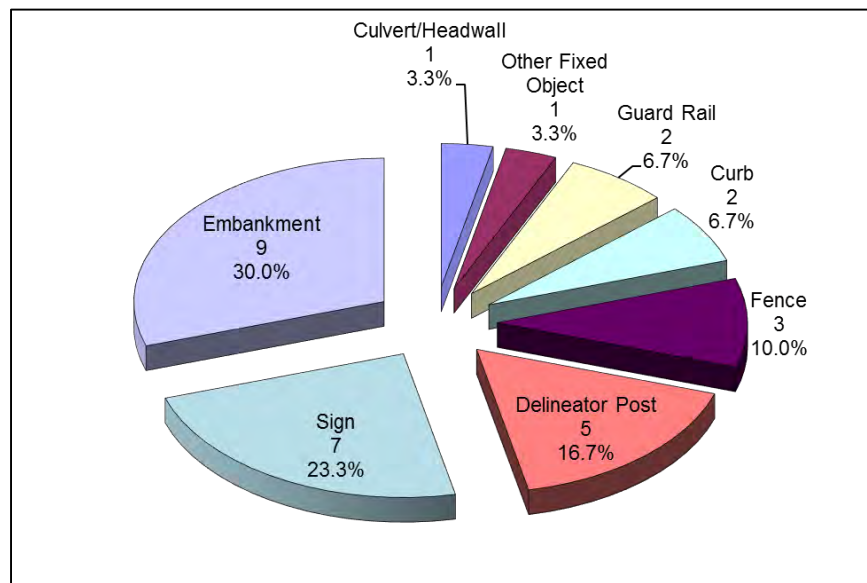
**Figure 31**  
**Non-Intersection Crash Types**  
**(Segment 3G: MP 257.01 – MP 262.00)**

The frequency of fixed object type crashes was higher than expected for this type of roadway. It can be seen in **Figure 31** of the fixed object type crashes, embankment type crashes (30.0%) were the predominant crash type. Of those embankment crashes, six crashes occurred northbound, and three crashes occurred southbound. Seven of the crashes occurred during dry roadway conditions. Seven of the fixed object crashes were sign type crashes. A review of the crash history indicates that the crashes occurred throughout the sub-segment, although there were concentrations between MP 258.69 and MP 258.76 (6 crashes – 3 off left) as well as at MP 261.3 (4 crashes – 3 off left). The cable rail barrier that was recently been constructed in the median should reduce the likelihood of these crashes becoming more serious. There are no further suggestions for improvement at this time.

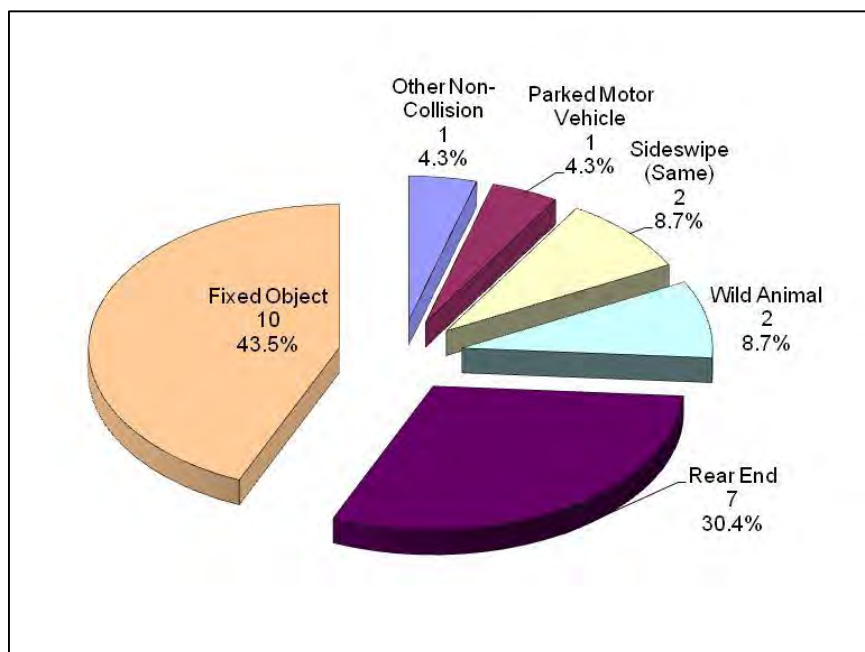
**Figure 33**  
**Non-Intersection Crash Types**  
**(Segment 4A: MP 262.01 – MP 263.80)**

Segment 4A begins approximately 600 feet north (MP 262.00) of the UPRR overpass in south LaSalle and extends north to approximately 1,900 feet north (MP 263.80) of CR 52, the southern portion of the South Platte River crossing. There were a total of 23 non-intersection crashes along this sub-segment of US 85C: 16 PDO crashes and 7 injury crashes along this US 85C segment. **Figure 33** presents a graphical representation of the non-intersection crash types for this sub-segment. Fixed object type crashes (43.5%) were the predominant crash type followed by rear end type crashes (30.4%).

There were no significant crash types in this segment of US 85C. However, it is worth noting that the fixed object type crashes had 10 crashes of which only five occurred on dry roadway conditions. Directionally, seven crashes were northbound and three crashes were southbound.

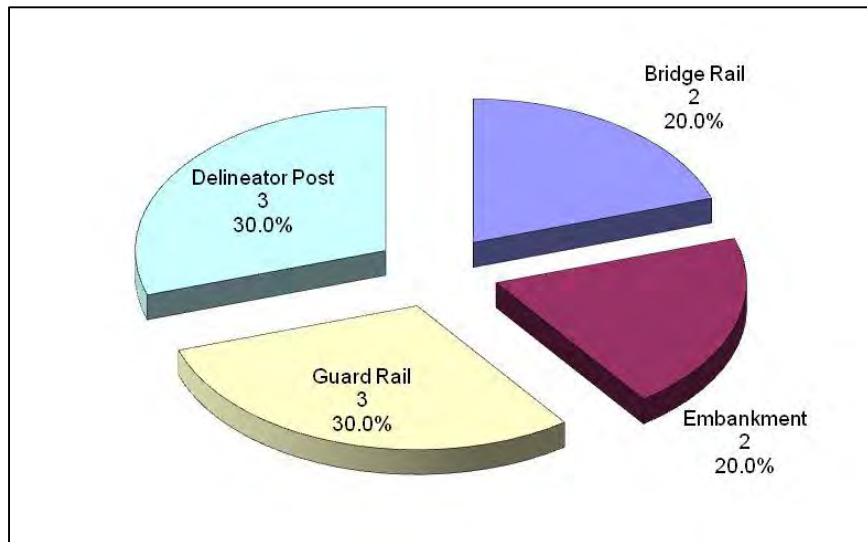
**Figure 34**  
**Fixed Object Crash Types**  
**(Segment 4A: MP 262.01 – MP 263.80)**

The fixed object type crashes were primarily concentrated near the southern portion of the bridge over the South Platte River. It can be seen in **Figure 34** of the fixed object type crashes, guard rail type crashes (30.0%) and delineator post type crashes (30.0%) were the predominant crash type followed by bridge rail and embankment (each 20%). Guardrail and bridge rail are normally designed and located to prevent crashes that are more serious. Based on a review of the crash history, it is recommended that the existing snow/ice removal procedures be reviewed to ensure existing procedures are sufficient.

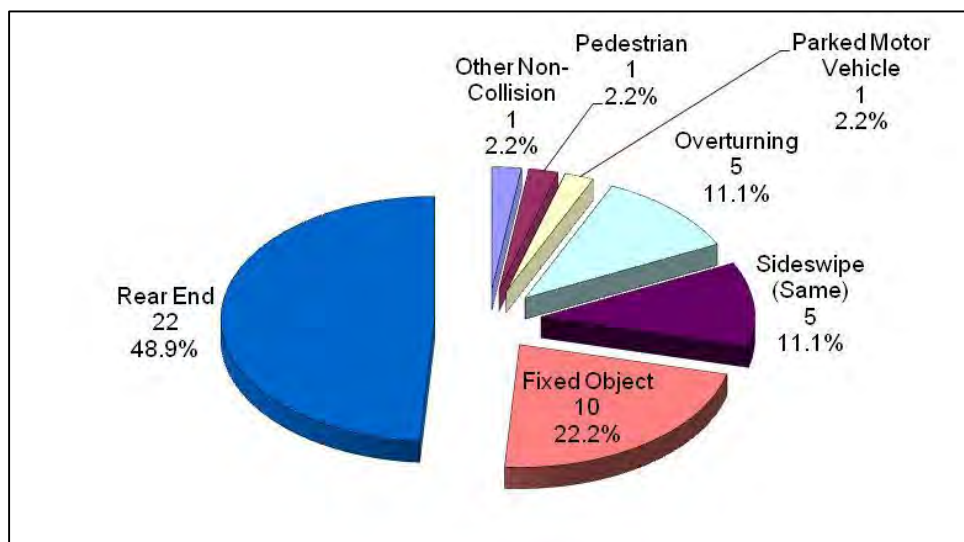
**Figure 35**  
**Non-Intersection Crash Types**  
**(Segment 4B: MP 263.81 – MP 265.76)**

Segment 4B lies begins approximately 1,600 feet south (MP 263.81) of the intersection with 42<sup>nd</sup> Street and extends north to the interchange with US 34 (MP 263.81). There were a total of 45 non-intersection crashes along this sub-segment of US 85C: 31 PDO crashes, 13 injury crashes and one fatal crash. **Figure 35** presents a graphical representation of the non-intersection crash types for this sub-segment. Rear end type crashes (48.9%) were the predominant crash type followed by fixed object type crashes (22.2%).

The frequency of rear end type crashes was higher than expected for this type of roadway. A review of the rear end crash history indicated that there were 14 crashes northbound, six crashes southbound, one crash eastbound, and one crash westbound. Road conditions for rear end type crashes showed that 20 of the 22 crashes were dry road conditions. Eighteen of the 22 crashes occurred during daylight lighting conditions. This crash pattern could be related to close approximate to intersections within the segment. A review of the crash history indicates that there is no current pattern, and there are no suggestions for improvement at this time. Reference the intersection section of this report for additional recommendations within this sub-segment of US 85C.

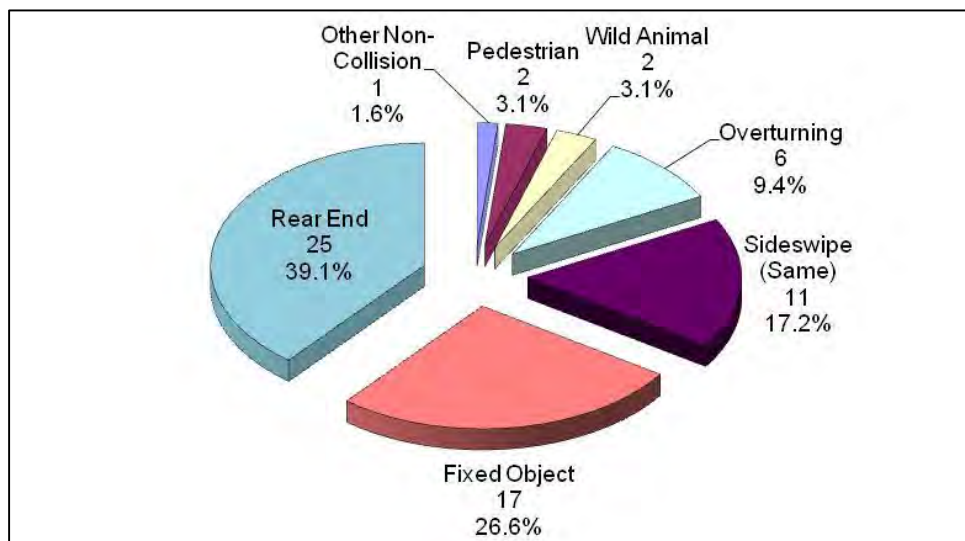
**Figure 37**  
**Non-Intersection Crash Types**  
**(Segment 5A: MP 265.85 – MP 269.50)**

Segment 5A begins near the UPRR overpasses within the interchange with US 34 (MP 265.85) and extends north to one-mile north of the intersection with 5<sup>th</sup> Street (MP 268.49) in Greeley. There were a total of 64 non-intersection crashes along this sub-segment of US 85L: 49 PDO crashes, 14 injury crashes and one fatal crash. **Figure 37** presents a graphical representation of the non-intersection crash types for this sub-segment. Rear end type crashes (39.1%) were the predominant crash type followed by fixed object type crashes (26.6%).

The frequency of rear end type crashes was higher than expected for this type of roadway. A review of the rear end crash history indicated that there were nine crashes northbound and 16 crashes southbound. Road conditions for rear end type crashes showed that 22 of the 25 crashes were dry road conditions. Eighteen of the 25 crashes occurred during daylight lighting conditions. This crash pattern seen above could be related to close approximate to intersections within the segment. A review of the crash history indicates that there is no current pattern, and there are no suggestions for improvement at this time. Reference the intersection section of this report for additional recommendations within this sub-segment of US 85L.

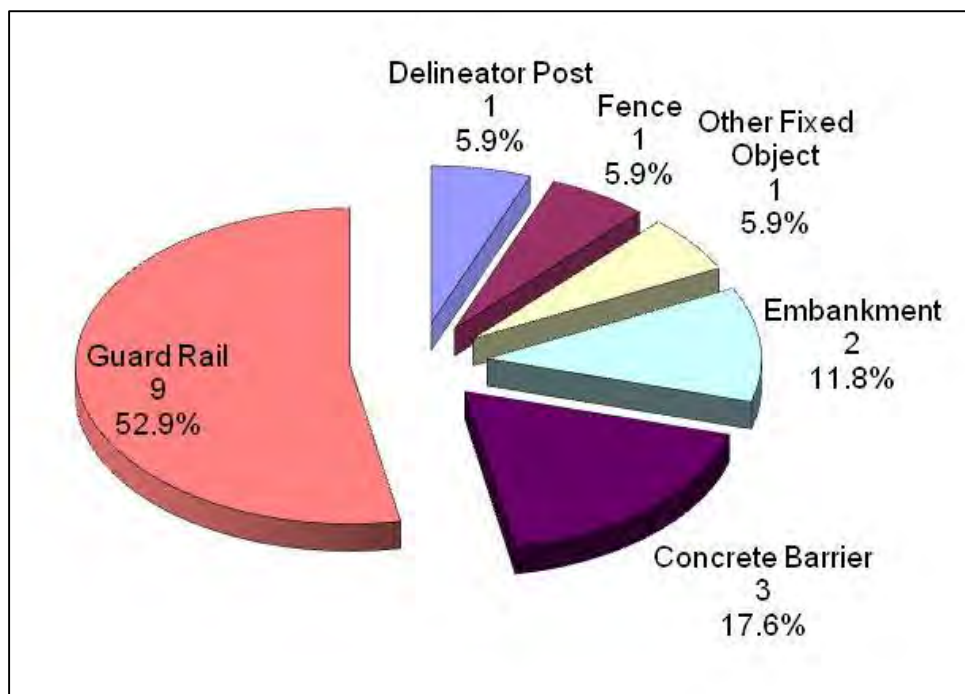
**Figure 38**  
**Fixed Object Crash Types**  
**(Segment 5A: MP 265.85 – MP 269.50)**

The frequency of fixed object type crashes was higher than expected for this type of roadway. It can be seen in **Figure 38** of the fixed object type crashes, guardrail type crashes (52.9%) were the predominant crash type followed by concrete barrier type crashes (17.6%). A review of the guard type crashes indicated that eight of the nine crashes occurred north of the US 85/US 34 interchange. Of those guardrail crashes, one crash occurred northbound and eight crashes occurred southbound. Seven of the nine crashes occurred with dry roadway conditions. Four of the vehicles were noted as exceeding the posted speed limit (45 mph). Guardrail and concrete barrier are normally designed and located to prevent crashes that are more serious. It is recommended that a solar powered dynamic speed message display (DSMD – radar) be considered near the beginning of the curves to warn drivers that they are exceeding the speed limit.

Although there is no significant pattern of off-road left or head-on crashes, it is recommended that a cable rail median barrier be considered due to the high volumes and narrow median from MP 268.7 to the north. Rumble strips should be considered for both inside and outside shoulders through this section (and shoulders widened if necessary).

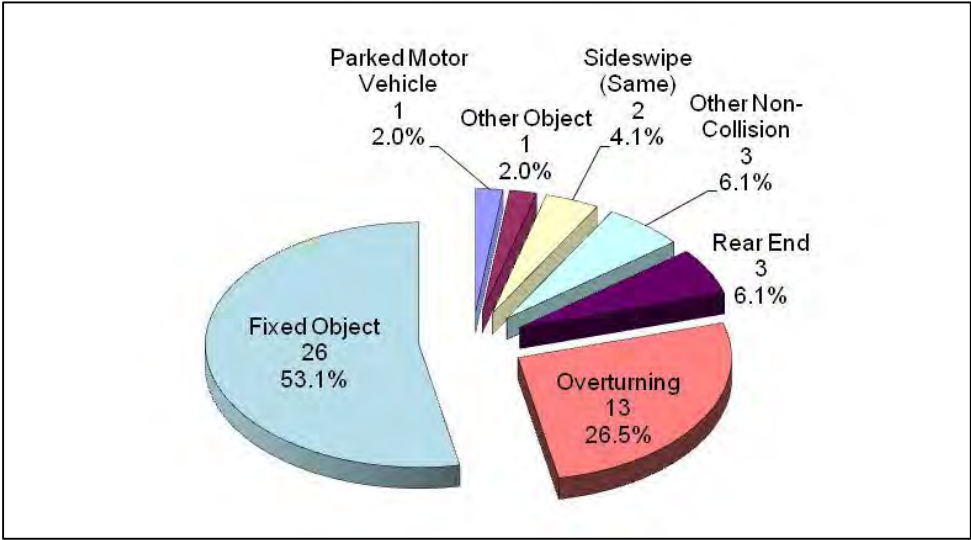
**Figure 39**  
**Non-Intersection Crash Types**  
**(Segment 5B: MP 269.51 – 273.00)**

Segment 5B begins one-mile north of the intersection with 5<sup>th</sup> Street (MP 268.49) in Greeley and extends north to approximately the mid-point (MP 273.00) between CR 68 and 70. There were a total of 49 non-intersection crashes along this sub-segment of US 85L: 30 PDO crashes, 18 injury crashes and one fatal crash. **Figure 39** presents a graphical representation of the non-intersection crash types for this sub-segment. Fixed object type crashes (53.1%) were the predominant crash type followed by overturning type crashes (26.5%).

The frequency of off-road, off-road right, and off-road left crashes were higher than expected for this type of roadway; there were 42 crashes with these outcomes. There were dry road conditions when slightly more than half (23) of the crashes occurred. There were approximately equal numbers during daylight versus dark, dawn, or dusk, and the directional split between northbound and southbound crashes was nearly equal. It is recommended that cable rail median barrier be considered to help reduce the number and severity of crashes into the median due to the high number of vehicles leaving the roadway. Rumble strips should be considered for outside shoulders (which should be widened as necessary to accommodate rumble strips).

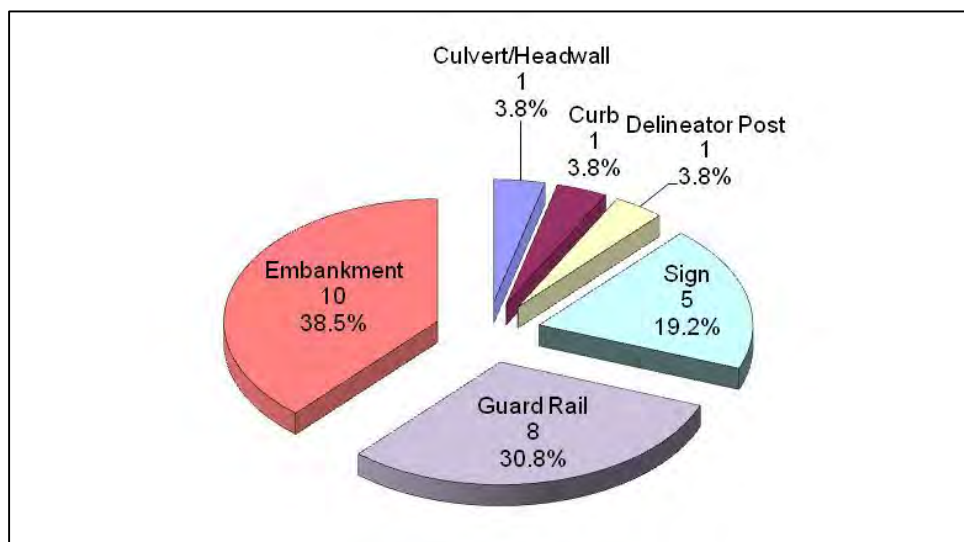
**Figure 40**  
**Fixed Object Crash Types**  
**(Segment 5B: MP 269.51 – 273.00)**

The frequency of fixed object type crashes was higher than expected for this type of roadway. It can be seen in **Figure 40** of the fixed object type crashes, embankment type crashes (38.5%) were the predominant crash type followed by guardrail type crashes (30.8%).

A review of the embankment type crashes indicated that two crashes occurred northbound and eight crashes occurred southbound. Six of the ten crashes occurred with dry roadway conditions. Only three of the crashes occurred during daylight conditions. Six of the ten crashes occurred between MP 272.63 and MP 273.00, just to the north of CR 68. As mentioned previously, rumble strips should be specifically considered between MP 272.63 and MP 273.00 for both inside and outside shoulders. Outside shoulders should be widened as necessary to accommodate rumble strips. A variable message sign (VMS) for each direction that is tied into pavement conditions sensors to warn drivers of slippery conditions should be considered through this section.

A review of the guardrail type crashes indicated that three crashes occurred northbound and five crashes occurred southbound. Half of the eight crashes occurred during daylight lighting conditions. Only one of the eight occurred with dry roadway conditions. Seven of the eight guardrail crashes occurred between MP 270.22 and MP 270.35 (the location relatively tight curves in both directions and a long bridge in the southbound direction). It is recommended the existing snow/ice removal procedures be reviewed to ensure existing procedures are sufficient.

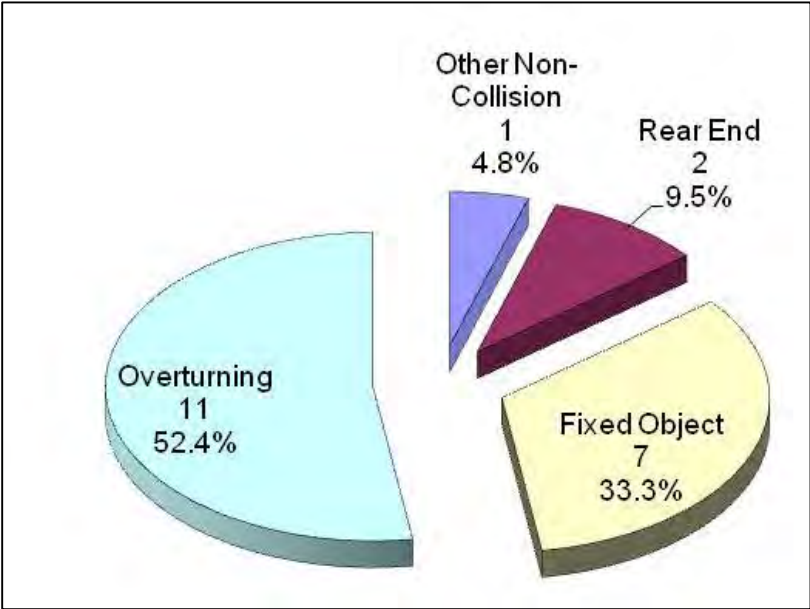
**Figure 44**  
**Non-Intersection Crash Types**  
**(Segment 6A: MP 273.01 – MP 275.00)**

Segment 6A begins near the mid-point between CR 68 and 70 (MP 273.00) and extends north to approximately 1,150 feet south (MP 275.00) of Colorado Parkway in Eaton. There were a total of 21 non-intersection crashes along this sub-segment of US 85L: 13 PDO crashes and eight injury crashes. **Figure 44** presents a graphical representation of the non-intersection crash types for this sub-segment. Overturning type crashes (52.4%) were the predominant crash type followed by fixed object type crashes (33.3%).

The frequency of overturning type crashes was higher than expected for this type of roadway. A review of the overturning type crashes indicated there were eight crashes northbound and three crashes southbound. Five of the 11 crashes occurred on icy/slushy roadway conditions. Five of the 11 overturning type crashes were located between MP 273.47 to MP 273.50 (the vicinity of the intersection with CR 70). Of the five crashes at that location, only one was indicated to be going over the posted speed limit of 65 mph. Two of the five that occurred in daylight lighting conditions and only one crash was in dry roadway conditions. The southbound roadway appears to have adequate outside shoulder width and some sections have rumble strips. It is recommended that CDOT consider widening the northbound outside shoulder so that rumble strips can be constructed along the entire sub-segment. While off-left crashes are not noted as significant, it is recommended that a cable rail median barrier be considered throughout the sub-segment. It is also recommended to review the existing snow/ice removal procedures to ensure existing procedures are sufficient.

The frequency of crashes in dark-unlighted conditions was higher than expected for this type of roadway. Eleven of the 21 crashes were in dark-unlighted conditions. The crashes were throughout the Segment 6A with two clusters of crashes, MP 273.02 – MP 273.10 (4 crashes) and MP 273.47 – MP 273.51 (4 crashes). It is recommended to review the retroreflectivity of all signs, delineator posts, and pavement markings to make sure they meet standards.

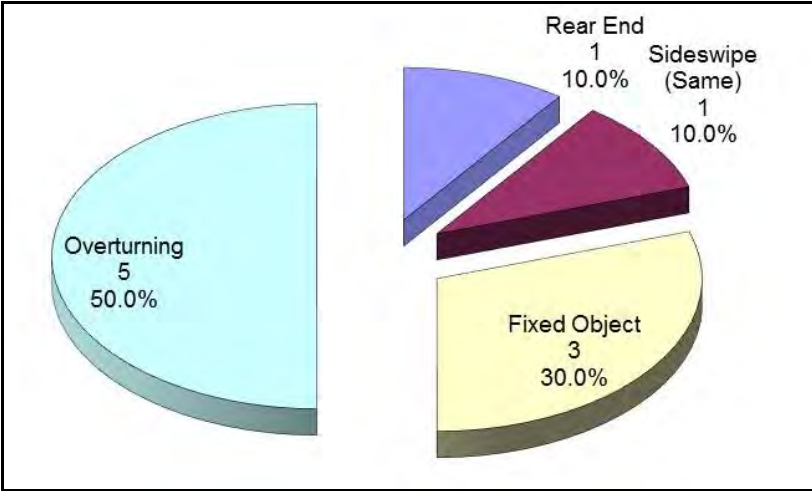
**Figure 46**  
**Non-Intersection Crash Types**  
**(Segment 6C: MP 276.11 – MP 279.26)**

Segment 6C begins at the intersection of 5<sup>th</sup> Street (MP 276.11) in Eaton and extends north to approximately 1,900 feet south (MP 279.26) of B Street in Ault. There were a total of 10 non-intersection crashes along this sub-segment of US 85L: five PDO crashes and five injury crashes. **Figure 46** presents a graphical representation of the non-intersection crash types for this sub-segment. Overturning type crashes (50.0%) were the predominant crash type followed by fixed object type crashes (30.0%).

Although the frequency of overturning type crashes was not higher than expected for this type of roadway, a review of the overturning type crashes indicated some concern. All five of the crashes were northbound. Four of the five crashes occurred on dry roadway conditions. Alcohol was involved in two of crashes. These five crashes were spread through Segment 6C. The southbound roadway appears to have adequate outside shoulder width with rumble strips installed. It is recommended that CDOT consider widening the northbound outside shoulder so that rumble strips can be constructed. North of CR 37 (MP 276.86), US 85L returns to the cross section with a depressed median. While off-left crashes are not noted as significant, it is recommended that a cable rail median barrier be considered through this section.

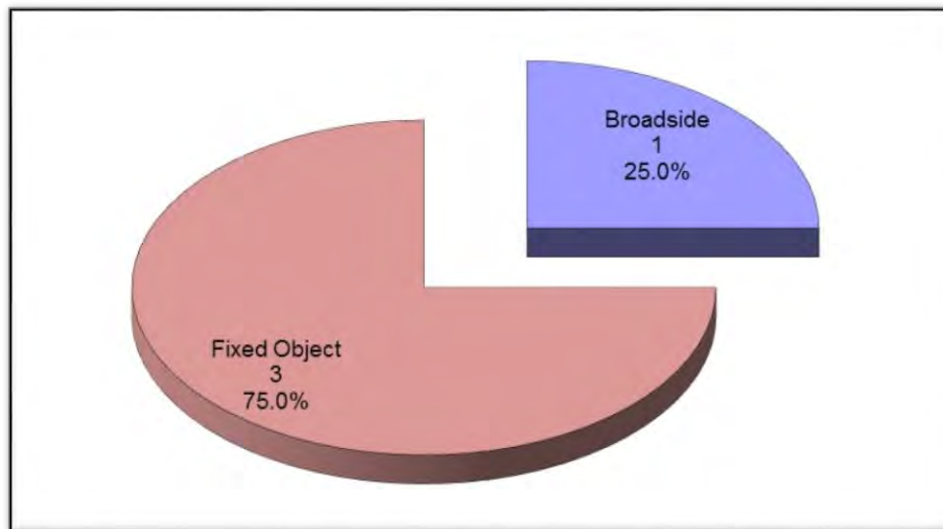
**Figure 47**  
**Non-Intersection Crash Types**  
**(Segment 6D: MP 279.27 – MP 280.27)**

Segment 6D begins approximately 1,900 feet south of B Street (MP 279.62) and extends north to the intersection with Jackie Ann Street and 1<sup>st</sup> Avenue (MP 280.27) in Ault. There were a total of four non-intersection crashes along this sub-segment of US 85L: all four were PDO crashes. **Figure 47** presents a graphical representation of the non-intersection crash types for this sub-segment. Fixed object type crashes (75.0%) were the predominant crash type followed by a broadside type crash (25.0%).

Although the frequency of fixed object type crashes was higher than expected for this type of roadway, three crashes in a five-year period is not considered a pattern.

The most southerly one-quarter mile of this sub-section has a cross section with a depressed median. The southbound roadway appears to have adequate outside shoulder width with rumble strips installed. It is recommended that CDOT consider widening the northbound outside shoulder so that rumble strips can be constructed. While off-left crashes are not noted as significant, it is recommended that a cable rail median barrier be considered through this section with a depressed median.

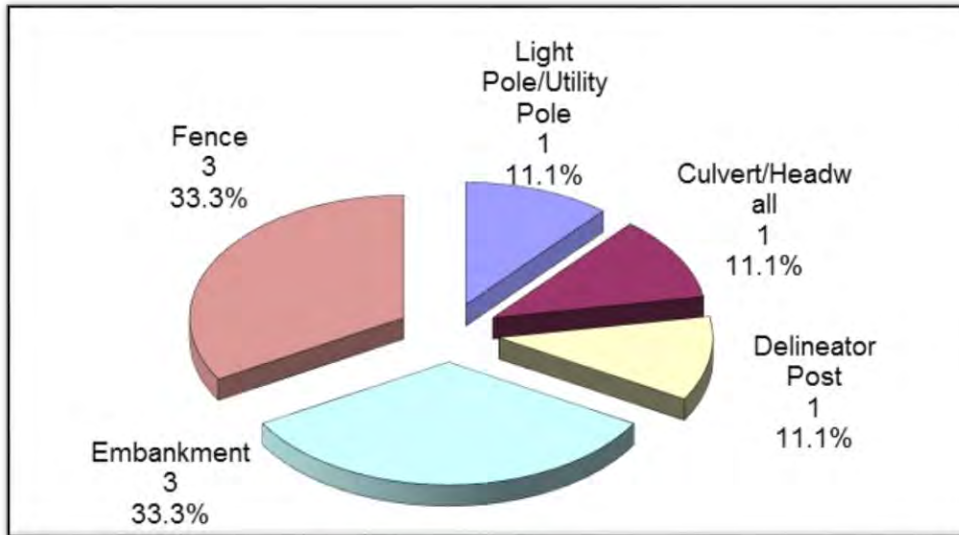
**Figure 52**  
**Fixed Object Crash Types**  
**(Segment 7A: MP 280.28 – MP 283.90)**

The frequency of fixed object type crashes was higher than expected for this type of roadway. It can be seen in **Figure 52** of the fixed object type crashes, fence and embankment type crashes (33.3% each) were the predominant crash type. A review of the fixed object type crashes indicated that eight of the nine crashes occurred between MP 280.5 and MP 281.50. Of these crashes, six crashes occurred northbound and three crashes occurred southbound. Four of the nine crashes occurred with dry roadway conditions. In addition, off-road and off-road right type crashes were higher than expected for this type of roadway. Outside of Pierce or where there is adjacent residential development, it is recommended that CDOT consider widening the shoulders sufficiently so that outside rumble strips can be constructed for both directions. In addition, a centerline rumble strip should also be considered through this sub-segment, as it might help both head-on and off-road left type crashes.

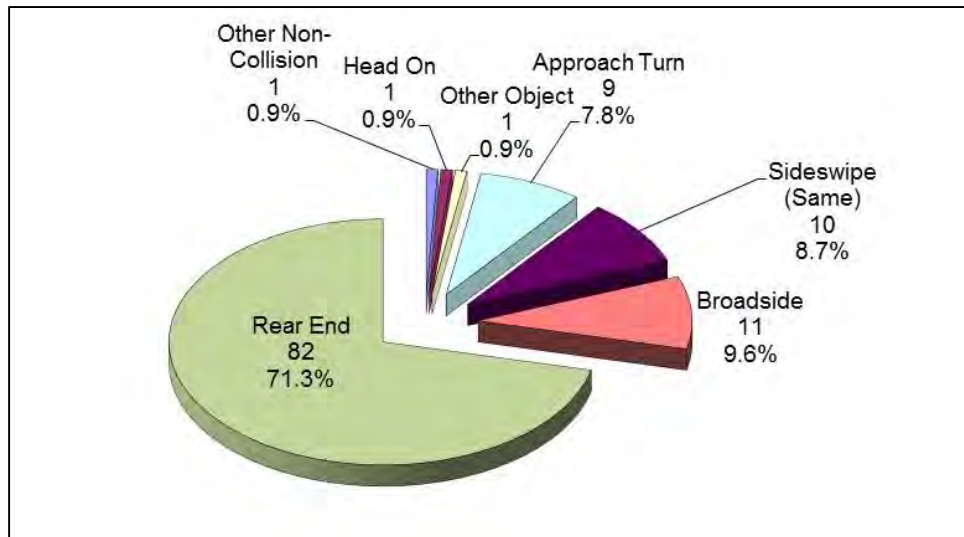
**Figure 57**  
**US 85C / SH 44 [104<sup>th</sup> Avenue] (MP 227.39 & MP 1.80)**  
**115 Total Crashes**

During the five-year study period (1/1/2008 – 12/31/2012), there were 115 crashes, 86 were property damage only, 28 resulted in injuries and one fatal crash. **Figure 57** provides a graphical representation of crash types for this location. Rear end crashes (71.3%) were predominant followed by broadside (9.6%) and sideswipe same direction (8.7%) type crashes.

The frequency of rear end type crashes was higher than expected for this type of intersection. A review of the rear end crash history indicated that there were 29 crashes northbound, 26 crashes southbound, 12 crashes eastbound and 15 crashes westbound. Road conditions for rear end type crashes showed that only eight of 82 crashes (9.7%) were related to inclement weather.

- Reviewing/updating the existing yellow/all red clearance intervals could help reduce the frequency of rear end type crashes.
- Consider repositioning flashing warning signs (W2-1) at an appropriate distance for current approach speeds) of the upcoming signalized intersection further south on US 85C for the northbound traffic and consider adding one north of the intersection for the southbound traffic. These signs should be appropriately sized for an expressway (48"x48"). If the separation distance allows, the flashing beacon should be connected to the signal controller in order to anticipate red phases.

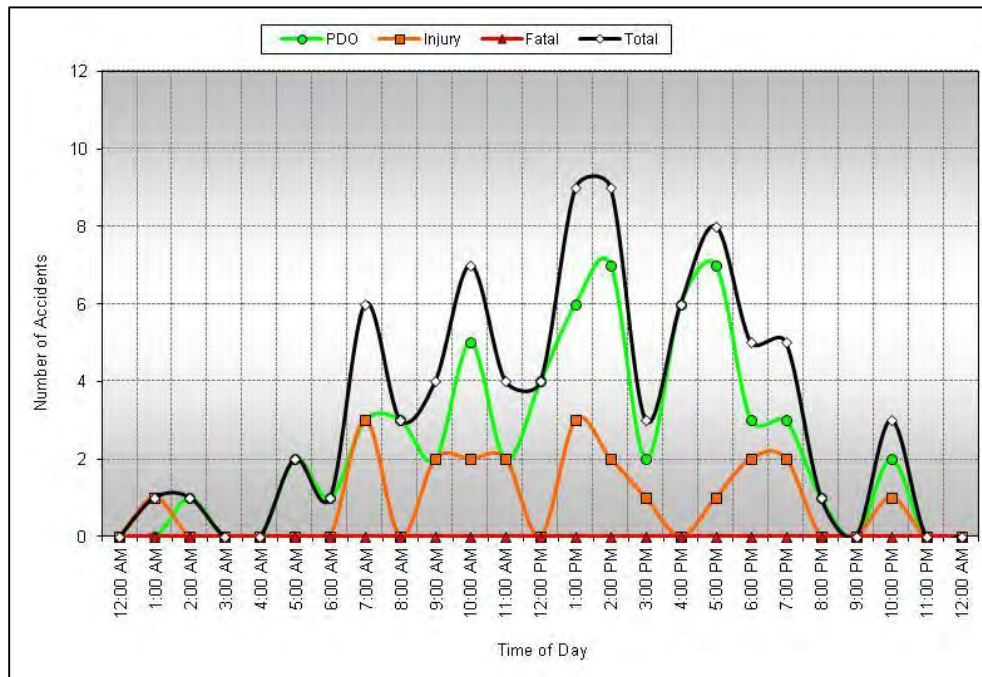
**Figure 58**  
**Time of Day – Rear End Type Crashes**

**Figure 58** indicates the time of day rear end type crashes occurred. It can be seen that rear end type crashes occur during peak periods of the day including the AM, mid-day and PM peak periods when congestion is typically higher.

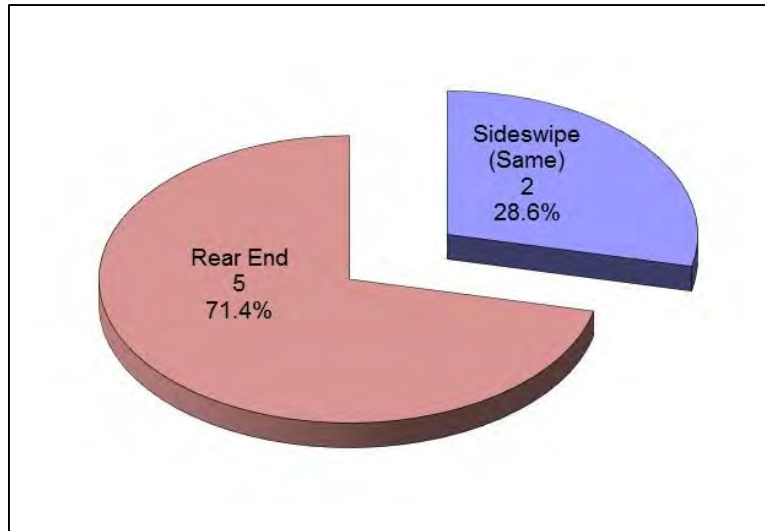
**Figure 64**  
**US 85C / 112<sup>th</sup> Avenue (MP 228.57)**  
**7 Total Crashes**

During the five-year study period (1/1/2008 – 12/31/2012), there were seven crashes, which all seven were property damage only. **Figure 64** provides a graphical representation of crash types for this location. Rear end type crashes (71.4%) were the predominant crash type followed by sideswipe (same) type crashes (28.6%).

There are no significant crash types at this intersection. However, it is worth noting that the rear end crashes had five crashes of which four occurred on dry roadway conditions. Directionally, two occurred northbound and three occurred southbound.
