## **Appendix D. Traffic Safety Report**

**US 85 PEL  
SAFETY ASSESSMENT**

Colorado Department of Transportation  
Region 4  
10601 West 10<sup>th</sup> Street  
Greeley, CO 80634  
970/350-2148 or 970/350-2163

March 2016

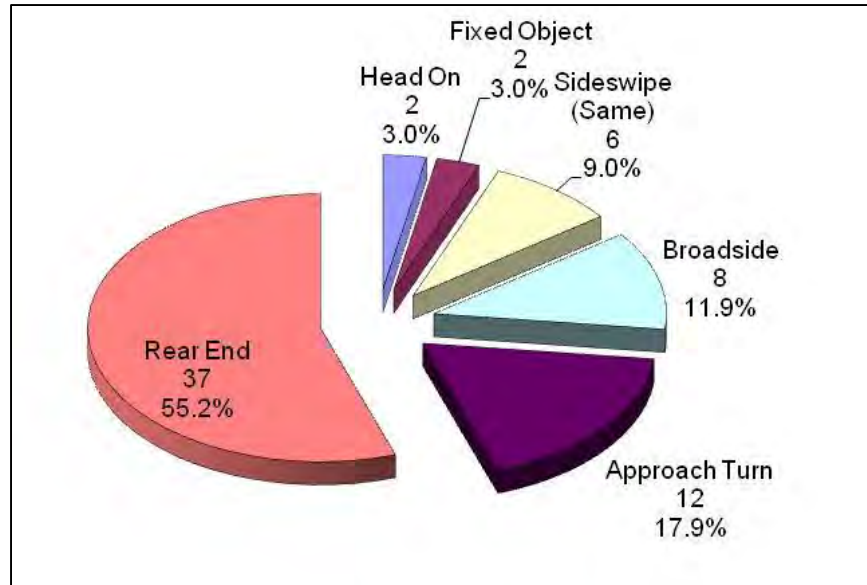
**Figure 68**  
**US 85C / 120<sup>th</sup> Avenue (MP 229.76)**  
**67 Total Crashes**

During the five-year study period (1/1/2008 – 12/31/2012), there were 67 crashes, 51 were property damage only, and 16 resulted in injuries. **Figure 68** provides a graphical representation of crash types for this location. Rear end type crashes (55.2%) were the predominant crash type followed by approach turn type crashes (17.9%) and broadside type crashes (11.9%).

The frequency of rear end type crashes was higher than expected for this type of intersection. Directionally, 18 rear end type crashes occurred northbound, nine southbound, eight eastbound and two westbound. Thirty-six of the 37 rear end crashes occurred on dry pavement and one crash was on icy road conditions. Reviewing and updating the existing yellow/all red clearance intervals should be considered to help reduce the frequency of rear end type crashes.

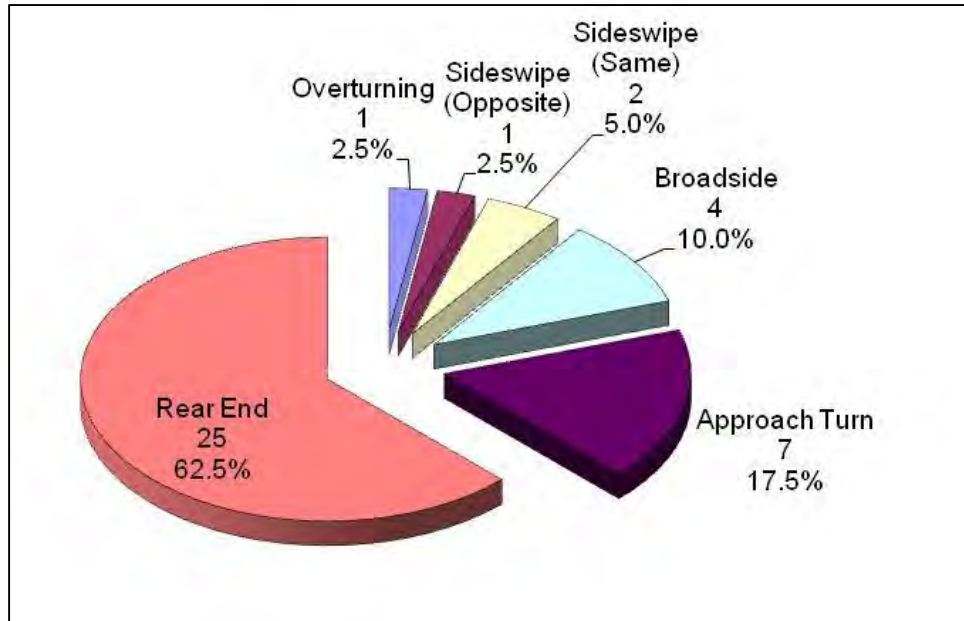
**Figure 72**  
**US 85C / 124<sup>th</sup> Avenue (MP 230.29)**  
**40 Total Crashes**

During the five-year study period (1/1/2008 – 12/31/2012), there were 40 crashes, 26 were property damage only, and 14 resulted in injuries. **Figure 72** provides a graphical representation of crash types for this location. Rear end type crashes (62.5%) were the predominant crash type followed by approach turn type crashes (17.5%).

The frequency of rear end type crashes was higher than expected for this type of intersection. A review of the crash history indicated that 12 of the rear end crashes were northbound, 11 southbound, one eastbound and one westbound. Twenty-three of the 25 crashes occurred on dry pavement, one crash on wet road conditions and one on icy road conditions. Reviewing and updating the existing yellow/all red clearance intervals should be considered to help reduce the frequency of rear end type crashes.

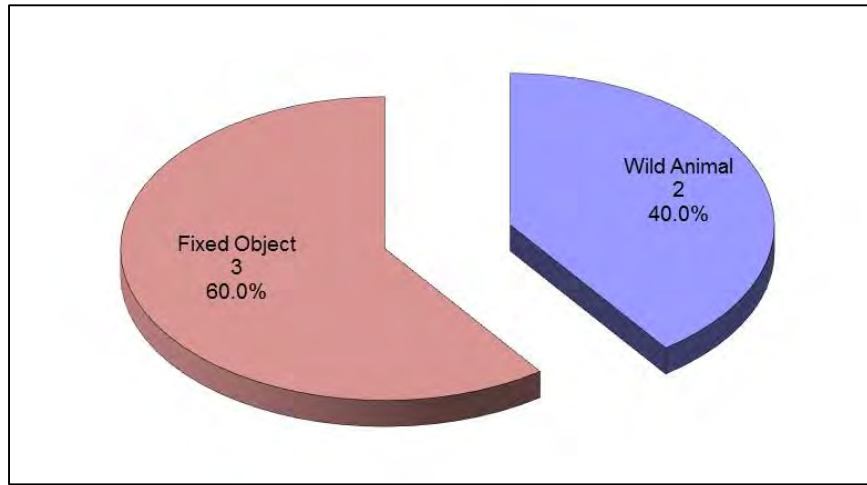
**Figure 74**  
**US 85C / 132<sup>nd</sup> Avenue (MP 231.38)**  
**5 Total Crashes**

During the five-year study period (1/1/2008 – 12/31/2012), there were five crashes, all five were property damage only. **Figure 74** provides a graphical representation of crash types for this location. Fixed object type crashes and wild animal type crashes were the only types of crashes occurring at the 132<sup>nd</sup> Avenue intersection.

A review of the crash history indicates that there is no current pattern to crashes at the intersection of US 85C and 132<sup>nd</sup> Avenue. There are no suggestions for improvement at this time.

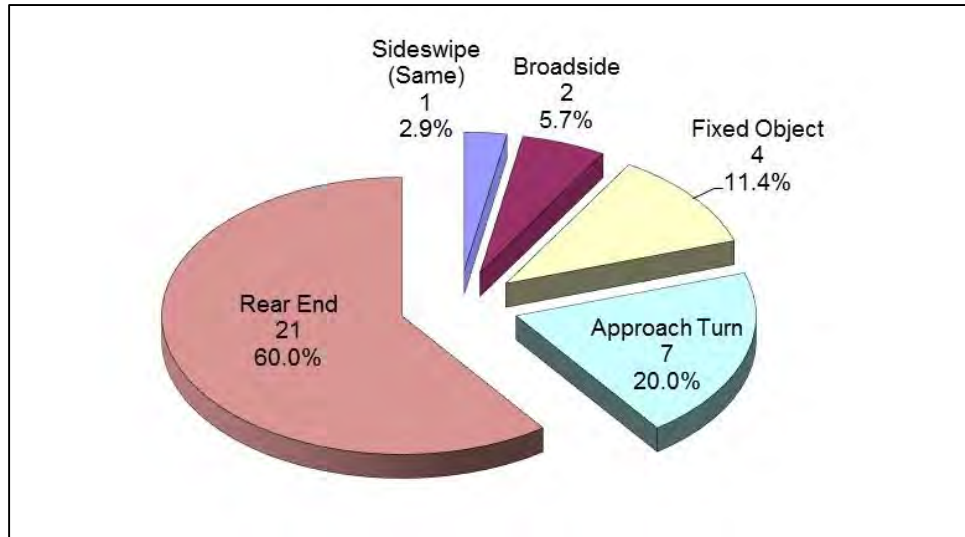
**Figure 78**  
**US 85C / 136<sup>th</sup> Avenue (MP 231.93)**  
**35 Total Crashes**

During the five-year study period (1/1/2008 – 12/31/2012), there were 35 crashes, 29 were property damage only, and six resulted in injuries. **Figure 78** provides a graphical representation of crash types for this location. Rear end type crashes (60.0%) were the predominant crash type followed by approach turn type crashes (20.0%).

The frequency of rear end type crashes was higher than expected for this type of intersection. A review of the crash history indicated that 13 of the rear end crashes were northbound, seven southbound, and one westbound. Nineteen of the 21 rear end crashes occurred on dry pavement, and two crashes occurred on wet road conditions.

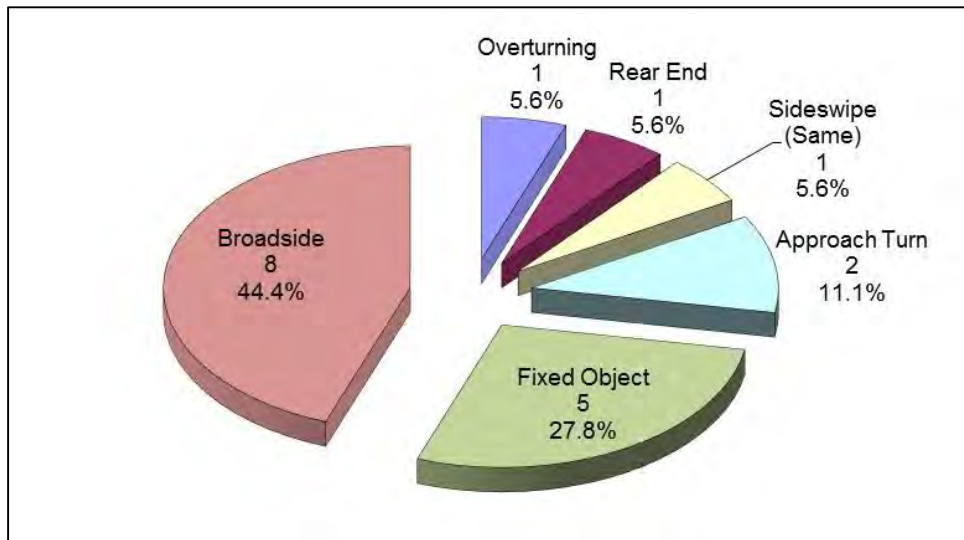
**Figure 80**  
**US 85C / 144<sup>th</sup> Avenue (MP 233.04)**  
**18 Total Crashes**

During the five-year study period (1/1/2008 – 12/31/2012), there were 18 crashes, eleven were property damage only, five resulted in injuries and two were fatalities. **Figure 80** provides a graphical representation of crash types for this location. Broadside type crashes (44.4%) were the predominant crash type followed by fixed object turn type crashes (27.8%).

The first crash occurred on July 5, 2008 at 14:08 during dry, daylight conditions. Vehicle #1 was traveling westbound on 144<sup>th</sup> Avenue and failed to stop for the stop sign at US 85C, causing a broadside crash with Vehicle #2 that was traveling southbound. The front passenger of Vehicle #1 was the fatality. Alcohol was not involved; however, the driver of Vehicle #1 was driving without a valid driver’s license.

The second reported fatal crash occurred on July 9, 2008 at 18:46 in dry, daylight conditions. Vehicle #1 was traveling northbound approaching 144<sup>th</sup> Avenue to make a left-turn. Vehicle #2 was traveling southbound. Vehicle #1 failed to yield to Vehicle #2, causing an approach turn crash. The driver in Vehicle #1 was the fatality.

The frequency of broadside type crashes was higher than expected for this type of intersection. A review of the crash history indicated that the eight broadside crashes occurred before the 144<sup>th</sup> Avenue approaches were converted into right-turn onto US 85C only in early 2011. Since the conversion, there has been no more broadside type crashes reported at 144<sup>th</sup> Avenue. It is recommended to monitor situation for possible additional corrective measures.

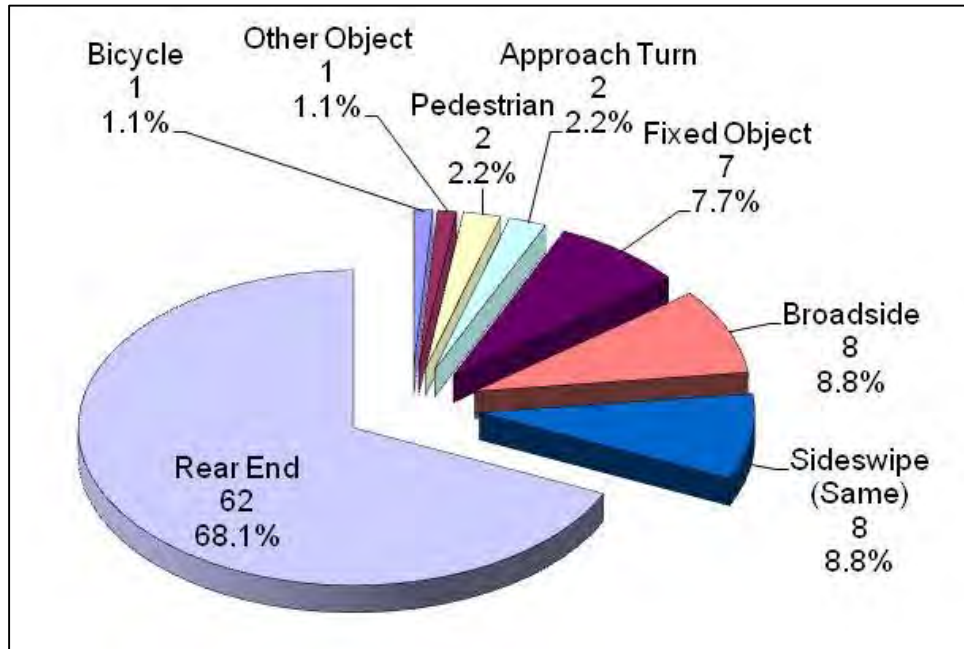
**Figure 84**  
**US 85C / Bromley Lane (MP 234.09)**  
**91 Total Crashes**

During the five-year study period (1/1/2008 – 12/31/2012), there were 91 crashes, 82 were property damage only, eight resulted in injuries, and one fatal crash. **Figure 84** provides a graphical representation of crash types for this location. Rear end type crashes (68.1%) were the predominant crash type followed by sideswipe (same side) and broadside type crashes (8.8% each).

The one fatal crash at the intersection with Bromley Lane occurred on May 15, 2008 at 23:38, under dry, dark-lighted conditions. A pedestrian was crossing US 85C eastbound south of Bromley Lane, not at the crosswalk. Vehicle #1 was traveling southbound on US 85C with the green light and collided with the pedestrian. The fatality was the pedestrian. No drugs or alcohol were reported.

The frequency of rear end type crashes was higher than expected for this type of intersection. A review of the crash history indicated that 39 of the rear end crashes were northbound, nine southbound, six eastbound, and eight westbound. Fifty-five of the 62 rear end crashes occurred on dry pavement, five crashes on wet road conditions, and two were on snowy/slushy road conditions. Reviewing the existing yellow/all red clearance intervals could help reduce rear end type crashes. Additionally, consideration of repositioning intersection warning signs (at an appropriate distance for current approach speeds) further away from the intersection could improve driver awareness of the upcoming signalized intersection. If the separation distance allows, the flashing beacon should be connected to the signal controller in order to anticipate red phases.

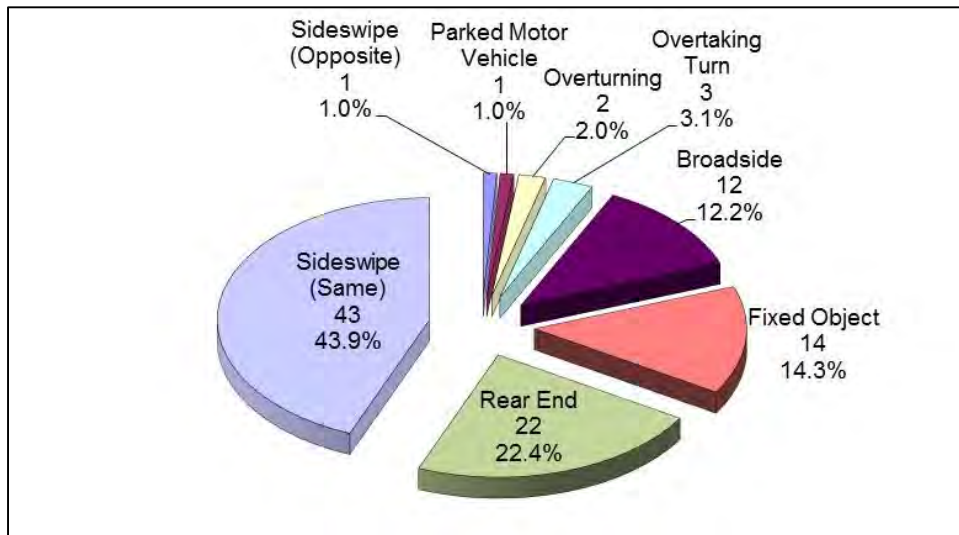
**Figure 86**  
**US 85C / SH 7D (MP 235.10 & MP 76.99)**  
**98 Total Crashes**

During the five-year study period (1/1/2008 – 12/31/2012), there were 98 crashes related to the roundabouts, 91 were property damage only and seven resulted in injury. **Figure 86** provides a graphical representation of crash types for this location. Sideswipe (same) type crashes (43.9%) were the predominant crash type followed by rear end (22.4%), fixed object (14.3%), and broadside type crashes (12.2%). There were 46 crashes at the west roundabout, while the east experienced 52. The percentage of rear-end type crashes was higher at the west roundabout (37% vs. 10%) while the percentage of sideswipe (same) and broadside type crashes was higher at the east roundabout (62% vs. 50%).

There are no diagnostics nor SPFs available for roundabouts, but the prevalence of sideswipe (same) and rear end type crashes appears to be the expected types of crashes. Although only a few officer narratives were available at this location for review, many “broadside” crashes have probably been incorrectly coded. Officer narratives at other roundabouts reference vehicles failing to yield right-of-way when entering the roundabout and colliding with a vehicle in the roundabout as both broadside and sideswipe (same direction) crashes. Thus, if broadside crashes are mostly miscoded, sideswipe (same) crashes would be between 50 and 55 percent of the total. Without a frame of reference, the total number of crashes seems high – an average of ten crashes at each roundabout over the five-year study period. After 2008 (8 crashes), the other four years had crash totals in the mid-20’s. There were 46 crashes at the west roundabout and 52 at the east. A total of nine crashes were noted as being caused by vehicles on the US 85C off-ramps (six northbound and three southbound).

A brief review (Google StreetView) of the signing reveals that the regulatory, warning, and guide signing for the roundabout is inconsistent. It is recommended that a thorough review of the signing be conducted and signing upgraded to conform to the most recent guidance in the MUTCD (2012 Supplement).

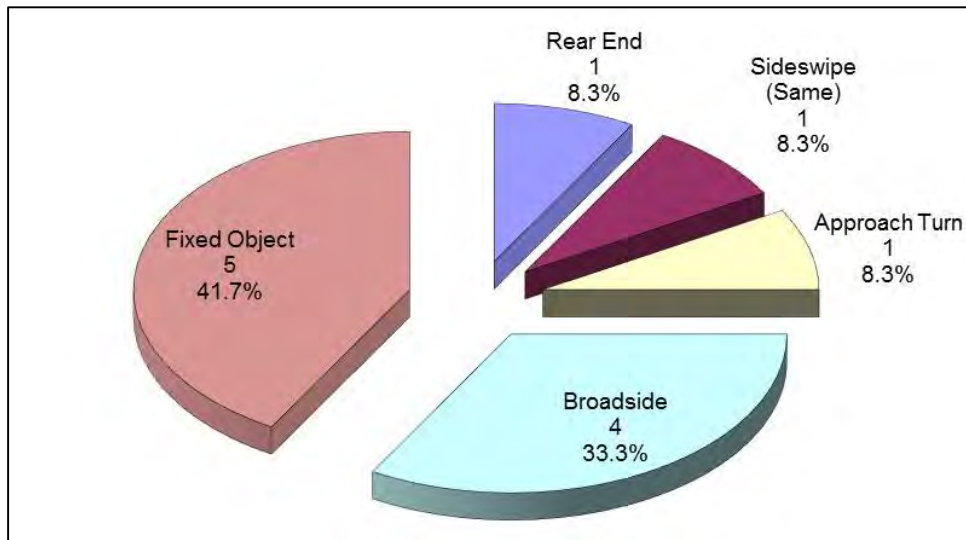
**Figure 88**  
**US 85C / Denver Street (MP 235.60)**  
**12 Total Crashes**

During the five-year study period (1/1/2008 – 12/31/2012), there were 12 crashes, eleven were property damage only and only one resulted in injury. **Figure 88** provides a graphical representation of crash types for this location. Fixed object type crashes (41.7%) were the predominant crash type followed by broadside type crashes (33.3%).

The frequency of fixed object type crashes was higher than expected for this type of intersection. A review of the crash history indicated that the four fixed object type crashes occurred in dry road conditions and one in icy road conditions. Two occurred in daylight conditions and three in dark unlighted/lighted conditions. Three vehicles struck signs, one hit a fence, and one hit a light pole. There is no correctible pattern to these crashes, and there are no suggestions for improvement at this time.

It should be noted that the island restricting westbound Denver Street traffic to right turns only was installed in early 2013. The four broadside crashes all were caused by westbound vehicles on Denver Street, and the turn restriction should have corrected the broadside problem. The intersection should be monitored to make sure this has happened.

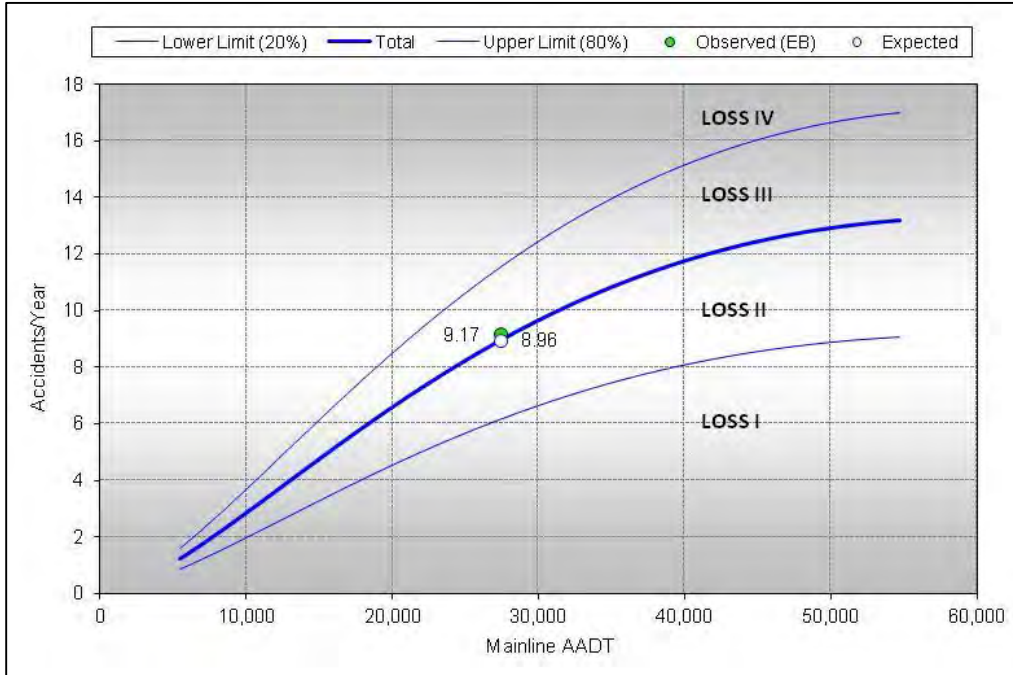
**Figure 90**  
**Four-Lane Divided Signalized Four-Leg Intersection**  
**Total Crashes per Year (CR 2 [168<sup>th</sup> Avenue/Baseline Road])**  
**Minor AADT = 4,500**

For the intersection of US 85C with CR 2 (168<sup>th</sup> Avenue/Baseline Road), **Figure 90** shows that the frequency of total crashes over the five-year study period indicates a moderate to high potential for crash reduction (LOSS III) for a four-lane divided signalized four-leg intersection. **Figure 91** shows that the severity of crashes also indicates a moderate to high potential for crash reduction for this intersection type (LOSS III).

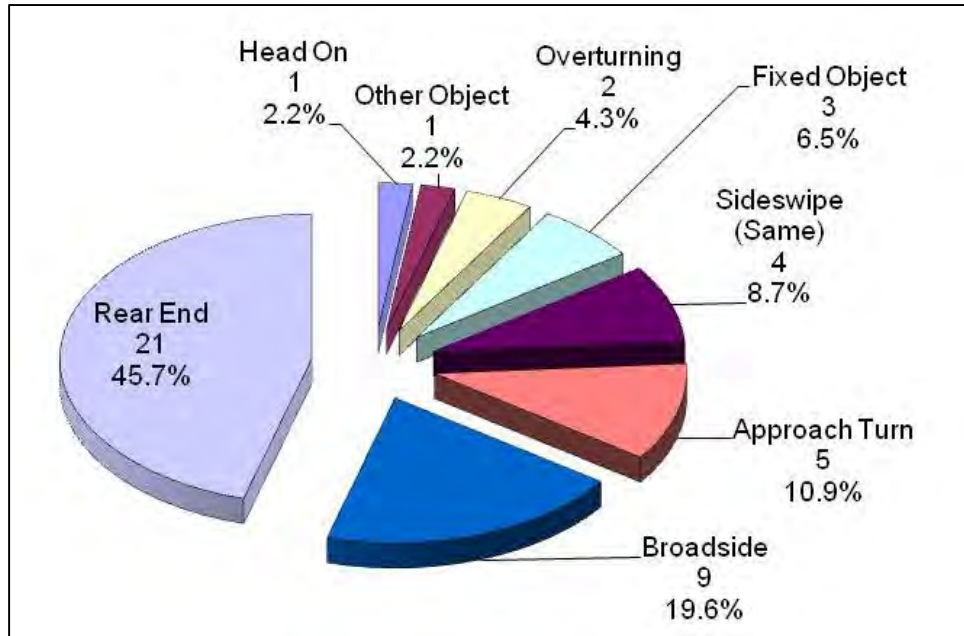
**Figure 92**  
**US 85C / CR 2 (168<sup>th</sup> Avenue/Baseline Road) (MP 236.03)**  
**46 Total Crashes**

During the five-year study period (1/1/2008 – 12/31/2012), there were 46 crashes, 31 were property damage only and 15 resulted in injuries. **Figure 92** provides a graphical representation of crash types for this location. Rear end type crashes (45.7%) were the predominant crash type followed by broadside type crashes (19.6%).

There are no significant crash types at this intersection. However, it is worth noting that the rear end crashes had 21 crashes of which 19 occurred on dry roadway conditions. Directionally, ten of the 21 occurred northbound, five southbound, one eastbound, and five westbound.

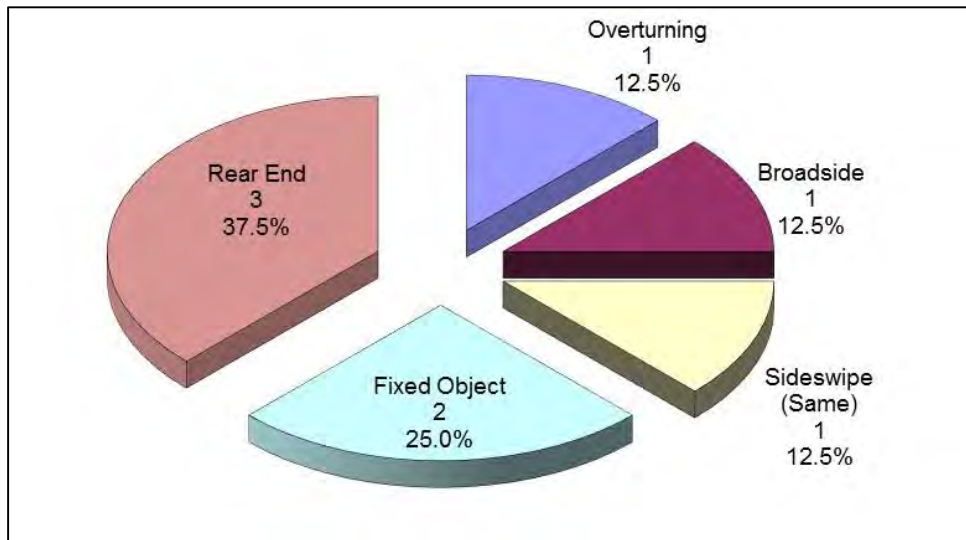
**Figure 94**  
**US 85C / CR 2.5 (MP 236.55)**  
**8 Total Crashes**

During the five-year study period (1/1/2008 – 12/31/2012), there were eight crashes, three were property damage only and five resulted in injuries. **Figure 94** provides a graphical representation of crash types for this location. Rear end type crashes (37.5%) were the predominant crash type followed by fixed object type crashes (25.0%).

A review of the crash history indicates that there is no current pattern to crashes at the intersection of US 85C and CR 2.5. There are no suggestions for improvement at this time.

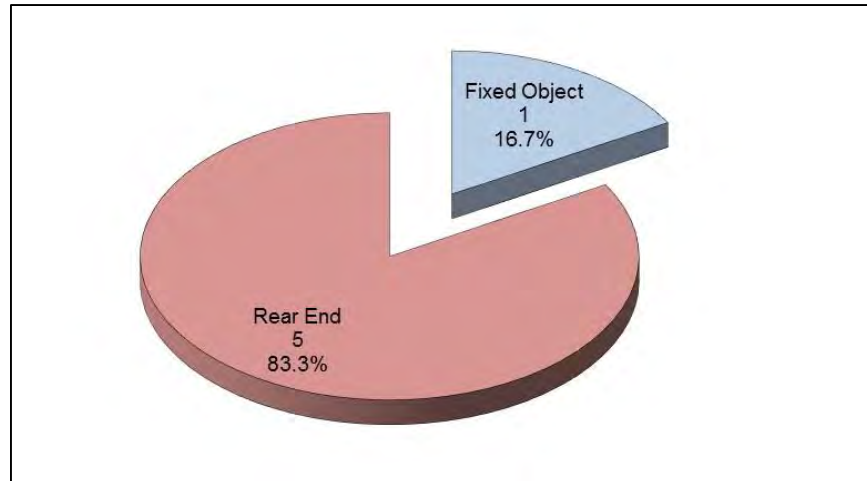
**Figure 98**  
**US 85C / CR 6 (MP 238.09)**  
**6 Total Crashes**

During the five-year study period (1/1/2008 – 12/31/2012), there were six crashes, four were property damage only and two resulted in injuries. **Figure 98** provides a graphical representation of crash types for this location. Rear end type crashes (83.3%) were the predominant crash type followed by fixed object type crashes (16.7%).

The frequency of rear end type crashes was higher than expected for this type of intersection. A review of the crash history indicated that all five of the rear end crashes were southbound and all occurred on dry pavement.

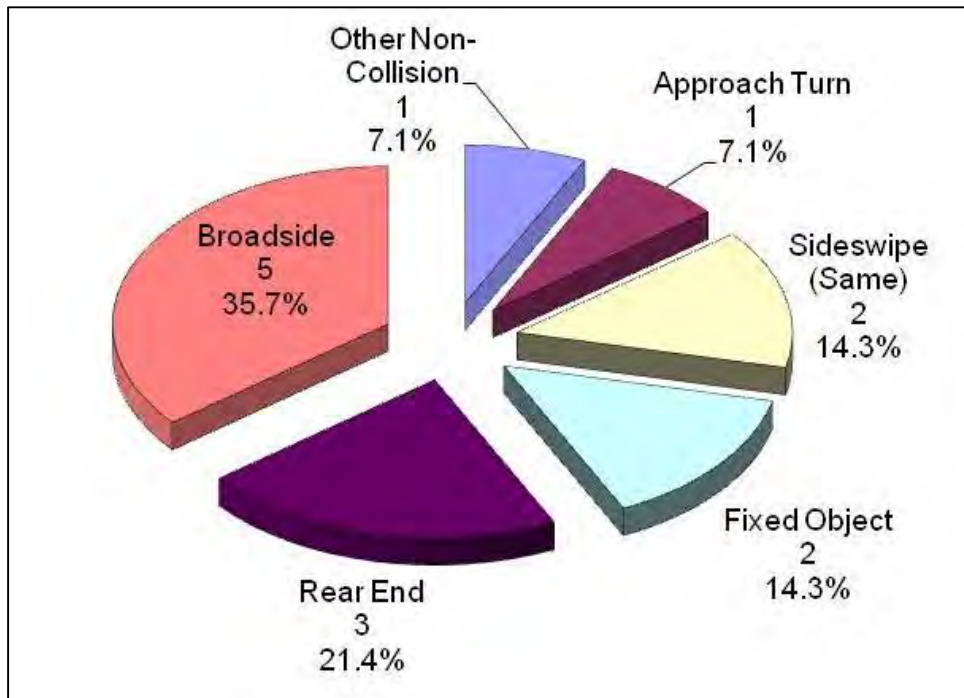
**Figure 100**  
**US 85C / CR 8 (MP 239.08)**  
**14 Total Crashes**

During the five-year study period (1/1/2008 – 12/31/2012), there were 14 crashes, seven were property damage only and seven resulted in injuries. **Figure 100** provides a graphical representation of crash types for this location. Broadside type crashes (35.7%) were the predominant crash type followed by rear end type crashes (21.4%).

There are no significant crash types at this intersection. However, it is worth noting that the broadside crashes had five crashes that all occurred on dry roadway conditions. Directionally, the five broadside type crashes occurred westbound. Field visit did not find sight distance as an issue. It is recommended to monitor this intersection for future broadside crashes and review the need for a right-turn only island for westbound traffic if the issue persists.

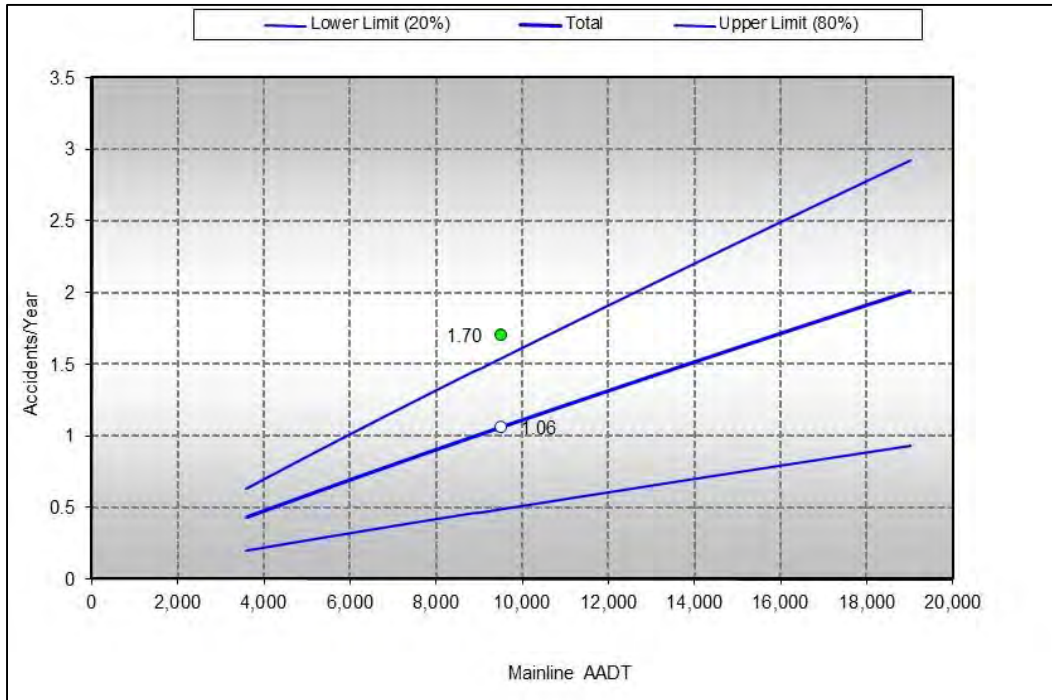
**Figure 102**  
**Two-Lane (Mainline) Signalized Ramp Intersection**  
**Total Crashes per Year (West Ramps – SH 52A at US 85C)**  
**SH 52A AADT = 9,500**

For the west intersections of SH 52A with the ramps to/from US 85C, **Figure 102** shows that the frequency of total crashes indicates a high potential for crash reduction for a signalized two-lane ramp intersection (LOSS IV). **Figure 103** shows that the severity of crashes also indicates a to moderate to high potential for crash reduction (LOSS III).

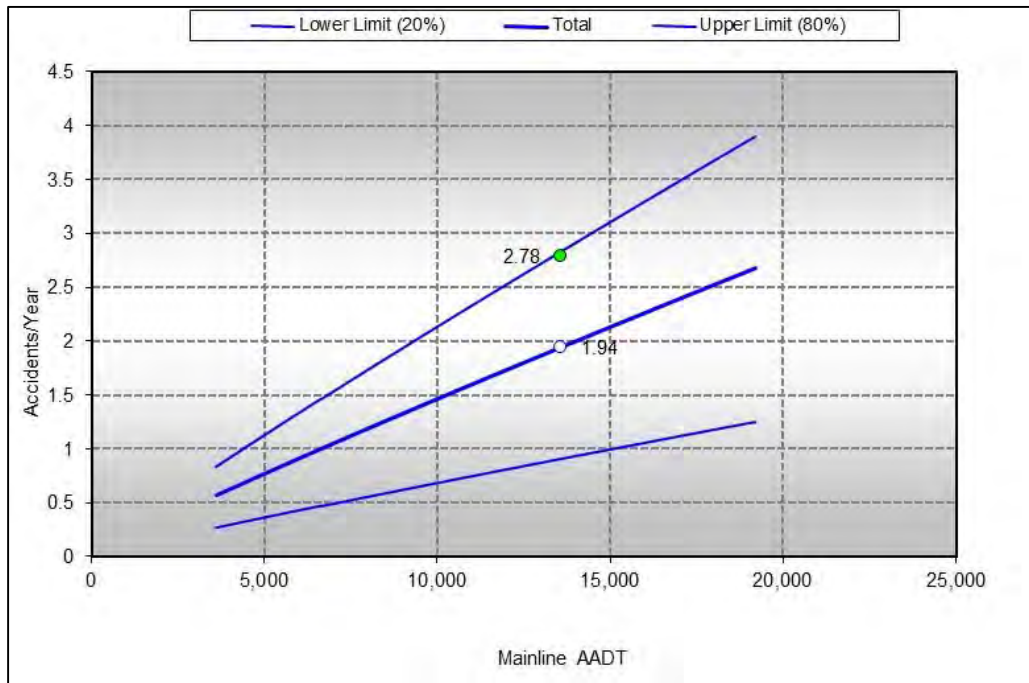
**Figure 104**  
**Two-Lane (Mainline) Signalized Ramp Intersection**  
**Total Crashes per Year (East Ramps – SH 52A at US 85C)**  
**SH 52A AADT = 13,600**

For the east intersections of SH 52A with the ramps to/from US 85C, **Figure 104** shows that the frequency of total crashes indicates a high potential for crash reduction for a signalized two-lane ramp intersection (LOSS III/IV). **Figure 105** shows that the severity of crashes also indicates a to moderate potential for crash reduction (LOSS II/III).

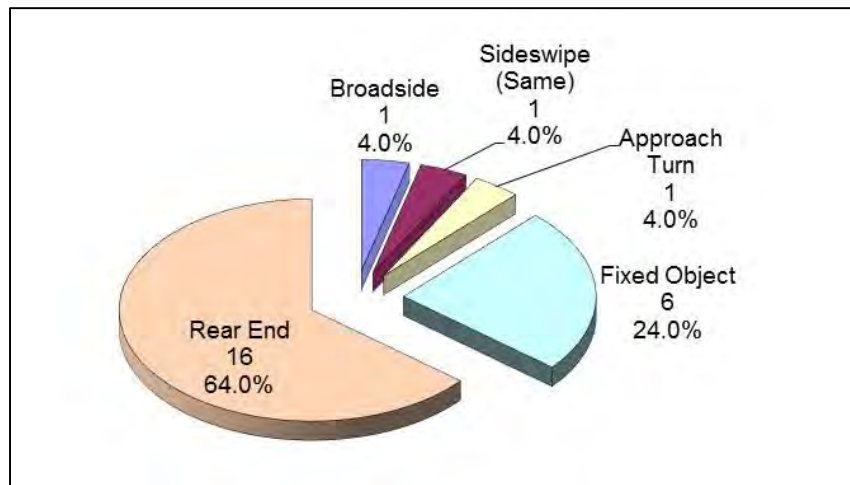
**Figure 106**  
**US 85C / SH 52A (MP 235.10 & MP 19.96)**  
**25 Total Crashes**

During the five-year study period (1/1/2008 – 12/31/2012), there were 25 crashes at the intersections or related to them, 21 were property damage only and four resulted in an injury. **Figure 106** provides a graphical representation of crash types for this location. Rear-end (64.0%) type crashes were the predominant crash type followed by fixed object (24.0%) type crashes (12.2%). The east intersection/ramps experienced 15 of the crashes, and the west had 10. The patterns of rear-end and fixed object type crashes was fairly consistent between the two intersections.

There are no direct diagnostics available for two-lane (mainline) signalized ramp intersection roundabouts to determine the expected number of crashes. However, the prevalence of rear end type crashes would be higher than expected if these intersections were either normal 3-leg or 4-leg intersections. Since most of the crashes were caused by vehicles travelling on SH 52A, this general comparison would appear to be valid. At the west intersection, four of the six rear-end type crashes were eastbound, while five of the rear-end crashes at the east intersection were westbound on SH 52A and four were northbound on the US 85C off-ramp. These vehicles were all approaching the first of two signalized intersections at the interchange. There does not appear to be a sight-distance concern with see the second signal when looking from under the US 85C bridges.

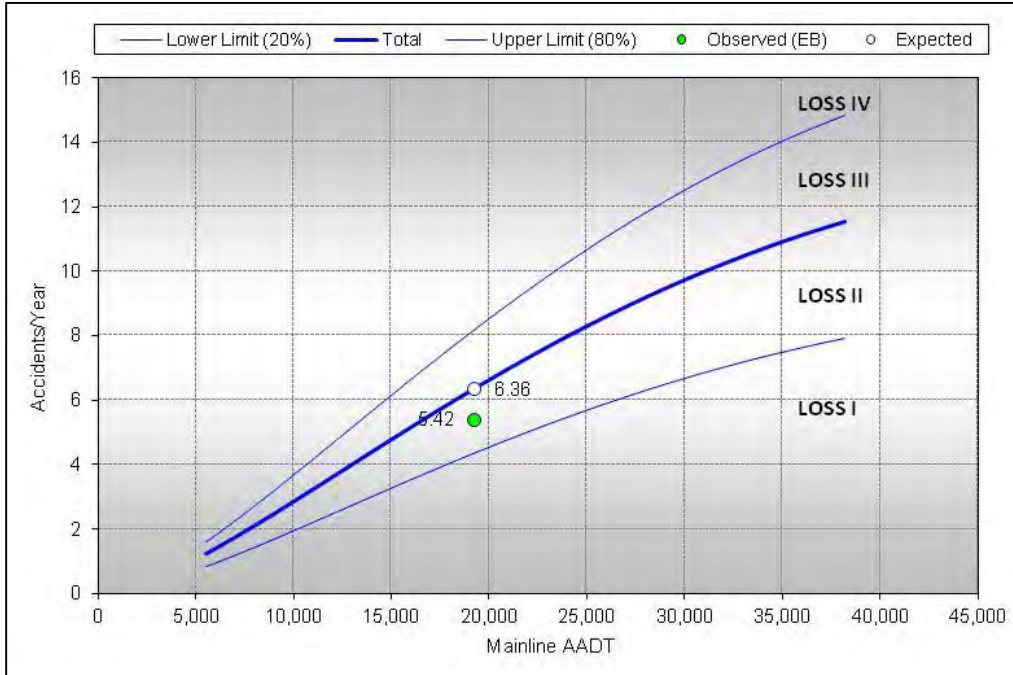
**Figure 108**  
**Four-Lane Divided Signalized Four-Leg Intersection**  
**Total Crashes per Year (CR 14.5 [14<sup>th</sup> Street])**  
**Minor AADT = 4,550**

For the intersection of US 85C with CR 14.5, **Figure 108** shows that the frequency of total crashes indicates a low to moderate potential for crash reduction for a signalized four-lane divided four-leg intersection (LOSS II). **Figure 109** shows that the severity of crashes indicates a moderate to high potential for crash reduction for this intersection type (LOSS III).

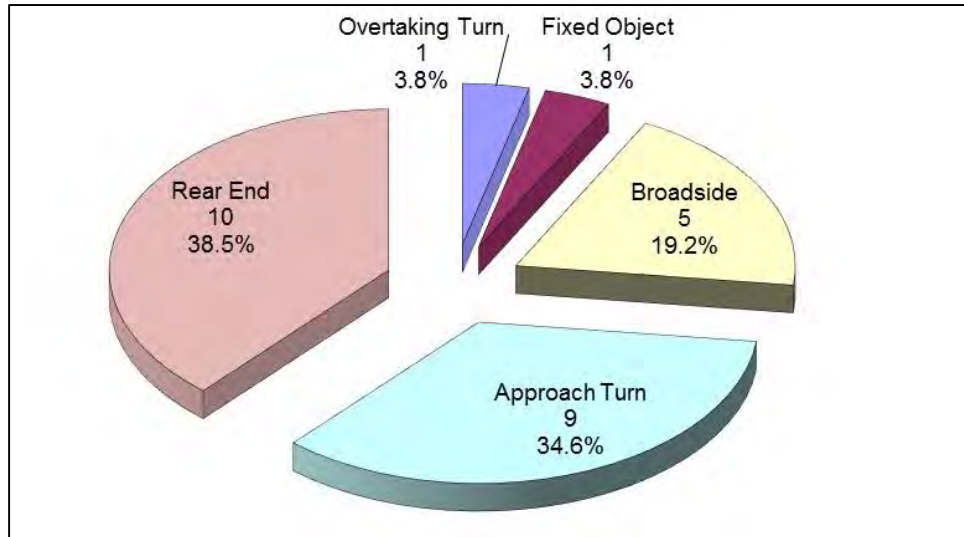
**Figure 110**  
**US 85C / CR 14.5 [14<sup>th</sup> Street] (MP 242.66)**  
**26 Total Crashes**

During the five-year study period (1/1/2008 – 12/31/2012), there were 26 crashes, 15 were property damage only, ten resulted in injuries, and one fatal crash. **Figure 110** provides a graphical representation of crash types for this location. Rear end type crashes (38.5%) were the predominant crash type followed by approach turn type crash (34.6%).

There was one fatal crash that occurred on August 13, 2010 at 9:14 under dry, daylight conditions. Vehicle #1 was traveling northbound on US 85C approaching 14½ Street and was attempting a left-turn when it was struck by southbound Vehicle # 2 on the passenger side of the vehicle. This approach turn type crash was noted to be careless driver and driver inexperience for the driver of Vehicle #1. Neither vehicle was speeding. No alcohol or drugs were suspected. Fatality was the passenger of Vehicle #1.

The frequency of approach turn type crashes was higher than expected for this type of intersection. A review of the crash history indicated that five of the approach turn type crashes were northbound, three southbound, and one westbound. All nine of the approach turn type crashes occurred on dry pavement road conditions. The signal provides protect-permitted left-turn movements along the mainline. Site visit indicated there could be a sight distance issue due to the intersection is positioned on a curve along US 85C. It was observed that northbound left-turning vehicles have difficulty viewing the mainline when there are opposing left-turning vehicles.

It is recommended to consider converting the northbound and southbound left-turn operations to protected only. Additionally, reviewing/updating the existing yellow/all red clearance intervals could provide more clearance time for turning movements to clear the intersection. Consideration of repositioning intersection warning signs (at an appropriate distance for current approach speeds) further away from the intersection could improve driver awareness of the upcoming signalized intersection. If the separation distance allows, the flashing beacon should be connected to the signal controller in order to anticipate red phases.

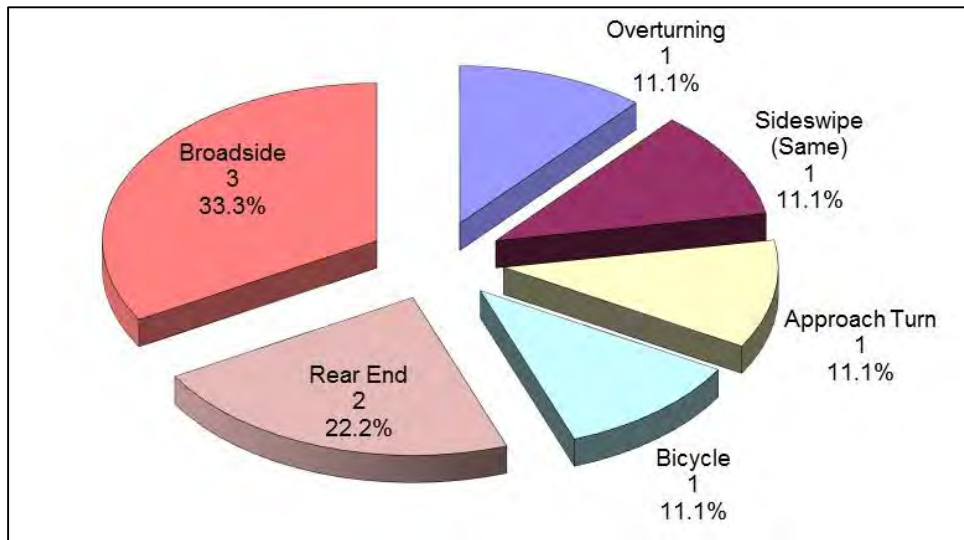
**Figure 112**  
**US 85C / CR 16 (MP 243.21)**  
**9 Total Crashes**

During the five-year study period (1/1/2008 – 12/31/2012), there were nine crashes, five were property damage only and four resulted in injuries. **Figure 112** provides a graphical representation of crash types for this location. Broadside type crashes (33.3%) were the predominant crash type followed by rear end type crashes (22.2%).

There are no significant crash types at this intersection. However, it is worth noting that there were three broadside crashes that all occurred before 2012. Sometime in early 2012, the median was closed so that westbound vehicles can only turn right at the intersection. This has eliminated the broadside crash problem through 2014.

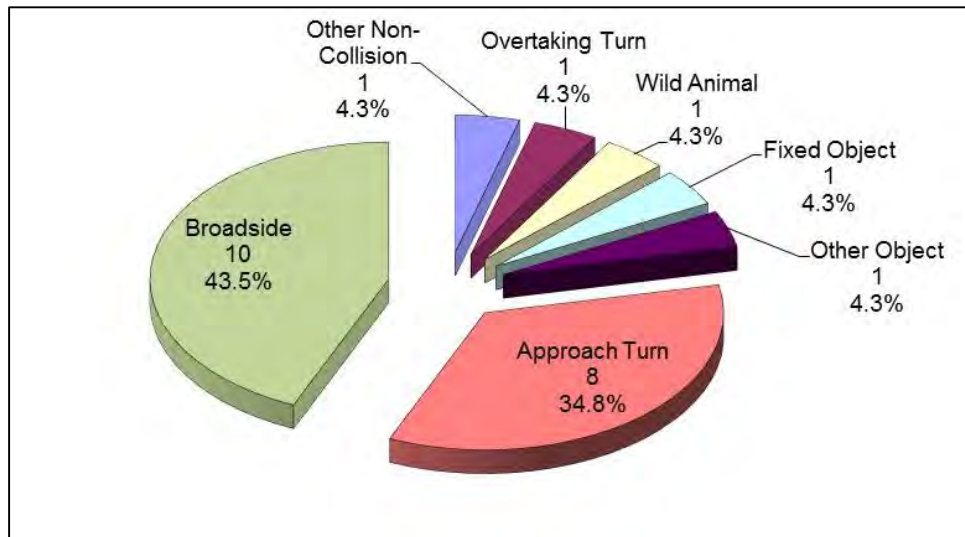
**Figure 114**  
**US 85C / CR 18 (MP 244.21)**  
**23 Total Crashes**

During the five-year study period (1/1/2008 – 12/31/2012), there were 23 crashes, ten were property damage only and 13 resulted in injuries. **Figure 114** provides a graphical representation of crash types for this location. Broadside type crashes (43.5%) were the predominant crash type followed by approach turn type crashes (34.8%).

The frequency of broadside type crashes was higher than expected for this type of intersection. A review of the crash history indicated that six of the broadside type crashes were eastbound vehicles (four hitting southbound vehicles and two hitting northbound vehicles) and three were westbound (all hitting northbound vehicles). None of the at-fault vehicles was a large truck. Six of the crashes resulted in a total of 15 injuries. Ten broadside type crashes occurred on dry pavement road conditions during daylight hours. Only two of the crashes involved eastbound vehicles that crossed the median and struck a northbound vehicle; seven vehicles struck US 85C vehicles in the closer direction of travel. Six of the vehicles were going straight while three were making left turns. A site visit indicated there is not a sight distance issue. There is no indication in the crash records that the at-fault vehicles failed to stop at the stop signs. There are double posted intersection warning signs (W2-1) on both approaches of US 85C. It is recommended that the size of these signs be increased to freeway standard (48"x48"). This intersection should be monitored in the future to see if more aggressive measures (such as beacons on the stop signs, intersection warning signs, or ultimately right turn only restrictions for both CR 18 approaches) might be appropriate.

The frequency of approach turn type crashes was higher than expected for this type of intersection. A review of the crash history indicated that one of the approach turn type crashes was northbound and seven were southbound. Seven of the crashes resulted in 15 injuries. All eight of the approach turn type crashes occurred on dry pavement road conditions. Five of the crashes occurred during daylight hours. It should be noted that the position of the southbound left-turn lane was shifted further east in the median to give better visibility of oncoming northbound traffic. There was only one southbound approach turn crash in 2012. It is recommended to monitor this intersection for future approach turn crashes and determine the need for more aggressive measures (such as closing the median to create right-in, right-out turns for both CR 18 approaches) if the issue persists.

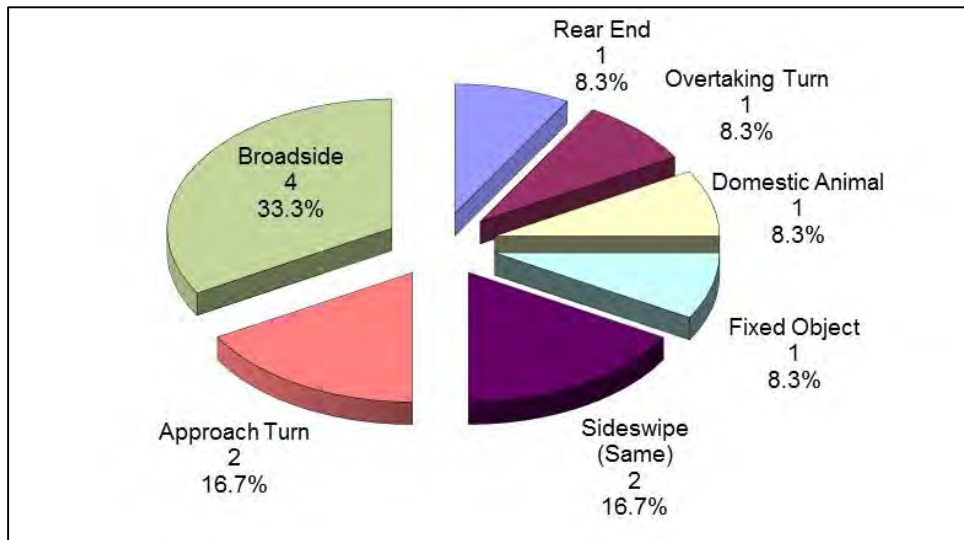
**Figure 116**  
**US 85C / CR 22 (MP 246.21)**  
**12 Total Crashes**

During the five-year study period (1/1/2008 – 12/31/2012), there were 12 crashes, six were property damage only and six resulted in injuries. **Figure 116** provides a graphical representation of crash types for this location. Broadside type crashes (33.3%) were the predominant crash type followed by approach turn and sideswipe (same) type crashes (16.7% each).

There are no significant crash types at this intersection. However, it is worth noting that there were four broadside crashes that all occurred on dry roadway conditions. Directionally, the four broadside type crashes occurred westbound. Three vehicles were making left turns, and two hit northbound vehicles while one hit a southbound vehicle. A field visit did not find sight distance as an issue. There are double posted intersection warning signs (W2-1) on both approaches of US 85C. Increasing the size of these signs to freeway standard (48"x48") could be considered. This intersection should be monitored in the future to see if more aggressive measures (such as beacons on the stop signs, intersection warning signs, or ultimately right turn only restrictions for both CR 18 approaches) might be appropriate.

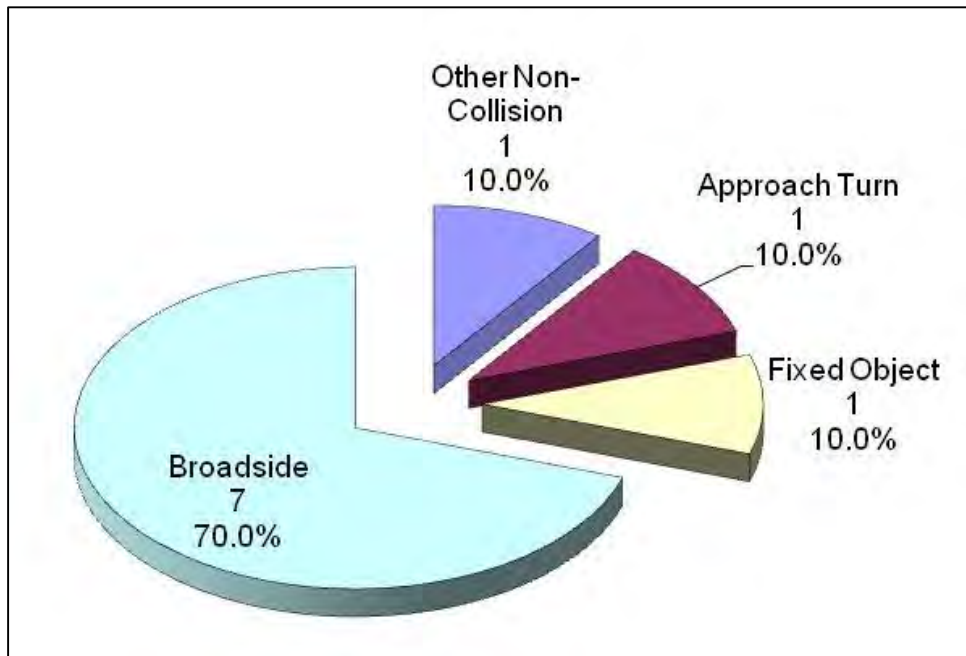
**Figure 120**  
**US 85C / CR 28 (MP 249.22)**  
**10 Total Crashes**

During the five-year study period (1/1/2008 – 12/31/2012), there were 10 crashes, four were property damage only and six resulted in injuries. **Figure 120** provides a graphical representation of crash types for this location. Broadside type crashes (70.0%) were the predominant crash type.

The frequency of broadside type crashes was higher than expected for this type of intersection. A review of the crash history indicated that four of the approach turn type crashes were eastbound and three were westbound. There was no strong pattern by direction for the vehicles on US 85C that were struck. All seven of the broadside type crashes occurred on dry pavement road conditions. Site visit did not find sight distance as an issue. There are double posted intersection warning signs (W2-1) on both approaches of US 85C. Increasing the size of these signs to freeway standard (48"x48") could be considered. This intersection should be monitored in the future to see if more aggressive measures (such as beacons on the stop signs, intersection warning signs, or ultimately right turn only restrictions for both CR 18 approaches) might be appropriate.

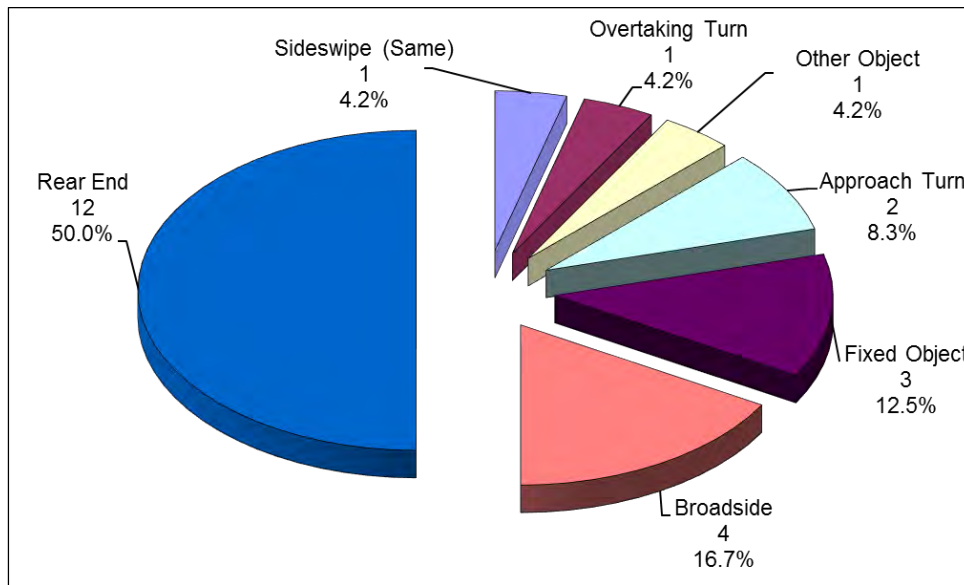
**Figure 122**  
**US 85C / SH 66 (MP 250.65)**  
**24 Total Crashes**

During the five-year study period (1/1/2008 – 12/31/2012), there were 24 crashes, 20 were property damage only and four that resulted in injuries. **Figure 122** provides a graphical representation of crash types for this location. Rear end type crashes (50.0%) were the predominant crash type followed by broadside type crash (16.7%).

There are no significant crash types at this intersection. However, it is worth noting that the rear end type crashes had 12 crashes of which 11 occurred on dry roadway conditions and one on icy road conditions. Directionally, four occurred northbound, five were southbound, and three occurred eastbound. Reviewing and updating the existing yellow/all red clearance intervals could be considered to help reduce the frequency of rear end type crashes. Additionally, consideration of repositioning intersection warning signs (at an appropriate distance for current approach speeds) further away from the intersection could improve driver awareness of the upcoming signalized intersection. If the separation distance allows, the flashing beacon should be connected to the signal controller in order to anticipate red phases.

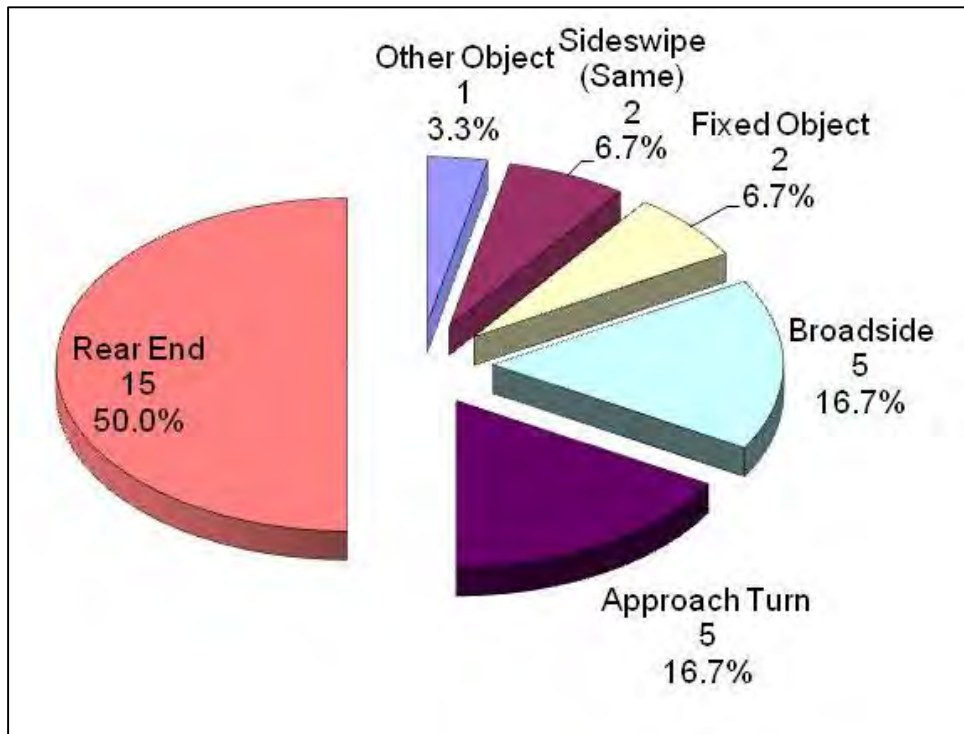
**Figure 124**  
**US 85C / CR 32 (MP 251.22)**  
**30 Total Crashes**

During the five-year study period (1/1/2008 – 12/31/2012), there were 30 crashes, 22 were property damage only and eight that resulted in injuries. **Figure 124** provides a graphical representation of crash types for this location. Rear end type crashes (50.0%) were the predominant crash type followed by broadside and approach turn type crashes (16.7% each).

There are no significant crash types at this intersection. However, it is worth noting that the rear end type crashes had 15 crashes of which ten occurred on dry roadway conditions and three on icy road conditions. Directionally, five occurred northbound and ten occurred southbound. Reviewing and updating the existing yellow/all red clearance intervals could be considered to help reduce the frequency of rear end type crashes. There should be consideration of shifting the change in speed limit sign further north to provide drivers more time to slow down before a signalized intersection. Additionally, consideration of repositioning intersection warning signs (at an appropriate distance for current approach speeds) further away from the intersection could improve driver awareness of the upcoming signalized intersection. If the separation distance allows, the flashing beacon should be connected to the signal controller in order to anticipate red phases.

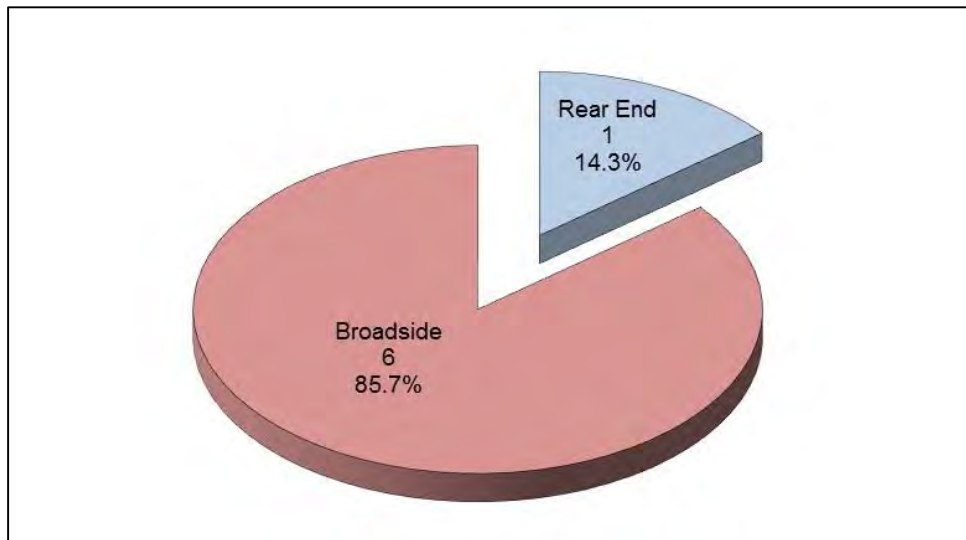
**Figure 130**  
**US 85C / CR 42 (MP 257.26)**  
**7 Total Crashes**

During the five-year study period (1/1/2008 – 12/31/2012), there were seven crashes, five were property damage only and two resulted in injuries. **Figure 130** provides a graphical representation of crash types for this location. Broadside type crashes (85.7%) were the predominant crash type.

The frequency of broadside type crashes was higher than expected for this type of intersection. Broadside type crashes are common for unsignalized intersections. Since the five-year study period (1/1/2008 – 12/31/2012), a traffic signal has been installed. It is expected that this signal will mitigate the historic pattern of broadside type crashes. It is recommended to monitor this intersection for any future crash patterns.
