## **Appendix D. Traffic Safety Report**

**US 85 PEL  
SAFETY ASSESSMENT**

Colorado Department of Transportation  
Region 4  
10601 West 10<sup>th</sup> Street  
Greeley, CO 80634  
970/350-2148 or 970/350-2163

March 2016

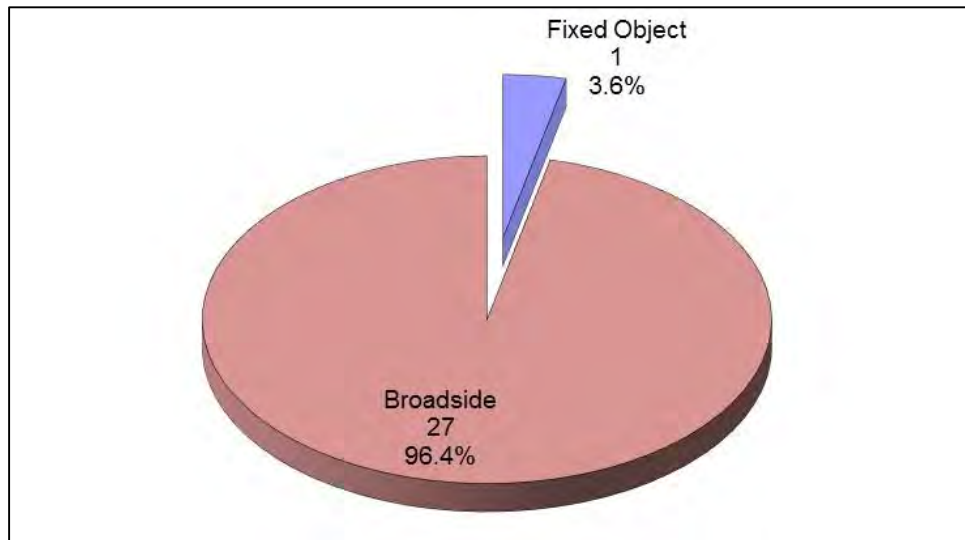
**Figure 132**  
**US 85C / CR 44 (MP 258.60)**  
**28 Total Crashes**

During the five-year study period (1/1/2008 – 12/31/2012), there were 28 crashes, fifteen were property damage only and thirteen resulted in injuries. **Figure 132** provides a graphical representation of crash types for this location. Broadside type crashes (96.4%) were the predominant crash type.

The frequency of broadside type crashes was higher than expected for this type of intersection. A review of the crash history indicated that 11 of the broadside type crashes were eastbound, 15 westbound and one southbound. Twenty-four of the 27 broadside type crashes occurred on dry pavement road conditions, two on wet road conditions and one on icy road conditions. Broadside type crashes at this intersection had 18 crashes that involved either trucks or buses. Twenty-four of the crashes involved eastbound and northbound vehicles or westbound and southbound vehicles – meaning that the side road vehicles crossed the median and then were struck from the right. Site visit did not find sight distance as an issue; however, the intersection is angled at approximately 45 degrees. This means that the drivers of almost all of the at-fault vehicles had to look more than 90-degrees over their shoulders to see oncoming traffic. This larger angle may make it harder for large trucks and busses to see oncoming traffic.

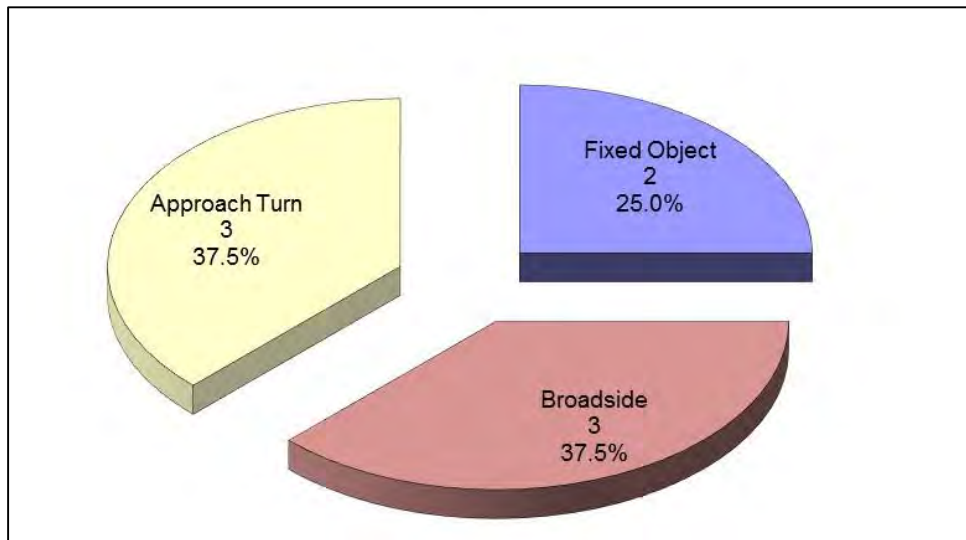
**Figure 134**  
**US 85C / CR 46 / CR 35 (MP 259.93)**  
**8 Total Crashes**

During the five-year study period (1/1/2008 – 12/31/2012), there were eight crashes, five were property damage only and three resulted in injuries. **Figure 134** provides a graphical representation of crash types for this location. Broadside type crashes (37.5%) and approach turn type crashes (37.5%) were the predominant crash types.

A review of the crash history indicates that there is no current pattern to crashes at the intersection of US 85C and CR 46/CR 35. There are no suggestions for improvement at this time.

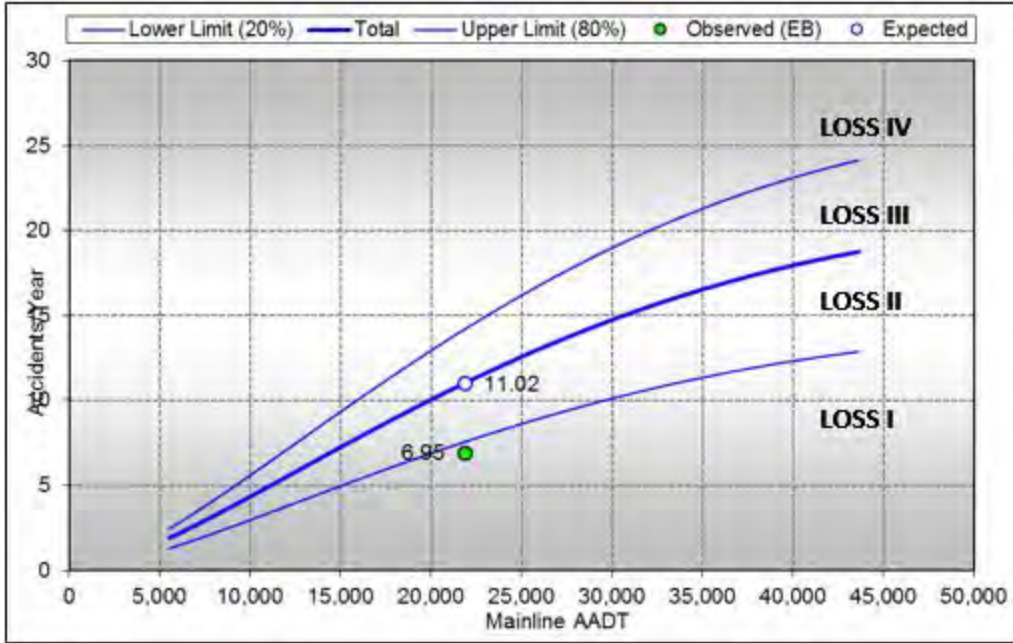
**Figure 136**  
**Four-Lane Divided Signalized Four-Leg Intersection**  
**Total Crashes per Year (SH 375 [1<sup>st</sup> Avenue])**  
**Minor AADT = 3,200**

For the intersection of US 85C with SH 375 (1<sup>st</sup> Avenue), **Figure 136** shows that the frequency of total crashes over the five-year study period indicates a low potential for crash reduction for a four-lane divided signalized four-leg intersection which indicates a low potential for crash reduction (LOSS I). **Figure 137** shows that the severity of crashes also indicates a low potential for crash reduction (LOSS I).

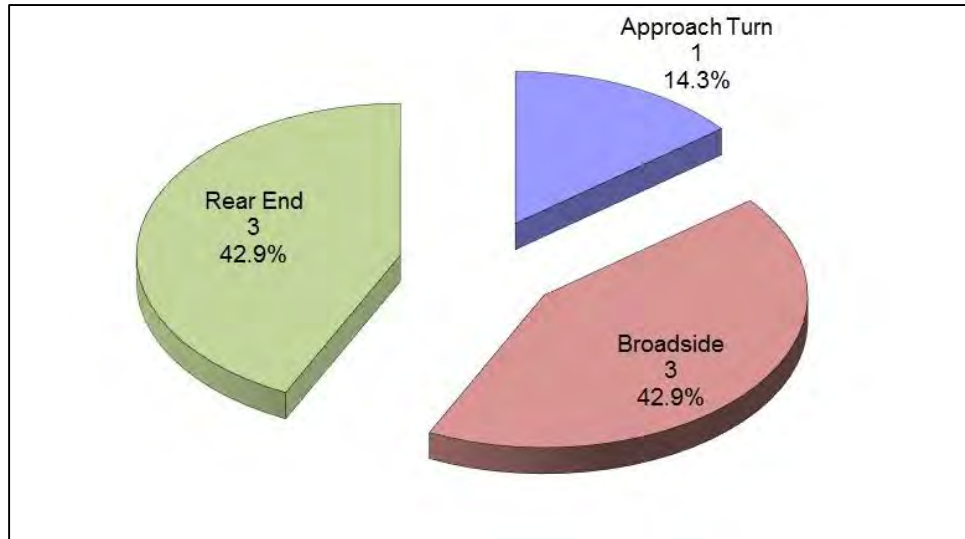
**Figure 138**  
**US 85C / SH 375 [1<sup>st</sup> Avenue] (MP 262.63)**  
**7 Total Crashes**

During the five-year study period (1/1/2008 – 12/31/2012), there were seven crashes, five were property damage only and two resulted in injury. **Figure 138** provides a graphical representation of crash types for this location. Broadside type crashes (42.9%) and approach turn type crashes (42.9%) were the predominant crash types.

A review of the crash history indicates that there is no current pattern to crashes at the intersection of US 85C and SH 375 (1<sup>st</sup> Avenue). There are no suggestions for improvement at this time.

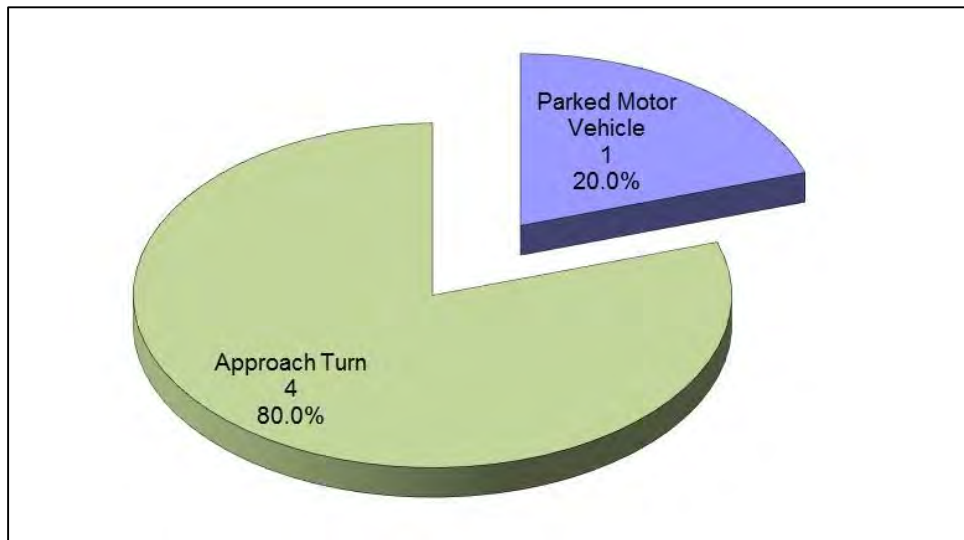
**Figure 140**  
**US 85C / 5<sup>th</sup> Avenue (MP 262.99)**  
**5 Total Crashes**

During the five-year study period (1/1/2008 – 12/31/2012), there were five crashes, one was property damage only and four resulted in injuries. **Figure 140** provides a graphical representation of crash types for this location. Approach turn type crashes (80.0%) were the predominant crash type.

There are no significant crash types at this intersection. However, it is worth noting that the approach turn type crashes had four crashes that all occurred on dry roadway conditions. Directionally, two of the approach turn type crashes occurred northbound and two occurred southbound. Field visit did not find sight distance as an issue. This intersection should be monitored for future approach turn crashes and the need for more aggressive measures reviewed if the issue persists.

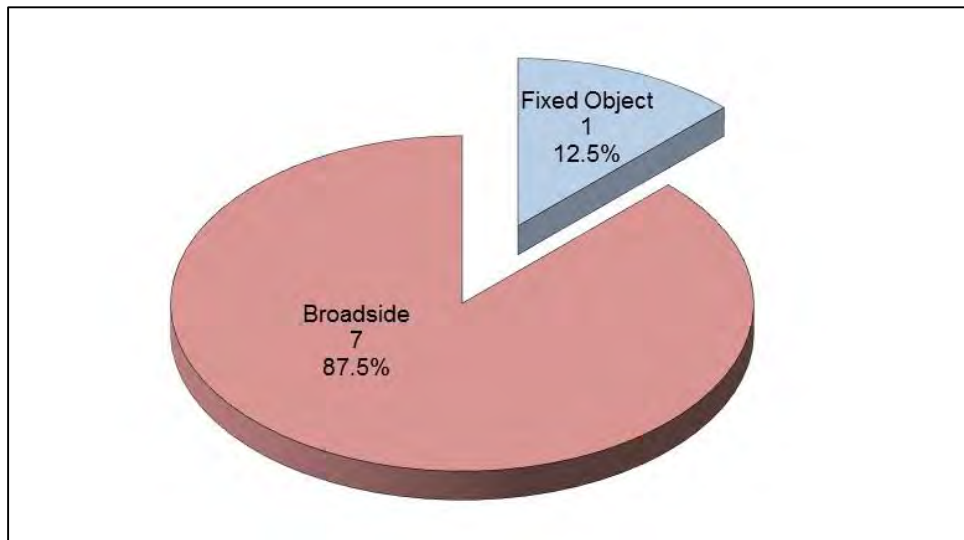
**Figure 142**  
**US 85C / CR 52 (MP 263.44)**  
**8 Total Crashes**

During the five-year study period (1/1/2008 – 12/31/2012), there were eight crashes, four were property damage only and four resulted in injuries. **Figure 142** provides a graphical representation of crash types for this location. Broadside type crashes (87.5%) were the predominant crash type.

The frequency of broadside type crashes was higher than expected for this type of intersection. A review of the crash history indicate that the broadside type crashes had seven crashes which five occurred on dry roadway conditions, one occurred on wet road conditions, and one with road treatment roadway conditions. Directionally, five broadside type crashes occurred eastbound, one occurred westbound and one occurred southbound. Field visit did not find a sight distance issue for westbound traveling vehicles but did observe that eastbound traffic has an issue seeing northbound US 85C vehicles. Three of the five eastbound crashes were with northbound vehicles that require drivers to look more than ninety-degrees out of the right side of their vehicles. It is noted that the railroad crossing on the east leg was not a contributing factor to the broadside type crashes. There are currently double posted (inside and outside shoulders) intersection warning signs (W10-2) on both approaches of US 85C. Increasing the size of these signs to freeway standard (48"x48") and adding flashing beacons should be considered. This intersection should be monitored for future broadside crashes and the need for more aggressive measures reviewed if the issue persists.

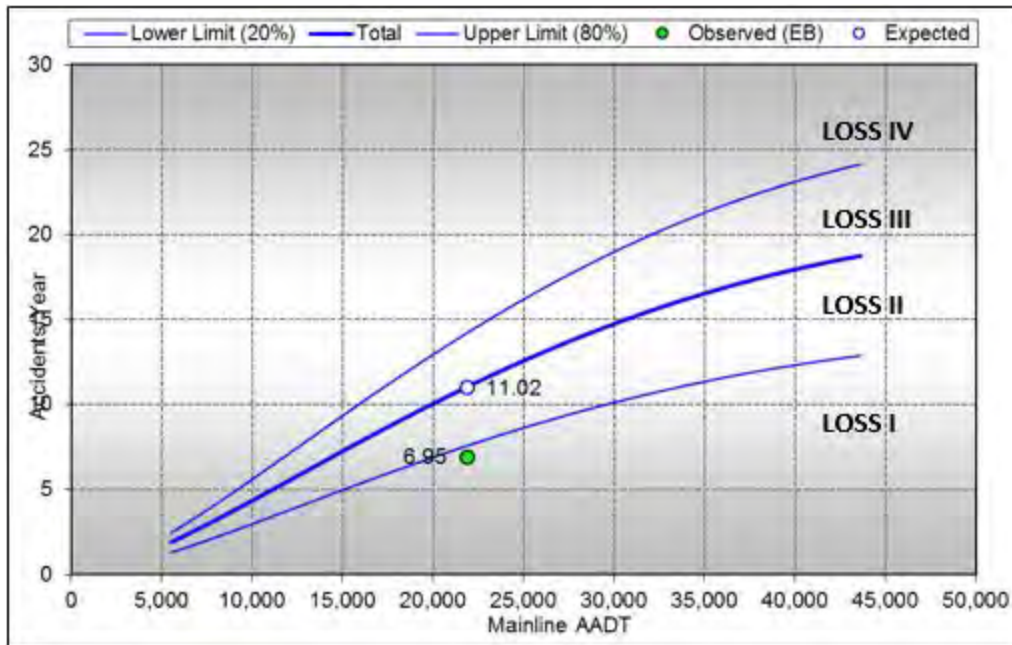
**Figure 144**  
**Four-Lane Divided Signalized Four-Leg Intersection**  
**Total Crashes per Year (42<sup>nd</sup> Street)**  
**Minor AADT = 10,500**

For the intersection of US 85C with 42<sup>nd</sup> Street (MP 264.11), **Figure 144** shows that the frequency of total crashes over the five-year study period was significantly better than expected for a four-lane divided signalized four-leg intersection which indicates a low potential for crash reduction (LOSS I). **Figure 145** shows that the severity of crashes also indicates a low potential for crash reduction (LOSS I).

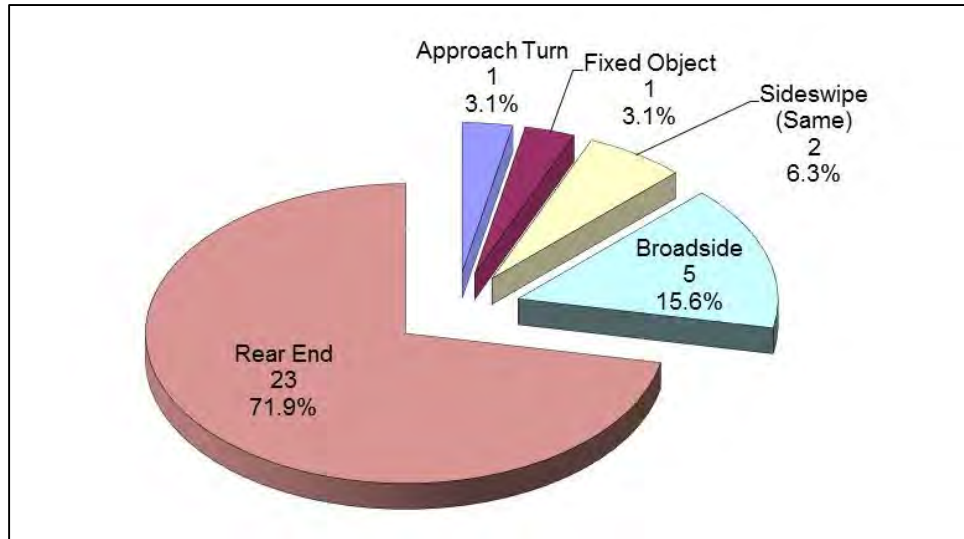
**Figure 146**  
**US 85C / 42<sup>nd</sup> Street (MP 264.11)**  
**32 Total Crashes**

During the five-year study period (1/1/2008 – 12/31/2012), there were 32 crashes, 24 were property damage only and eight resulted in injuries. **Figure 146** provides a graphical representation of crash types for this location. Rear end type crashes (71.9%) were the predominant crash type.

The frequency of rear end type crashes was higher than expected for this type of intersection. A review of the crash history indicated that 12 of the rear end crashes were northbound, four southbound, four eastbound, and three westbound. Sixteen of the 23 rear end crashes occurred on dry pavement, two crashes on wet roads, four were on snowy/icy roads, and one on a treated roadway.

It was noted that this is the first signalized intersection in the northbound direction entering the Greeley urban area. There are currently no upcoming intersection warning signs provided for the intersection. Installing an intersection warning sign (W2-1) with flashing beacon on northbound US 85L should be considered. If the separation distance allows, the flashing beacon should be connected to the signal controller in order to anticipate red phases. This could improve driver awareness of the upcoming signalized intersection and reducing the frequency of rear end type crashes. Additionally, it is recommended to review/update the existing yellow/all red clearance intervals to reduce the frequency of rear end type crashes at the other approaches to the intersection.

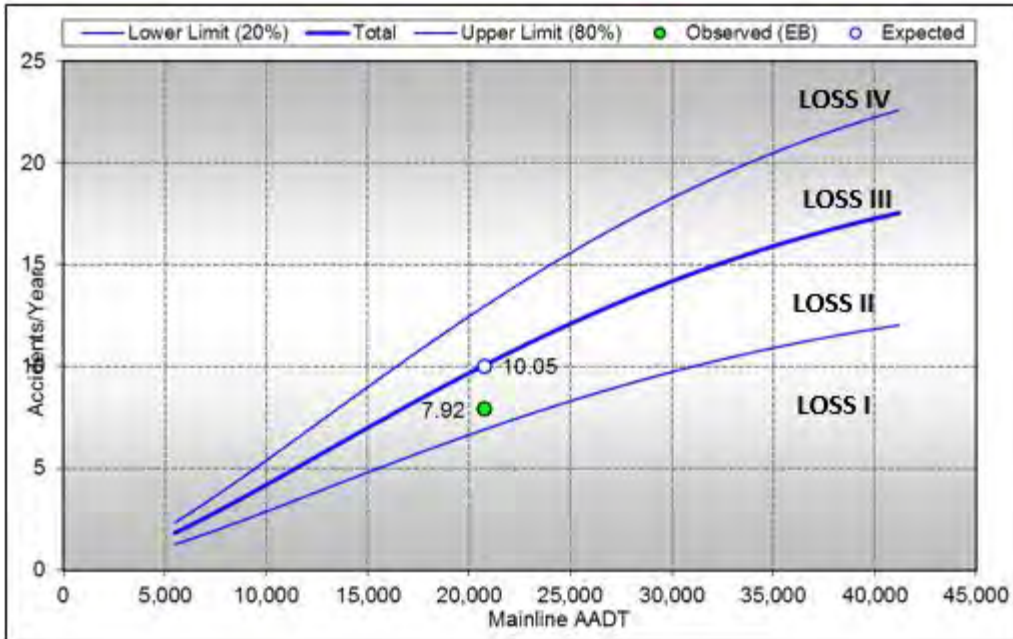
**Figure 148**  
**Four-Lane Divided Signalized Four-Leg Intersection**  
**Total Crashes per Year (CR 54 [37<sup>th</sup> Street])**  
**Minor AADT = 9,700**

For the intersection of US 85C with CR 54 (37<sup>th</sup> Street), **Figure 148** shows that the frequency of total crashes indicates a low to moderate potential for crash reduction for a signalized four-lane divided four-leg intersection (LOSS II). **Figure 149** shows that the severity of crashes indicates a low to moderate potential for crash reduction for this intersection type (LOSS II).

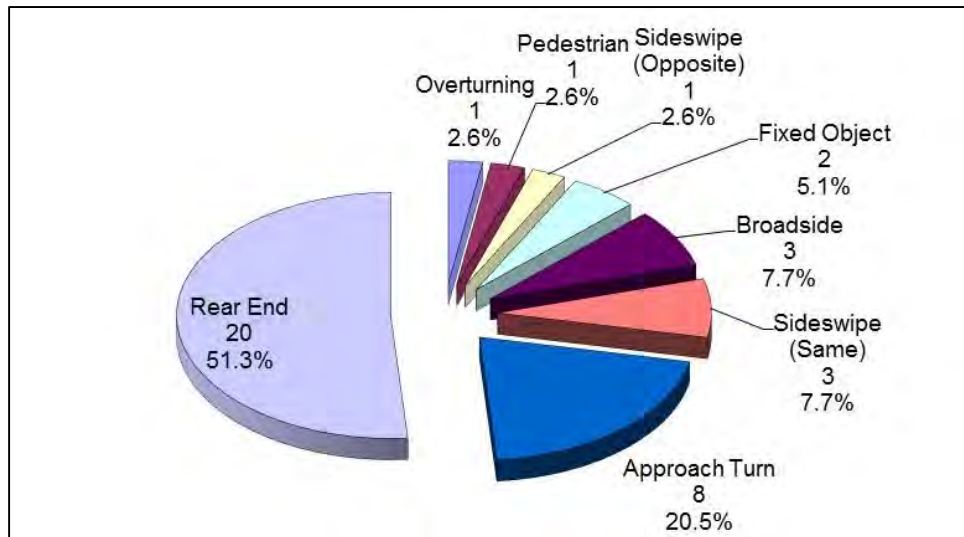
**Figure 150**  
**US 85C / CR 54 [37<sup>th</sup> Street] (MP 264.71)**  
**38 Total Crashes**

During the five-year study period (1/1/2008 – 12/31/2012), there were 38 crashes, 27 were property damage only, 10 resulted in injuries and one fatal crash. **Figure 150** provides a graphical representation of crash types for this location. Rear end type crashes (51.3%) were the predominant crash type.

The one fatal crash at the intersection of US 85C / CR 54 (37<sup>th</sup> Street) occurred on January 8, 2009 at 5:55am. The crash occurred in dry dark-lighted conditions. Vehicle #1 (a motorcycle) was traveling westbound on 37<sup>th</sup> Street and was stopped at a red light waiting to make a left-turn. When the light turned green, Vehicle #1 began to turn left and collided with Vehicle #2 that was traveling eastbound through the intersection. Alcohol and drugs was suspected for both the driver and passenger of Vehicle #1. Cause was failure to yield right of way. No crash pattern found.

There are no significant crash types at this intersection. However, it is worth noting that the rear end crashes had 19 crashes or which 16 occurred on dry roadway conditions and three on snowy road conditions. Directionally, 13 occurred northbound, three occurred southbound, one occurred eastbound and two occurred westbound. Based on this information, there does not appear to be a correctable pattern. However, consideration of repositioning intersection warning signs further away from the intersection could improve driver awareness of the upcoming signalized intersection. If the separation distance allows, the flashing beacon should be connected to the signal controller in order to anticipate red phases. It was noted that reduction of the posted speed limit is located after the intersection warning signs. Providing more distance before the intersection with slower speeds might also help reduce the frequency of rear end type crashes. It is also recommended to review/update the existing yellow/all red clearance intervals for the signals at the intersection to reduce rear end type crashes.

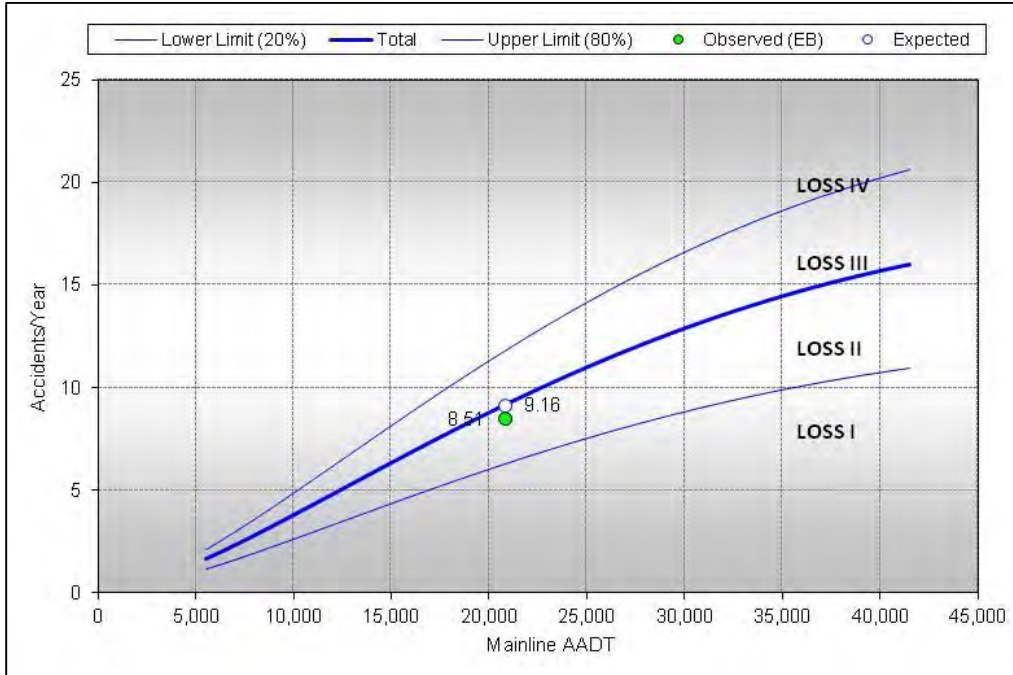
**Figure 152**  
**Four-Lane Divided Signalized Four-Leg Intersection**  
**Total Crashes per Year (31<sup>st</sup> Street)**  
**Minor AADT = 8,000**

For the intersection of US 85C with 31<sup>st</sup> Street, **Figure 152** shows that the frequency of total crashes indicates a low to moderate potential for crash reduction for a signalized four-lane divided four-leg intersection (LOSS II). **Figure 153** shows that the severity of crashes also indicates a low to moderate potential for this intersection type (LOSS II).

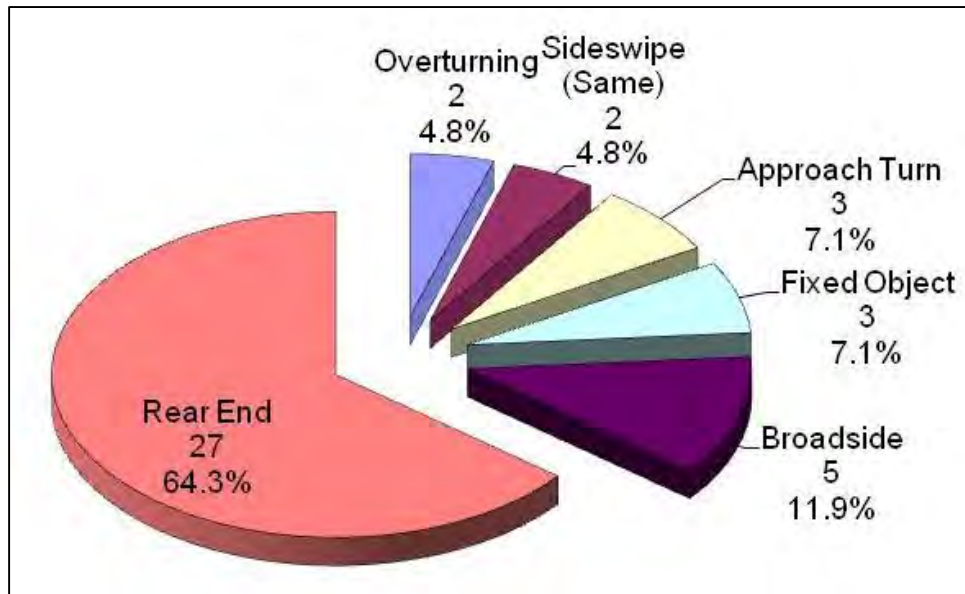
**Figure 154**  
**US 85C / 31<sup>st</sup> Street (MP 265.19)**  
**42 Total Crashes**

During the five-year study period (1/1/2008 – 12/31/2012), there were 42 crashes, 29 were property damage only and 13 resulted in injuries. **Figure 154** provides a graphical representation of crash types for this location. Rear end type crashes (64.3%) were the predominant crash type.

The frequency of rear end type crashes was higher than expected for this type of intersection. A review of the crash history indicated that 12 of the rear end crashes were northbound, 10 southbound, two eastbound, and three westbound. Twenty-two of the 27 rear end crashes occurred on dry pavement, one crash on wet road conditions, two were on snowy road conditions, one on road treatment road conditions and one marked as foreign material road conditions. Twenty-two of the rear end type crashes occurred during the day, three during the night, one at dawn/dusk and one was unknown.

The intersection of US 85C with 31<sup>st</sup> Street is directly south of the interchange with US 34. The close proximity to the interchange can cause drivers not to notice the signalized intersection before it is too late to stop. It is recommended to consider intersection warning signs to improve driver awareness of the upcoming signalized intersection. If the separation distance allows, the flashing beacon should be connected to the signal controller in order to anticipate red phases. It is also recommended to review/update the existing yellow/all red clearance intervals which could help reduce the frequency of rear end type crashes.

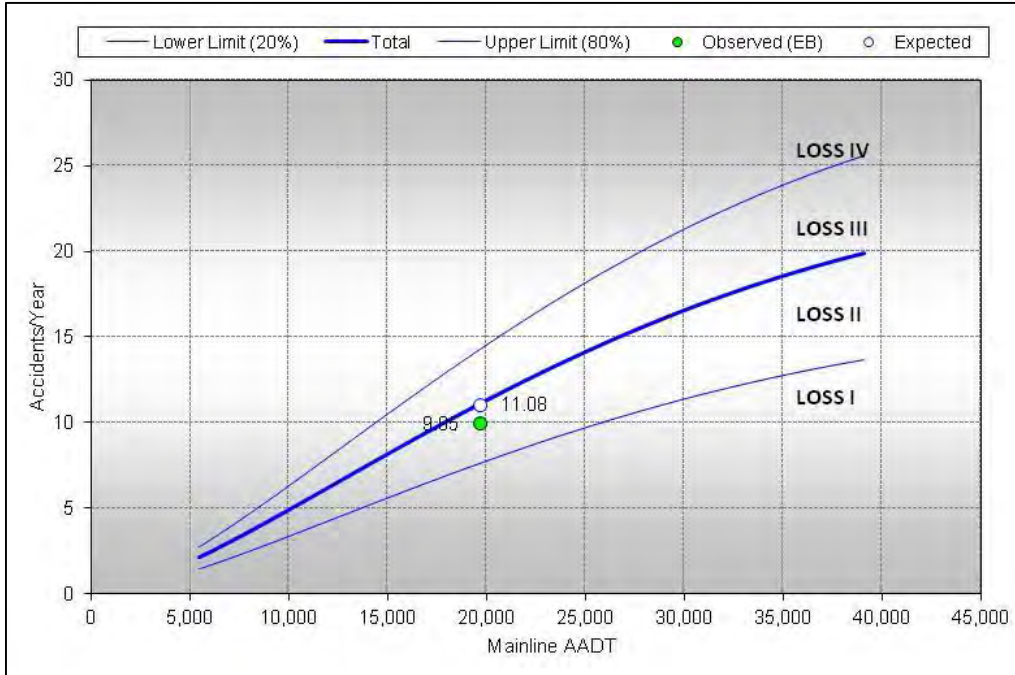
**Figure 156**  
**Four-Lane Divided Signalized Four-Leg Intersection**  
**Total Crashes per Year (22<sup>nd</sup> Street)**  
**Minor AADT = 13,200**

For the intersection of US 85L with 22<sup>nd</sup> Street **Figure 156** shows that the frequency of total crashes indicates a low to moderate potential for crash reduction for a signalized four-lane divided four-leg intersection (LOSS II). **Figure 157** shows that the severity of crashes indicates a moderate potential for crash reduction for this intersection type (LOSS II/LOSS III).

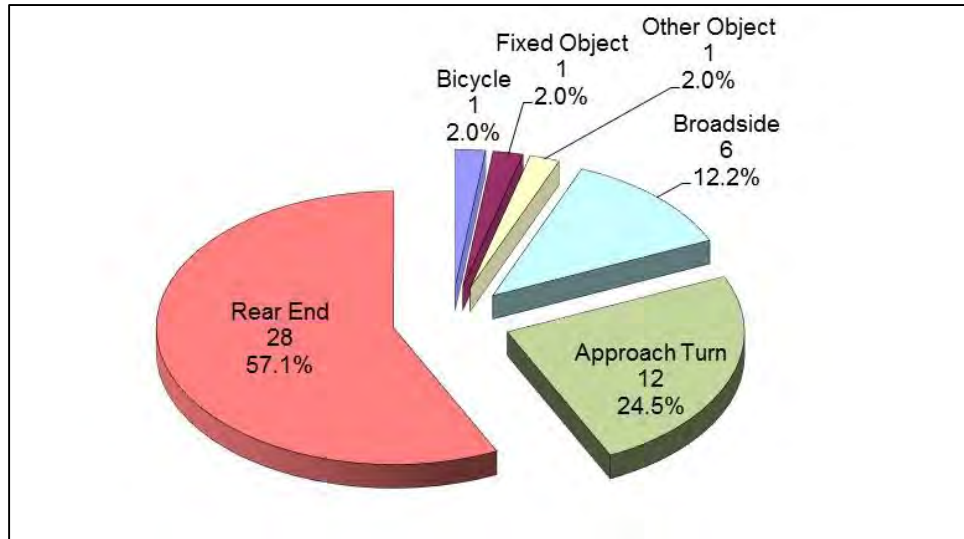
**Figure 158**  
**US 85C / 22<sup>nd</sup> Street (MP 266.65)**  
**49 Total Crashes**

During the five-year study period (1/1/2008 – 12/31/2012), there were 49 crashes, 33 were property damage only and 16 resulted in injuries. **Figure 158** provides a graphical representation of crash types for this location. Rear end type crashes (57.1%) were the predominant crash type followed by approach turn type crashes (24.5%).

The frequency of rear end type crashes was higher than expected for this type of intersection. A review of the crash history indicated that eight of the rear end crashes were northbound, six southbound, two eastbound, and twelve westbound. Twenty-four of the 28 rear end crashes occurred on dry pavement and four crashes were on wet road conditions. Twenty-six of the rear end type crashes occurred during the day, one during the night and one at dawn/dusk lighting conditions. Rear end type crashes at this intersection had nine crashes that involved either trucks or buses.

The intersection of US 85C with 22<sup>nd</sup> Street is directly north of the interchange with US 34. The close proximity to the interchange can cause drivers not to notice the signalized intersection before it is too late to stop. It is recommended to consider intersection warning signs in the northbound direction to improve driver awareness of the upcoming signalized intersection.

Although the frequency of approach turn type crashes were not higher than expected, it is worth noting that the approach type crashes had 12 crashes of which 11 occurred on dry roadway conditions and one on wet roadway conditions. Directionally, three occurred northbound, five occurred southbound and four occurred westbound. None of the approach turn type crashes involved trucks or buses. All left-turn movements at the intersection are currently protected-only. Based on this information, there does not appear to be a correctable pattern. However, it is recommended to review/update the existing yellow/all red clearance intervals for the signals at the intersection to reduce approach turn type crashes.

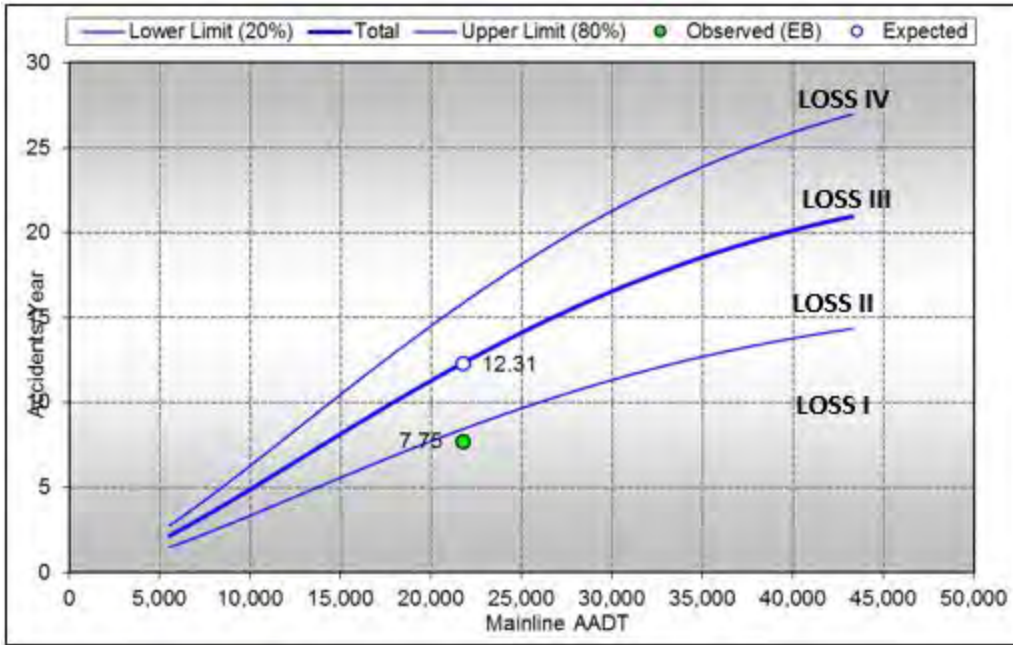
**Figure 160**  
**Four-Lane Divided Signalized Four-Leg Intersection**  
**Total Crashes per Year (US 34D [18<sup>th</sup> Street])**  
**Minor AADT = 9,000**

For the intersection of US 85L with US 34 (18<sup>th</sup> Street), **Figure 160** shows that the frequency of total crashes over the five-year study period was significantly better than expected for a four-lane divided signalized four-leg intersection which indicates a low potential for crash reduction (LOSS I). **Figure 161** shows that the severity of crashes also indicates a low potential for crash reduction (LOSS I).

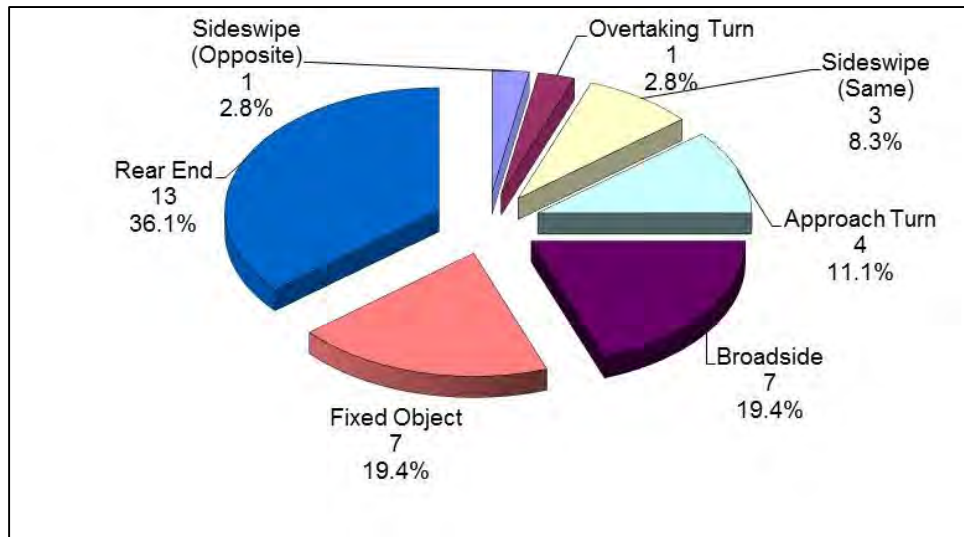
**Figure 162**  
**US 85L / US 34D [18<sup>th</sup> Street] (MP 267.18)**  
**36 Total Crashes**

During the five-year study period (1/1/2008 – 12/31/2012), there were 36 crashes, 28 were property damage only, and 8 resulted in injuries. **Figure 162** provides a graphical representation of crash types for this location. Rear end type crashes (36.1%) were the predominant crash type followed by fixed object and broadside turn type crashes (both 19.4%).

The frequency of fixed object type crashes was higher than expected for this type of intersection. A review of the crash history indicated that five of the fixed object crashes were northbound, one southbound, and one westbound. Five of the seven fixed object crashes occurred on dry pavement, one was on icy and one was on slushy road conditions. Two of the fixed object type crashes occurred during the day, three during the night and two at dawn/dusk lighting conditions. Fixed object type crashes at this intersection had three that involved either trucks or buses. There was no pattern to the fixed objects that were hit and therefore no improvement recommendations.

Although the frequency of rear end type crashes was not higher than expected it is worth noting that the approach type crashes had 13 crashes that 11 occurred on dry roadway conditions and two on wet roadway conditions. Directionally, five occurred northbound, seven occurred southbound and one occurred westbound. Only one of the approach turn type crashes involved trucks or buses. Northbound and southbound left-turn movements at the intersection are currently protected-only. It is unknown when this more restrictive phasing was instituted. Westbound left-turn movements are permitted with a sign that specifies that "left turn yield on green." However, it is recommended to review/update the existing yellow/all red clearance intervals for the signals at the intersection to reduce approach turn type crashes.

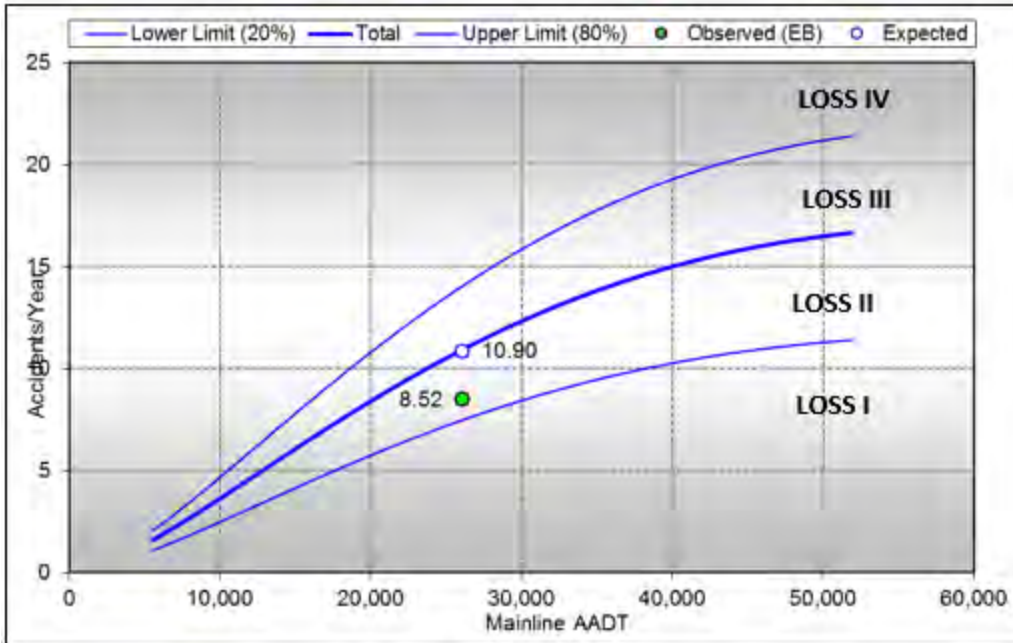
**Figure 164**  
**Four-Lane Divided Signalized Four-Leg Intersection**  
**Total Crashes per Year (16<sup>th</sup> Street)**  
**Minor AADT = 7,300**

For the intersection of US 85L with 16<sup>th</sup> Street, **Figure 164** shows that the frequency of total crashes indicates a low to moderate potential for crash reduction for a signalized four-lane divided four-leg intersection (LOSS II). **Figure 165** shows that the severity of crashes also indicates a low to moderate potential for reduction (LOSS II).

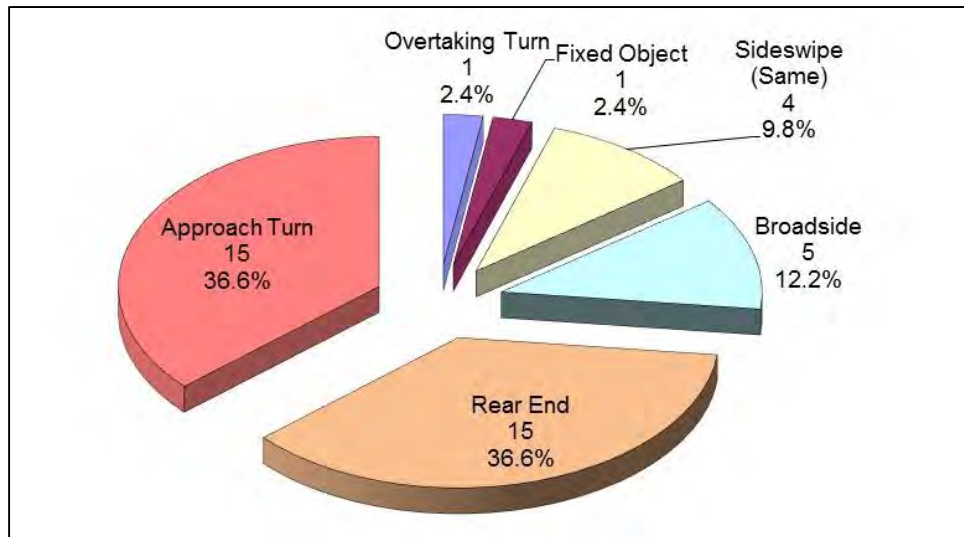
**Figure 166**  
**US 85L / 16<sup>th</sup> Street (MP 267.44)**  
**41 Total Crashes**

During the five-year study period (1/1/2008 – 12/31/2012), there were 41 crashes, 31 were property damage only and 10 resulted in injuries. **Figure 166** provides a graphical representation of crash types for this location. Rear end type crashes (36.6%) and approach turn type crashes (36.6%) were the predominant crash types.

The frequency of approach turn type crashes was higher than expected for this type of intersection. A review of the crash history indicated that six of the approach turn crashes were northbound, seven southbound, and two westbound. Twelve of the 15 approach turn crashes occurred on dry pavement, one on wet conditions, one on snowy conditions, and one marked as foreign material road conditions. Eleven of the approach turn type crashes occurred during the day, three during the night and one at dawn/dusk lighting conditions. Approach turn type crashes at this intersection had three crashes that involved either trucks or buses.

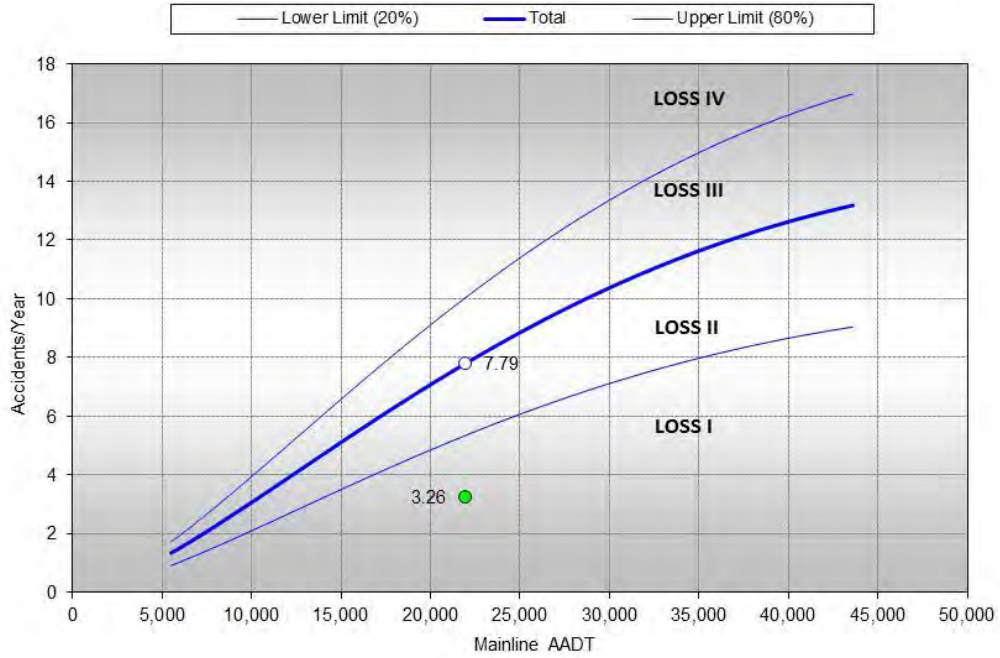
**Figure 168**  
**Four-Lane Divided Signalized Four-Leg Intersection**  
**Total Crashes per Year (13<sup>th</sup> Street)**  
**Minor AADT = 5,200**

For the intersection of US 85L with US 34 (13<sup>th</sup> Street), **Figure 168** shows that the frequency of total crashes indicates a low potential for crash for a signalized four-lane divided three-leg intersection (LOSS I). **Figure 169** shows that the severity of crashes indicates a low potential for crash reduction (LOSS I).

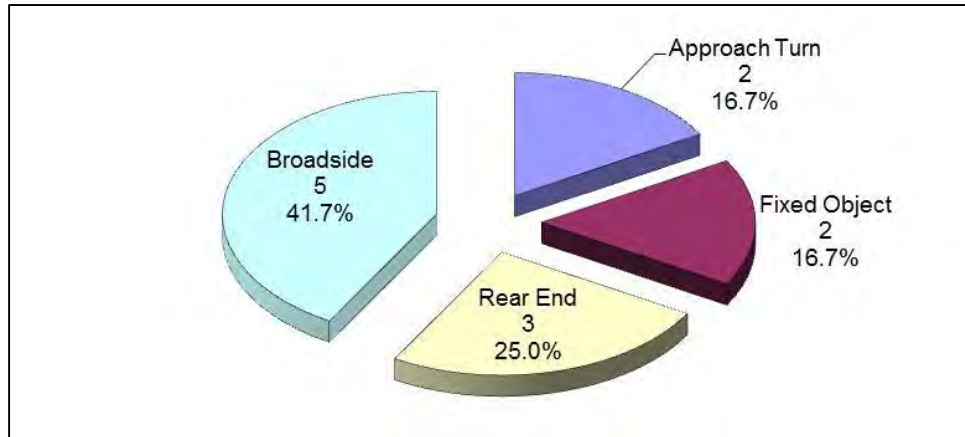
**Figure 170**  
**US 85C / 13<sup>th</sup> Street (MP 267.77)**  
**12 Total Crashes**

During the five-year study period (1/1/2008 – 12/31/2012), there were 12 crashes, eight were property damage only and four resulted in injuries. **Figure 170** provides a graphical representation of crash types for this location. Broadside type crashes (41.7%) were the predominant crash type followed by rear end type crashes (25.0%).

The frequency of broadside type crashes was higher than expected for this type of intersection. A review of the crash history indicated that three of the broadside crashes were eastbound and two were westbound. Four of the five broadside crashes occurred on dry pavement and one crash was on wet road conditions. Four of the broadside type crashes occurred during the day and one during the night. None of the broadside type crashes at this intersection involved either trucks or buses.

The intersection of US 85L and 13<sup>th</sup> Street was recently signalized. Since the range of the crash analysis occurred during a time when the intersection was not signalized and the fact that all of the broadside crashes involved side street traffic, it is expected that the recent signal installation will reduce the number of broadside crashes at this intersection. No additional improvements are recommended.

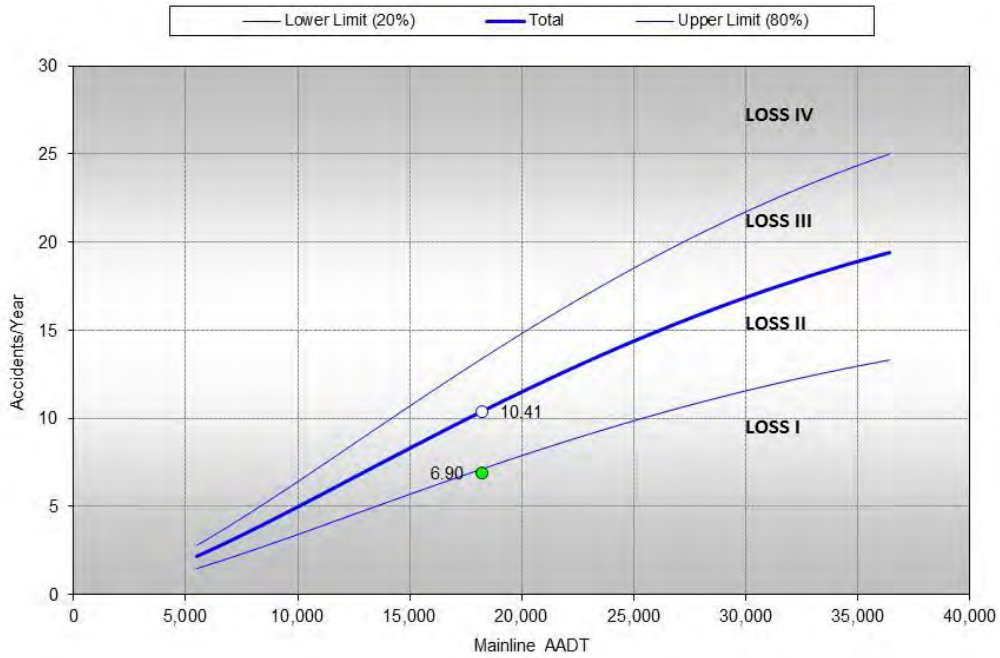
**Figure 172**  
**Four-Lane Divided Signalized Four-Leg Intersection**  
**Total Crashes per Year (SH 263A [8<sup>th</sup> Street])**  
**Minor AADT = 13,700**

For the intersection of US 85L with SH 263A (8<sup>th</sup> Street), **Figure 172** shows that the frequency of total crashes indicates a low potential for crash for a signalized four-lane divided three-leg intersection (LOSS I). **Figure 173** shows that the severity of crashes indicates a low potential for crash reduction (LOSS I).

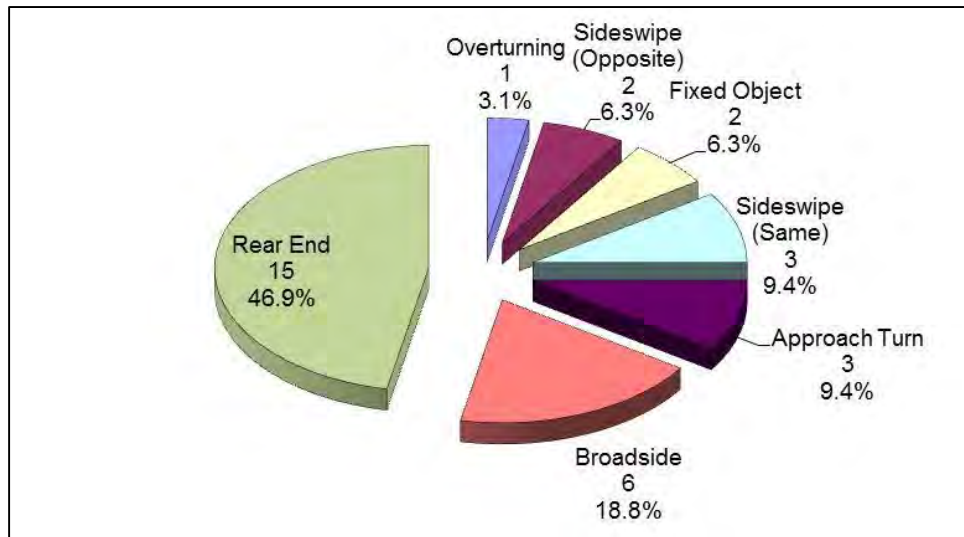
**Figure 174**  
**US 85C / SH 263A (8<sup>th</sup> Street) (MP 268.22)**  
**32 Total Crashes**

During the five-year study period (1/1/2008 – 12/31/2012), there were 32 crashes, 26 were property damage only and six resulted in injuries. **Figure 174** provides a graphical representation of crash types for this location. Rear end type crashes (46.9%) were the predominant crash type followed by broadside type crashes (18.8%).

Although none of the crash types at this intersection are significantly higher than expected, there are patterns to the rear end and broadside type crashes that consideration should be given to addressing. Eight of the 15 rear end crashes were northbound and six of these occurred in the afternoon and early evening. Five of the six broadside crashes occurred when vehicles on US 85L ran through a red light. There are a number of guide signs of the US 85L approaches to this intersection so drivers should be aware that they are approaching it but may not be aware that the signal is red. There are currently no upcoming intersection warning signs provided for the intersection. Installing intersection warning signs (W2-1) with flashing beacon on US 85L should be considered. The speed limit on US 85L is 45 mph so there should be sufficient separation distance to connect the flashing beacon to the signal controller in order to anticipate red phases. This would improve driver awareness of the upcoming signalized intersection and reducing the frequency of rear end type crashes. Additionally, it is recommended to review/update the existing yellow/all red clearance intervals to reduce the frequency of rear end type crashes at the other approaches to the intersection.

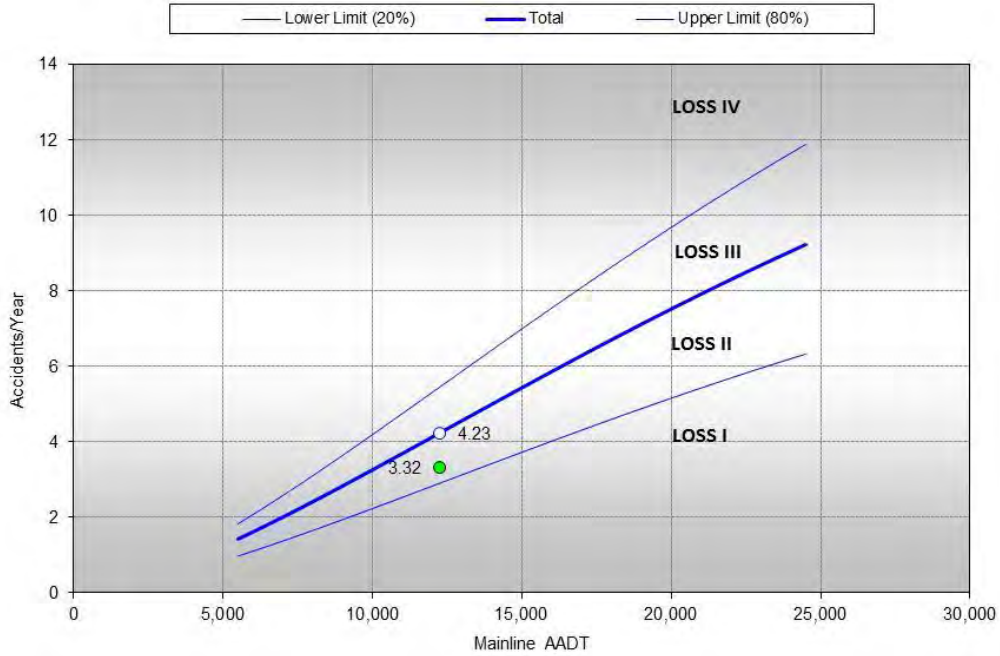
**Figure 176**  
**Four-Lane Divided Signalized Four-Leg Intersection**  
**Total Crashes per Year (5<sup>th</sup> Street [MP 268.49])**  
**Minor AADT = 5,800**

For the intersection of US 85L with 5<sup>th</sup> Street, **Figure 176** shows that the frequency of total crashes indicates a low to moderate potential for crash for a signalized four-lane divided three-leg intersection (LOSS II). **Figure 177** shows that the severity of crashes indicates a low to moderate potential for crash reduction for this intersection type (LOSS II/).

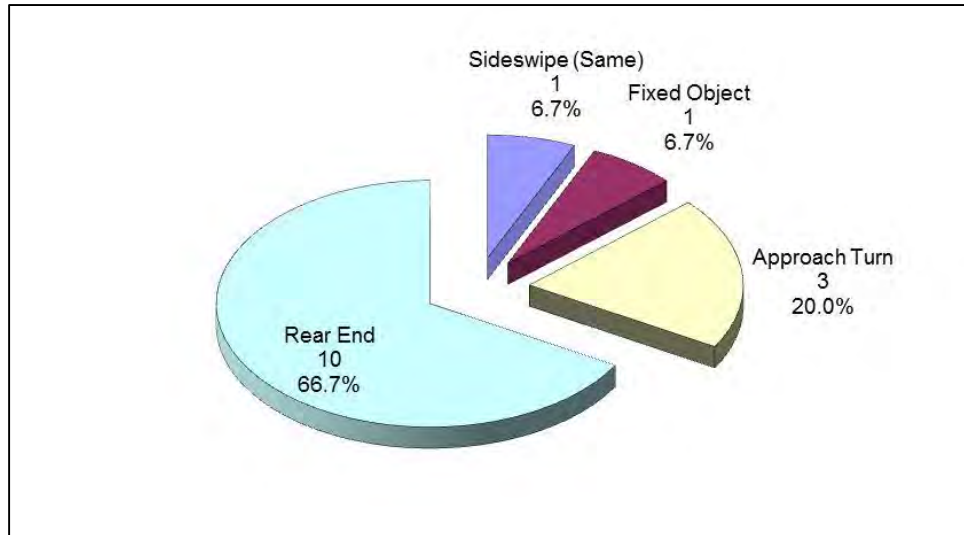
**Figure 178**  
**US 85L / 5<sup>th</sup> Street (MP 268.49)**  
**15 Total Crashes**

During the five-year study period (1/1/2008 – 12/31/2012), there were fifteen crashes, eleven were property damage only and four resulted in injuries. **Figure 178** provides a graphical representation of crash types for this location. Rear end type crashes (66.7%) were the predominant crash type followed by approach turn type crashes (20.0%).

The frequency of rear end type crashes was higher than expected for this type of intersection. A review of the crash history indicated that two of the rear end crashes were northbound, six eastbound, and two westbound. Nine of the ten rear end crashes occurred on dry pavement and one crash was on wet road conditions. Eight of the rear end type crashes occurred during the day, one during the night and one at dawn/dusk lighting conditions. None of the rear end type crashes at this intersection involved either trucks or buses.

The intersection of US 85C with 5<sup>th</sup> Street was improved in 2012 with upgraded signals and mast arms and all approaches were brought up to current roadway standards. It is expected that these changes should provide some level of reduction in the level of crashes experienced at this intersection. It is recommended to review/update the existing yellow/all red clearance intervals to reduce the frequency of rear end type crashes at the other approaches to the intersection.

It is also recommended that crashes patterns continue to be monitored in the future. Advanced warning signs (W2-1) with flashing beacons might be a further improvement.

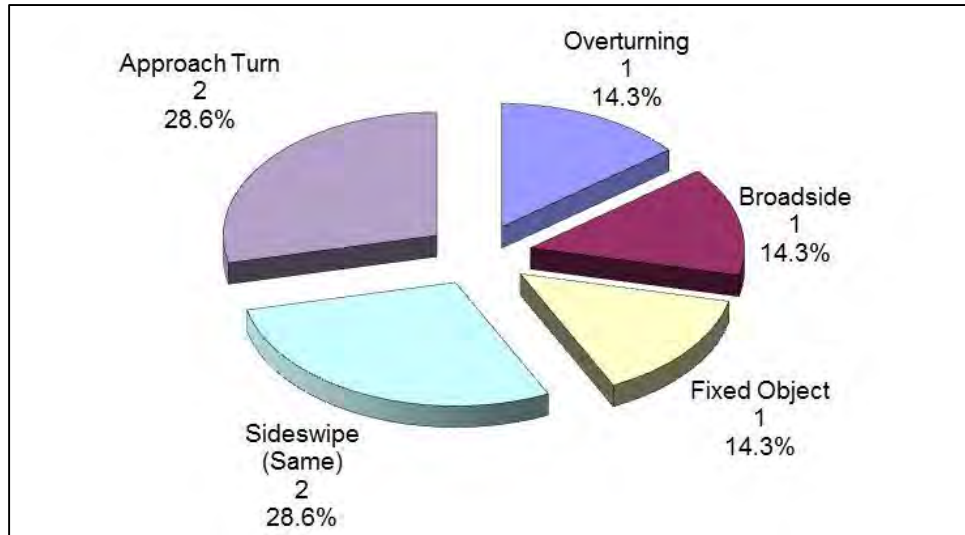
**Figure 180**  
**US 85L / O Street (MP 270.43)**  
**7 Total Crashes**

During the five-year study period (1/1/2008 – 12/31/2012), there were seven crashes, five were property damage only and two resulted in injuries. **Figure 180** provides a graphical representation of crash types for this location. Approach turn type crashes (28.6%) and sideswipe (same) type crashes (28.6%) were the predominant crash types.

There are no significant crash types at the intersection of US 85L and O Street. There are no suggestions for improvements at this time.

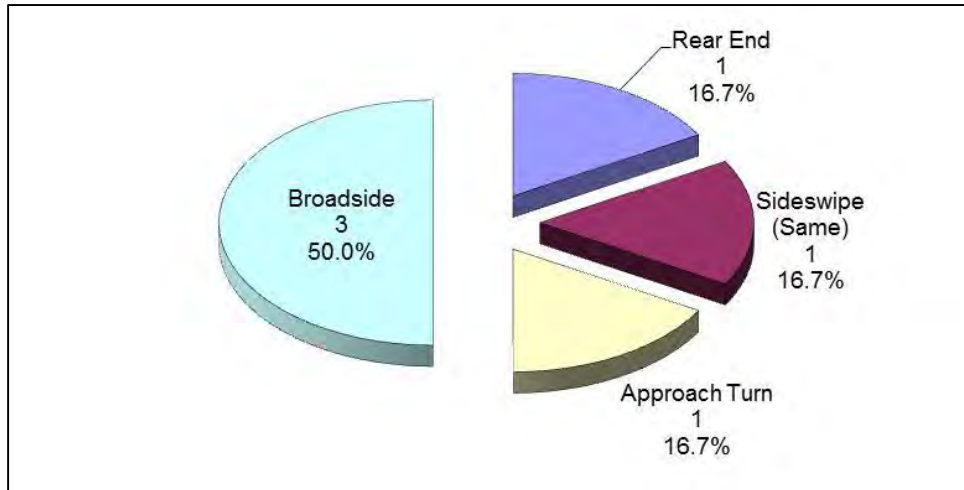
**Figure 182**  
**US 85L / 11<sup>th</sup> Street (MP 271.19)**  
**6 Total Crashes**

During the five-year study period (1/1/2008 – 12/31/2012), there were six crashes, three were property damage only and three resulted in injuries. **Figure 182** provides a graphical representation of crash types for this location. Broadside type crashes (50.0%) were the predominant crash type.

There are no significant crash types at the intersection of US 85L and 11<sup>th</sup> Street. There are no suggestions for improvements at this time.
