## **Appendix D. Traffic Safety Report**

**US 85 PEL  
SAFETY ASSESSMENT**

Colorado Department of Transportation  
Region 4  
10601 West 10<sup>th</sup> Street  
Greeley, CO 80634  
970/350-2148 or 970/350-2163

March 2016

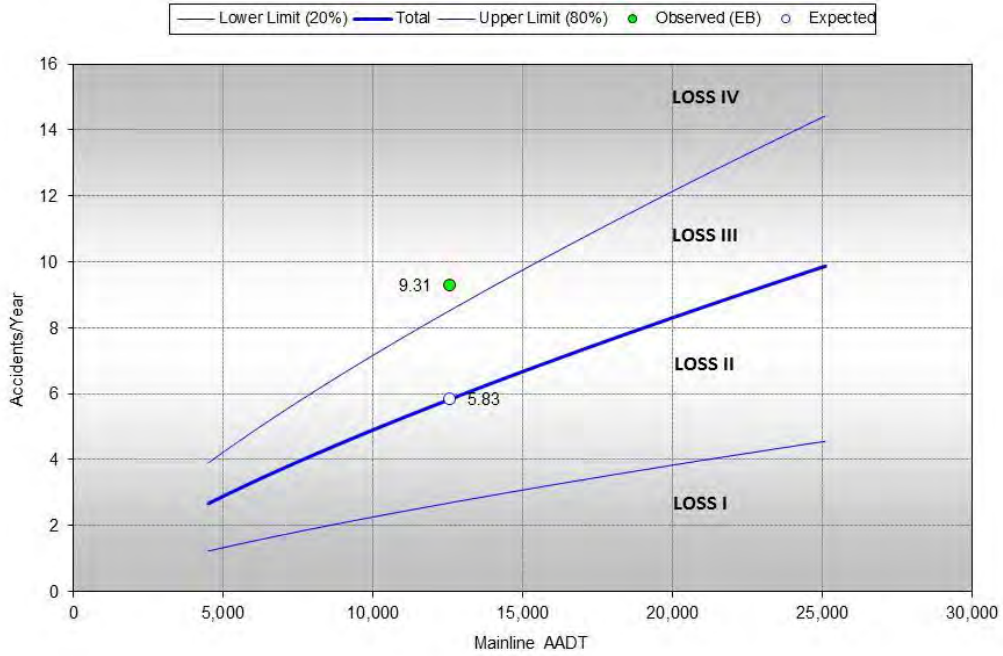
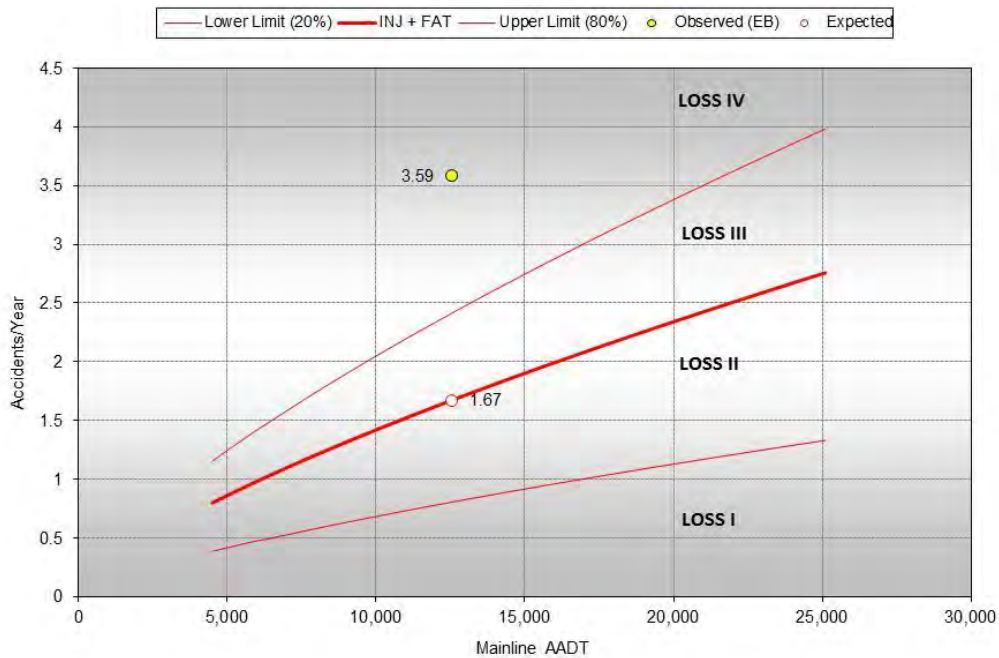
For the intersection of US 85L with State Highway 392 **Figure 184** shows that the frequency of total crashes indicates a high potential for crash reduction for a signalized four-lane divided four-leg intersection (LOSS IV). **Figure 185** shows that the severity of crashes indicates a high potential for crash reduction (LOSS IV).

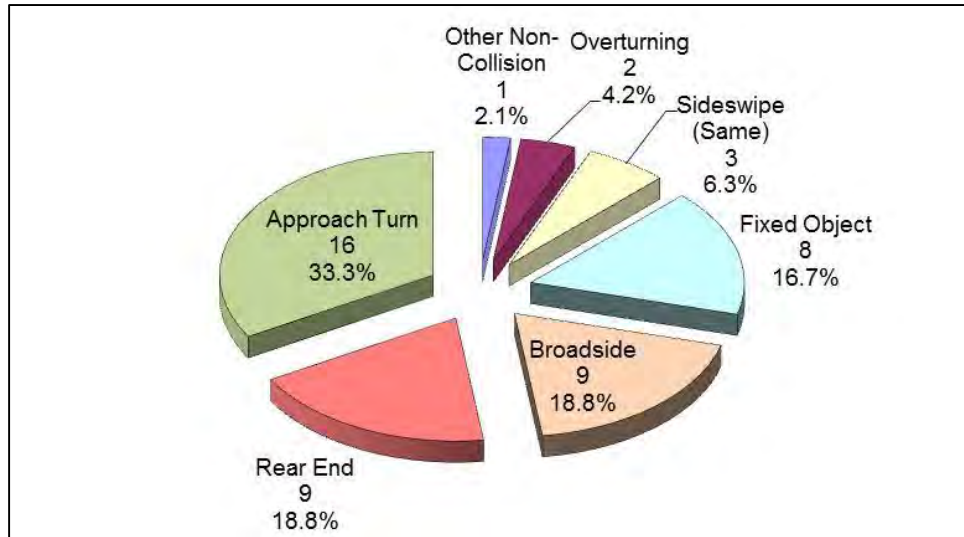
**Figure 186**  
**US 85C / SH 392A (MP 272.48)**  
**48 Total Crashes**

During the five-year study period (1/1/2008 – 12/31/2012), there were 48 crashes, 27 were property damage only and 21 resulted in injuries. **Figure 186** provides a graphical representation of crash types for this location. Approach turn type crashes (33.3%) were the predominant crash type followed by rear end type crashes (18.8%).

The frequency of approach turn type crashes was higher than expected for this type of intersection. A review of the crash history indicated that ten of the approach turn type crashes were northbound and six were southbound. Thirteen of the sixteen approach turn type crashes occurred on dry pavement, two crashes were on wet road conditions, and one was on icy road conditions. Nine of the approach turn type crashes occurred during the day, four during the night, and three at dawn/dusk lighting conditions. Approach turn type crashes at this intersection had two crashes that involved either trucks or buses.

Although the broadside type crashes at this intersection are not significantly higher than expected, there is a directional pattern with six of the nine crashes caused by US 85L vehicles. To possibly reduce the number of broadside type crashes, connecting the flashing beacons on the intersection warning signs (W2-1) on US 85L to the signal controller in order to anticipate red phases could be considered. It is also recommended to review/update the existing yellow/all red clearance intervals to reduce the frequency of rear end and other types of crashes.

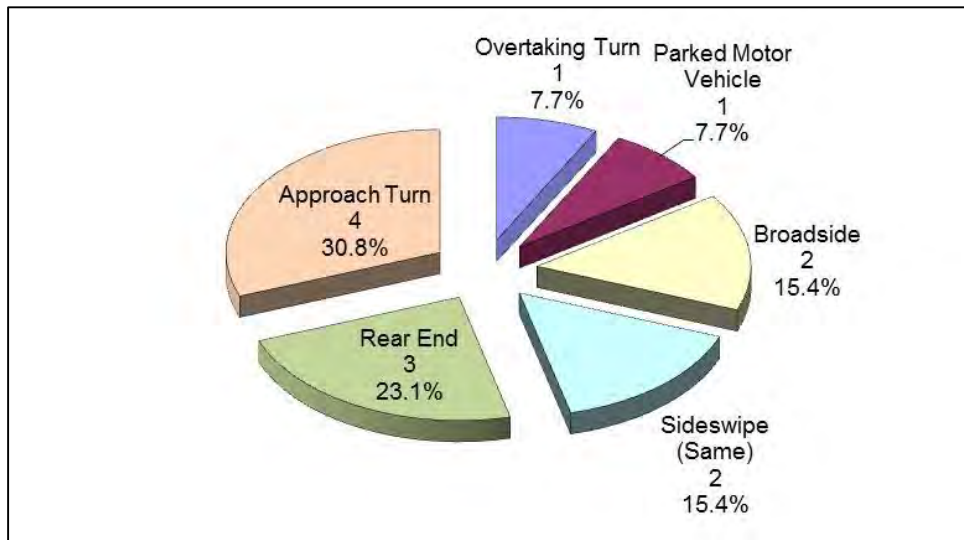
**Figure 188**  
**US 85L / CR 74 (Collins Street) (MP 275.59)**  
**13 Total Crashes**

During the five-year study period (1/1/2008 – 12/31/2012), there were 13 crashes and all 13 were property damage only. **Figure 188** provides a graphical representation of crash types for this location. Approach turn type crashes (30.8%) were the predominant crash type followed by rear end type crashes (23.1%).

A review of the crash history indicates that there is no current pattern to crashes at the intersection of US 85L and CR 74 (Collins Street). There are no suggestions for improvements at this time.

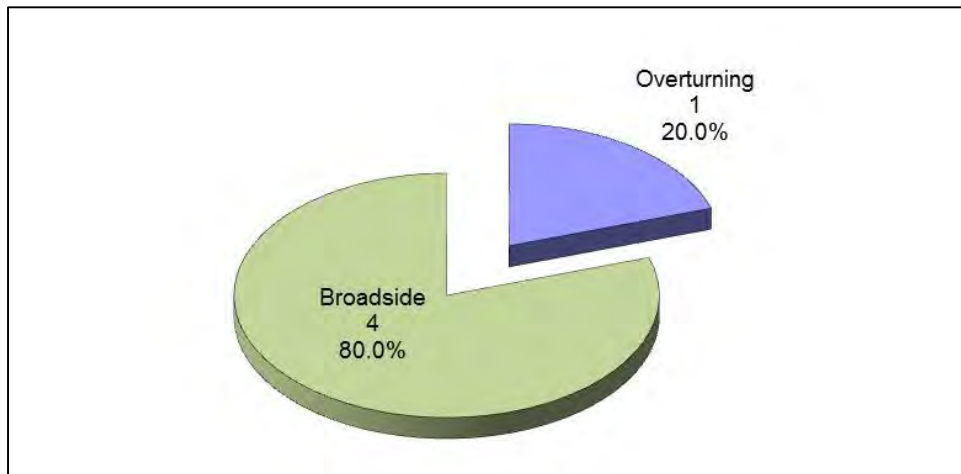
**Figure 190**  
**US 85C / CR 76 (MP 276.62)**  
**5 Total Crashes**

During the five-year study period (1/1/2008 – 12/31/2012), there were five crashes, and all five crashes resulted in injuries. **Figure 190** provides a graphical representation of crash types for this location. Broadside type crashes (80.0%) were the predominant crash type followed by overturning type crashes (20.0%).

The frequency of broadside type crashes was higher than expected for this type of intersection. A review of the crash history indicated that three of the four broadside type crashes were eastbound, and one was westbound. Three crashes were on dry pavement, and one was on icy road conditions. All of the crashes occurred during the day with the sun generally behind the drives. All of the crashes involved either passenger vehicles or SUVs.

- The intersection of US 85L with CR 76 in Ault is an unsignalized intersection that has a higher than expected number of broadside crashes, primarily caused by eastbound drivers. Placing larger stop signs (R1-1 – 48"x48") should be considered for both CR 76 approaches to the intersection. The pattern of crashes should be monitored, and if the broadside pattern persists, a flashing red beacon should be considered for the stop signs and a flashing yellow beacon for the advanced warning sign (W2-1) west of the intersection for eastbound CR 76 traffic.

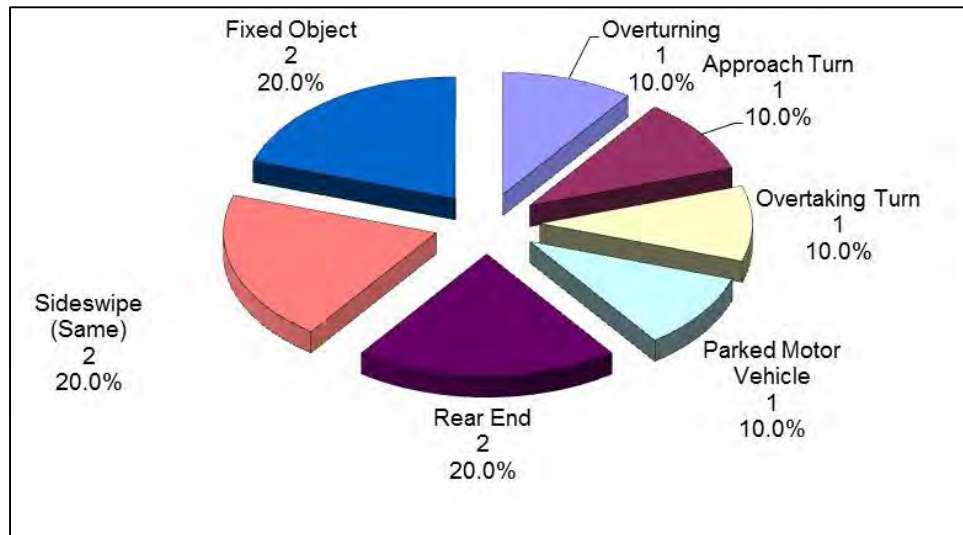
**Figure 192**  
**US 85L / SH 14C (1<sup>st</sup> Street) (MP 279.76)**  
**10 Total Crashes**

During the five-year study period (1/1/2008 – 12/31/2012), there were ten crashes, nine were property damage only and one resulted in injury. **Figure 192** provides a graphical representation of crash types for this location. Rear end type crashes, sideswipe (same), and fixed object crashes (20.0%) were the predominant crash types at this intersection.

A review of the crash history indicates that there is no current pattern to crashes at the intersection of US 85L and SH 14C. There are no suggestions for improvements at this time.

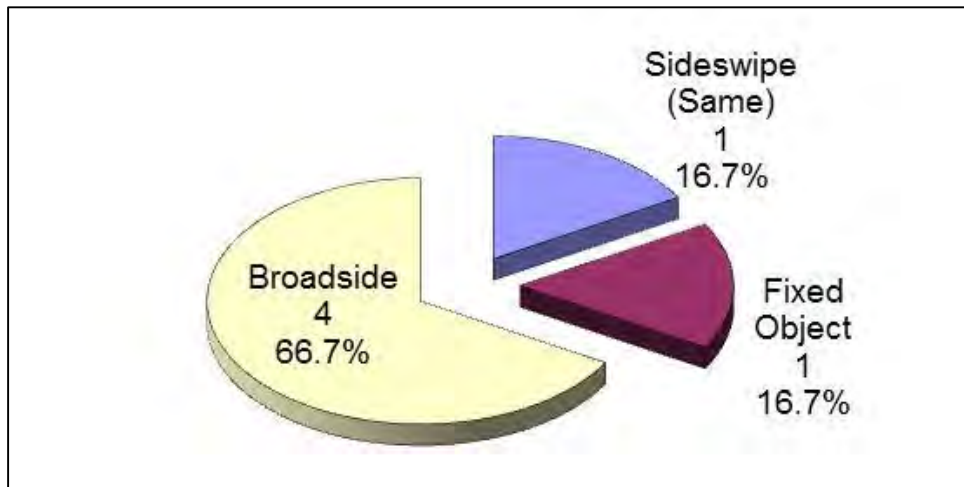
**Figure 194**  
**US 85L / CR 100 (MP 289.00)**  
**6 Total Crashes**

During the five-year study period (1/1/2008 – 12/31/2012), there were six crashes, two were property damage only, three resulted in injuries, and one fatal crash. **Figure 194** provides a graphical representation of crash types for this location. Broadside crashes (66.7%) were the predominant crash type followed by sideswipe (same direction) crashes (16.7%) and fixed object crashes (16.7%).

This broadside type crash occurred on October 14, 2010 at 19:10 under dry and dark-unlighted conditions. Vehicle #1 (a passenger car) was traveling eastbound on CR 100, and Vehicle #2 (a large truck) was traveling northbound. The crash was reported as a front to side collision. Alcohol was suspected for the driver of Vehicle #1. Vehicle #1 was reported to be traveling 20 miles over the speed limit of 35 mph. Vehicle #1 was reported to disregard the stop sign.

The frequency of broadside type crashes was higher than expected for this type of intersection. A review of the crash history indicated that three of the four broadside type crashes were eastbound, and one was northbound (unusual circumstances). Three crashes were on dry pavement, and one was on wet road conditions. Two of the crashes occurred during the day, and the other two were in dark, unlighted conditions. Three of the crashes involved either passenger vehicles or light trucks, and one involved a larger truck.

Currently, there are stop signs for both approaches of CR 100. In addition, there is an additional stop sign before the intersection are eastbound traffic at the gravel frontage road approaching from the south. Placing larger stop signs (R1-1 – 48"x48") should be considered for both CR 100 approaches to the intersection. The additional stop sign on the west leg should be replaced with a "Do Not Block Intersection" (R10-7) sign to reduce confusion about where eastbound vehicles should stop. The pattern of crashes should be monitored, and if the broadside pattern persists, a flashing red beacon should be considered for the stop signs and a flashing yellow beacon for the advanced warning sign (W2-1) west of the intersection for eastbound CR 100 traffic.

- The intersection of US 85L with CR 100 in Nunn is an unsignalized intersection that has a higher than expected number of broadside crashes. Placing larger stop signs (R1-1 – 48"x48") should be considered for both CR 100 approaches to the intersection. The additional stop sign on the west leg should be replaced with a "Do Not Block Intersection" (R10-7) sign to reduce confusion about where eastbound vehicles should stop. The pattern of crashes should be monitored, and if the broadside pattern persists, a flashing red beacon should be considered for the stop signs and a flashing yellow beacon for the advanced warning sign (W2-1) west of the intersection for eastbound CR 100 traffic.
