RELIABILITY OF PUBLIC SERVICE COMPANY OF COLORADO'S ELECTRIC DISTRIBUTION SYSTEM

INITIAL REPORT TO THE
COLORADO PUBLIC UTILITIES COMMISSION
by the Staff of the Colorado Public Utilities Commission
and
The Office of Consumer Counsel

January 14, 2004

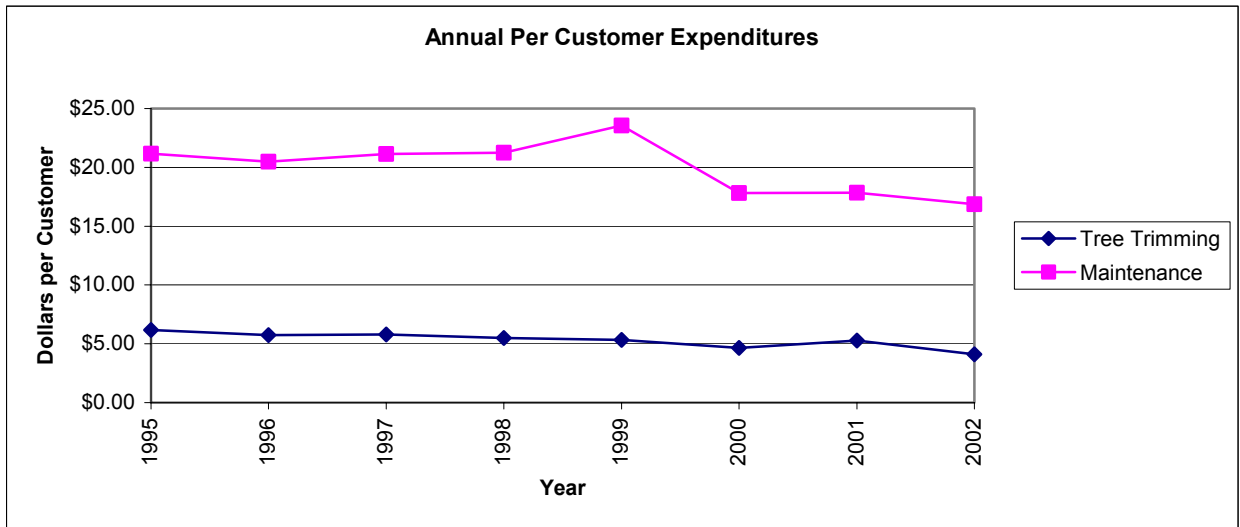
Figure II.

When plotted, it appears that distribution maintenance expenses decreased slightly, while PSCo earnings increased slightly, during the period. Over the last two years it is somewhat disturbing to note that net payments from PSCo to Xcel Energy (dividends paid less equity infusions received) have increased dramatically, even while PSCo's earnings and maintenance expenses have decreased.

Table XIII:	Summary of Non-Metro Outage Tickets.....	60
Chart 1:	Raw Data.....	63
Chart 2:	Normalized Data.....	64
Chart 3:	Per Customer Data.....	64
Figure 1:	Electric Distribution System (Attached)	
Figure 2:	Annual Per-Customer Expenditures.....	65
Figure 3:	Annual Per-Customer Expenditures.....	66
Attachment 1:	Directors' Letter to Vice President Stoffel	
Attachment 2:	Outages by Cause, Table DI-4, <i>Colorado Public Utilities Commission, Report on Staff Investigation of Public Service Company of Colorado Power Outages, October 13, 1998</i>	
Attachment 3:	2004 Reliability Action Plan for Colorado	
Attachment 4:	Seventh Set of Data Requests of the Commission Staff, September 18, 2003, Data Request No. Reliability 7-7

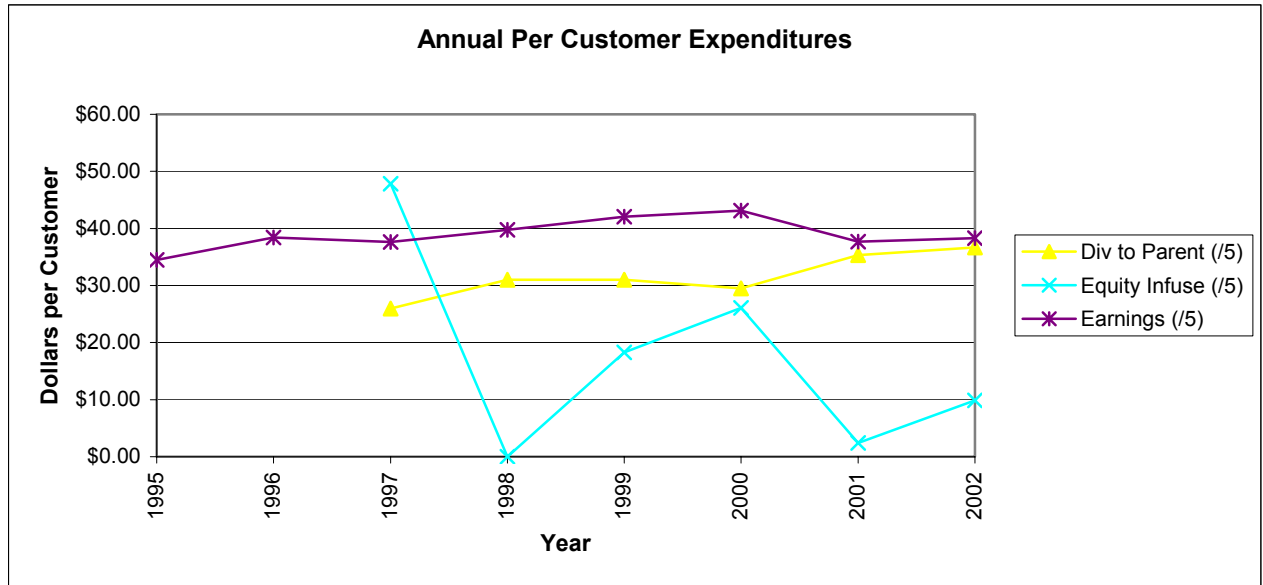
Figure III.

The trends show that Xcel Energy has drawn dividends from PSCo that were nearly equal to PSCo's profits during recent years. This, coupled with the dramatic decrease in equity infusions from Xcel, would have left less money available to PSCo to devote to maintenance of the distribution system. Even in years when PSCo's dividends paid and equity infusions were more balanced, there was still a trend toward increasing per-customer earnings, and decreasing per-customer expenses.

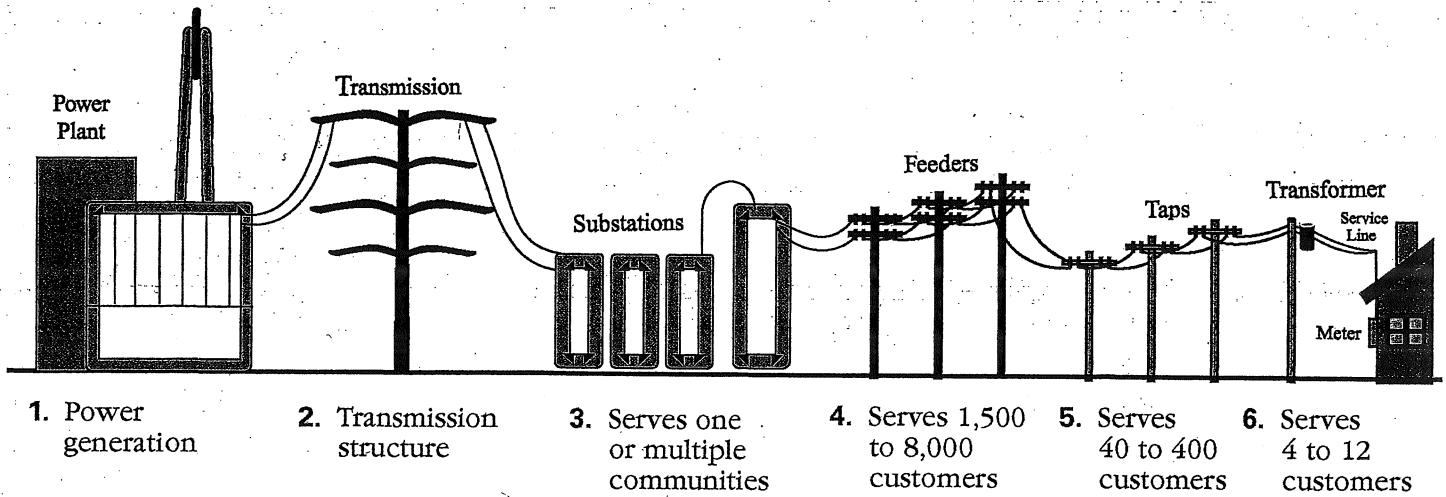
FIGURE 1

ELECTRIC DISTRIBUTION SYSTEM

How the Electric Distribution System Works

Power is carried to your home or business through an electric distribution system. Electricity is generated at a power plant and distributed by high-voltage transmission lines through various distribution systems until it reaches your home or business.

¹² See Figure 1 for pictorial of the parts of an electric system.

¹⁷ The distribution system begins where the voltage drops within the substation and ends at the connection to the customer's premises. Thus it includes cable, fuses and systems to protect the system, distribution transformers to drop the voltage even further, drop cables to the customer's premises, and meters. (See Figure 1)
