## **VISUAL RESOURCES TECHNICAL MEMORANDUM**

### **State Highway 9 Iron Springs Alignment Environmental Assessment**

**COLORADO DEPARTMENT OF TRANSPORTATION  
FEDERAL HIGHWAY ADMINISTRATION**

**April 2014**

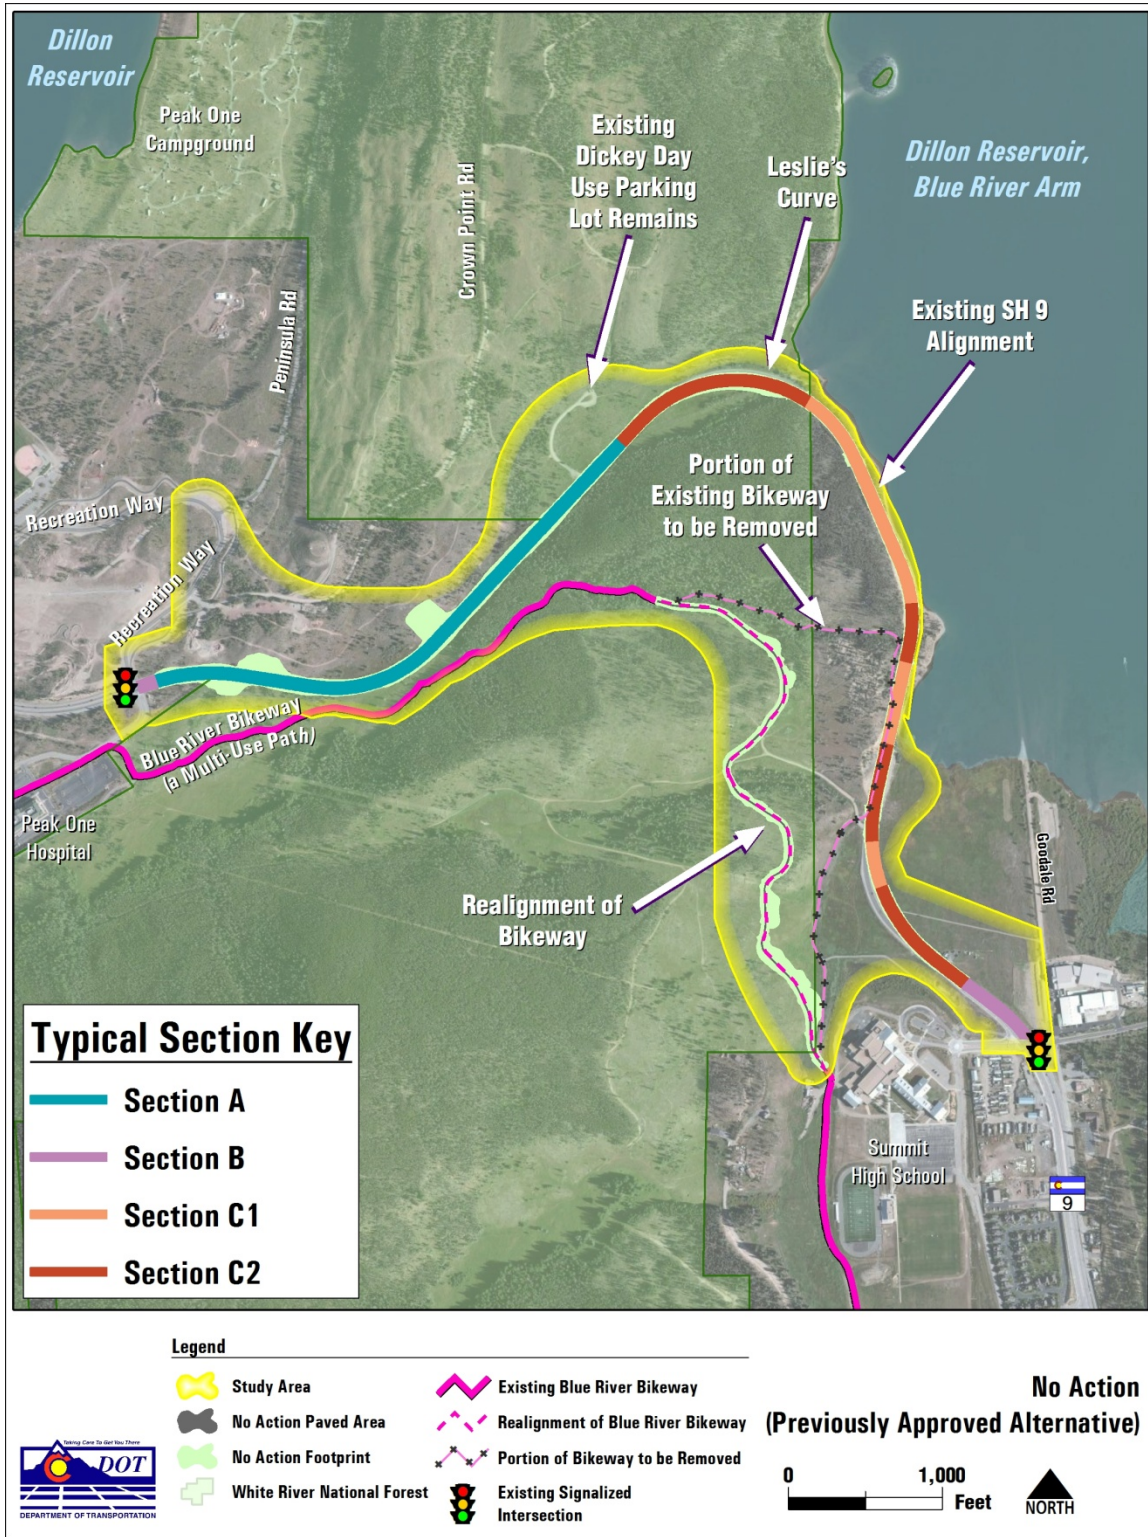
1 Figure 3 No Action Alternative (Previously Approved)

2 If the Proposed Action is not selected for implementation, SH 9 would be widened to provide a  
3 four-lane reduced section roadway along the existing alignment as previously approved in the  
4 SH 9 Frisco to Breckenridge EIS ROD (CDOT and FHWA, 2004a; 2004b) (**Figure 3**). The 2004  
5 Preferred Alternative is considered the “No Action Alternative” for this EA and is used as a  
6 baseline for comparison with the Proposed Action. These improvements would be implemented  
7 if the Proposed Action is not selected.

16 Additional detail regarding the No Action Alternative, including typical sections, is provided in  
17 the EA main text and the project drawings provided in Appendix A1 of the EA.

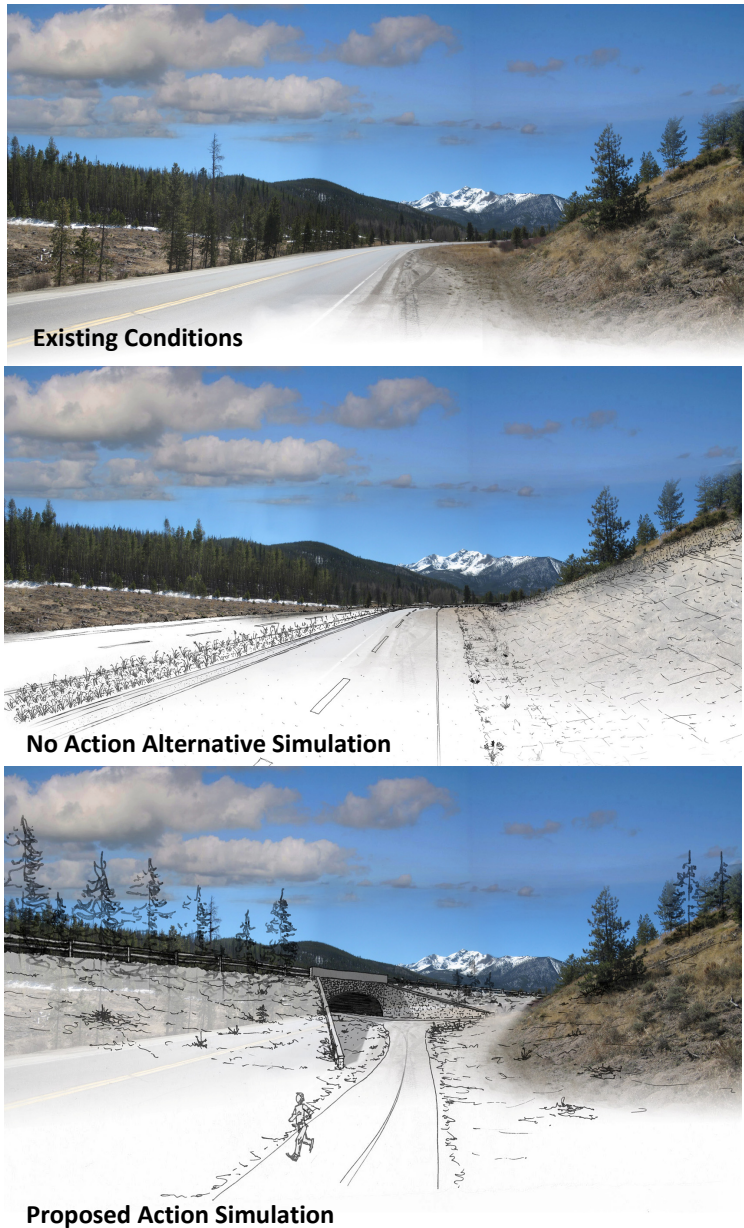
**Figure 8 KOP 2 Looking West toward Frisco**

3 The landscape includes a  
4 focal point, Peak 9, where the  
5 horizontal curve of the  
6 highway and right hillside  
7 lead the eye to a snow  
8 capped mountain. Colors  
9 include lighter brown and  
10 grey foreground with a finer  
11 texture, to the dark massing  
12 of the middle ground. There  
13 is little forested area in the  
14 immediate area of potential  
15 impact, rather it appears  
16 disturbed with a single line of  
17 trees adjacent to the  
18 roadway (appearing  
19 unnatural and reinforcing the  
20 highway edge). The single  
21 lines of trees should be  
22 considered for removal due  
23 to their poor health. **Figure 8**  
24 presents the existing  
25 conditions and simulations.

39 The axis (center line) of the landscape is maintained with the Blue River Bikeway and the scale of  
40 the horizontal line of the highway structure fills in for the mountain form. The sloping terrain  
41 now leads the eye to the underpass opening. The shade offered by an underpass can be a  
42 source of refuge for pedestrians, even if momentary, in a semi-arid, high elevation landscape.  
43 The height of the structure is appropriate in scale to repeat the size of adjacent landform  
44 (Moderate contrast). The path is visually neutral. Overall, the manmade elements relate to the

1 landform and reinforce each other. The structure is evident but does not detract from the scene  
2 and meets a Low SIO.

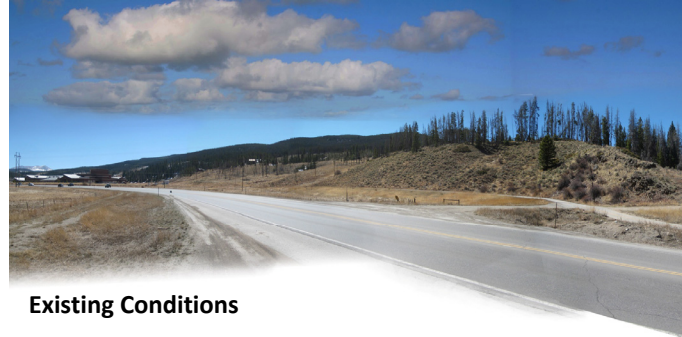
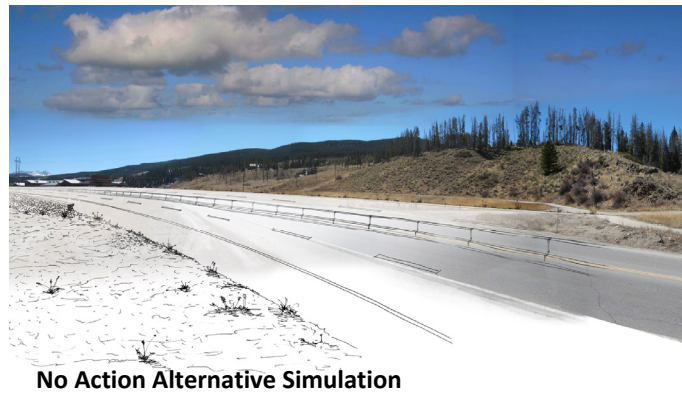
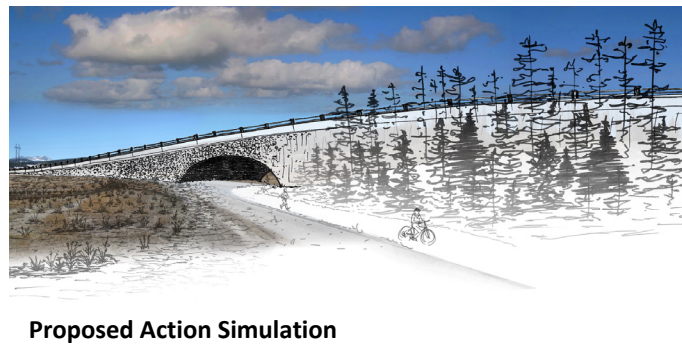
**Figure 9 KOP 3 Looking South toward Breckenridge**

6 The view south toward  
7 Breckenridge and Summit High  
8 School is enclosed by a rocky  
9 hillside, with a ridge of dead  
10 evergreens against the skyline.  
11 Texture is patchy and sparse. A  
12 dark line of low mountains  
13 reinforces the highway curve to  
14 the left (where there is a utility  
15 pole and rectangular structures).  
16 **Figure 9** presents the existing  
17 conditions and build alternative  
18 simulations.

30 The foreground view is  
31 dominated by the earthwork and  
32 amount of highway structure  
33 rising to the right, keeping the  
34 same outline as the original  
35 landscape, but blocking  
36 background views. Roadside plantings and careful selection of color and texture are needed to  
37 reduce the visual scale and strong contrast of the new element form. The sloping terrain would  
38 make the opening of the underpass obvious to users of the Blue River Bikeway. The uphill also  
39 becomes more prominent to travelers on SH 9. The structure (through careful selection of color  
40 and texture) would be less evident and meet SIO in middle and background views (where it is  
41 primarily viewed). The new highway structure may dominate but must harmonize and blend  
42 with the adjacent land. Slope molding would also lessen visual effects in a SIO area rated  
43 Moderate.

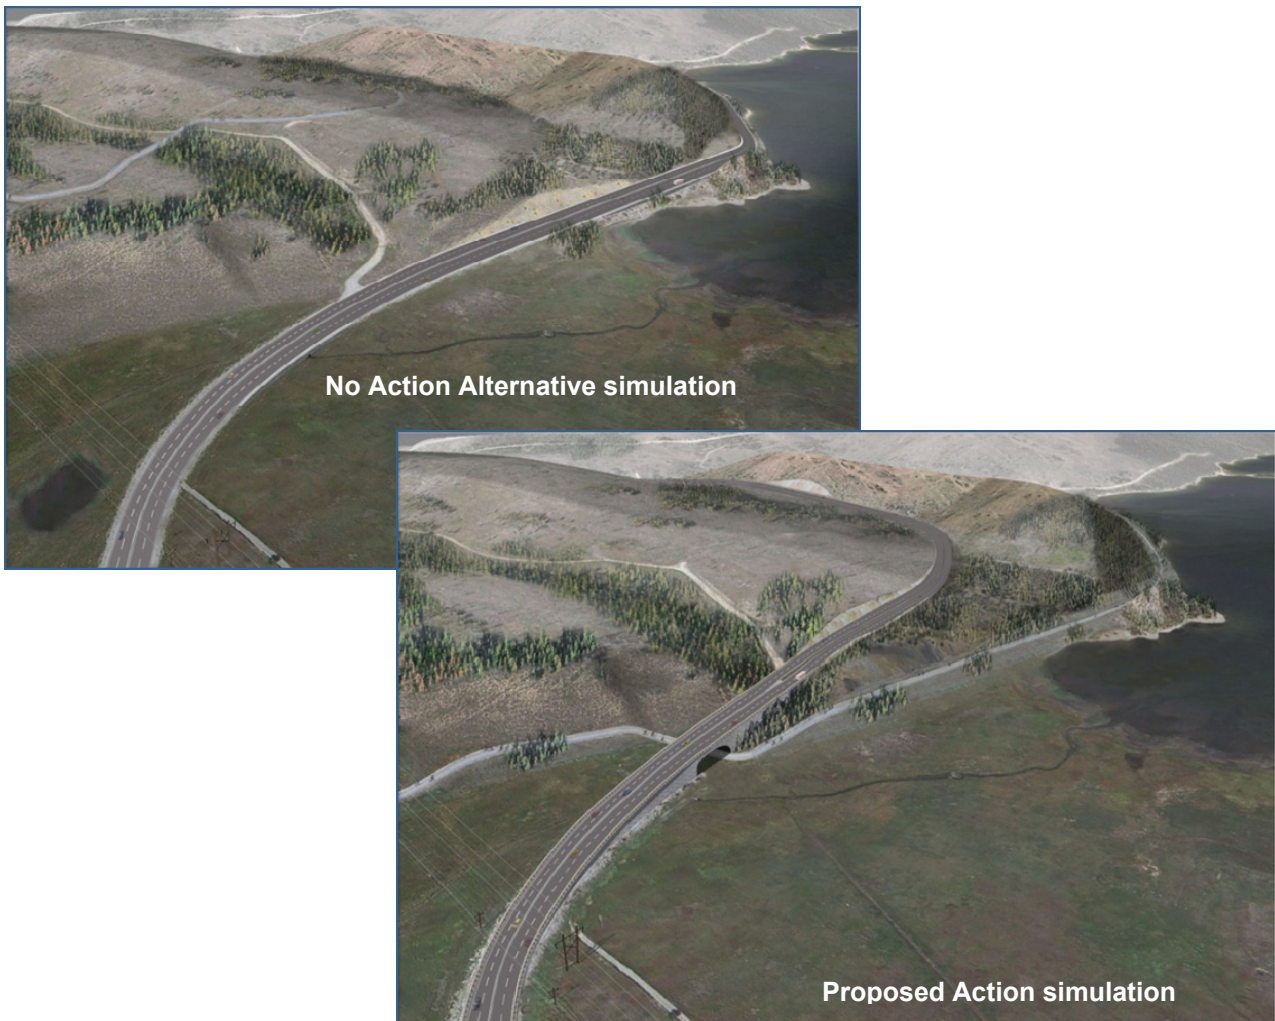
16 **Figure 10**       **KOP 4 Bird’s Eye View Simulations from the South**

9 The view from the south is an oblique perspective; bisected by a relatively flat and smooth  
10 foreground, a hilly and clumpy forested middle ground, with Dillon Reservoir to the right  
11 (**Figure 10**). SH 9 forms an inverted S shape, and secondary roads are visible, forming a dendritic  
12 network connection in the top left, reducing intactness of the view. Transmission lines are  
13 noticeable in the left bottom corner, crossing the highway at a right angle. Two other lines  
14 appear parallel to the transmission lines; a drainage form appears perpendicular from the  
15 highway and connects to the reservoir.

2 The alignment widens to four lanes with steep cuts and walls at the top right (Moderate  
3 contrast). The new retaining walls would not be as noticeable from this viewpoint, if color and  
4 texture are used to match the surrounding landscape. The CDLT lands are impacted with cuts  
5 along the property’s eastern edge, increasing talus slopes. The current line and form are  
6 reinforced and the existing character of the landscape is consistent with a SIO of Moderate for  
7 the USFS.

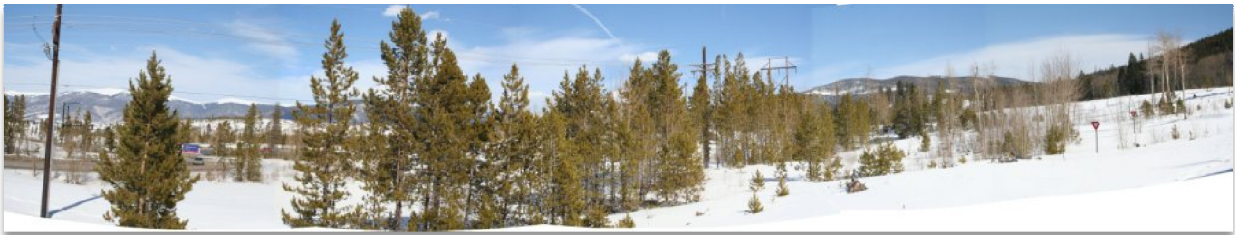
29 **Figure 11 KOP 5 Photomontage View Looking Northeast from the Peak One**  
30 **Hospital Parking Lot**

21 A portion of USFS land was converted to house the new St. Anthony’s Summit Medical Center  
22 and Peak One Hospital southwest of the new alignment termini. Standing in the northwest  
23 parking lot and looking east toward the project impact area, the foreground view is a gently  
24 rising forested wall forming a 45 degree angle sense of enclosure; with a distant form/line of  
25 mountains on the outside edges (**Figure 11**). Cultural modifications (visible transmission poles  
26 and lines) detract. Barely visible to the viewer is a portion of the SH 9 traffic signal intersection  
27 at Peninsula Drive/Peak One Drive (horizontal line in the middle ground), screened partially by  
28 evergreens.

31  
32 The No Action and Proposed Action are essentially the same for this section of SH 9. Activities  
33 may be barely visible but should not attract attention and will retain the existing character,  
34 which is a low relative change. Therefore, this view meets the Moderate SIO. No further visual  
35 analysis or mitigation was deemed necessary.

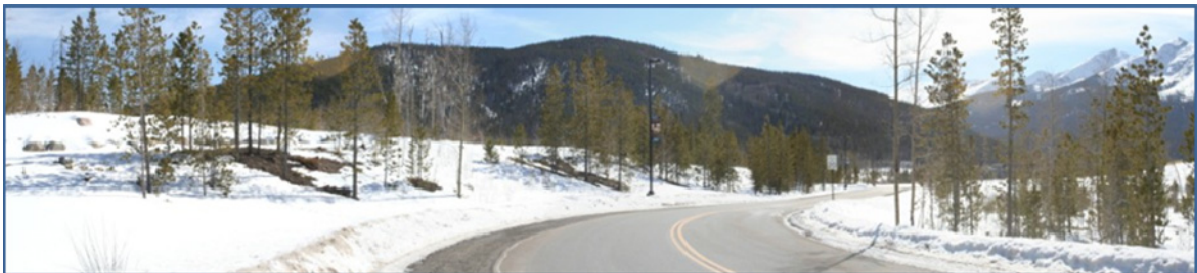
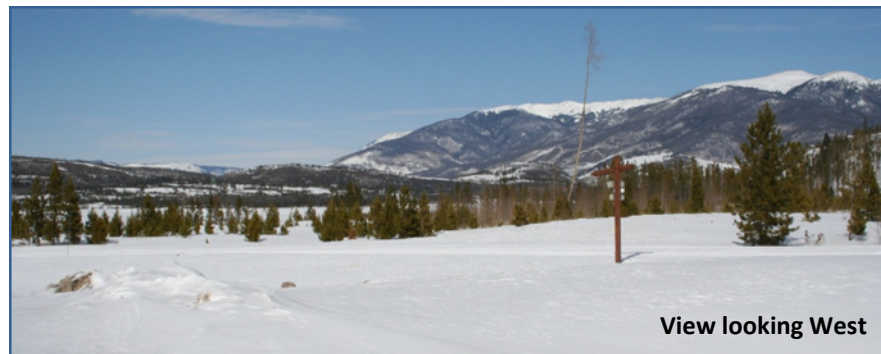
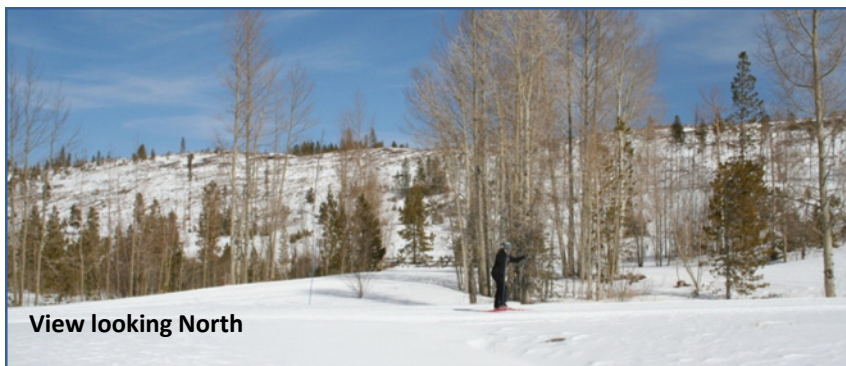
13 **Figure 12 Views from Recreation Way and Peninsula Road**

3 Deforestation, due to the MPB epidemic, has changed the focus of the Frisco Nordic Center  
4 (now the Frisco Adventure Park) and Peninsula Recreation Area to a more built outdoor  
5 recreation environment. The view is to the southeast at Recreation Way and Peninsula Road,  
6 within a portion of the Frisco Peninsula Recreation Area, and has scattered groups of trees  
7 (**Figure 12** upper photograph). A low hill in the middle ground screens SH 9; two light poles are  
8 noticeable. Iron Springs Hill forms a sense of enclosure, occupying much of the scene. The view  
9 west (**Figure 12** middle photograph) is a flat foreground with a linear line of trees bisecting the  
10 horizontal plane and mountains forming a feature landscape on the right. The view north  
11 (**Figure 12** bottom photograph) is screened by a hill with heavier vegetation, including aspen, at  
12 its base.

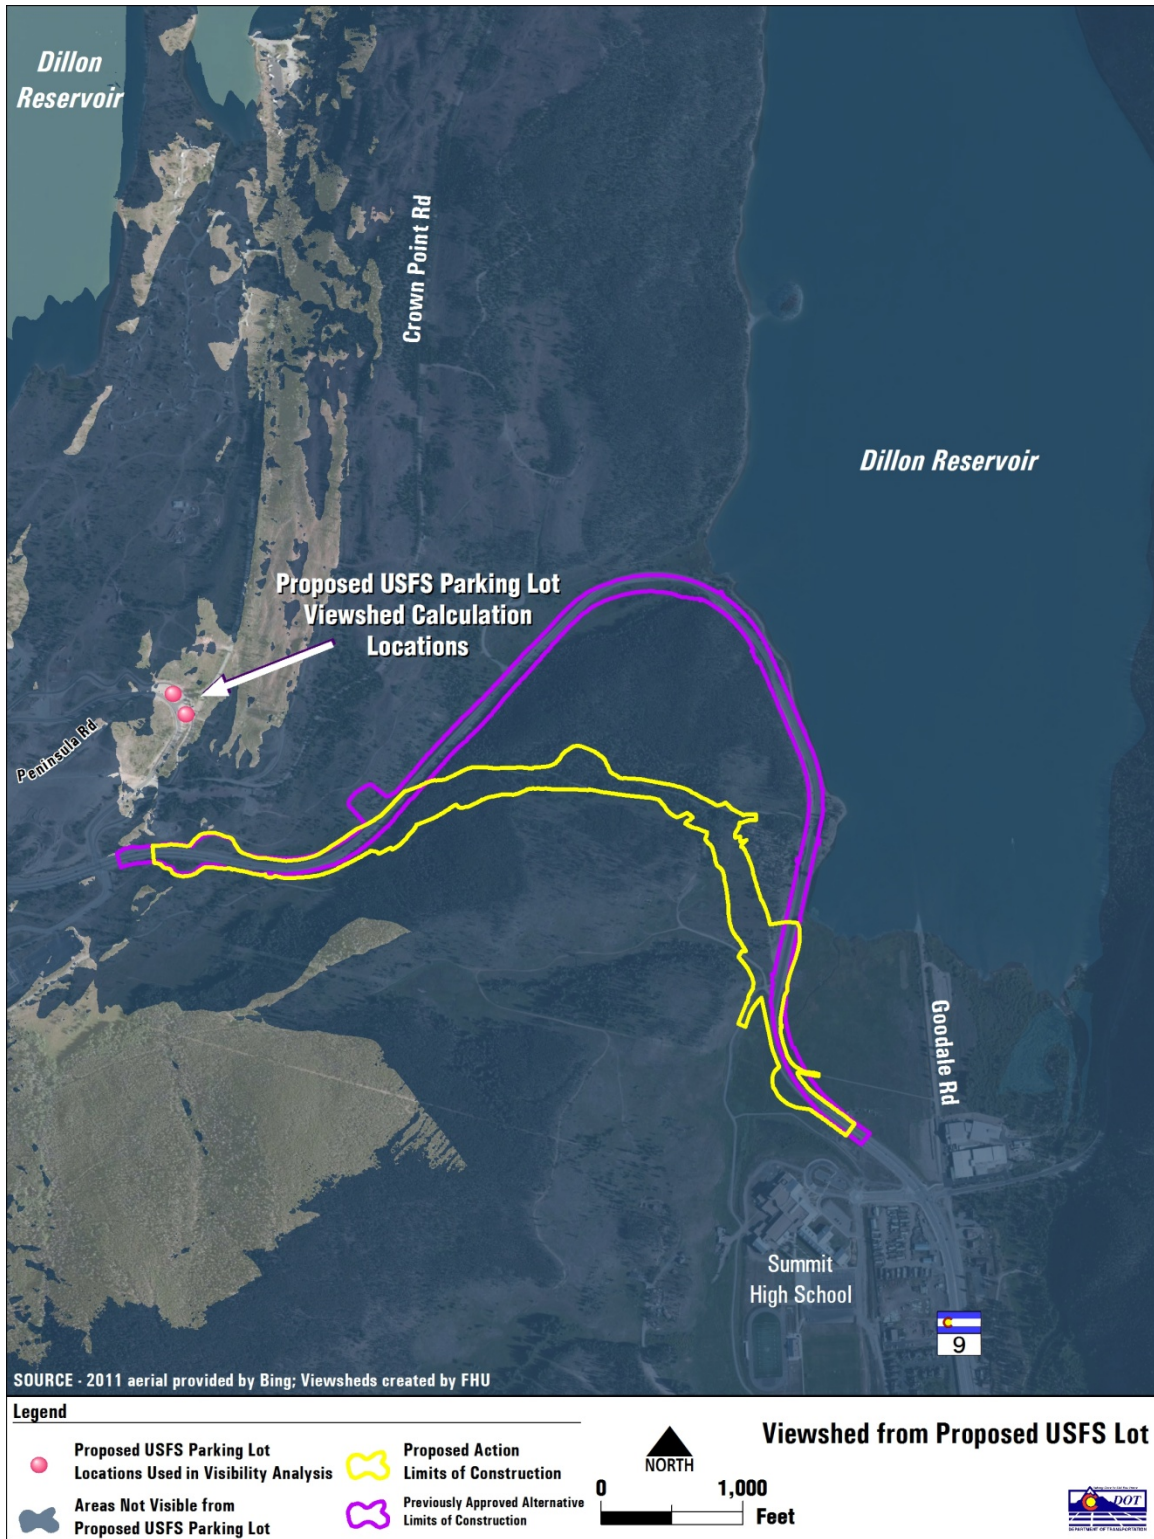
1 **Figure 13 Viewshed from Proposed Parking Lot**

6 The viewshed map from a Proposed Parking Lot (**Figure 13**) illustrates that the Proposed Action  
7 is not visible (confirming field observations). The Proposed Parking Lot would be constructed  
8 along Recreation Way to replace the existing Dickey Day Use Parking Lot. There would also be a  
9 Proposed Dickey Day Trail Connection—a 12-foot wide recreation path connecting the Boneyard  
10 going southeast toward SH 9 and heading northeast along the old SH 9 alignment. This would  
11 include a 300-foot long wall (with maximum 8-foot wall height). Given the strong curvilinear  
12 form and lines of existing trails and roadway, adequate parking to accommodate trailhead needs  
13 is compatible with surrounding land uses. The proposed location of the parking lot and trailhead  
14 is an opportunity to combine functions into multi-use facilities; and meets the SIO of Low.

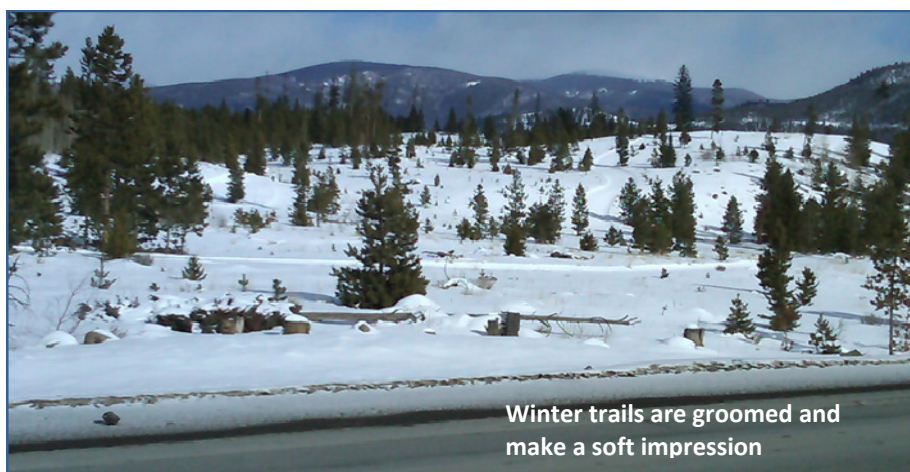
**Figure 14 View East toward Buzz Saw Nordic Trail from Recreation Way**

3 The Frisco Nordic Center provides a cross-country ski trail system; Buzz Saw Nordic Trail is  
4 parallel to SH 9 (**Figure 14**). Single trees appear evenly spaced and dispersed over gentle slopes  
5 in the foreground. The  
6 landscaped buffer  
7 between the roadway  
8 and adjacent trail  
9 appears only for a couple  
10 of seconds to SH 9 users  
11 (heading north) and  
12 drivers must be looking  
13 for the trail to notice it.  
14 Recreationists  
15 (snowshoers and cross  
16 country skiers) would  
17 view the highway longer.  
18 The roadway is hidden  
19 again behind hills as the  
20 trail user travels  
21 northeast, until the  
22 Dickey Day Use Area.

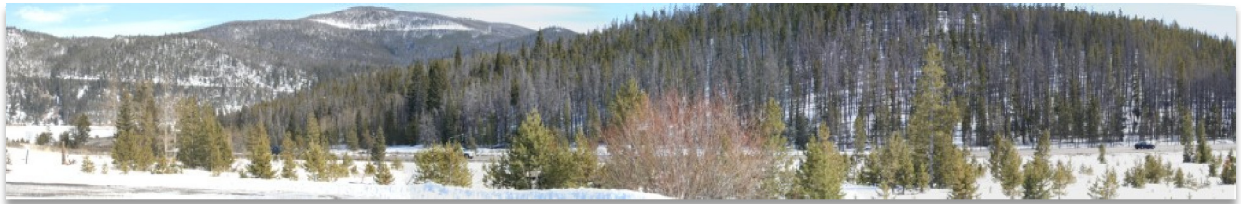
11 **Figure 16 KOP 8 Photomontage View Looking Southeast from Dickey Day Use**  
12 **Parking Lot**

3 The Dickey Day Use Area is under management of the WRNF. The area consists primarily of  
4 public parking and access to a network of trails on the peninsula and Dillon Reservoir. The area  
5 is also utilized for fishing, bicycling, and hiking, with incredible views along the trail. The road  
6 access is closed in winter season. The KOP view southeast has the horizontal line of SH 9  
7 partially screened by vegetation, and the eye detects the water of Dillon Reservoir in the  
8 summer (in the left side of the image and covered by snow in March) (**Figure 16**). Enclosed  
9 landscape type is formed by Iron Springs Hill and mountains in the background. This view  
10 illustrates the extensive stands of dead lodgepole pine that will be removed by the USFS.

15 The entrance to the Dickey Day Use Parking Lot (far right, just outside of frame) would require  
16 modification of undeveloped portions of the area where toe slope construction and  
17 maintenance clear zone are needed. The lands directly impacted are peripheral and views  
18 minimal. The highway widening would decrease vividness and intactness (Moderate contrast)  
19 but would meet the SIO of Low.

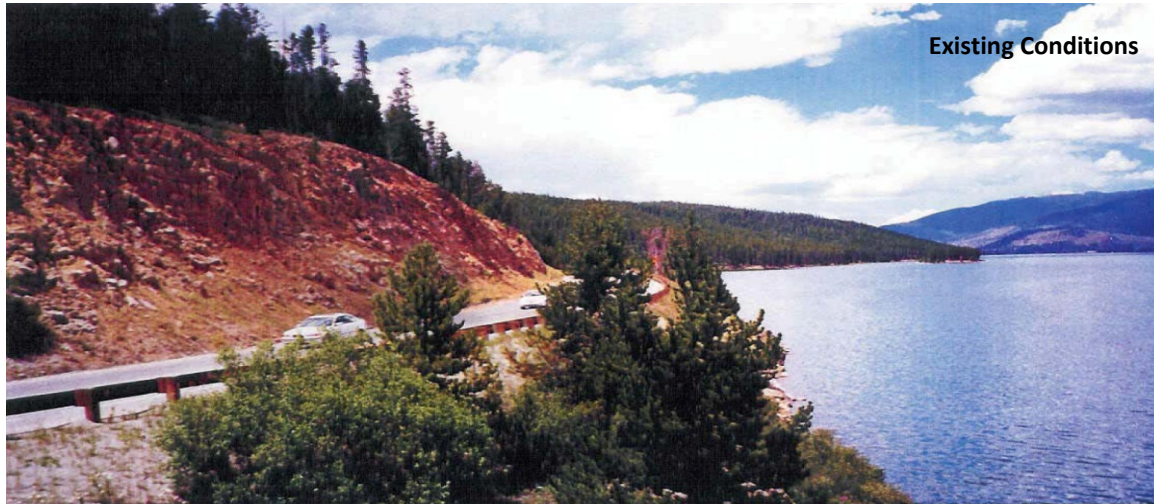
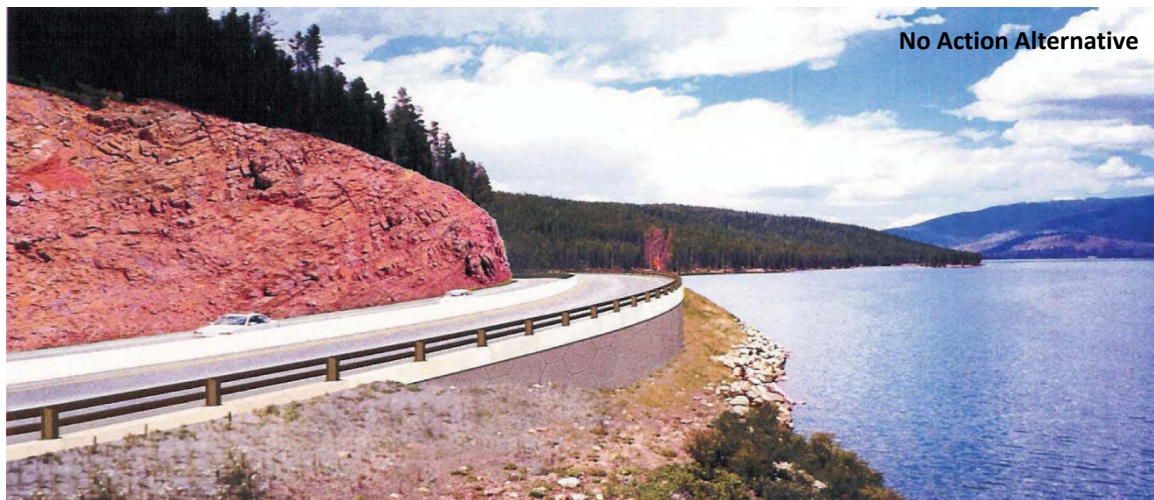
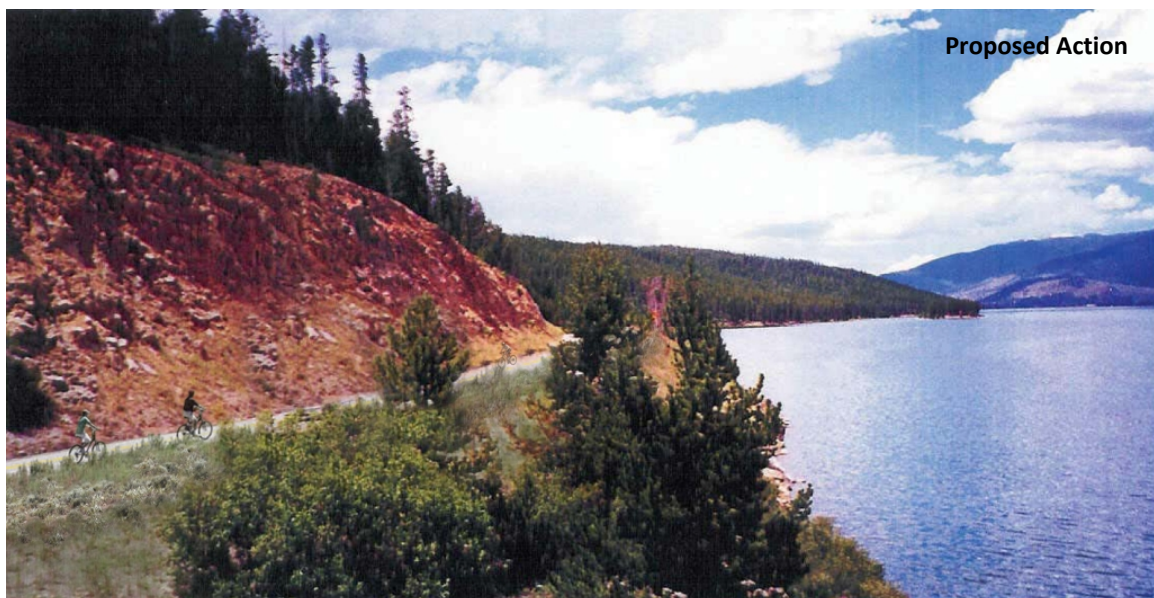
Figure 17 KOP 9 Views Looking Northwest, just South of Leslie's Curve

13 The area selected for KOP 9 is along SH 9, just south of Leslie’s Curve, along the Blue River Arm  
14 (**Figure 17**). Water and shorelines are highly valued focal points, lines, and color that give this  
15 landscape visual variety and moderate vividness. The reservoir is surrounded by stands of trees  
16 and steep, rocky orange/grey earth forms provide a sense of enclosure. Although the area is not  
17 within USFS lands, a Moderate SIO is assumed due to the Moderate SIO established for a large  
18 area of the Blue River Arm shoreline.

26 The bikeway is not visible in the No Action Alternative KOP. The bikeway continues in its current  
27 alignment until it approaches Dillon Placer Mine. The new path drops south with steep grades of  
28 8 to 10 percent making it difficult to meet Americans with Disability Act requirements and  
29 Forest Service Trail Accessibility Guidelines (USFS, 2006). Views are generally limited due to the  
30 forested edge along the western and northern portion, and then open along the bikeway’s  
31 southern route.

2 SH 9 will be relocated away from Dillon Reservoir and will not be visible in this view. To avoid  
3 bikeway user conflicts with vehicles, the Blue River Bikeway will be relocated on the old SH 9  
4 prism around Lake Dillon, resulting in greater visual vividness and unity. Users would have a  
5 gentler grade and improved recreation experience. The relocation would maintain the bikeway's  
6 original function, enhance overall aesthetic character and view shed by reducing the area of  
7 asphalt, and increase the area of potential vegetation. The closer the observer gets to the water,  
8 the greater the feature dominates the scene. The SIO is Moderate and the new elements reduce  
9 the degree of contrast, increasing visual resources.

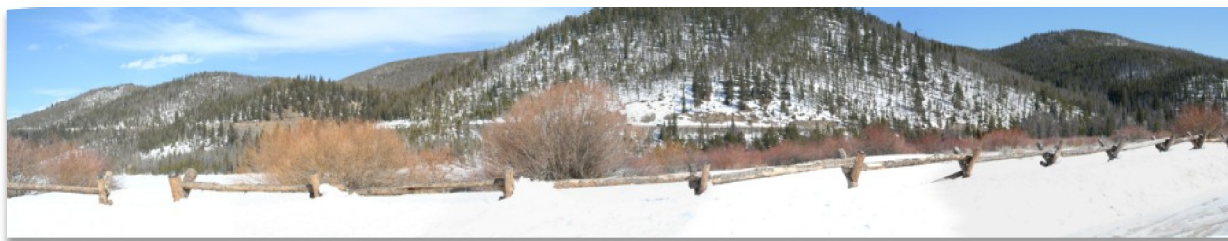
28 **Figure 18 KOP 11 Photomontage View Looking East from Goodale Road**

22 The Blue River is the primary inlet for the high mountain, fresh-water of Dillon Reservoir. Fishing  
23 is an important activity and there are some river restrictions in place allowing fly/lure only  
24 (Colorado Parks and Wildlife, 2013). A field observation from this KOP was not conducted due to  
25 snow cover. The view from KOP 11 (**Figure 18** - taken from the Goodale Road parking lot) and  
26 aerial photography suggests the observer position would be inferior and surface disturbance  
27 would not be visible. The site is part of the Dillon Reservoir Recreation Area.

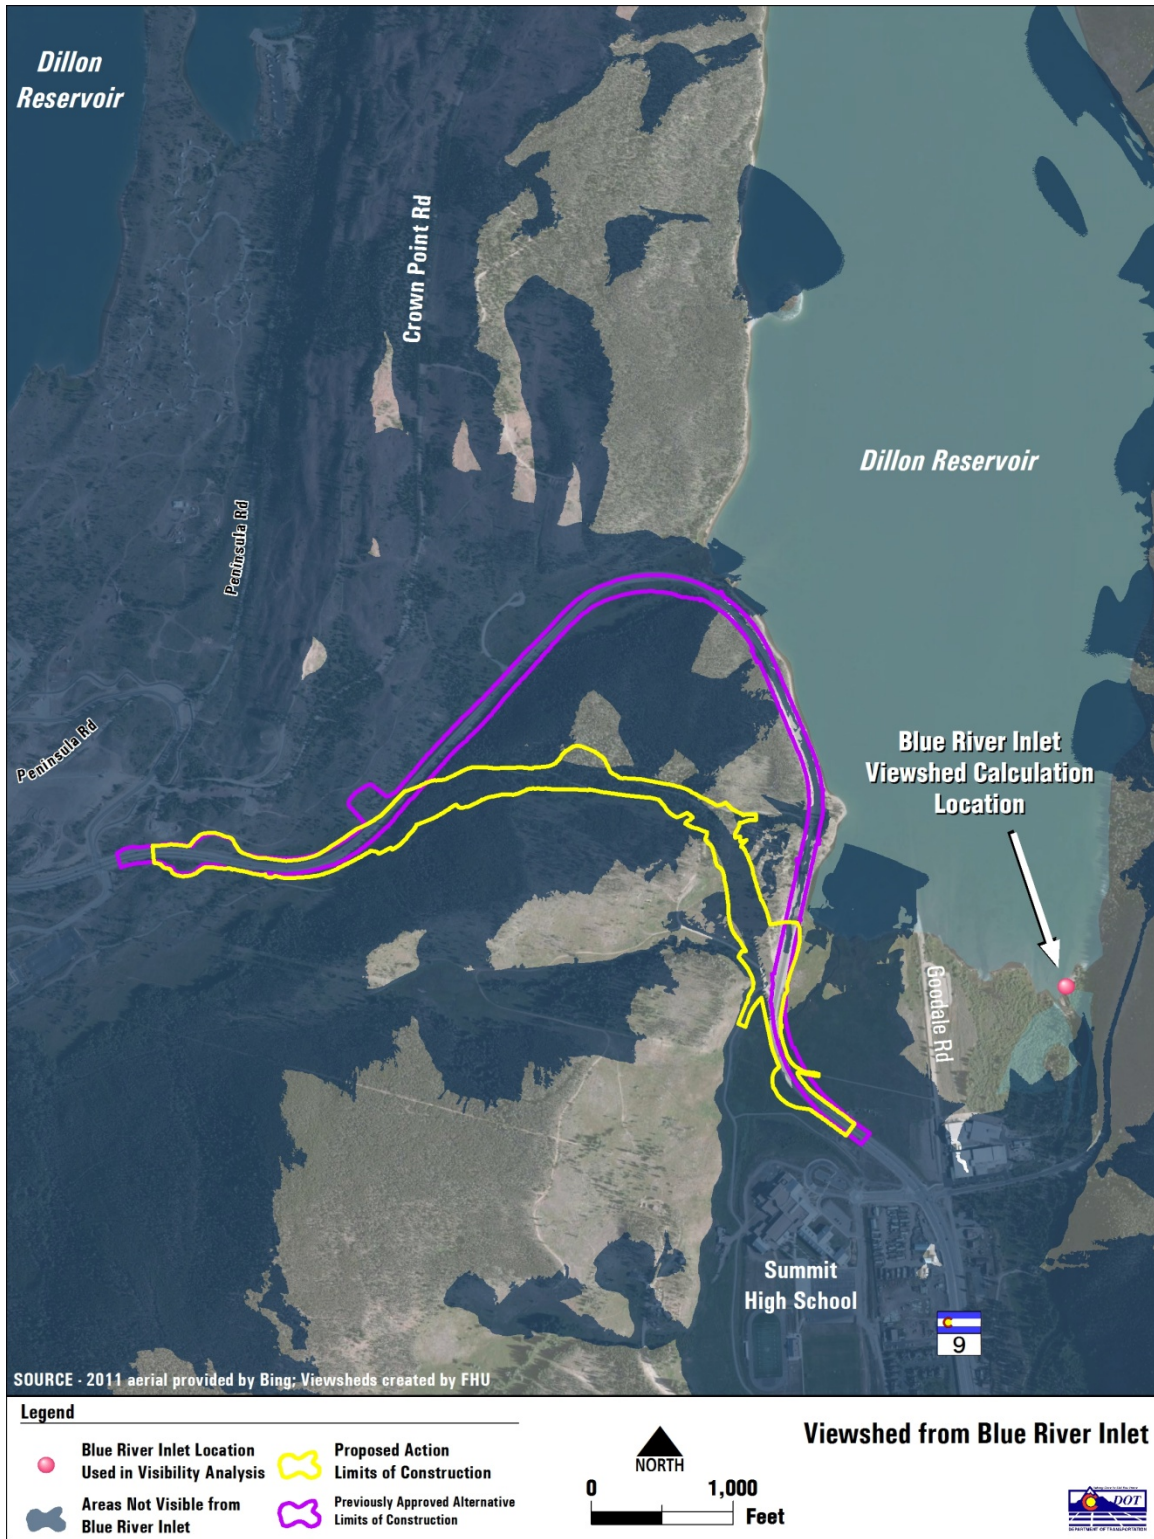
1 Figure 19 Viewshed from Blue River Inlet

31 The viewshed map (**Figure 19**) indicates the area surrounding the eastern structure and the  
32 eastern curve of SH 9 would be visible. However, discernment of the highway widening would  
33 be difficult due to the difference in view plane, vegetation, and distance. The greater distance  
34 means that walls would be less noticeable and smaller in scale than views from the parking lot.  
35 Appropriate color and texture would reduce any potential contrast.

18 **Figure 19** with the exception of a small segment of SH 9 just north of Summit High School being  
19 visible. Although the KOP is not within USFS lands, a Moderate SIO was assumed for analysis  
20 purposes.

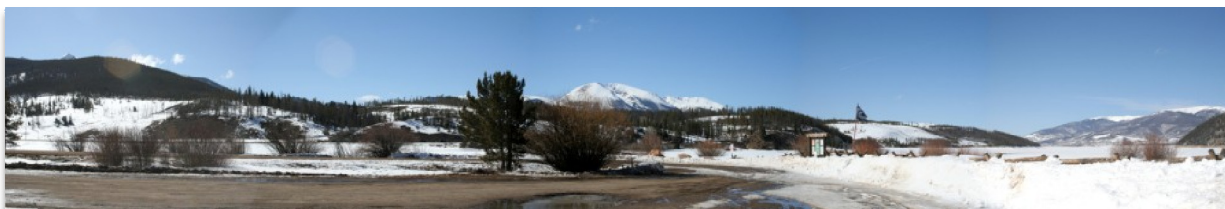
21 **Figure 20 KOP 11 Photomontage View Looking West from Goodale Road**

8 Goodale Road (County Road 985) places the observer west and 50 percent (about 1,000 feet)  
9 closer to the project than from the Blue River Inlet. County Road 985 is the original road leading  
10 to the old town of Dillon (now underneath the reservoir). The parking lot is for hand carry water  
11 craft and access to the Dillon Reservoir Recreation Area; the KOP view is to the west (**Figure 20**).  
12 The open country is a broad horizontal composition with views of Dillon Reservoir opening to  
13 the right (under snow) and mountains in the distance. The scene appears evenly divided among  
14 foreground, middle ground, and background; and has greater existing visual contrast. The  
15 foreground is relatively open and has some deciduous shrubs. The middle ground has the  
16 greatest visual mass given the relatively even horizontal bar formed by the hills and vegetated  
17 draws. A viewshed map was prepared for this KOP and is in the project file. It is similar to

24 The highway widening would be slightly noticeable, and walls more noticeable due to color and  
25 form contrast (Weak). The new elements should remain subordinate to the characteristic  
26 landscape and the scene would meet Moderate SIO.

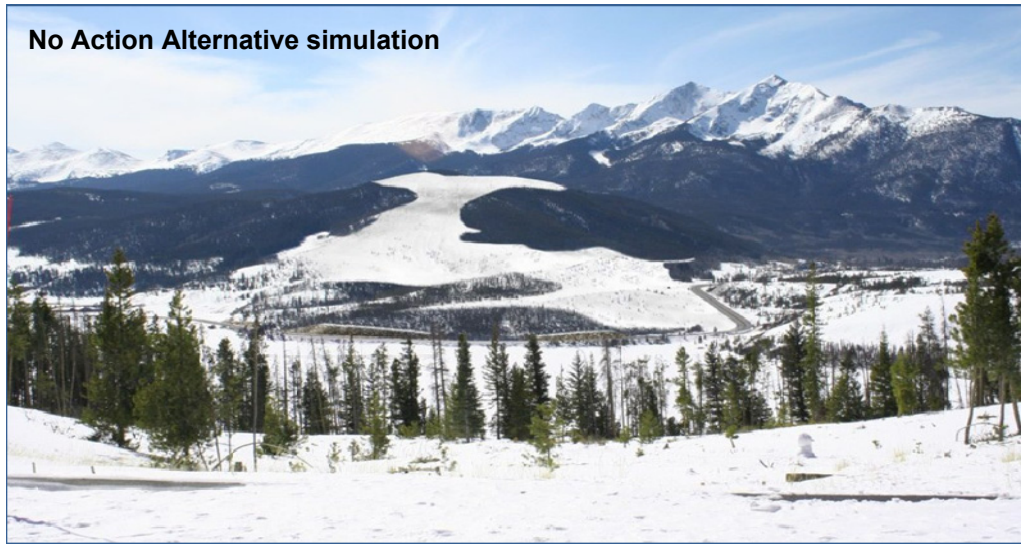
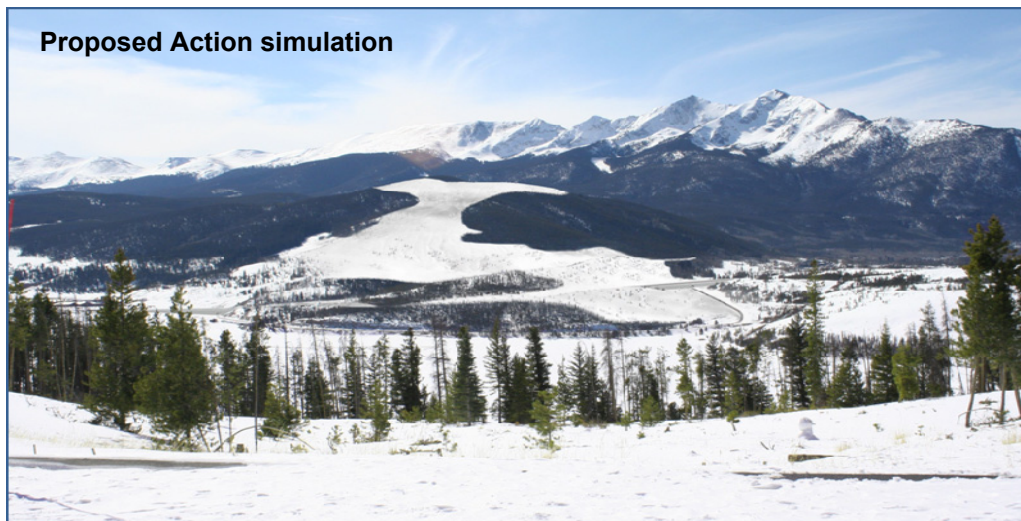
1 **Figure 21 KOP 12 Views Southwest from Sapphire Point, across Dillon Reservoir**

4 KOP 12 is at the Sapphire Point parking lot looking west; the overlook is at an elevation of  
5 9,606 feet (USFS, 2013). A loop trail to the overlook is only 0.74 mile; elevation gain is about  
6 100 feet and an easy hike. The landscape is a spectacular vista with a sense of boundary from  
7 Gore range and Tenmile. Ophir Mountain and Dillon Reservoir are in the middle ground (the  
8 latter covered in snow) and SH 9 circles Iron Springs Hill (**Figure 21**). The view is subject to more  
9 visual scrutiny since the vantage point is superior to the project area and there is high vividness  
10 due to the strongly defined skyline of the mountain landscape. Sapphire Point has been used for  
11 weddings and attracts a high number of viewers with high concern for scenery. Unfortunately,  
12 dead trees are noticeable in all views, but the landscape remains highly regarded because of its  
13 water landform, variety, and grand scale.

28 The Proposed Action simulation illustrates that a large segment of SH 9 is less visible, screened  
29 by the steep topography of Iron Springs Hill, particularly in the central focal point adjacent to  
30 Dillon Reservoir. There is more opportunity for future screening with vegetation along the  
31 eastern and western edges (Weak contrast). The old SH 9 alignment would be less noticeable  
32 with the removal of asphalt for the narrower bikeway path and revegetation. The view meets  
33 Moderate SIO.

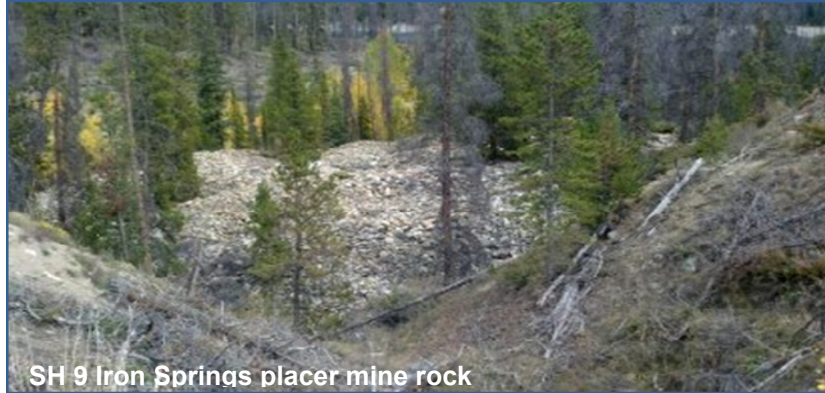
**Figure 22** KOP 13 View East toward Dillon Placer Mine Gravel Piles

5 The Dillon Placer Mine  
6 contains large, tall  
7 (15-foot) gravel piles of  
8 rounded river rock  
9 (**Figure 22**), ditches,  
10 sluicing features; and  
11 remnants of turn-of-  
12 the-century placer  
13 mining. The large rock  
14 piles are unstable and

15 not vegetated. Depending on the viewer's perspective, the landscape has been ravaged by gold  
16 dredging or is a quaint historic vignette. Cultural properties are considered a part of the  
17 landscape but historic aspects can, if applicable, override natural scenery. The area is sited  
18 mainly on CDLT property; with a small sliver of the western boundary on USFS lands. The area is  
19 not mapped for SIO but is assumed Moderate for analysis purposes. The site has previously  
20 been disturbed by past construction of the Blue River Bikeway (along the north edge of the  
21 Dillon Placer site) and logging. **Figure 23** illustrates the steep drop in rugged topography  
22 southeast of the placer mine dredge piles.
