Report No. CDOT-2007-1
Interim Report

STUDY ON THE USE OF SELF- CONSOLIDATING CONCRETE FOR THE REPAIR OF THE MEAD BRIDGES ON I-25

April 2007

COLORADO DEPARTMENT OF TRANSPORTATION
RESEARCH BRANCH

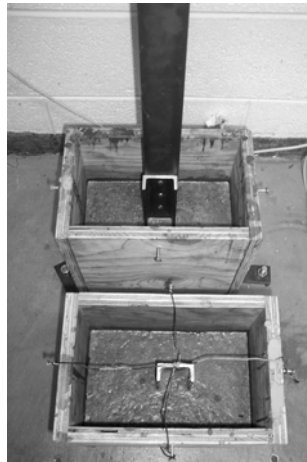
A series of experiments were developed to simulate the vibrations of the steel bridge girders in wet concrete under normal traffic conditions. These experiments are used to quantify the deterioration of bonding strength between the girder and the concrete that result from the vibratory motion of the girders in the freshly mixed SCC. The experiments consisted of steel channel sections of various sizes placed vertically in rectangular forms as shown in Figure 6. SCC was placed around the steel channels to a depth of seven inches. For each experiment, two blocks were cast. Each block had identical channels and depths of SCC. The channel in one block was vibrated for 24 hours, starting immediately after the concrete placement, while the channel in the second block remains perfectly still for the same period. Figure 6 presents a picture of a pair of tests with channels in fresh SCC.

Figure 6: Steel channels in fresh SCC

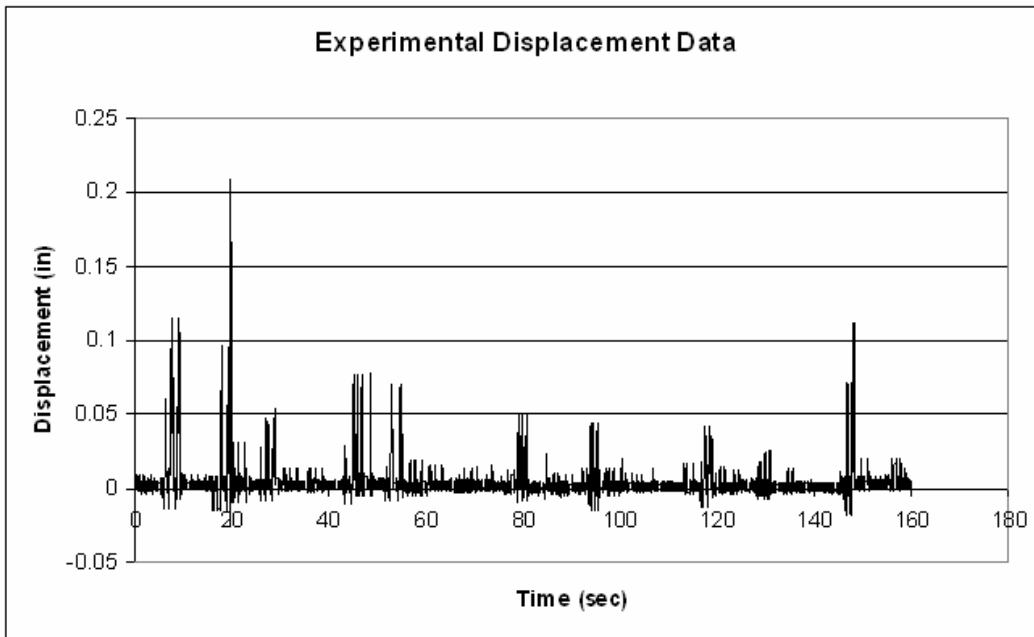
Figure 9 demonstrates a short time interval of the displacement data applied by the shake table. This signal is a modification of the recorded data. It has been filtered to reduce the electrical noise and it has also been shortened to remove periods of no traffic.

Figure 9: Displacement data for vibration experiments

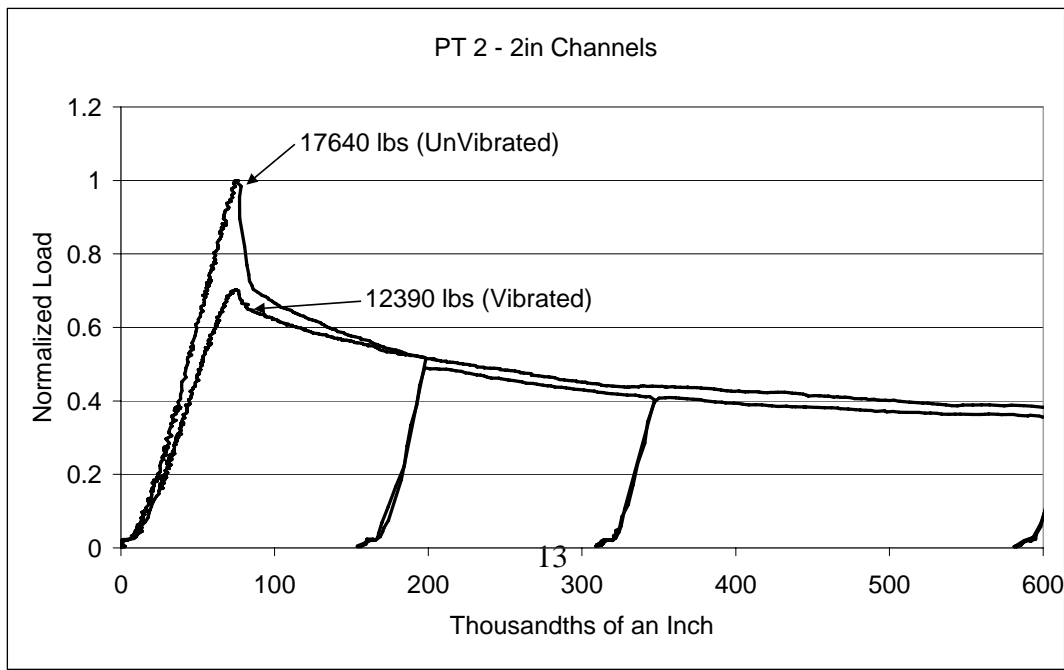
Figure 12 through 20 present the experimental load versus displacement plots for various push-through experiments. The push-through load in the plots is normalized to the bond strength of the un-vibrated channel. Note in Figures 17 and 19 that the bond strength of the vibrated

Figure 12: Push-through data for PT 2

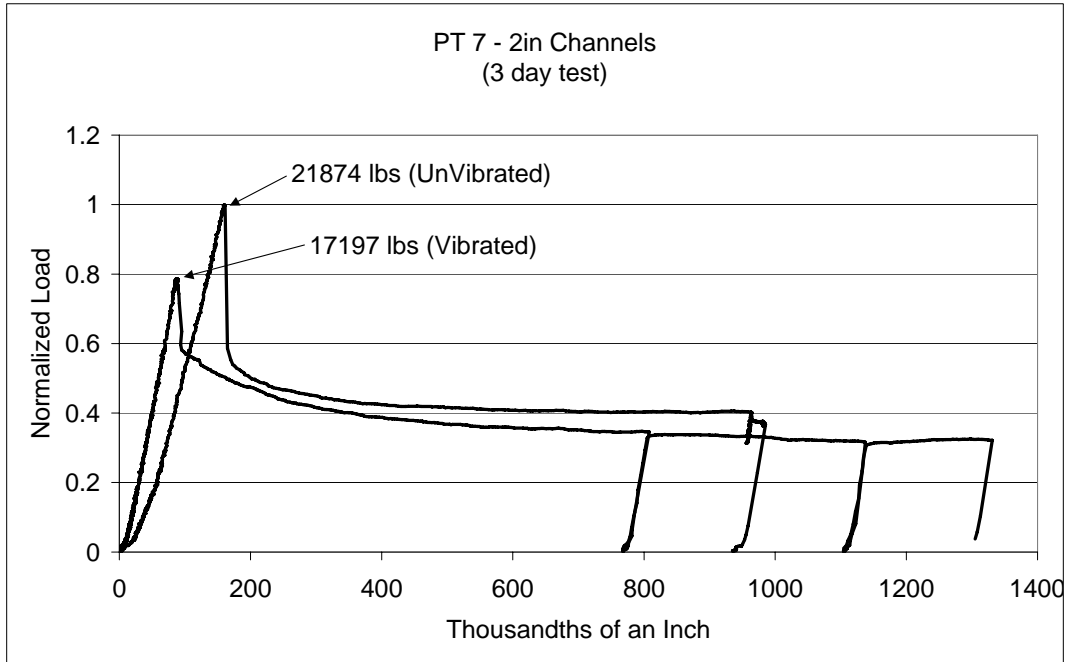
Figure 16: Push-through data for PT 7

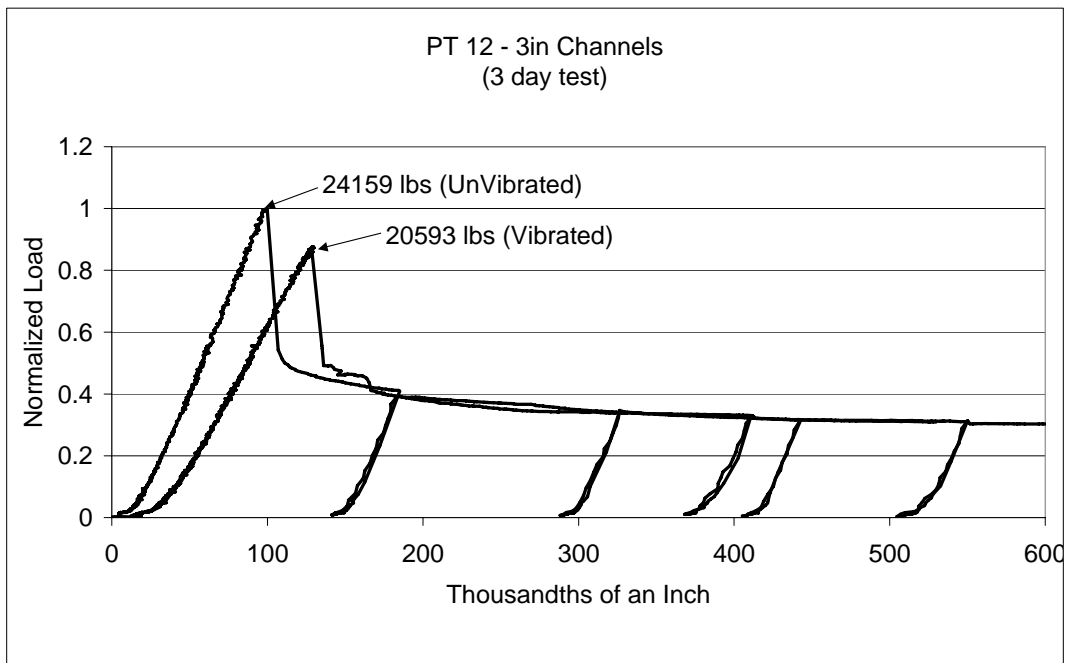
specimens was greater than that of the un-vibrated specimens. Also note the fairly significant (all frictional) residual strength after the initial failure even for large deformations indicating the excellent encapsulation of the channels by the SCC blocks. During the residual loading, unload-reload cycles were applied to separate the elastic and frictional response of the bond.

Figure 19: Push-through data for PT 12
