Report No. CDOT-2007-9
Final Report

EFFECTIVENESS OF LEDGES IN CULVERTS FOR SMALL MAMMAL PASSAGE

June 2007

**COLORADO DEPARTMENT OF TRANSPORTATION
RESEARCH BRANCH**

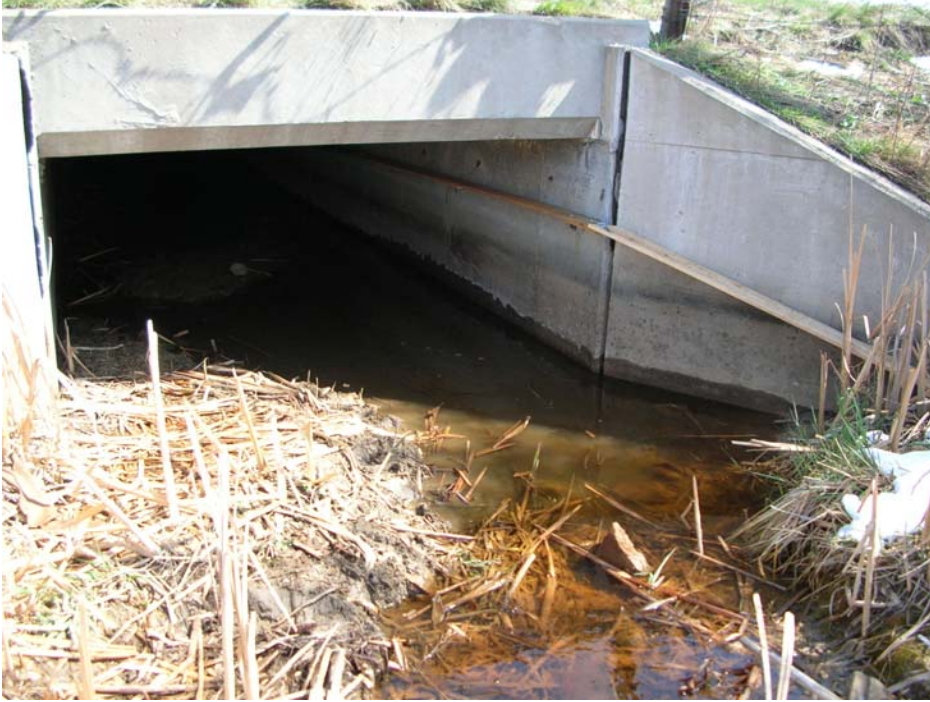
Culvert 1. Dry Creek Ditch No. 2 at U.S. 36.

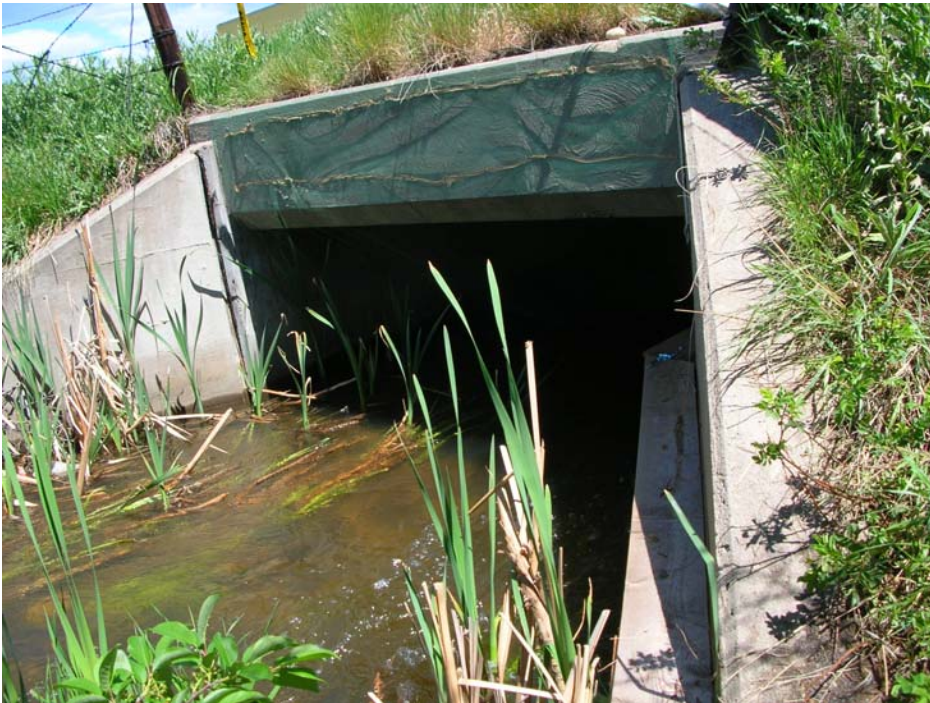
Culvert 2. Marshallville at U.S. 36.

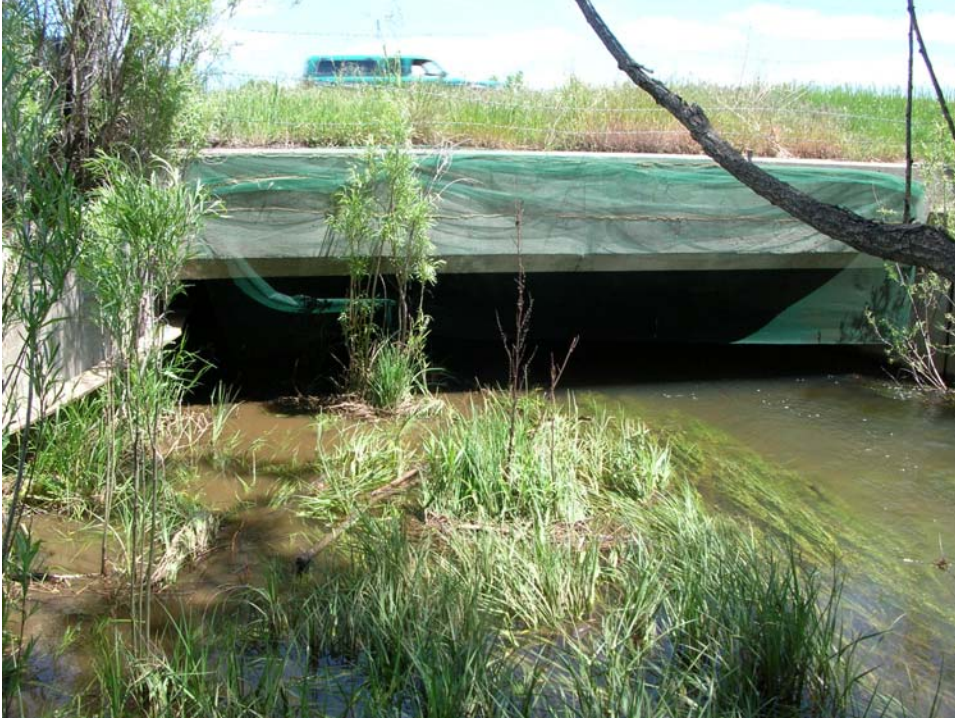
Culvert 3. Goodhue Ditch at U.S. 36. Bird netting visible.

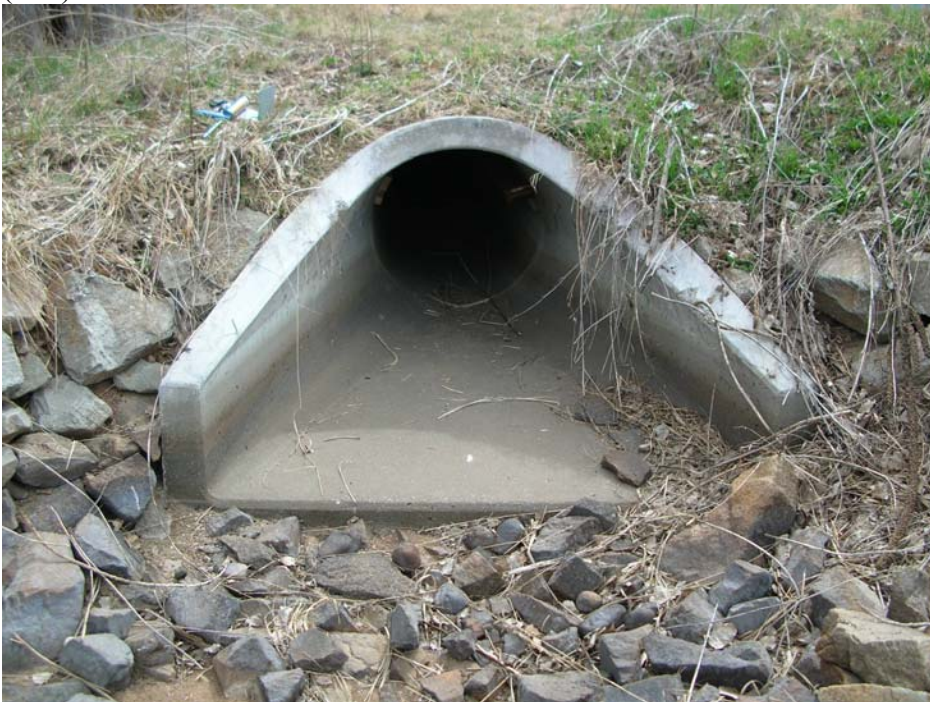
Culvert 4. East Boulder Ditch. This is a round concrete culvert and the smallest diameter (1 m) of all the culverts.

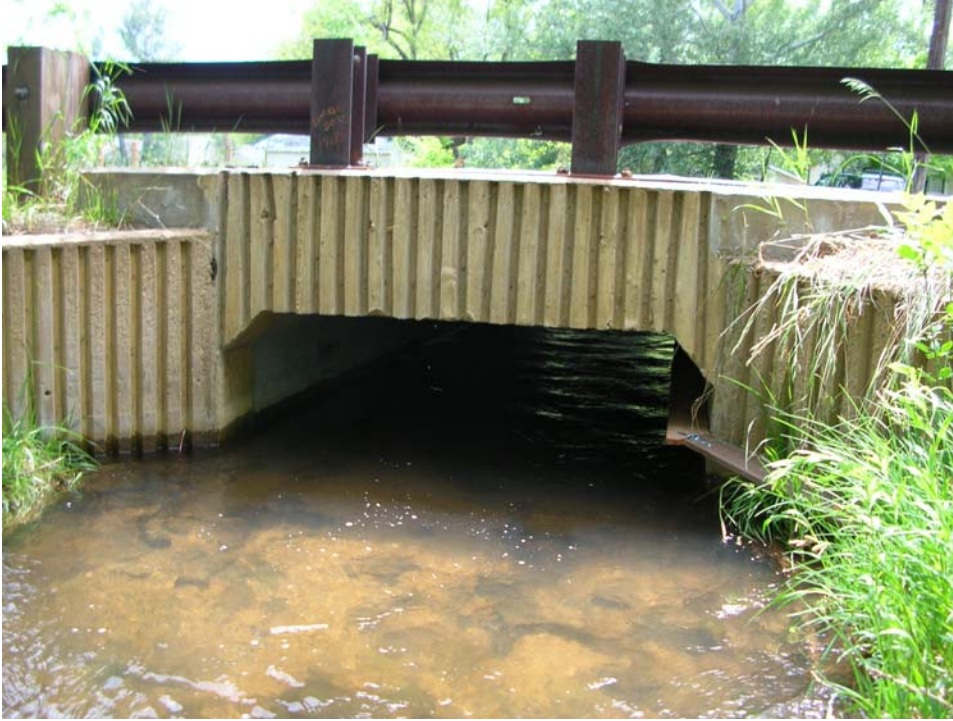
Culvert 5. Marshallville Ditch at Marshall Road. Both ledge and ramp visible at right; note strap hinge to connect them.

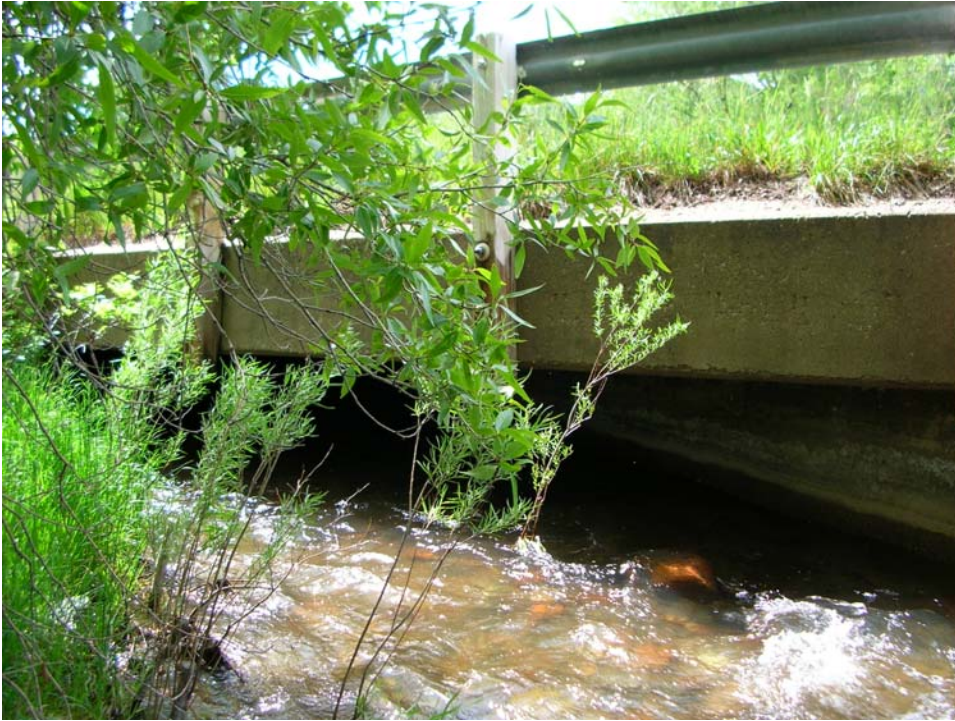
Culvert 7. Davidson Ditch at State Highway 170 in Eldorado Springs.
