# CDOT Region 3 Intersection Analysis and Prioritization Intersection Application 10<sup>th</sup> Street and Highway 50 City of Gunnison

# CDOT Region 3 Intersection Analysis and Prioritization Intersection Application Spencer Avenue and Highway 135 City of Gunnison

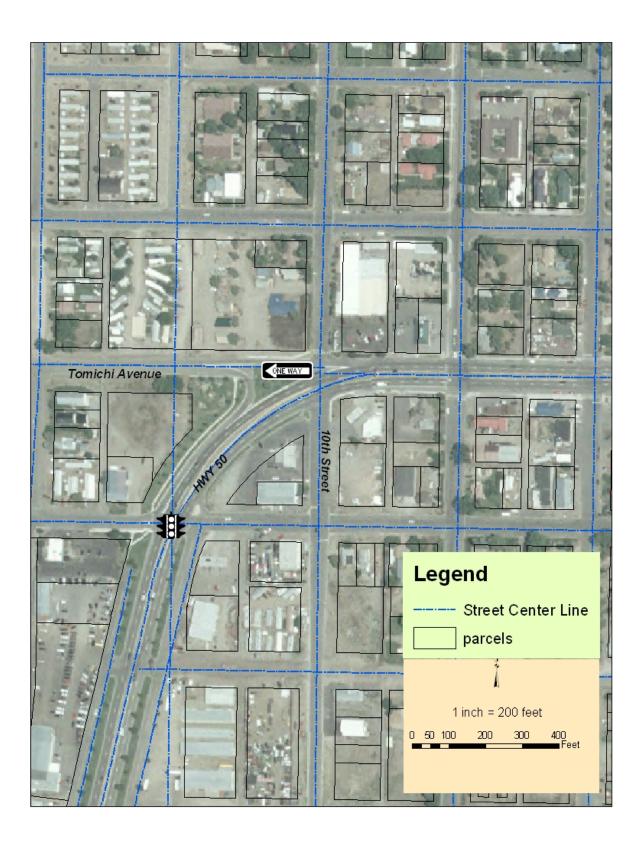
As noted in the text comments above, the width of the highway section and the geometric design are problematic. The intersection consists of five legs. A streetlight is located one block to the southwest of the 10<sup>th</sup> Street intersection which is problematic for optimal signalized separation.

The intersection serves to access the local high school, which is three blocks north of the intersection, and it also, serves to access a local retail business. Peak traffic volumes are experienced on weekdays (morning/afternoon) when school is in session. However, weekend traffic volumes during the summer season, which are generated by the retail store and summer visitors, is also very high.

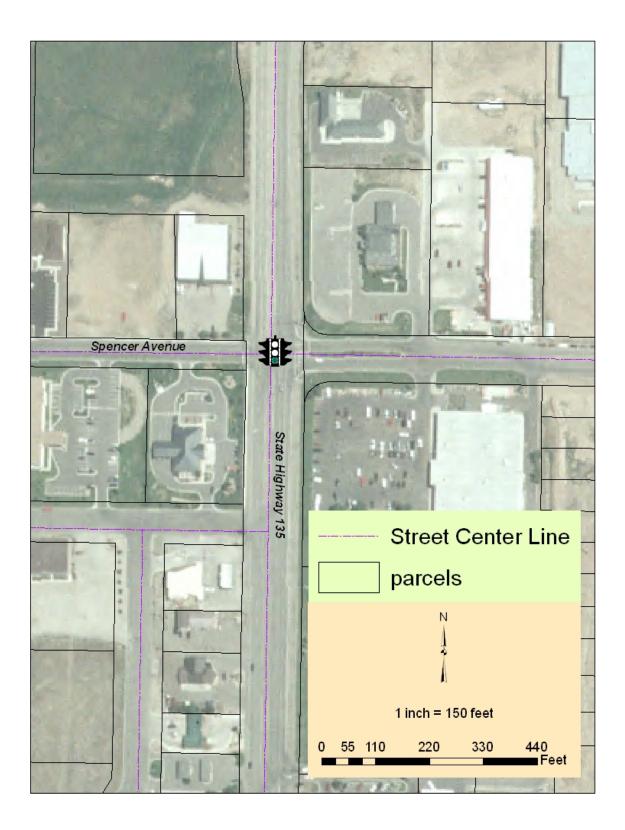
The geometric design does not accommodated functional and safe turning movements. Pedestrian facilities are not adequate and a significant number of citizens use this intersection crossing. Existing utility features make for challenging design solutions – some utilities will need to be moved.

The intersection serves to access to a major retail area and the City's Community Center and Pool. Peak traffic volumes are experienced on weekdays (morning/afternoon) when school is in session. However, weekend traffic volumes during the summer season, which are generated by the retail businesses and summer visitors, is also very high.
