<b>COLORADO DEPARTMENT OF TRANSPORTATION INITIAL SITE ASSESSMENT (ISA)</b>	Region: 2 Route ID: US 50	Project No.: STA 050A-002 Project Code (SA#): 19056
--	------------------------------	--

Project Name: **Westbound US 50 Lane Wills Blvd. to McCulloch Blvd.**  
Milepost Begin: **312.87** Milepost End: **307.00** County: **Pueblo**  
Location: **Approximate project center: NE ¼ SE ¼ Section 7, T20 S, R65 W (Lat 38.324 and Long -104.701)**  
Main Project Elements: **Widen US 50 (WB third travel lane) from Wills Blvd. to McCulloch Blvd. (approx 5.87 miles) and build new infrastructures at Purcell Blvd./US 50 and Pueblo Blvd./US 50 (See Figure 1)**

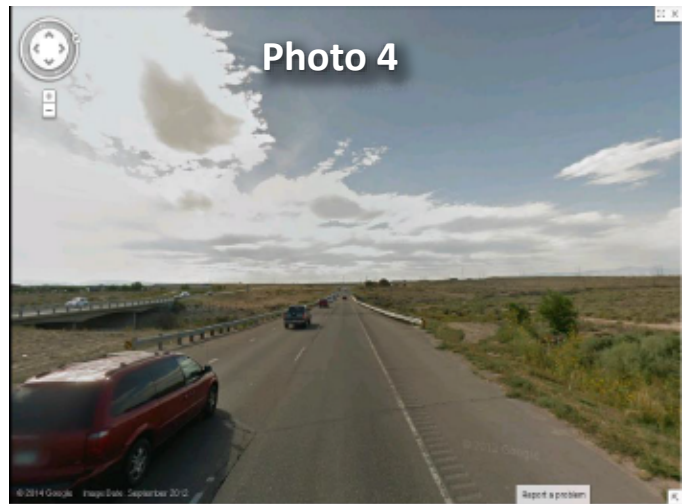
Photo 4

US 50 spanning over Wildhorse Creek.

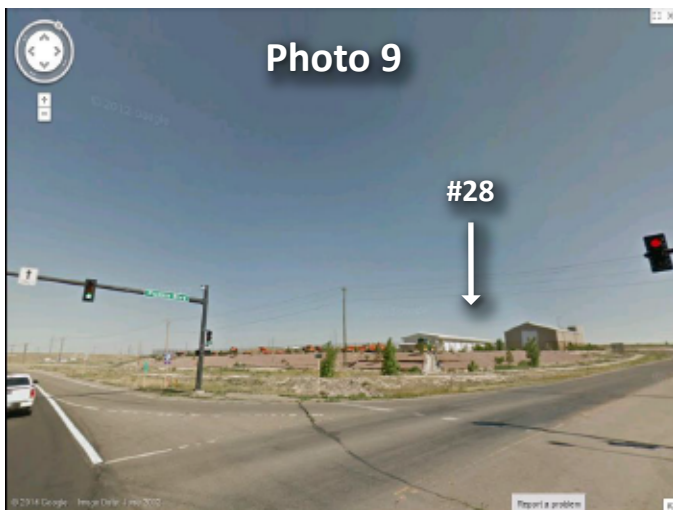
CDOT Maintenance facility (GeoSearch Site 28) is located in the NW corner of WB US 50 and Pueblo Blvd.

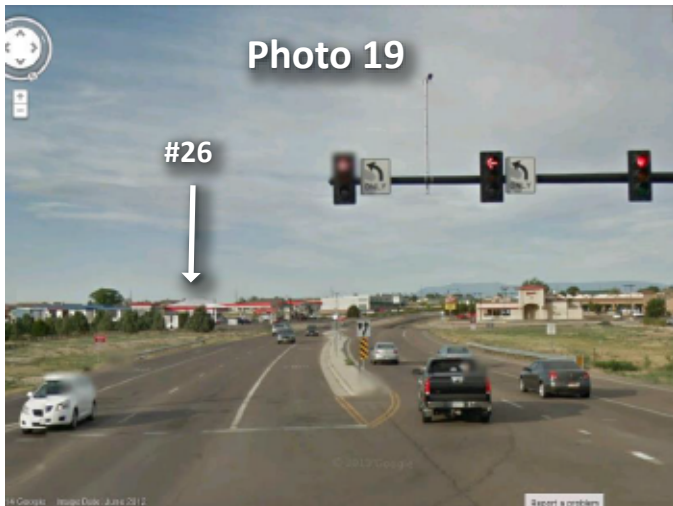
Looking south on Purcell from US 50, Loaf and Jug #85 (GeoSearch Site 26) with retail stores in the background.

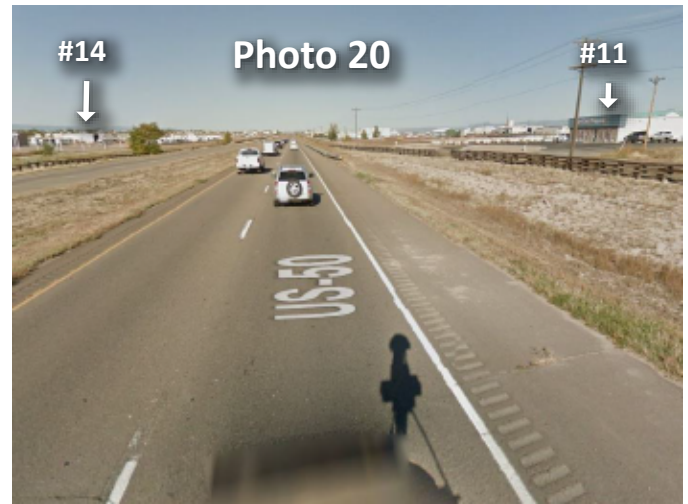
View of WB US-50, Zabukovic Motors (GeoSearch Site 14) located to the south of US 50 and Mar Gas Propane (GeoSearch Site 11) located to the north of US 50.

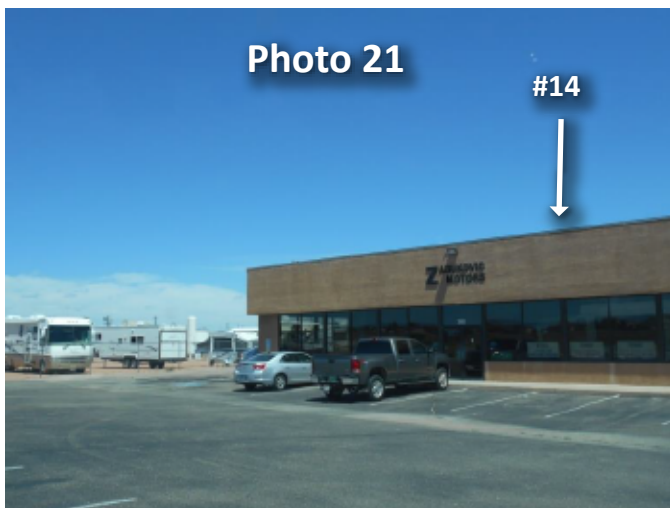
An aboveground storage tank was present at Zabukovic Motors (GeoSearch Site 14). Zabukovic Motors is located south of US 50.

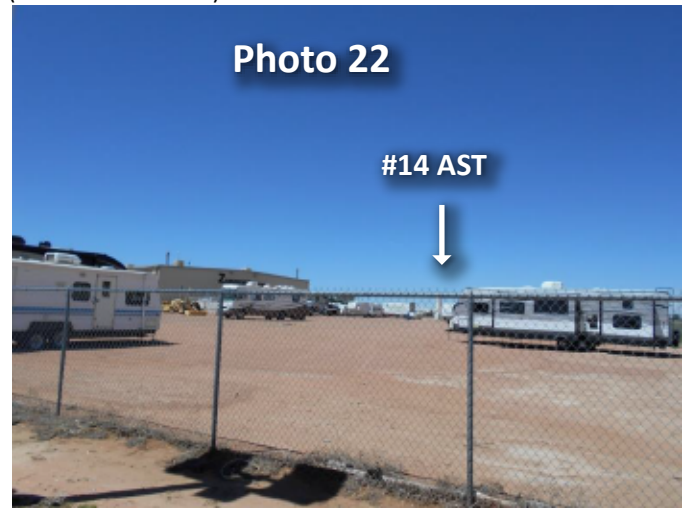
Zabukovic Motors (GeoSearch Site 14) seemed to be a motor home dealership or storage location. 55 gallon drums were observed on the north side of the building.

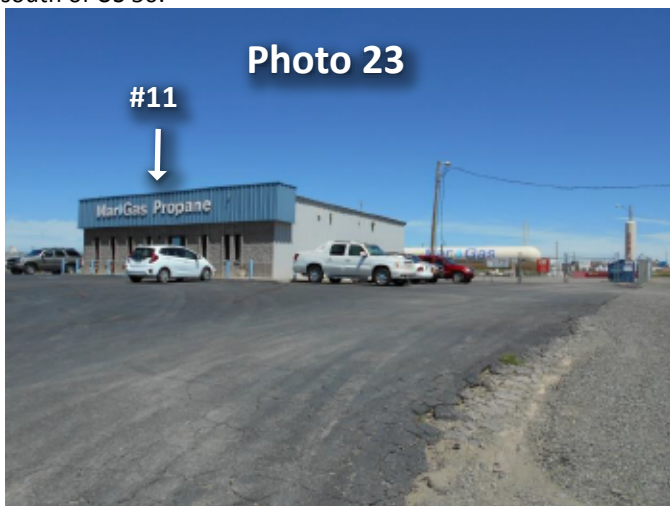
Aboveground storage tanks were present at Mar Gas Propane (GeoSearch Site 11).

38
11	AST	0.07 N Up-Gradient	MAR GAS PROPANE	805 ENTERPRISE DR	Propane gas storage facility with ten active ASTs and two non-active ASTs (closed date not recorded) containing liquefied petroleum gas. No records of leaks. No off site Haz Mat concerns during the site visit.	20, 23
12	SWF	0.07 SW Down-Gradient	GMACK ENTERPRISES	175 E SPAULDING	Automobile repair facility registered Tire Hauler that uses/stores RCRA of solvents (car repairs). No off site Haz Mat concerns during the site visit.	33
13	SWF	0.07 SE Up-Gradient	SOUTHWEST MOTORS INC	2680 W HWY 50	Automobile dealership registered tire hauler that uses/stores RCRA of solvents (car repair). No off site Haz Mat concerns during the site visit.	N/A
14	AST	0.07 SW Down-Gradient	ZABUKOVIC MOTORS	701 E SPAULDING	RV/trailer storage and dealership with one active AST containing liquefied petroleum gas. No record of leaks. No off site Haz Mat concerns during the site visit.	20, 21, 22

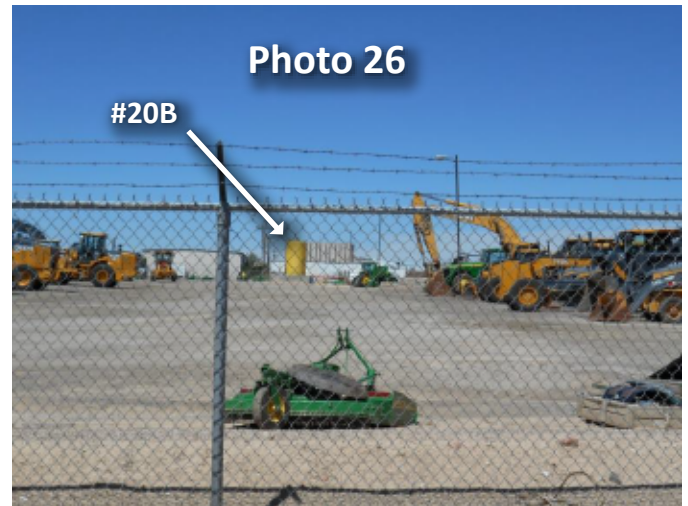
Aboveground storage tank was present north of the 4 Rivers Equipment and John Deer (GeoSearch Site 20/20B).

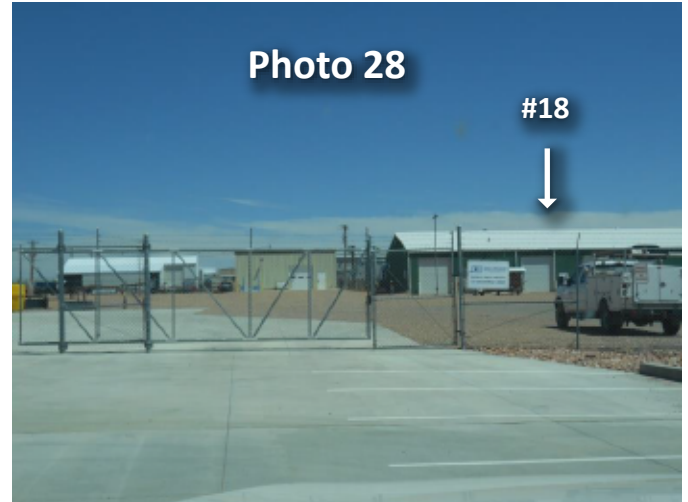
A water quality pond was located in the southeast of the Tri-State Generation (GeoSearch Site 18) lot.

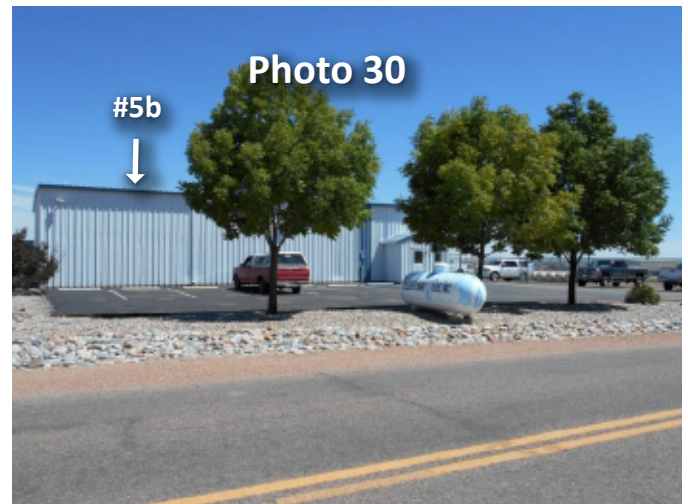
View of Blue Flame Gas (GeoSearch Site 5b) on the south side of the building. Located between milepost 308-309, west of undeveloped land and Abra Auto Body and Glass.

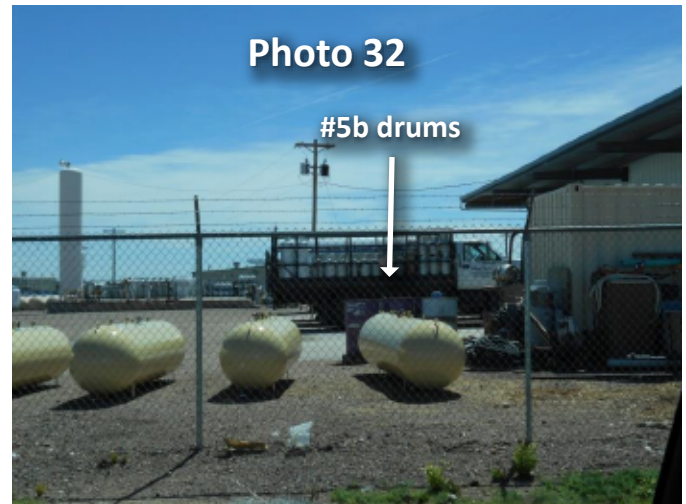
Looking east at Blue Flame Gas (GeoSearch Site 5b) aboveground tank facility and 55 gallon drums.

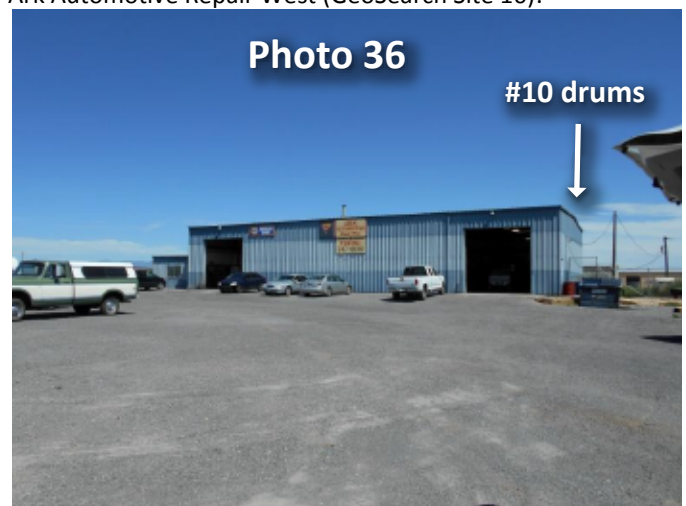
View of Ark Automotive Repair West (GeoSearch Site 10); east of the building is located 55 gallon drums. Located between milepost 208 to McCulloch.

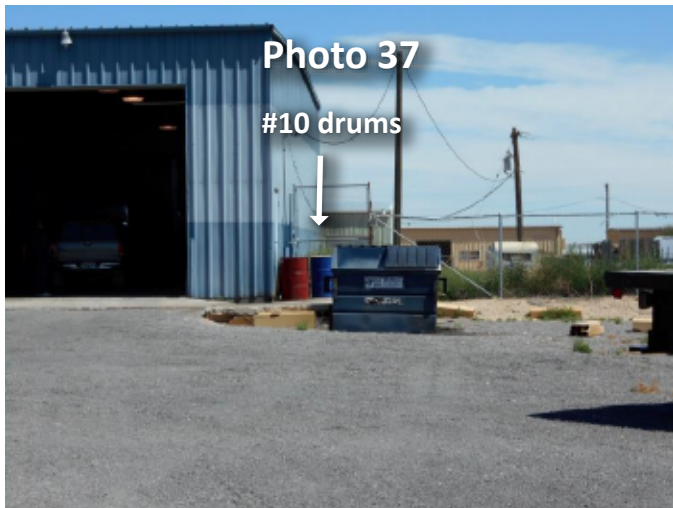
Located 55 gallon drums on the east side of Ark Automotive Repair West (GeoSearch Site 10).

10	SWF	0.06 N Up-Gradient	ARK AUTOMOTIVE REPAIR WEST	12 N RESEARCH DR	Automobile repair facility registered Tire Hauler that uses/stores RCRA of solvents (car repairs). No off site Haz Mat concerns during the site visit.	34, 36, 37,

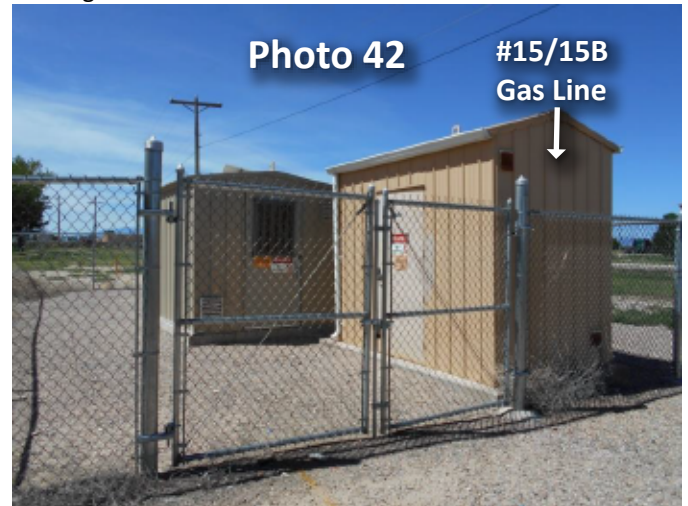
Two gas pipeline sheds are located on the west side of the Hewitt-Robin and Gartner USA building (GeoSearch Site 15/15B).
